| Project Name | Cornfield Close Validation |
| Project No. | GE18103 |
| Client | Thakeham Homes |

*Gas Protection Measures Inspection Report*

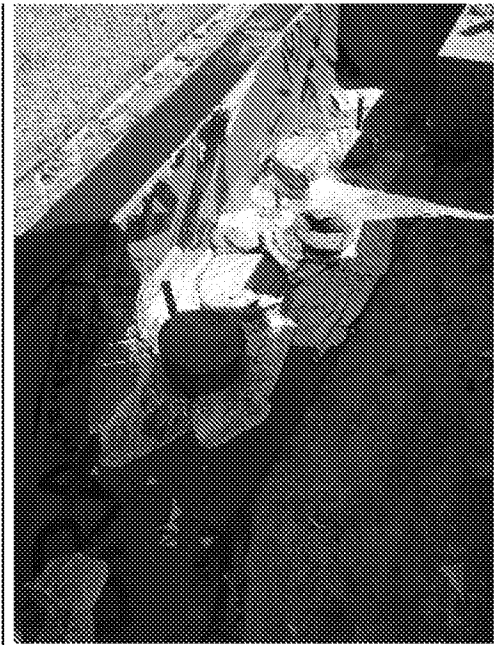
Block A services

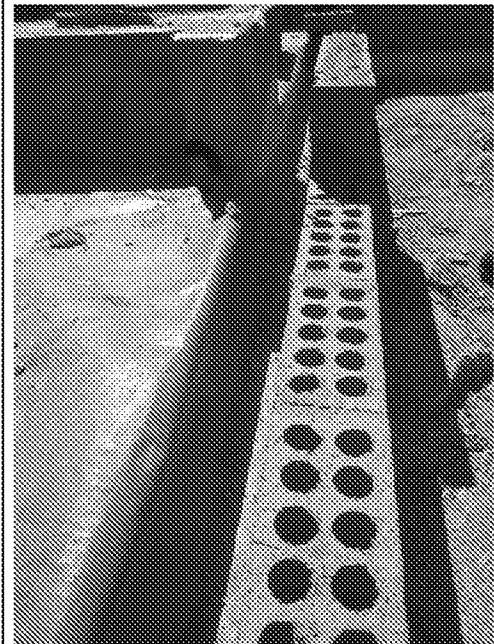
Block A cavity

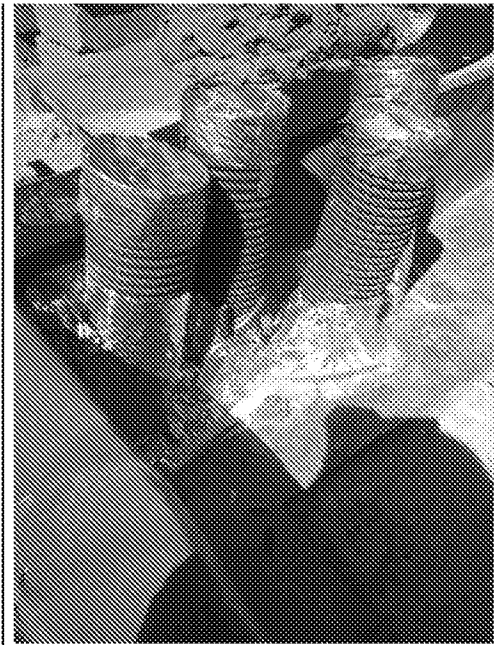
Block A water

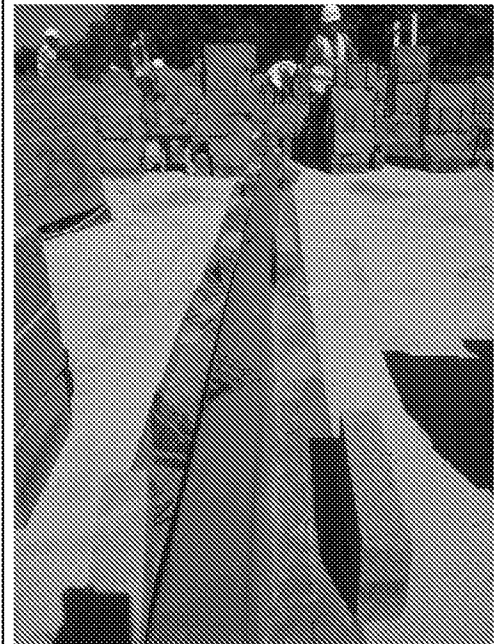
Block A overview

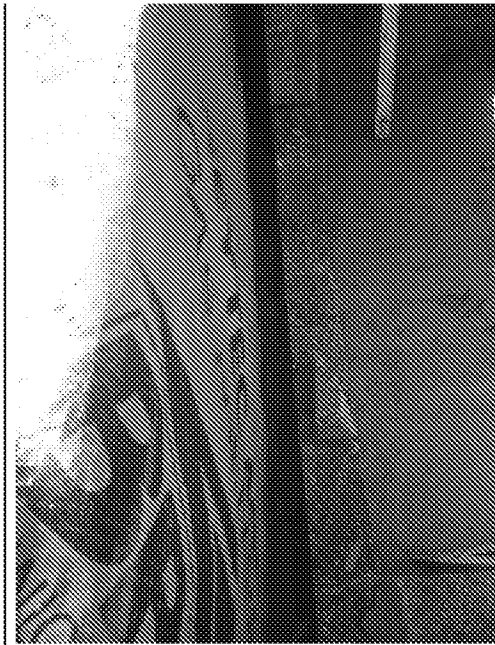
Block B pit

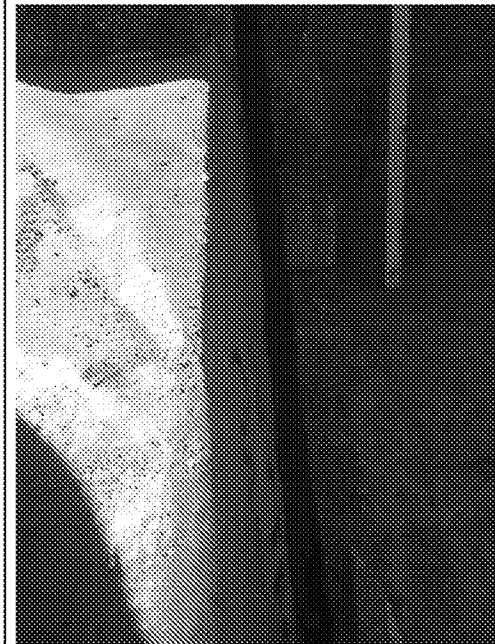
Block B damage

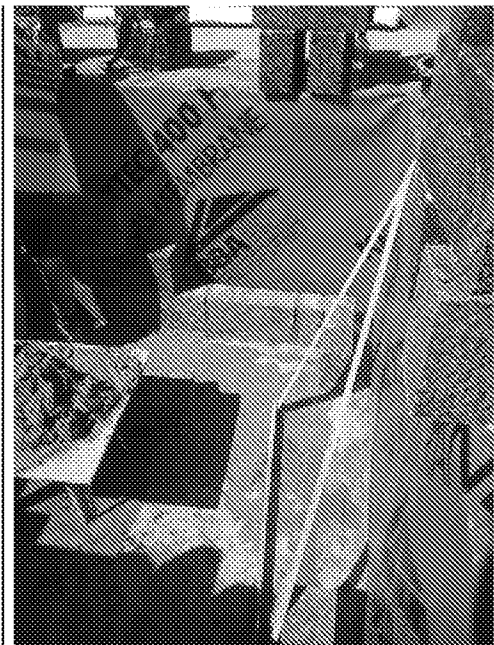
Block B overview

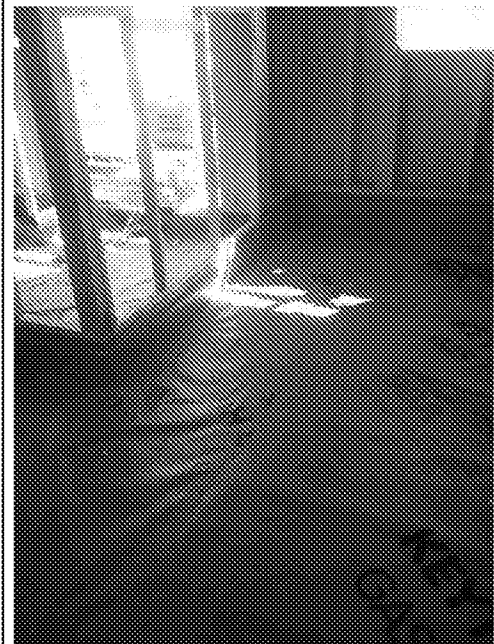
Plot 3 overview

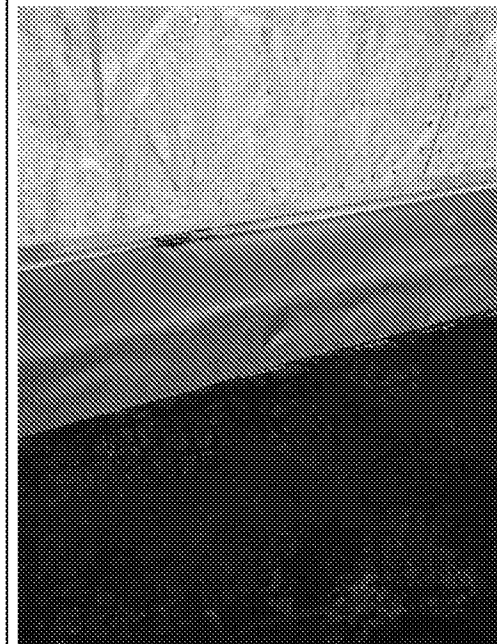
Plot 4 - Black putty tape sealant  
under frame

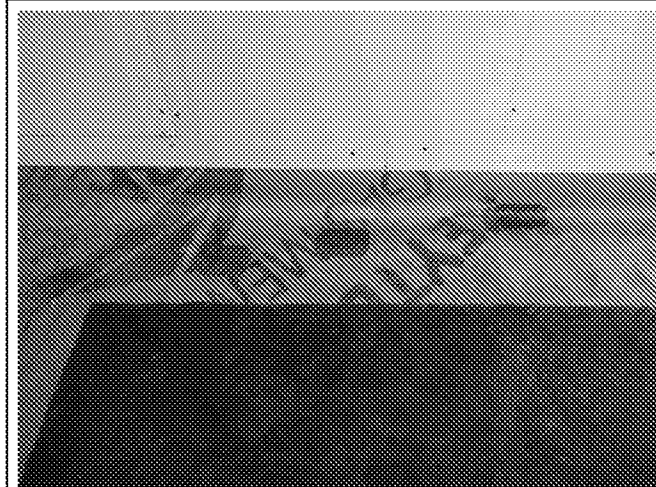
Plot 4 - Patching of any holes has  
already been completed

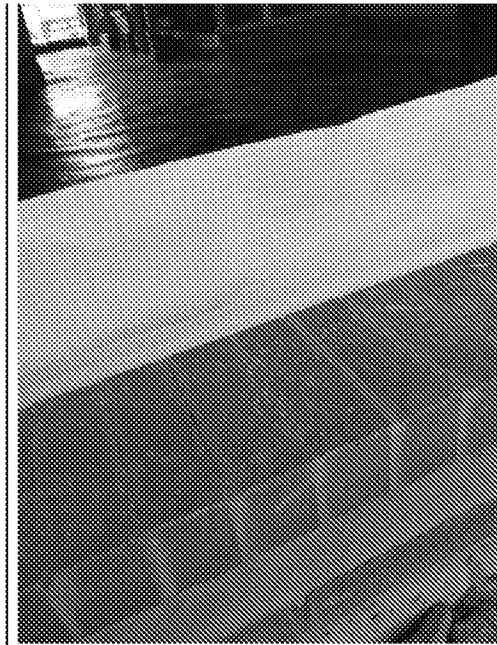
Plot 4 - underside of membrane in good condition

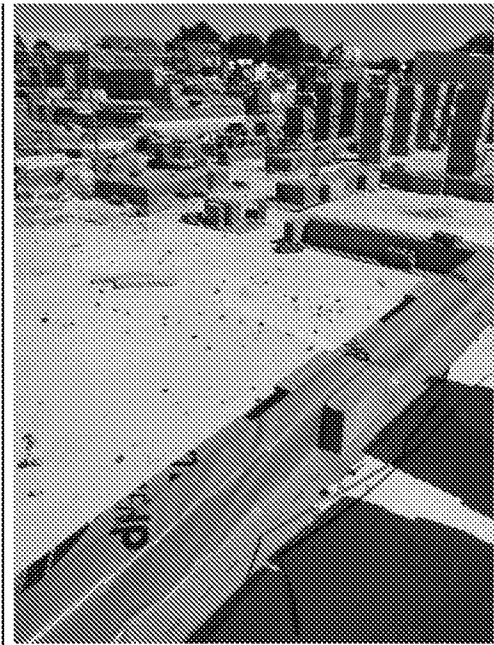
Block B - membrane

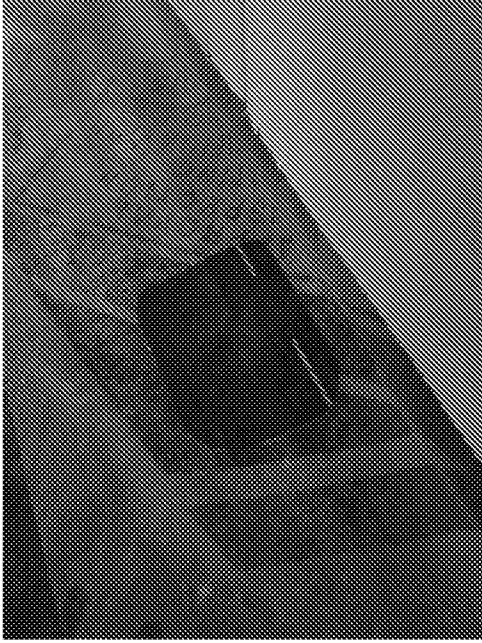
Plot 6 repair

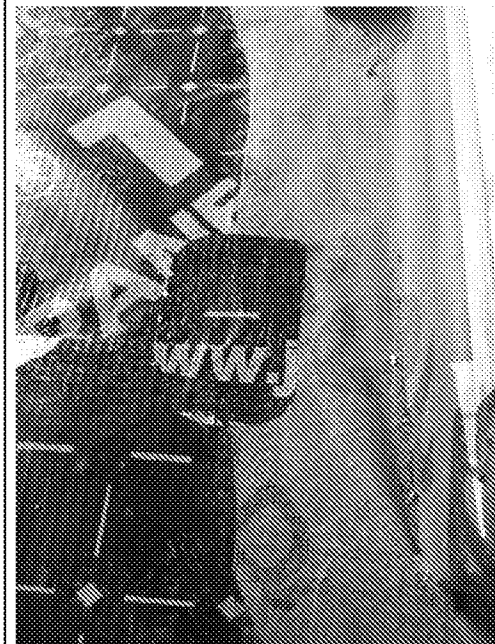
Plot 9 patch repair

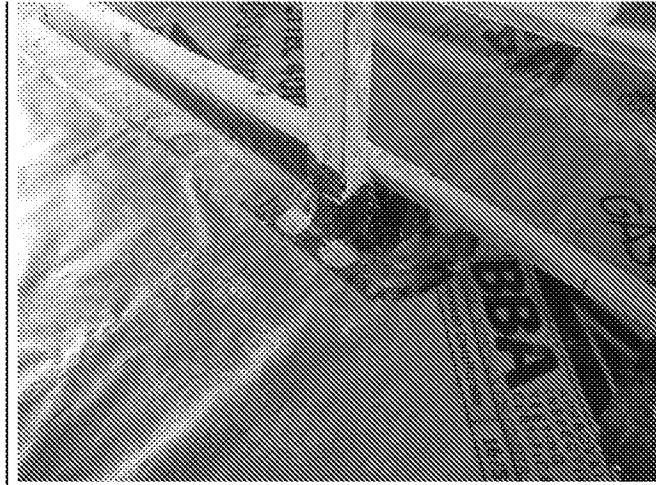
Plot 13 - Patching

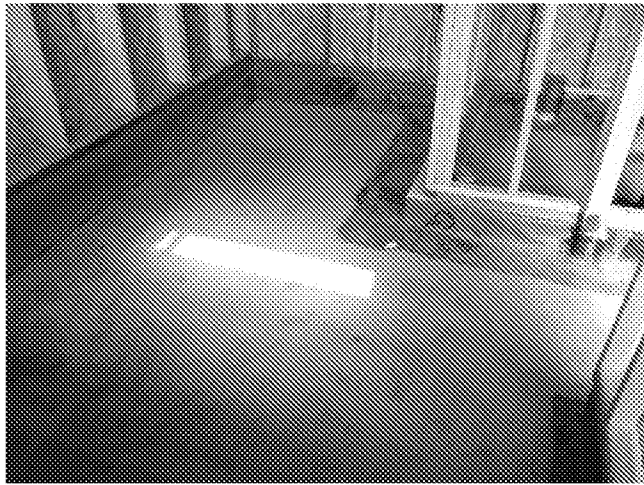
Plot 15 - Floor swept and in good condition

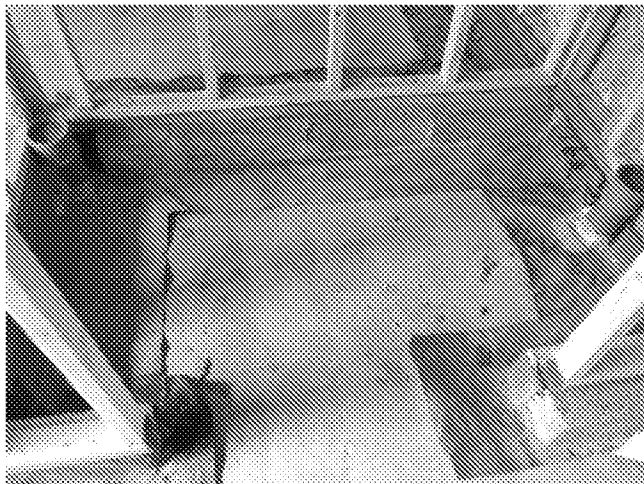
Plot 15 - Services sealed

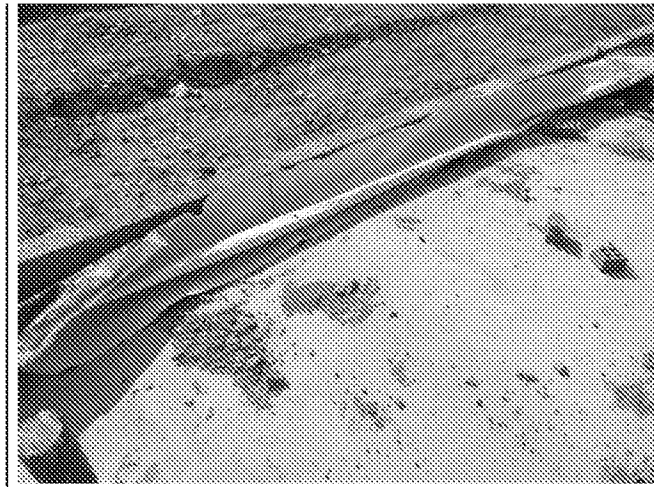
Plot 20-21(Phase 4) - Wind damage

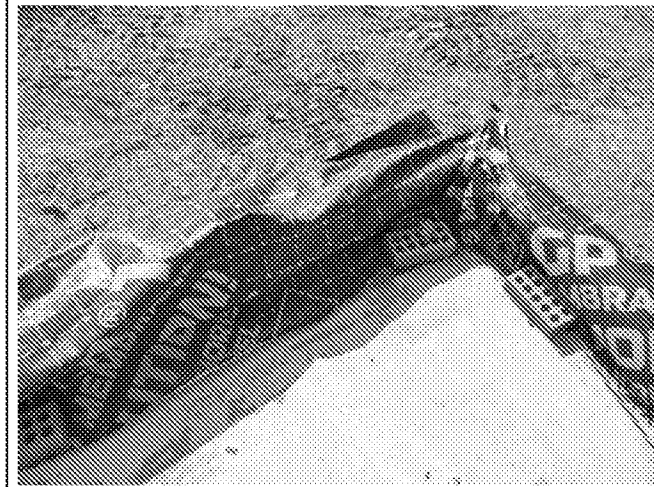
Plot 20-21(Phase 4) - Damaged membrane will be replaced before bitumen tape placement
