# **Windroos, Littlehampton**

## **Remediation Validation Report**

A111089

February 2020

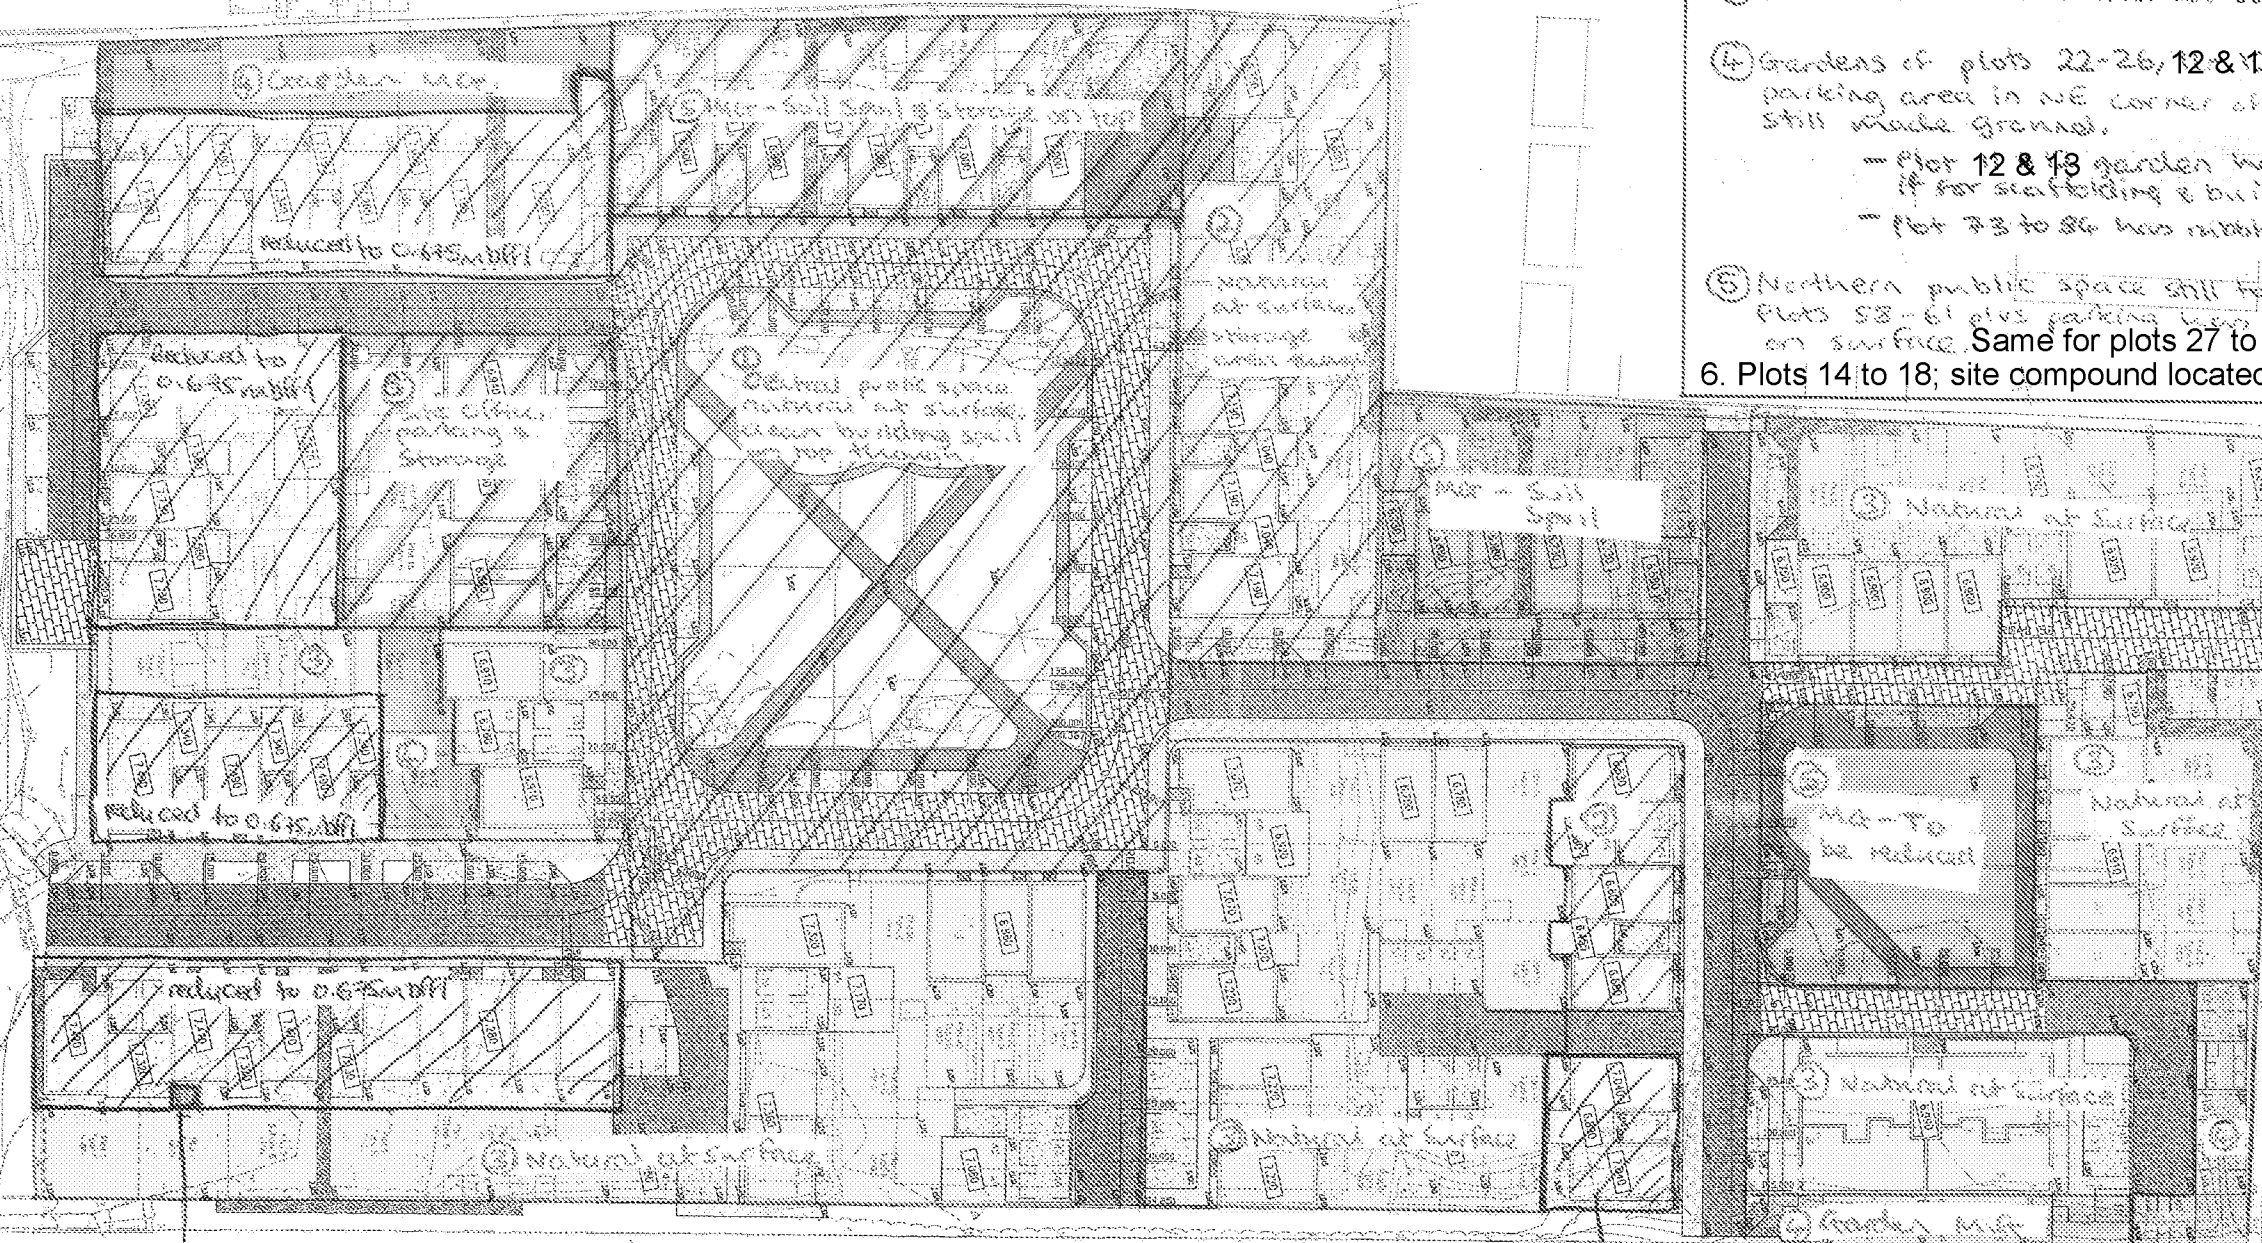
Old cesspit filled in in  
early July. New built  
over.

Raised to  
0.675, off  
with natural  
spot from  
green being  
reduced.

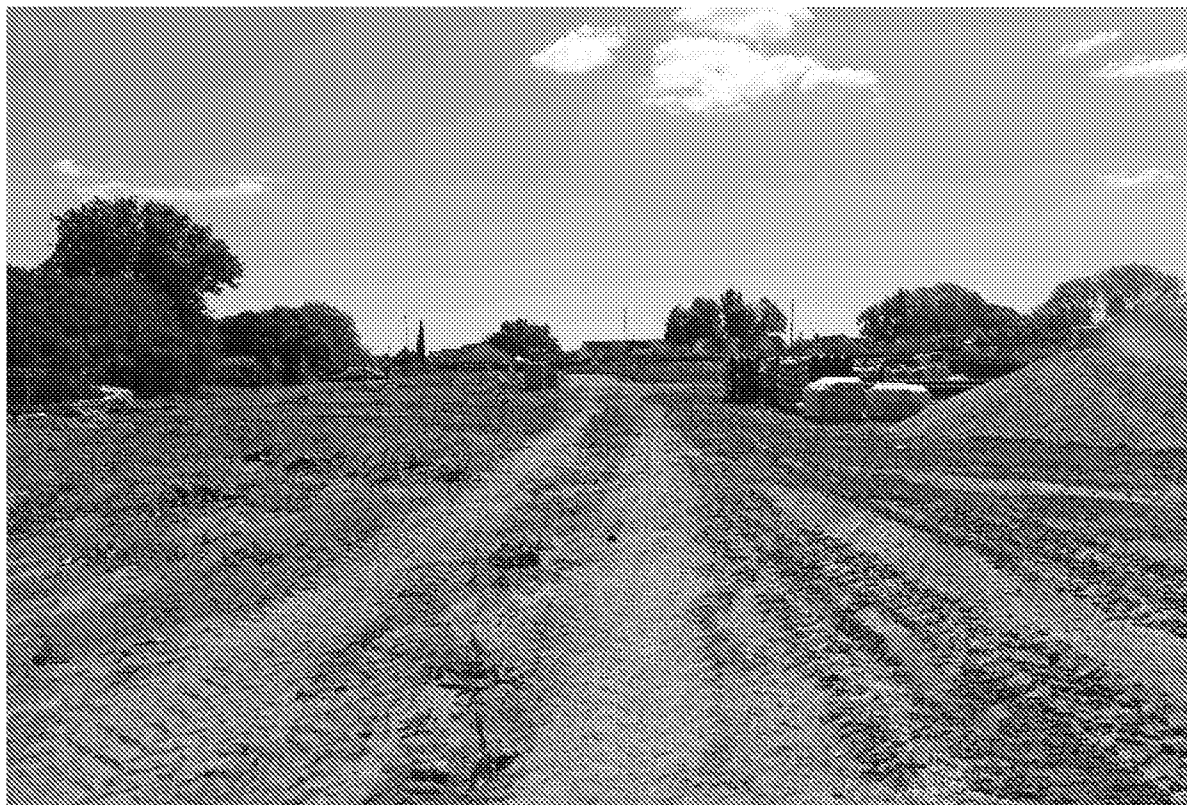
**Plate 1**      21st May 2019 - Looking South to the site entrance from centre east of site.

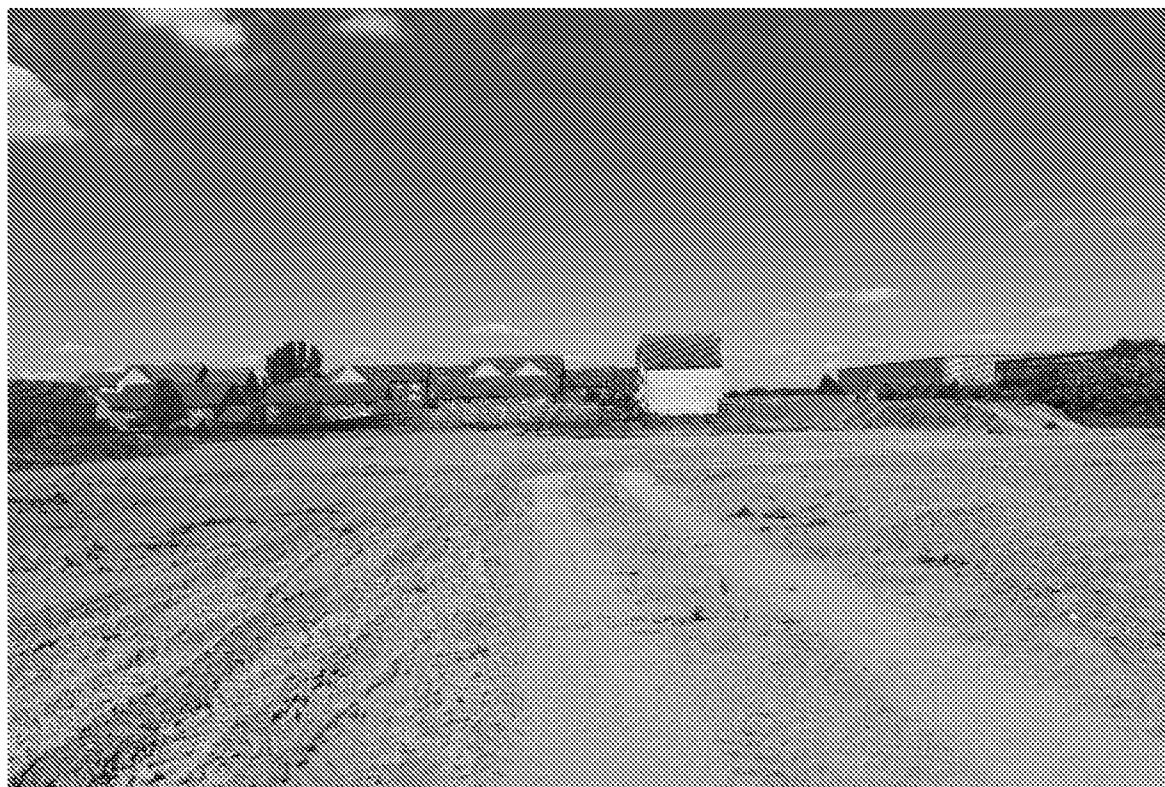
**Plate 2**      21st May 2019 - Looking to the North of the site from the centre of site

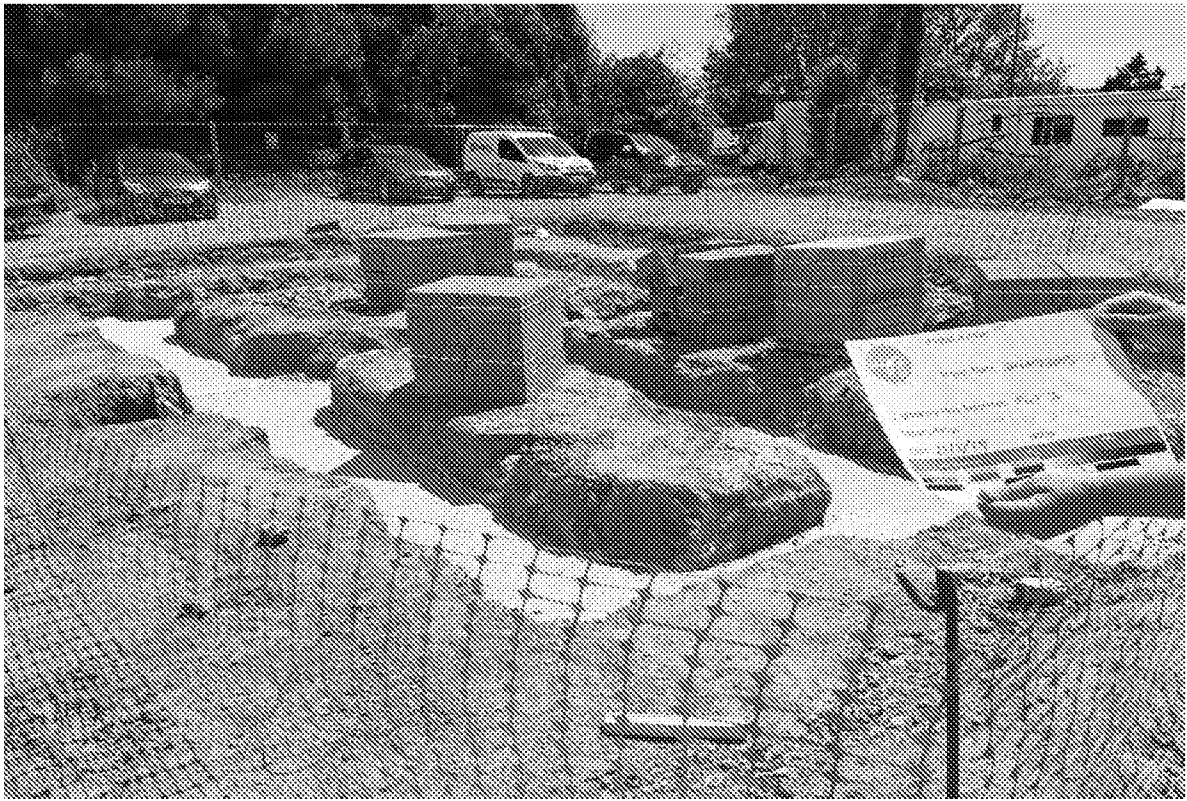
**Plate 3**

21st May 2019 - Plot 1 visible at natural surface.

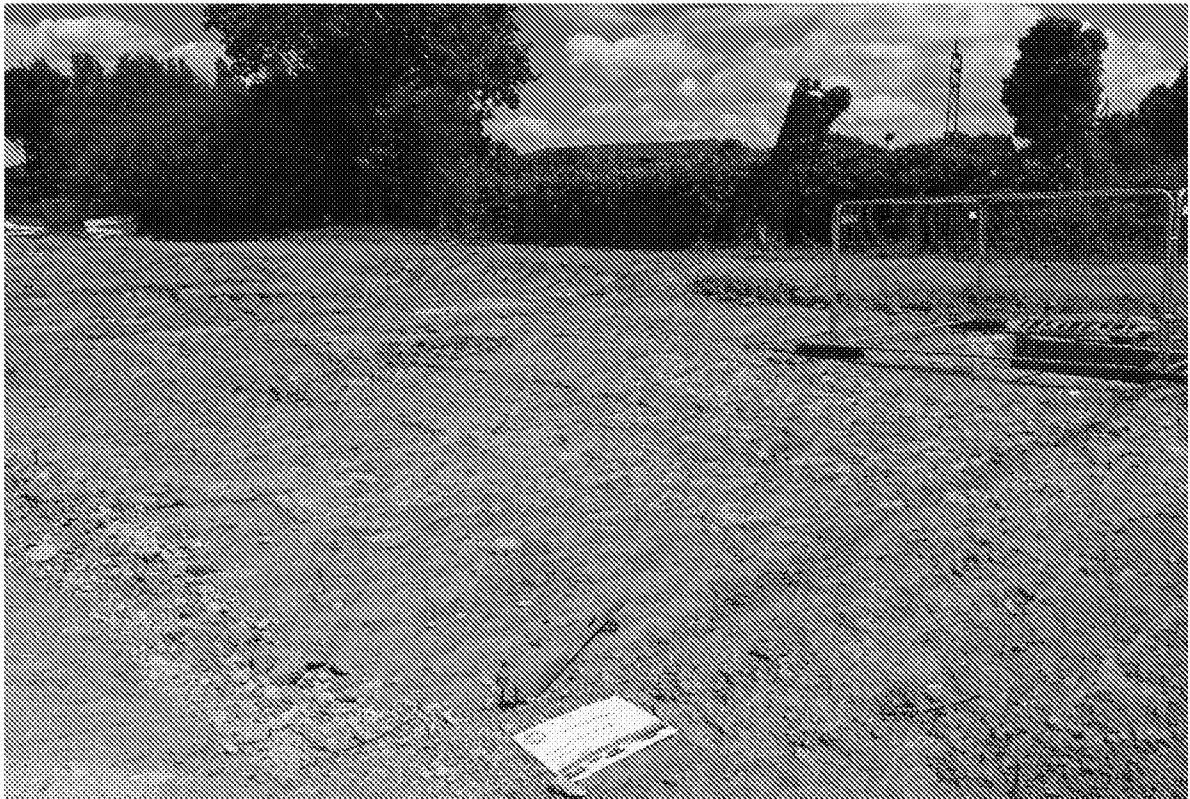
**Plate 4**

21st May 2019 - Plot 2 visible at natural surface.

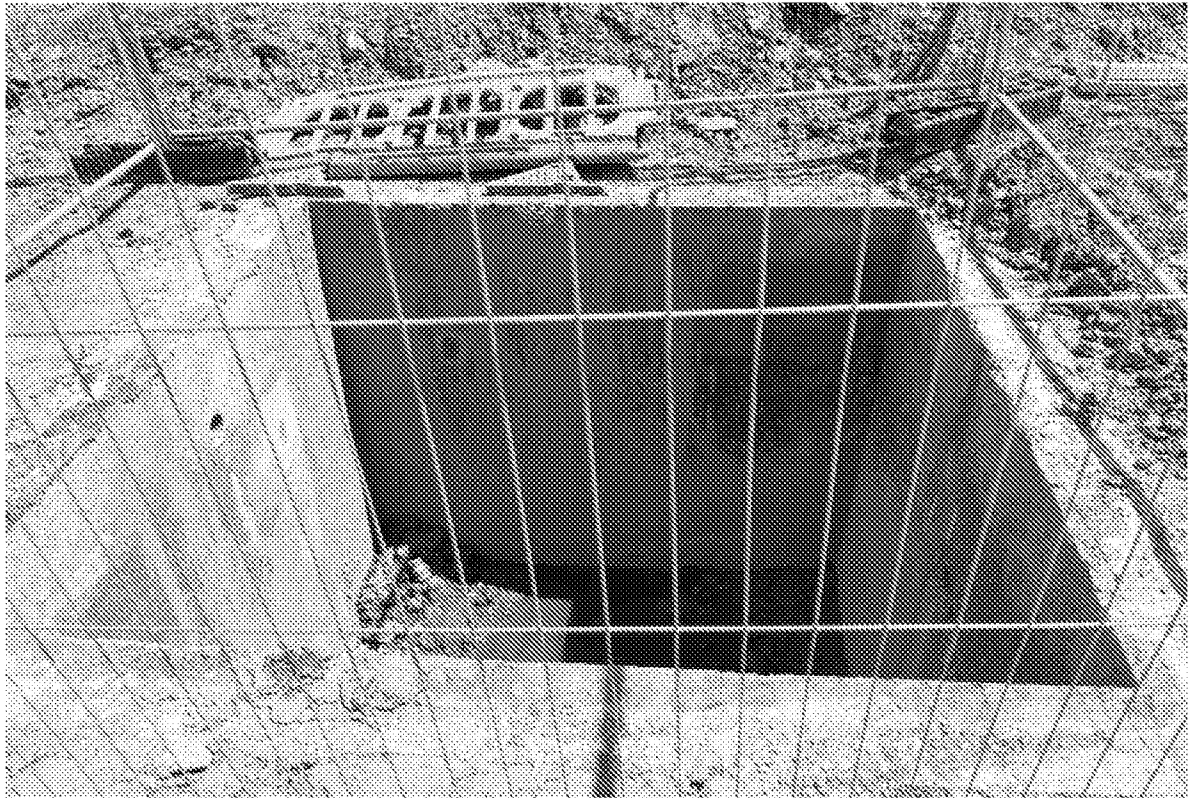
**Plate 5** 21st May 2019 - Cesspit located on plot 2 still visible on this visit.

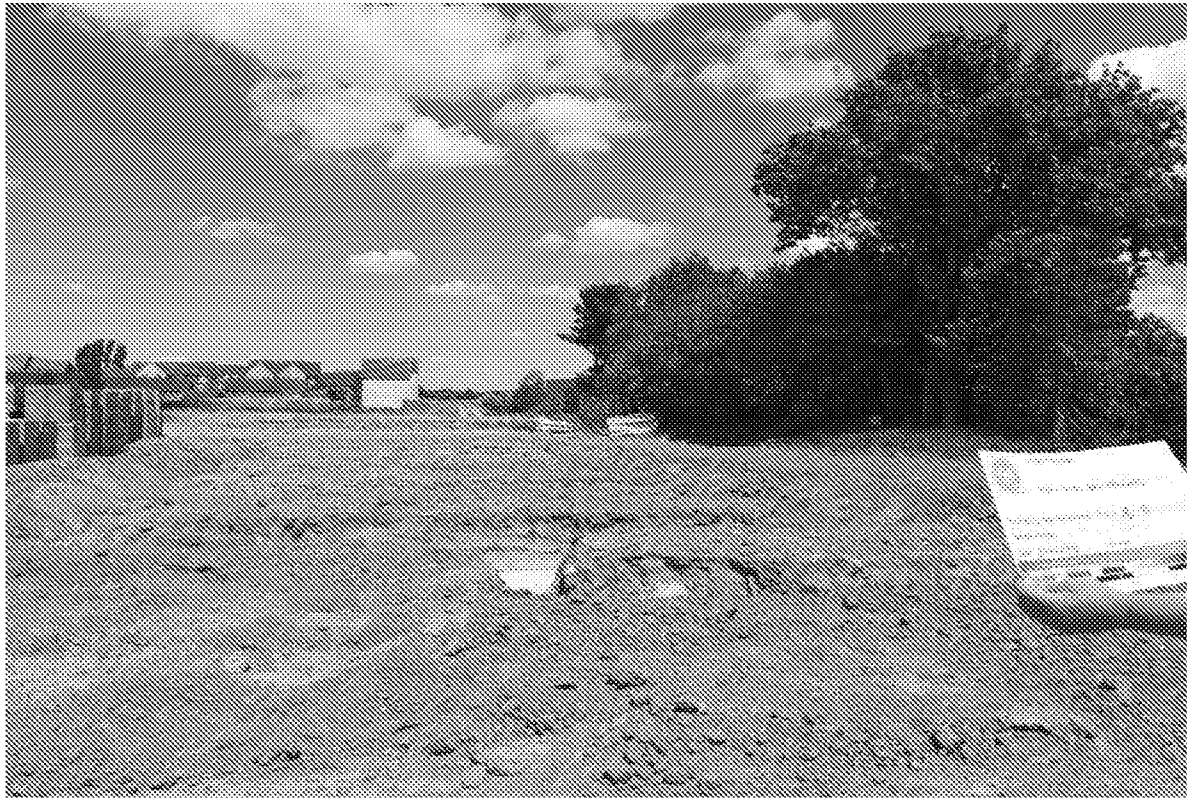
**Plate 6** 21st May 2019 - Plots 3 to 8 visible on this visit.

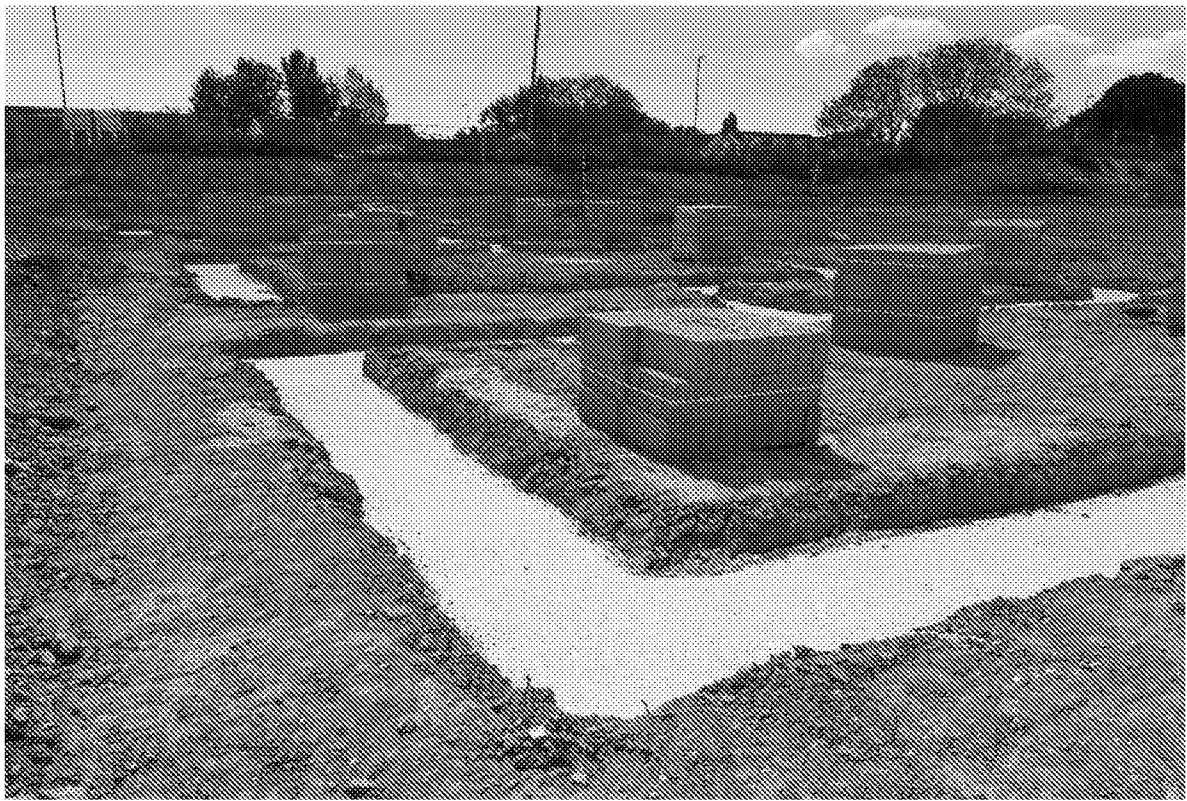
**Plate 7** 21st May 2019 - Plots 9 to 11 visible at natural surface.

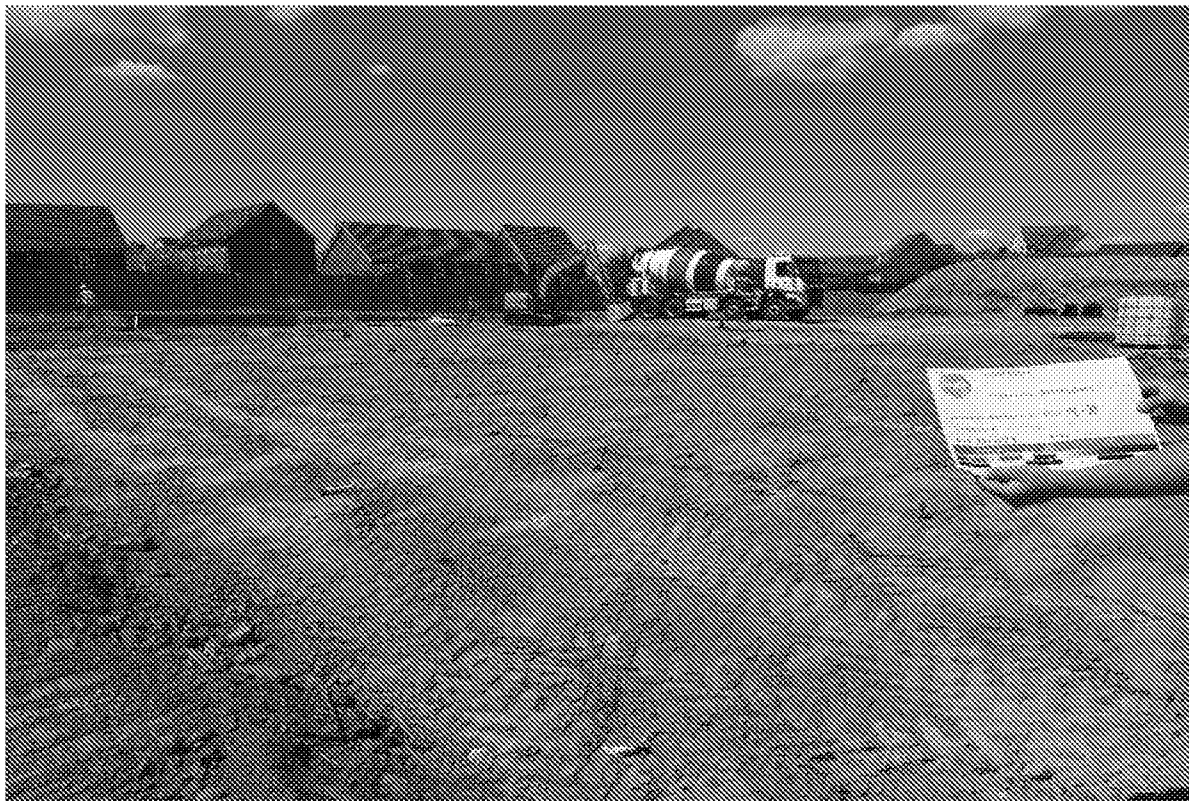
**Plate 8** 21st May 2019 - Plots 19 to 21 visible at natural surface. Including gardens.

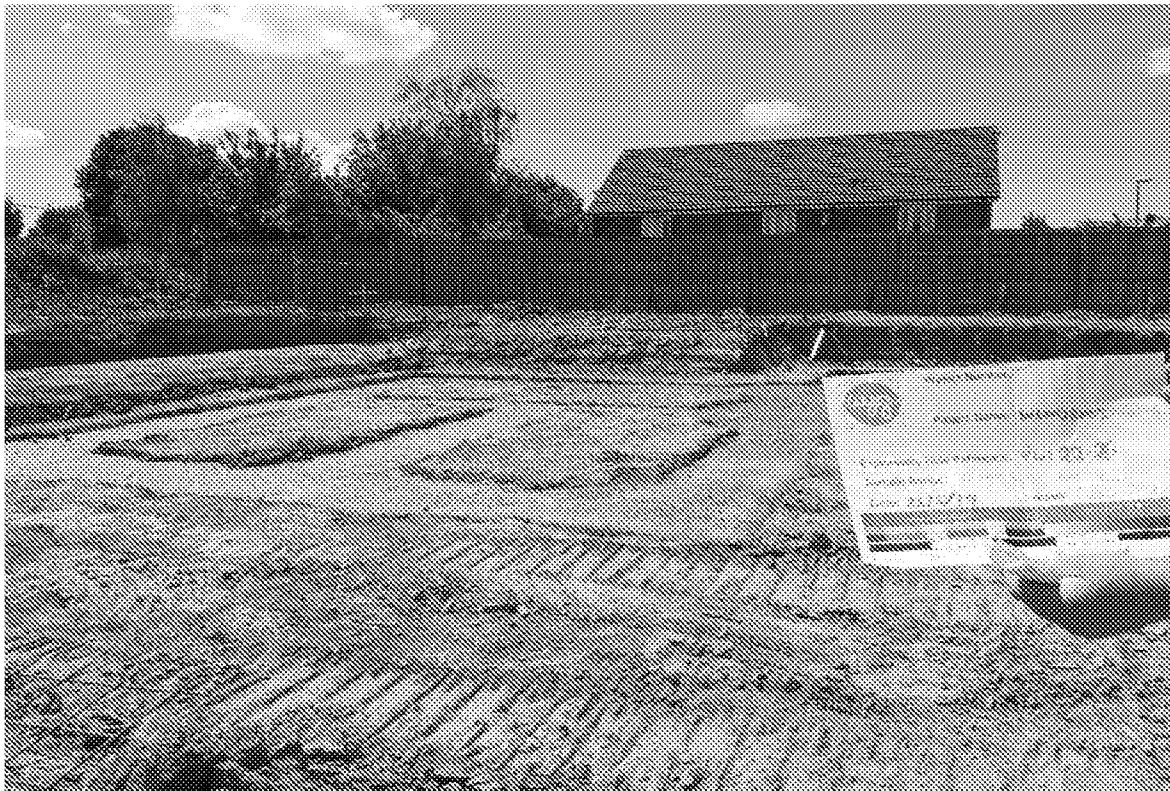
**Plate 9** 21st May 2019 - Plots 22 to 25 looking West, natural at surface.

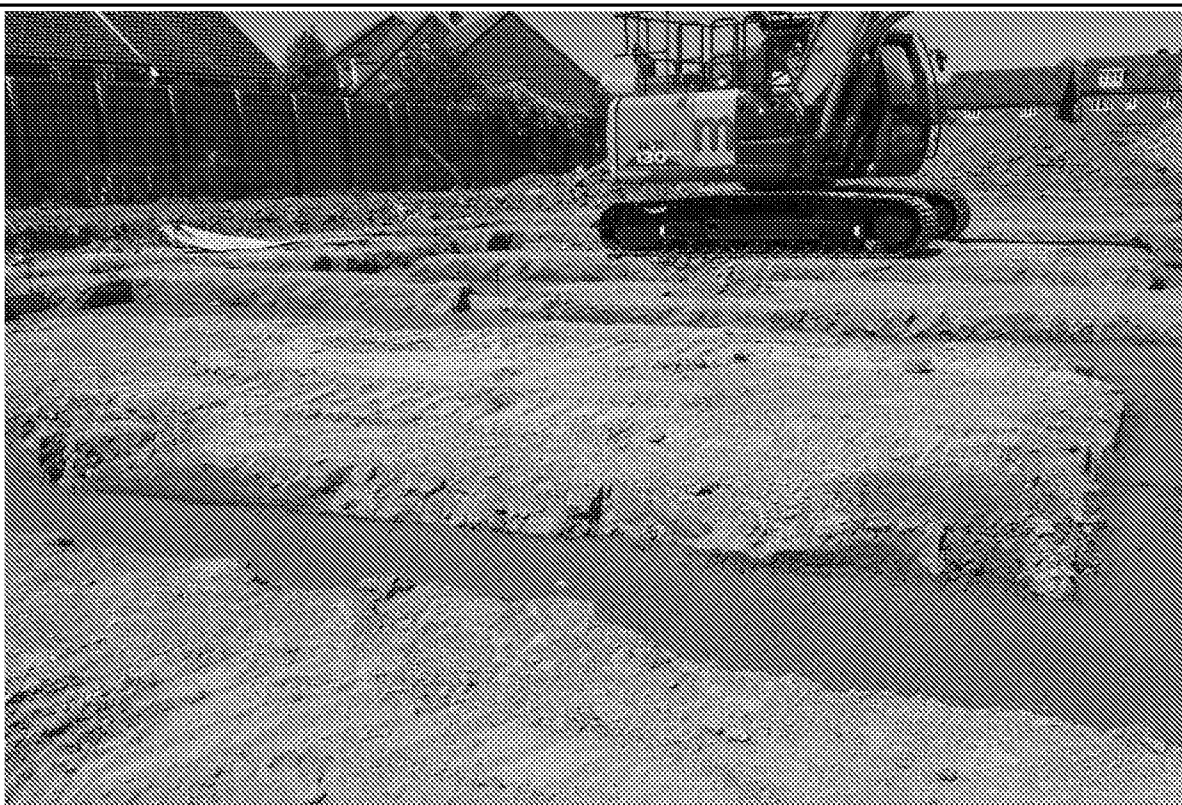
**Plate 10** 21st May 2019 - Plots 22 to 25 looking Northwest, natural at surface.

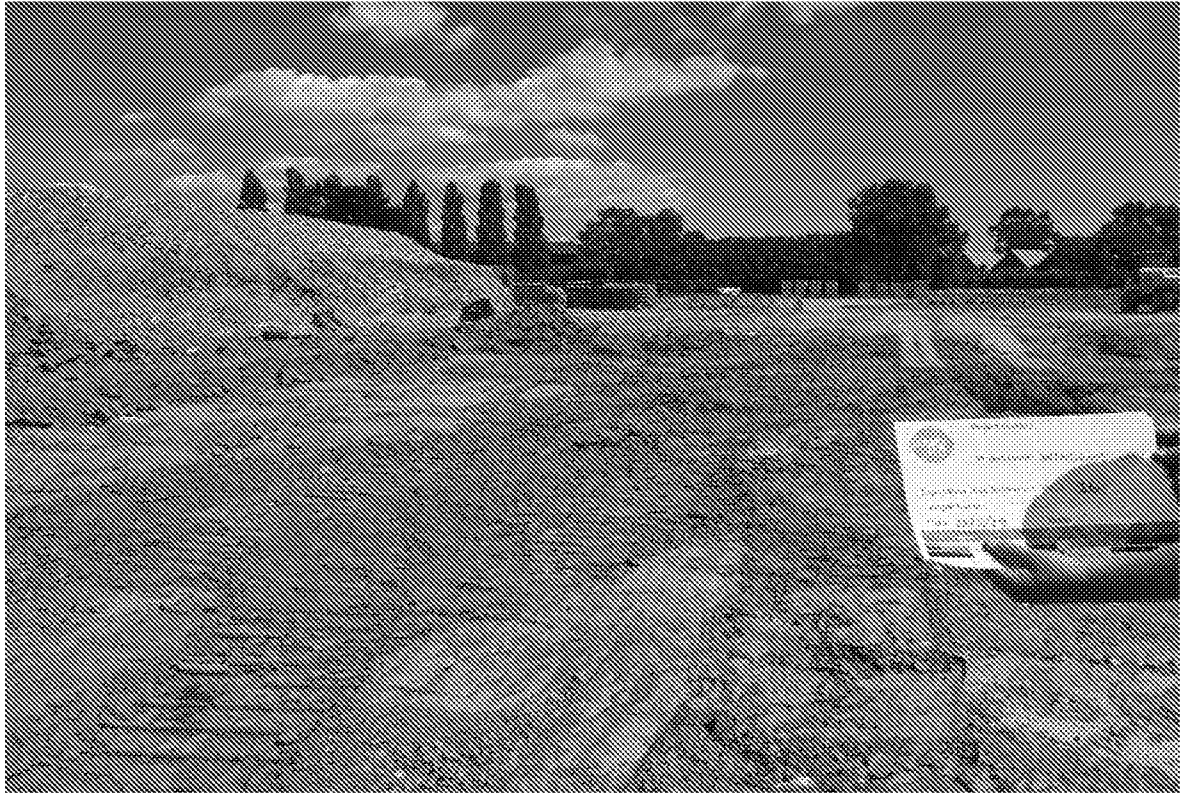
**Plate 11**

21st May 2019 - Plot 26 visible at natural surface.

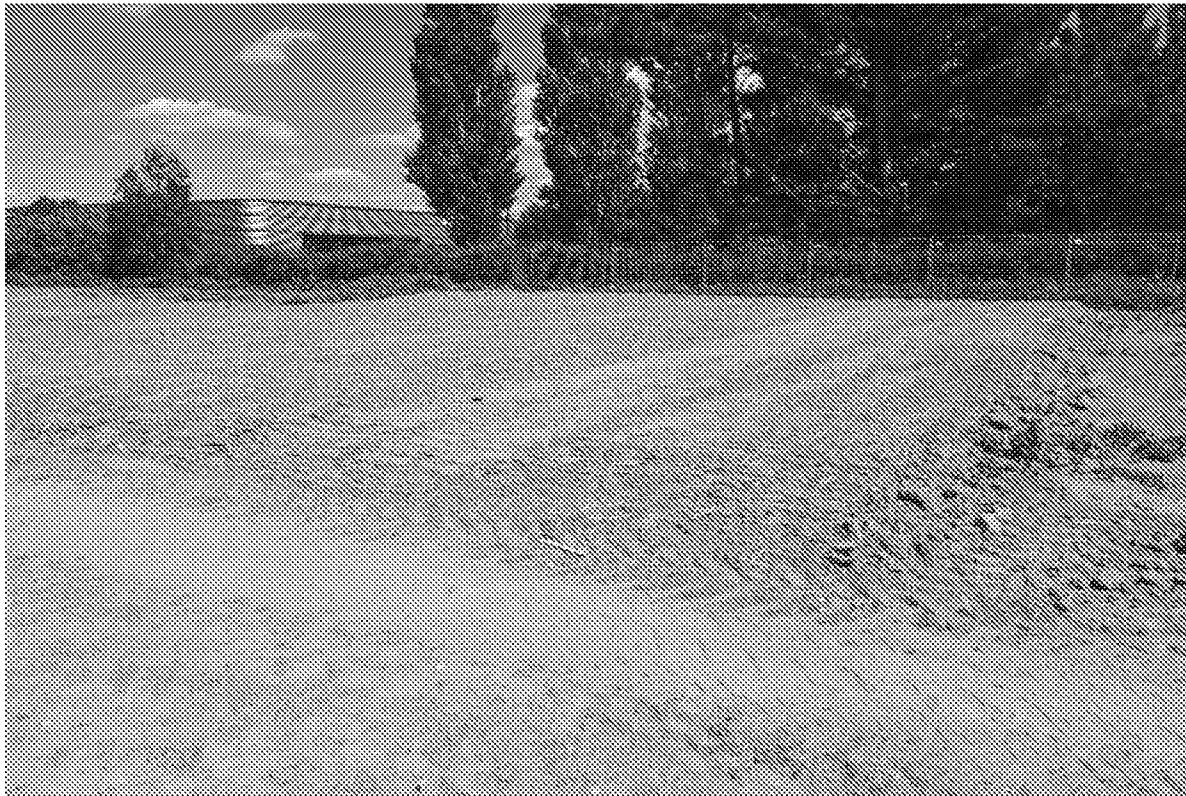
**Plate 12**

21st May 2019 - Plots 56 and 57 raised with natural cover.

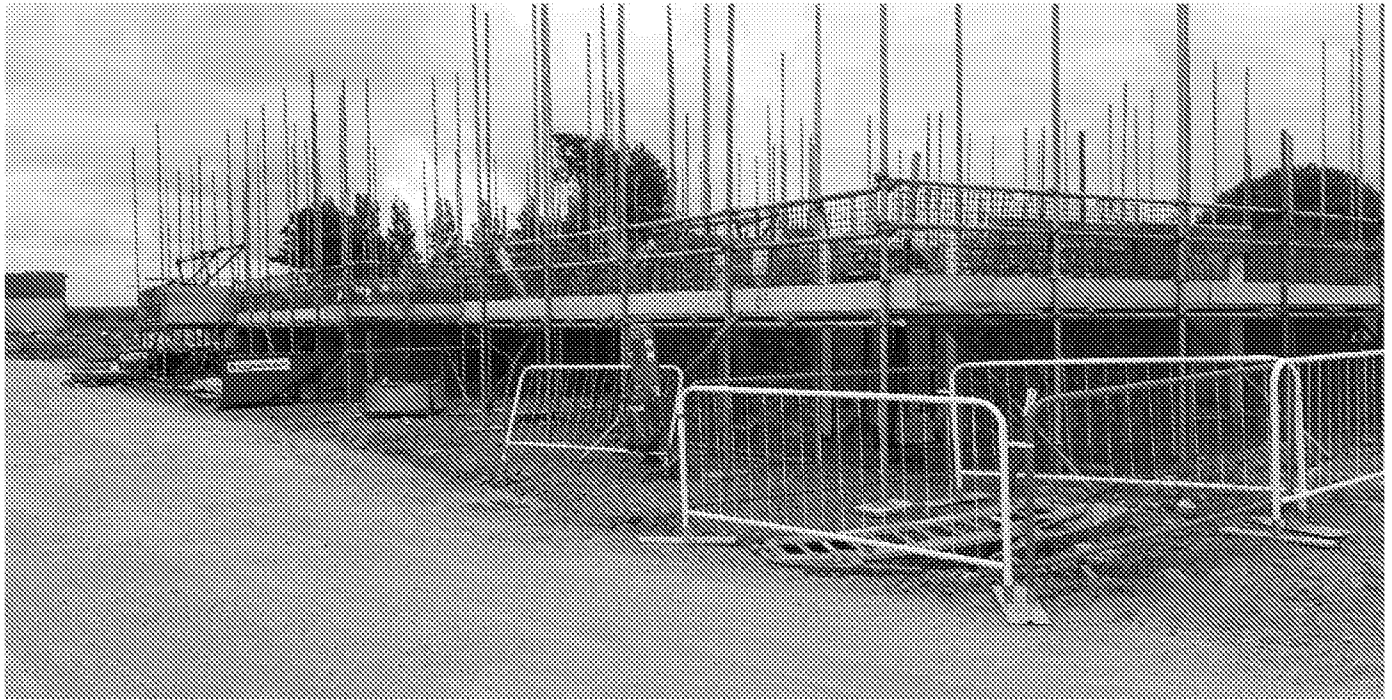
**Plate 13**      16th August 2019 - General Site - Plots 1 to 8 being built.

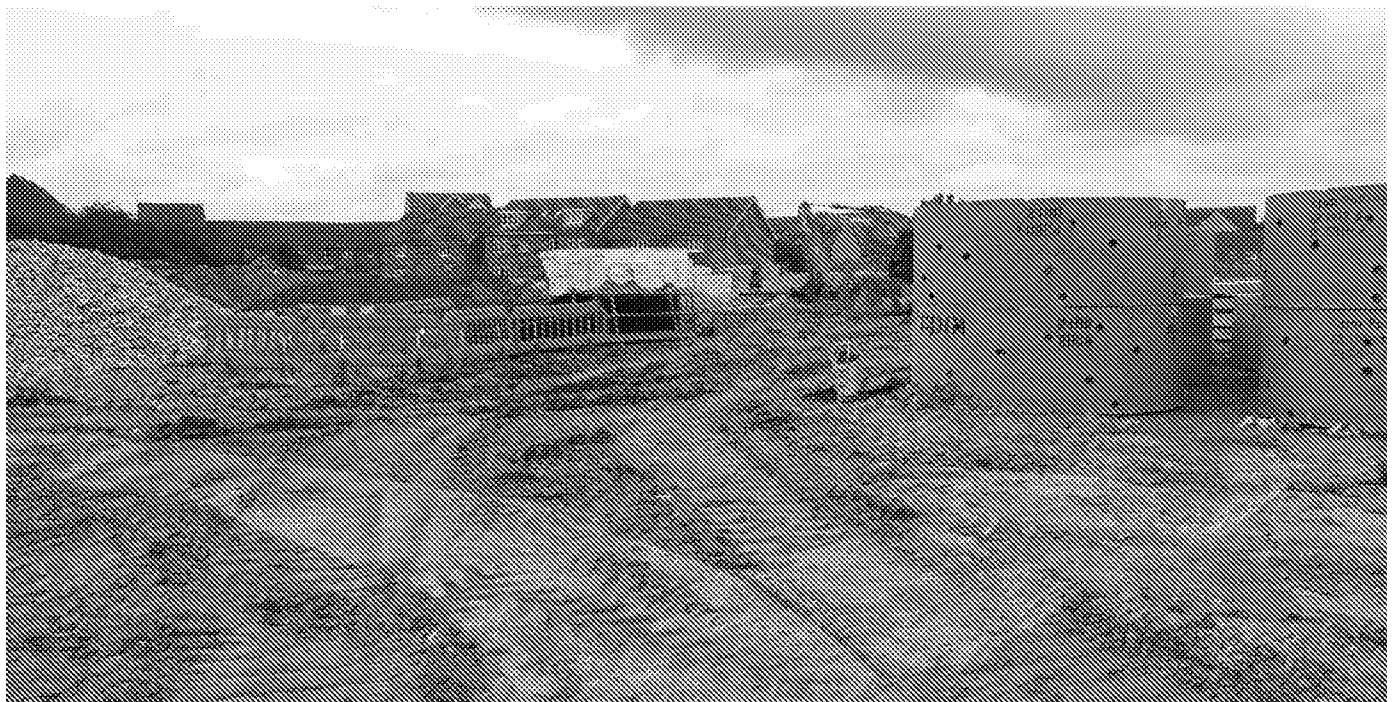
**Plate 14**      16th August 2019 - Central Public Space is visible at natural surface beneath the site storage.

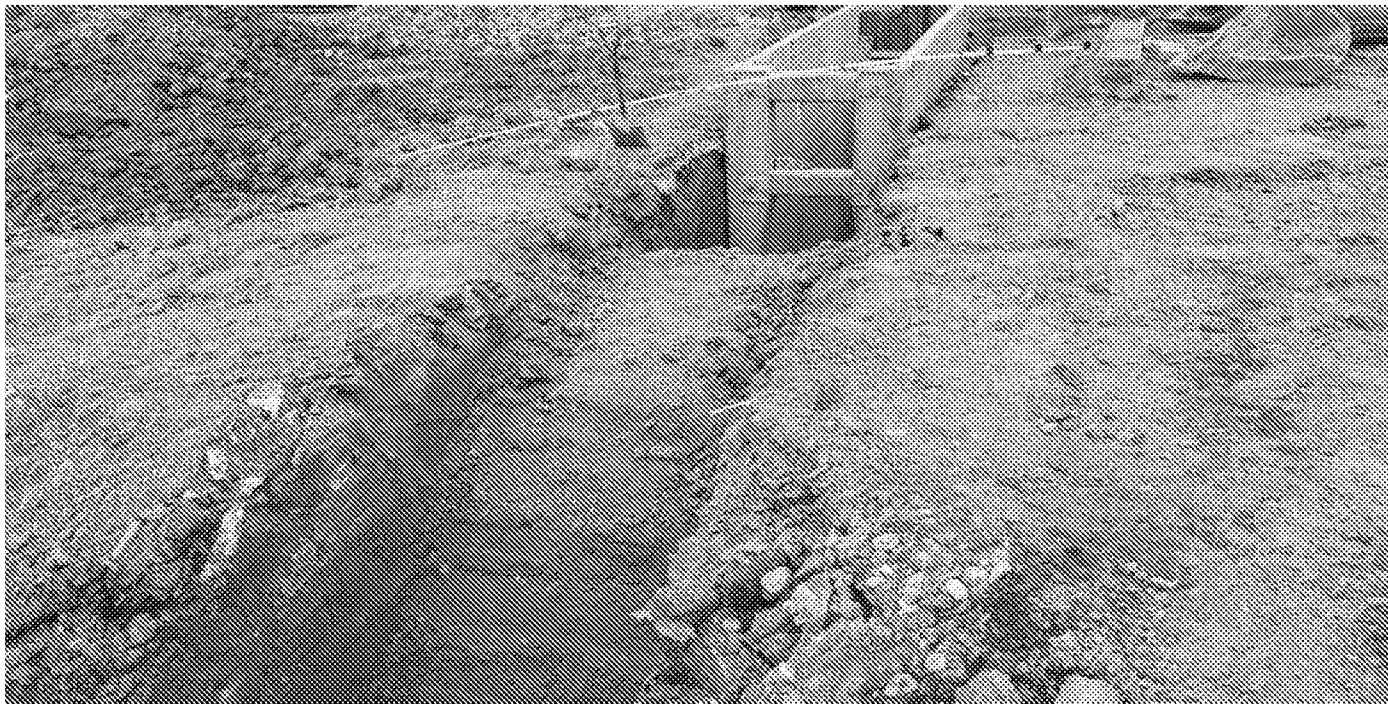
**Plate 15**

16th August 2019 - Soakaway trenches dug in to Central Public Space show natural strata.

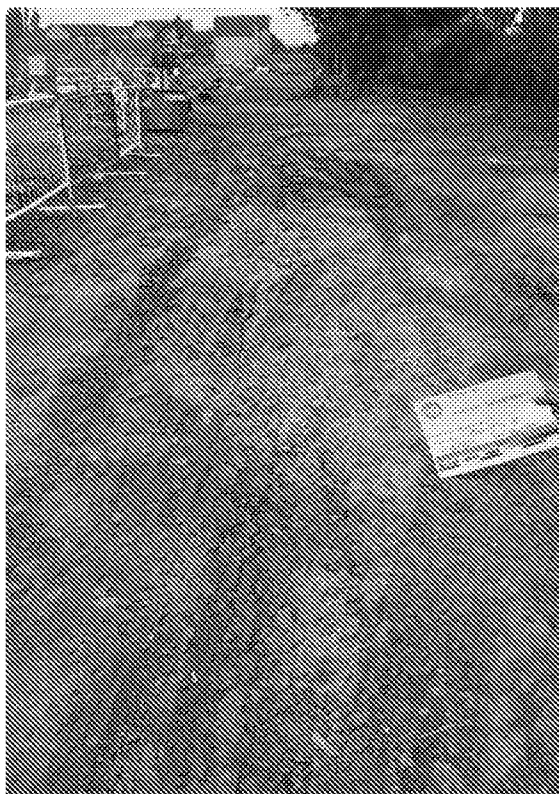
**Plate 16**

16th August 2019 - Plots 1 to 8 Gardens visible at natural surface.

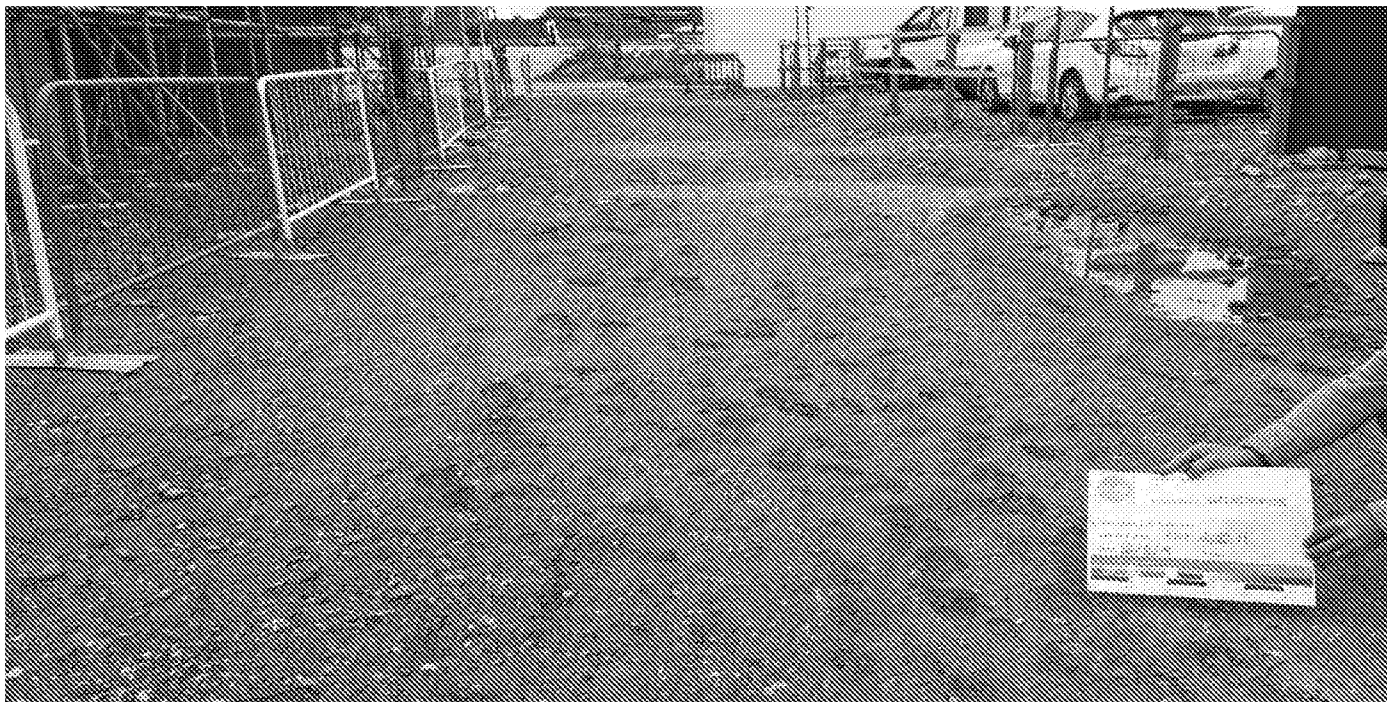
**Plate 17** 16th August 2019 - Plot 9 to 11 Gardens visible at natural surface.

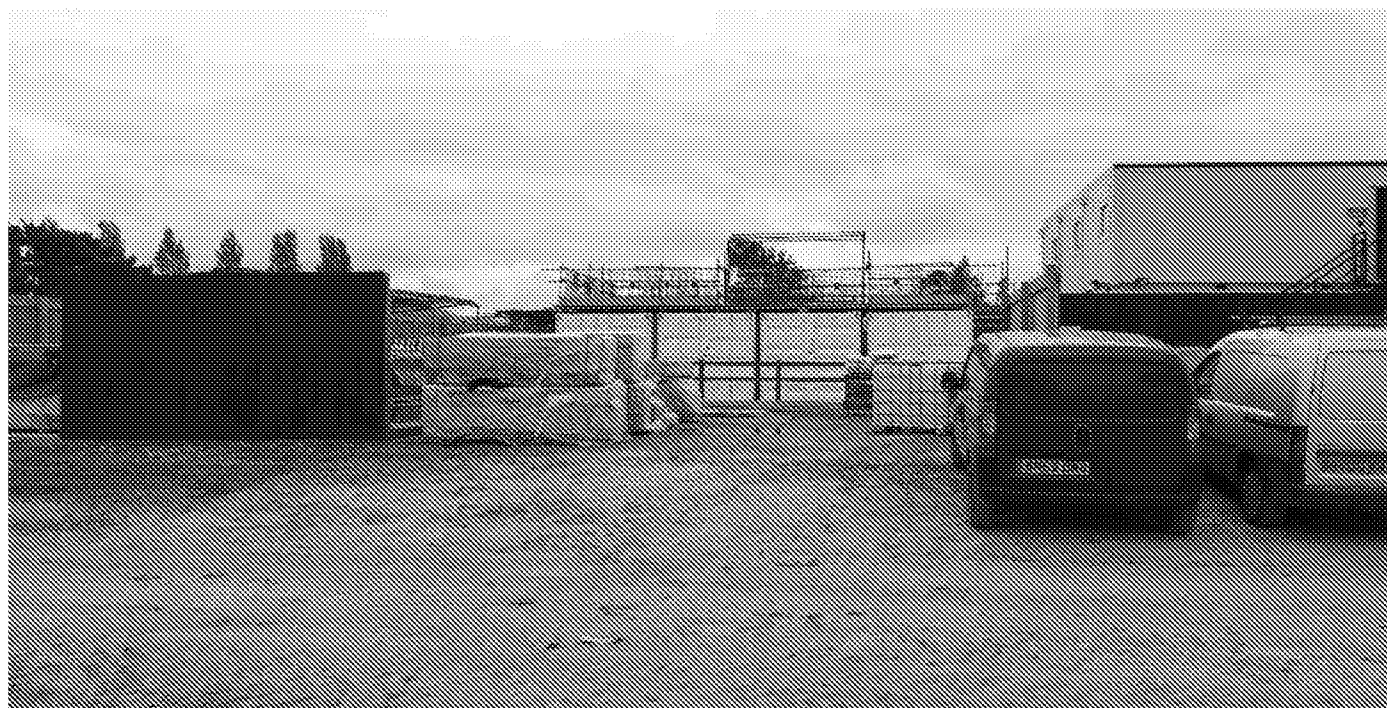
**Plate 18** 16th August 2019 - Plots 14 to 18 have site compound built upon them

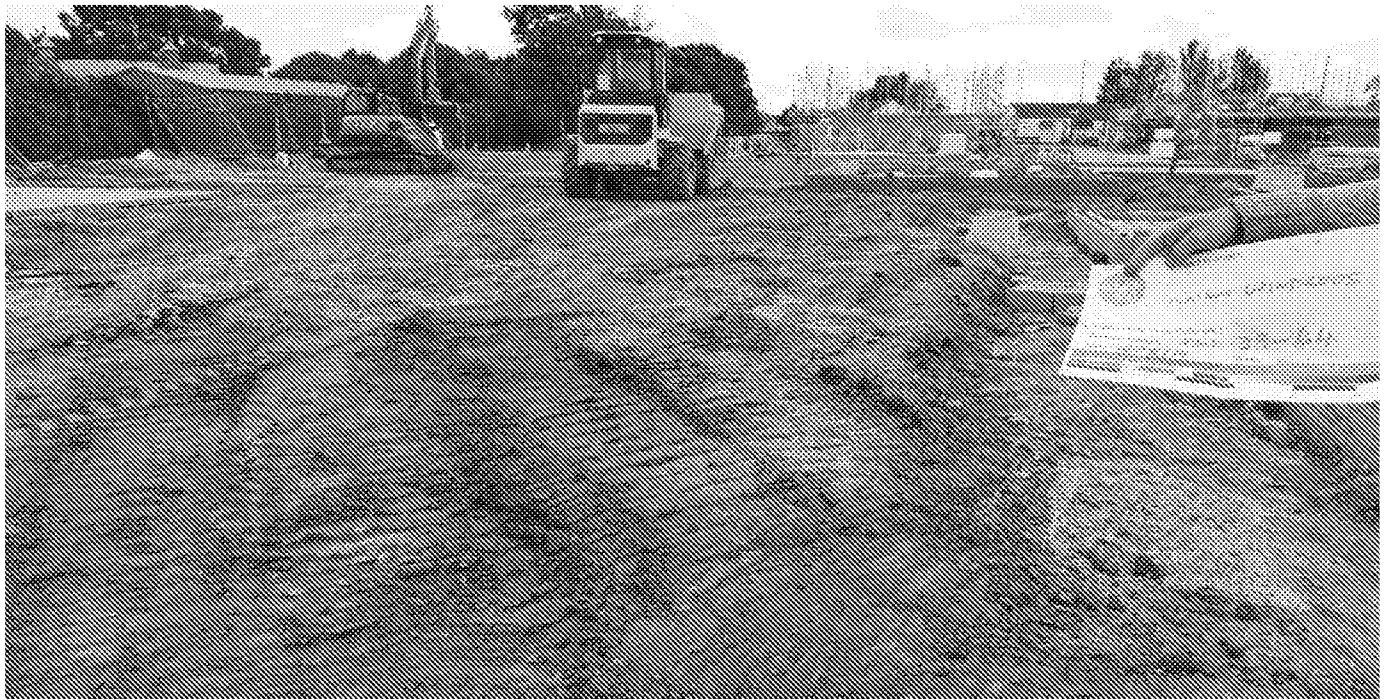
**Plate 19**

16th August 2019 - Plots 39 to 44 looking Southeast visible at natural surface. Including gardens.

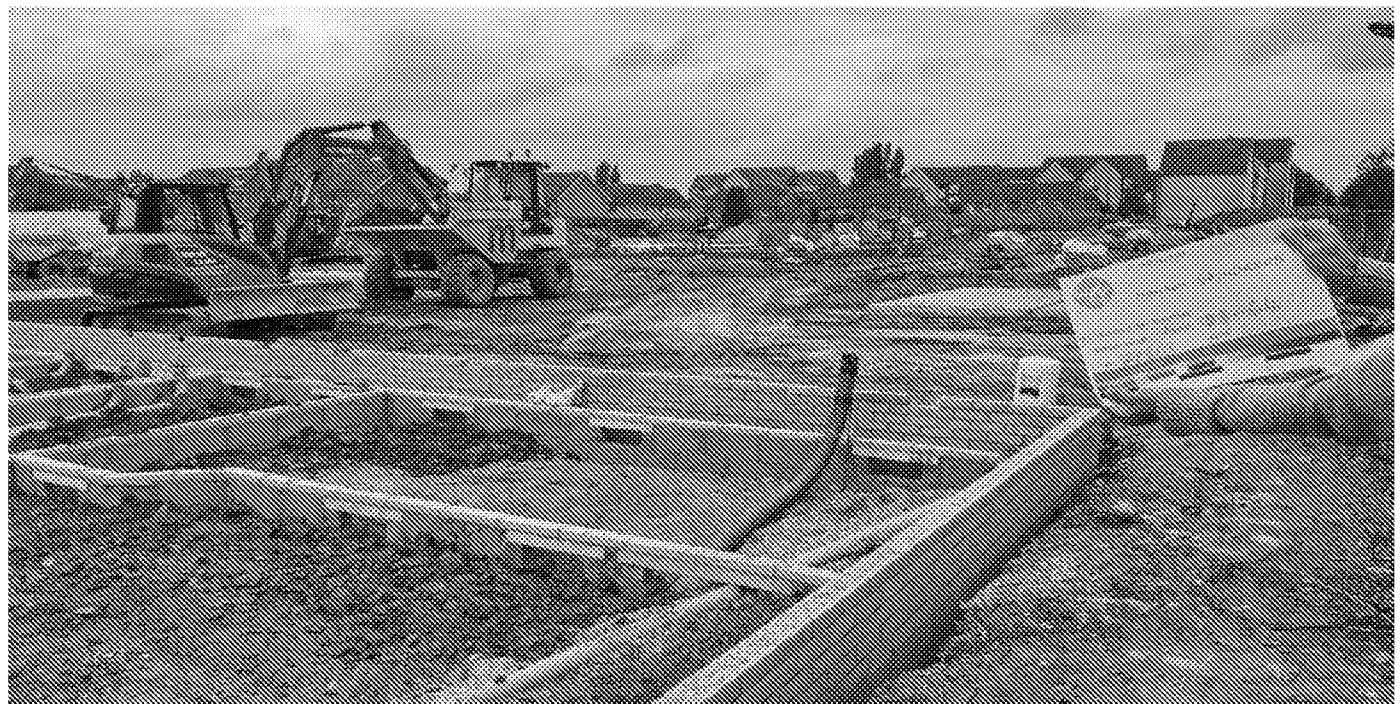
**Plate 20**

16th August 2019 - Plots 39 to 44 looking North visible at natural surface. Including gardens.

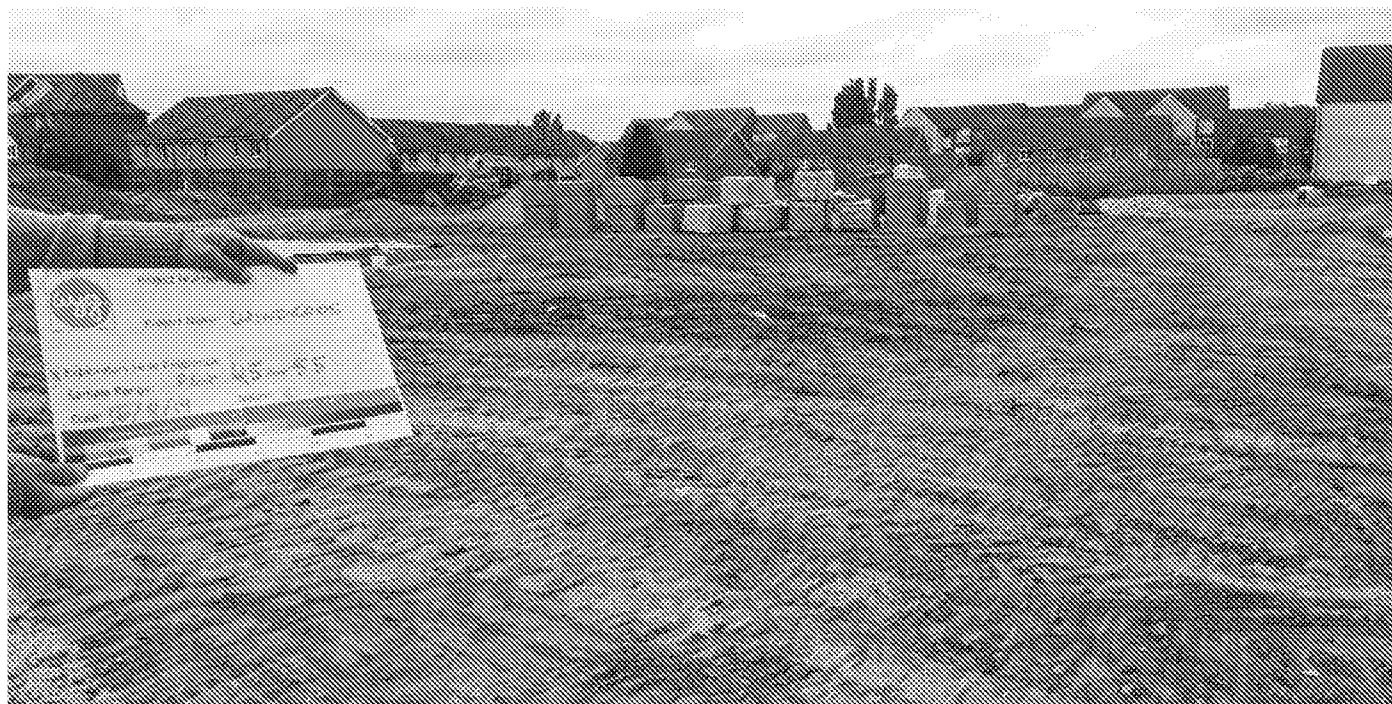
**Plate 21**

16th August 2019 - Plots 45 to 52 looking North visible at natural surface. Including Gardens. Plots 53 to 55 gardens also.
