# **Windroos, Littlehampton**

## **Remediation Validation Report**

A111089

February 2020

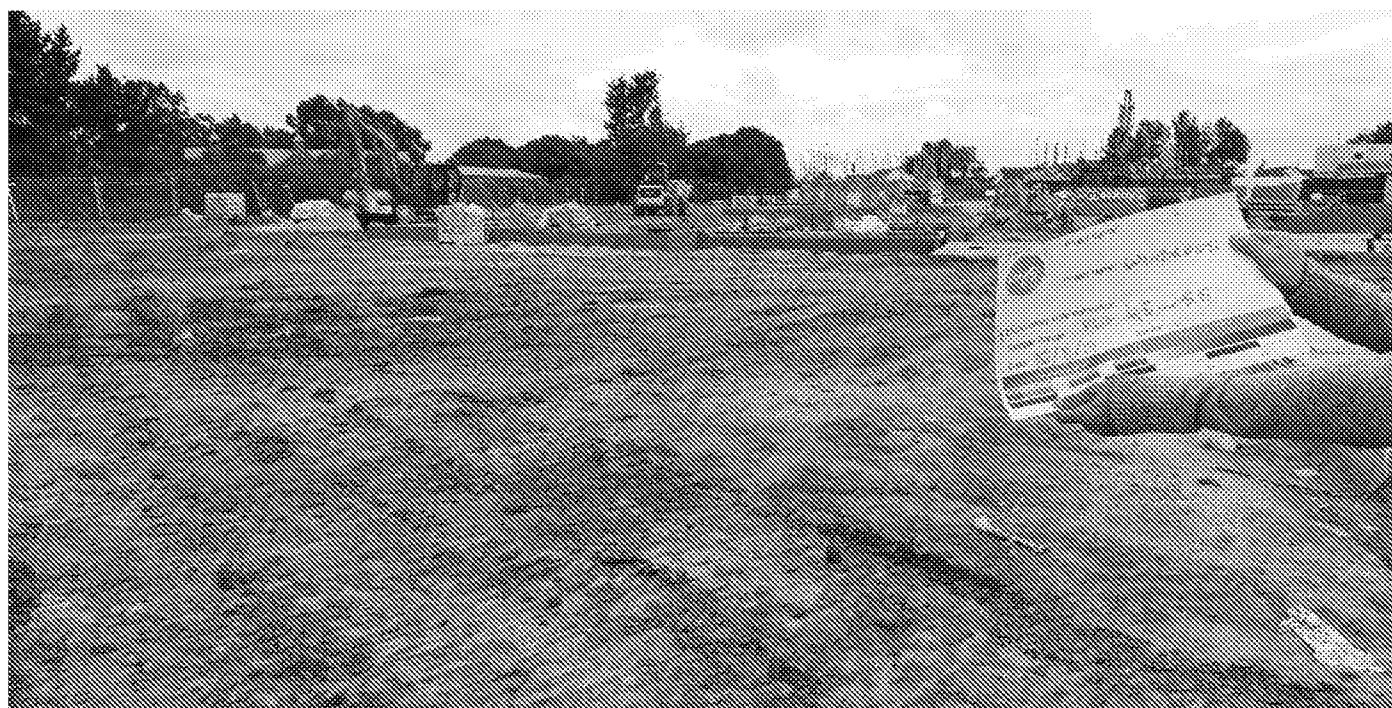
**Plate 22**

16th August 2019 - Plots 45 to 52 looking Southeast visible at natural surface. Including Gardens. Plots 53 to 55 gardens also.

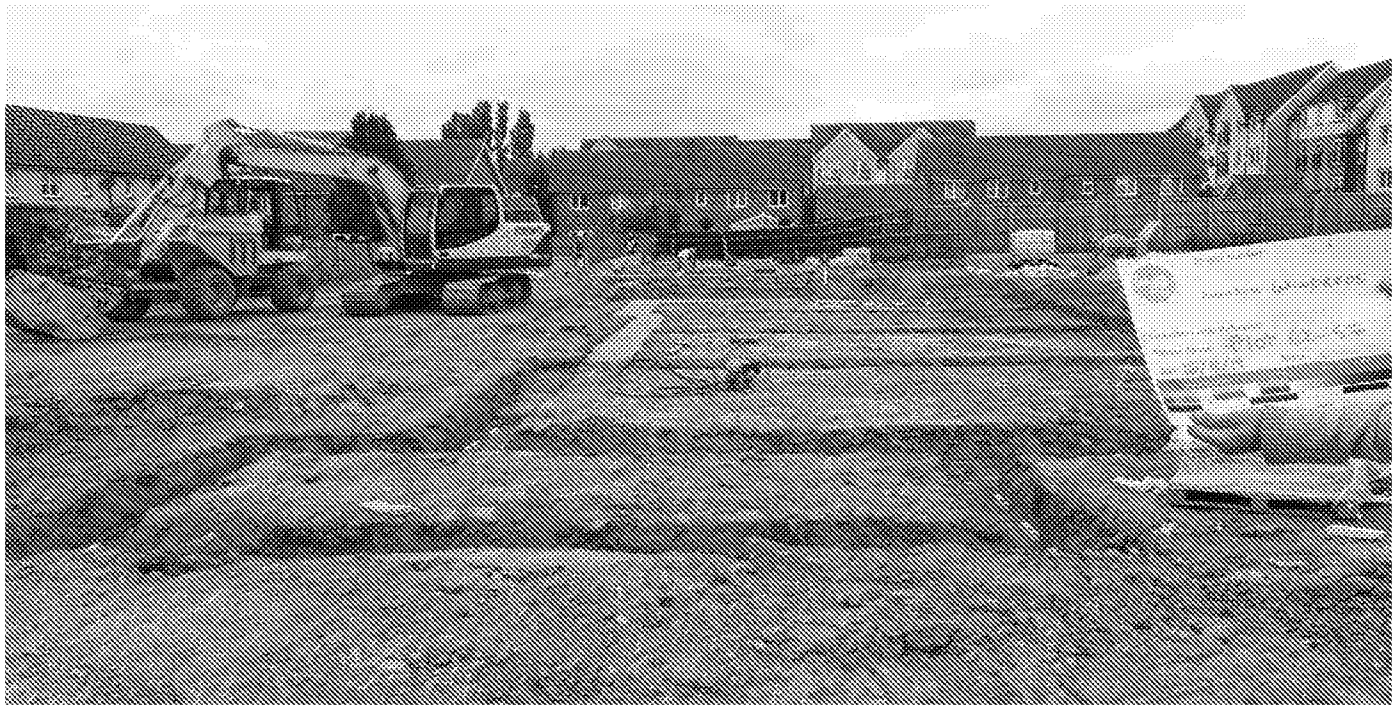
**Plate 23** 16th August 2019 - Plots 62 to 67 looking North visible at natural surface. Including Gardens.

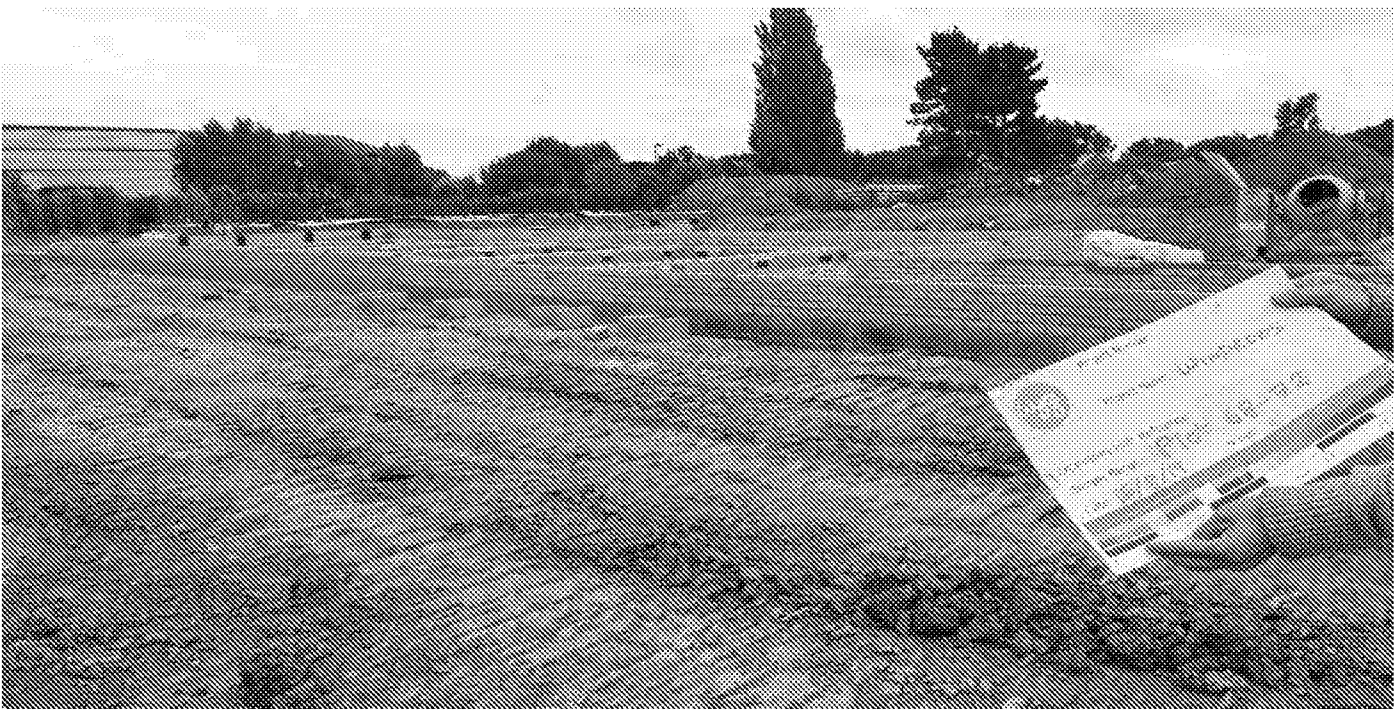
**Plate 24** 16th August 2019 - Plots 68 to 72 looking Southeast visible at natural surface. Including Gardens.

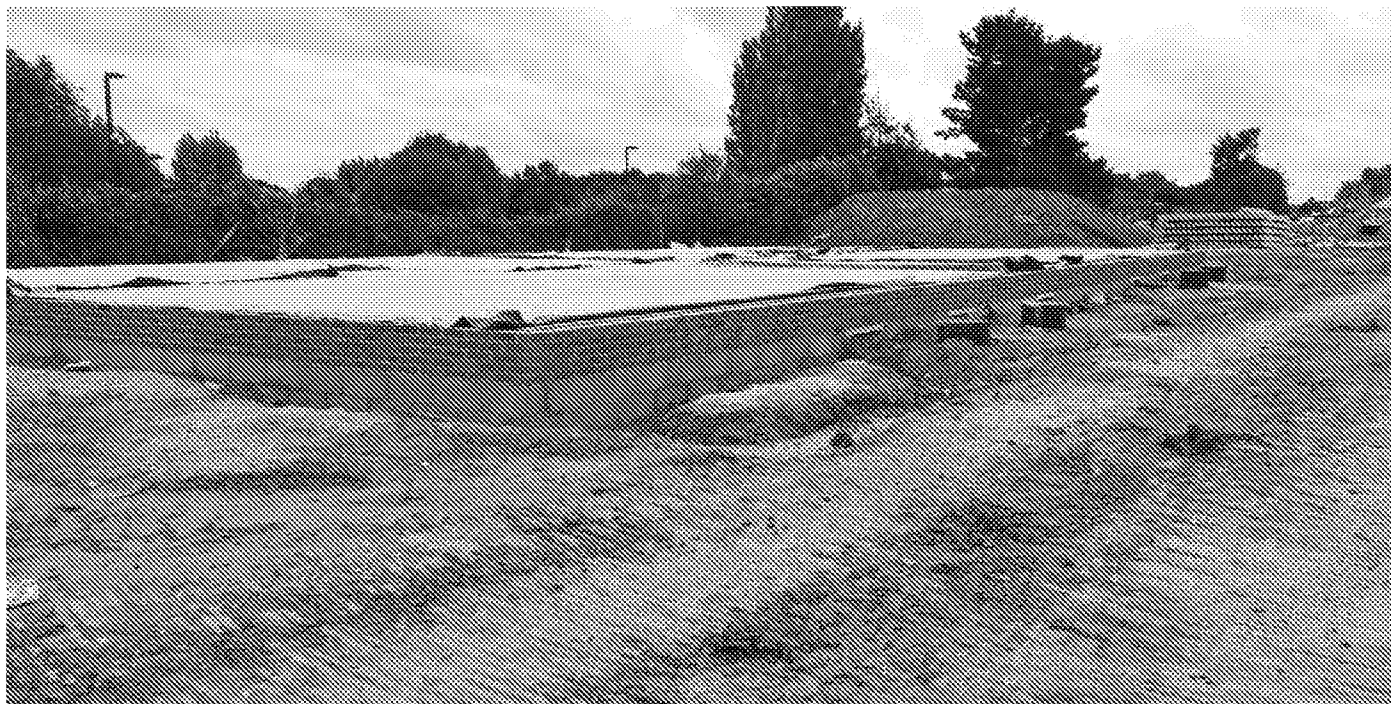
**Plate 25**

16th August 2019 - Plots 73to 84 visible at natural surface.

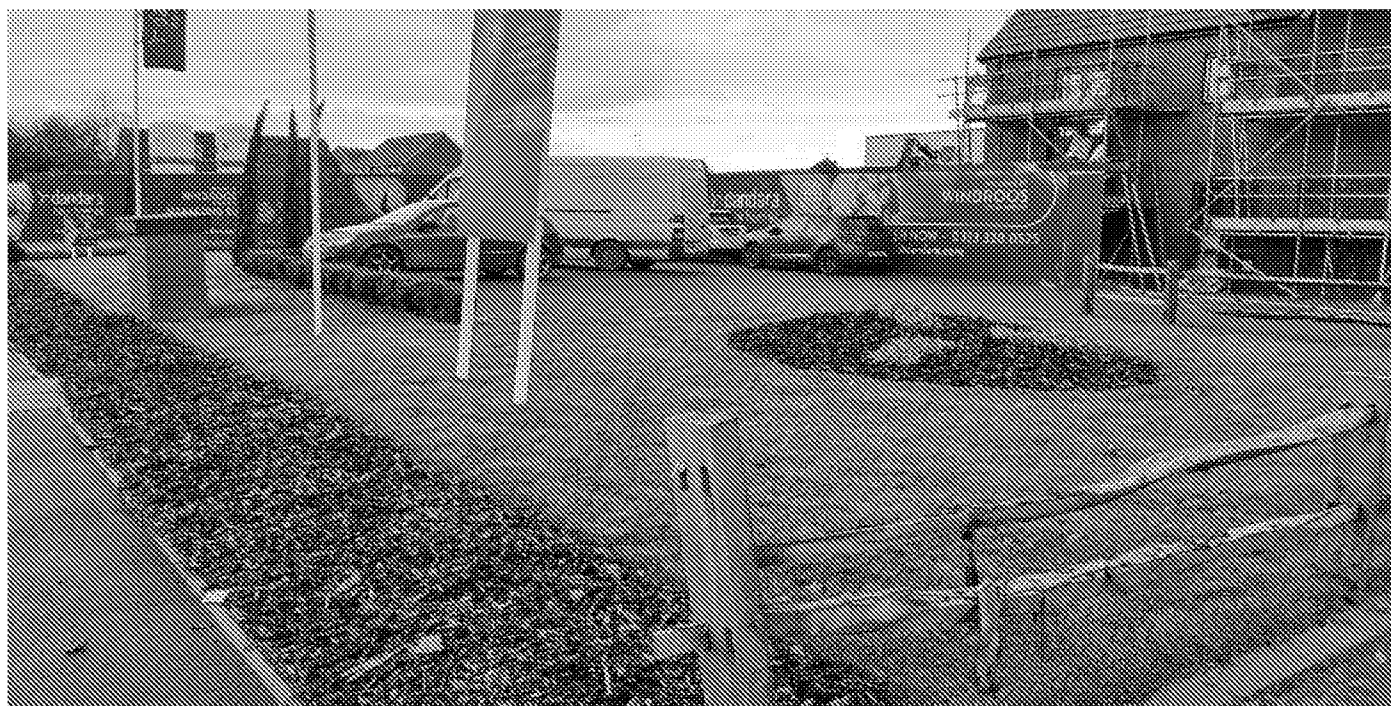
**Plate 26**

14th November 2019 - Front access area of site.

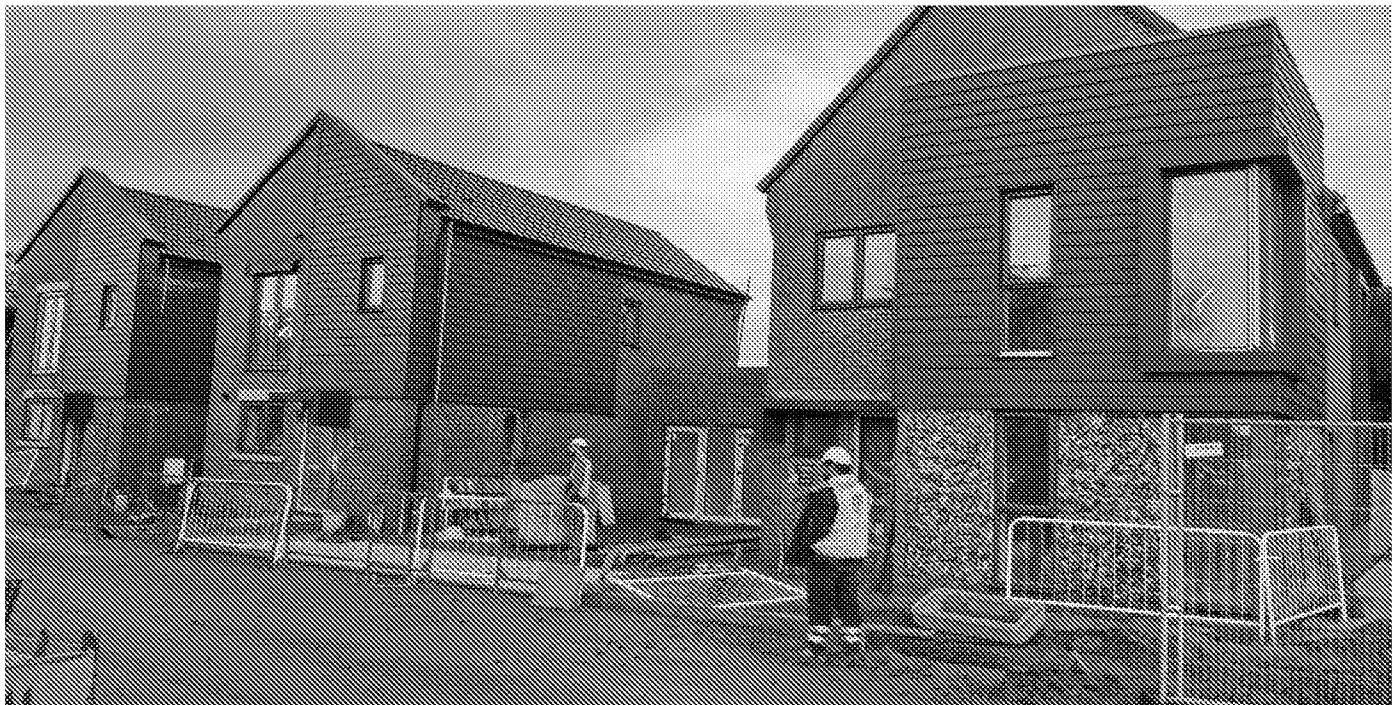
**Plate 27** 14th November 2019 - Plots 1 to 3 have houses built.

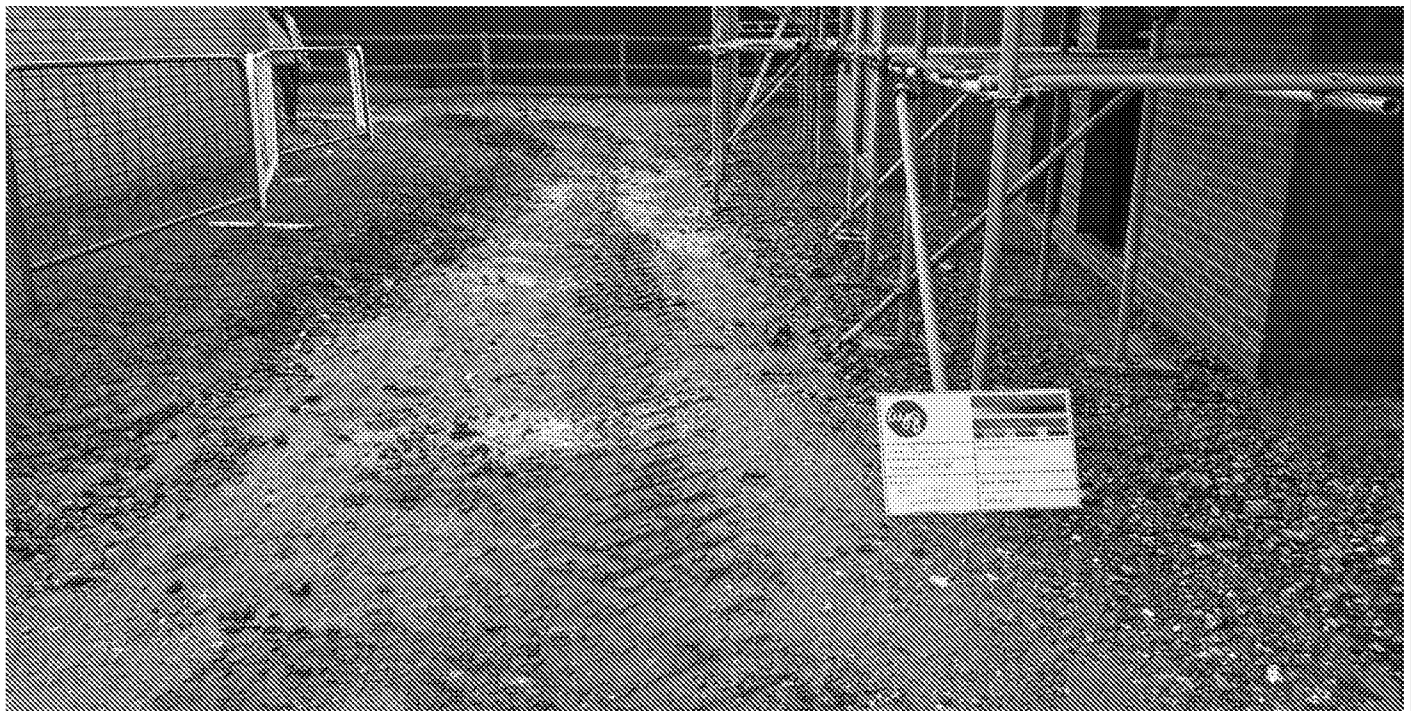
**Plate 28** 14th November 2019 - Plots 12 and 13 Gardens visible at natural surface.

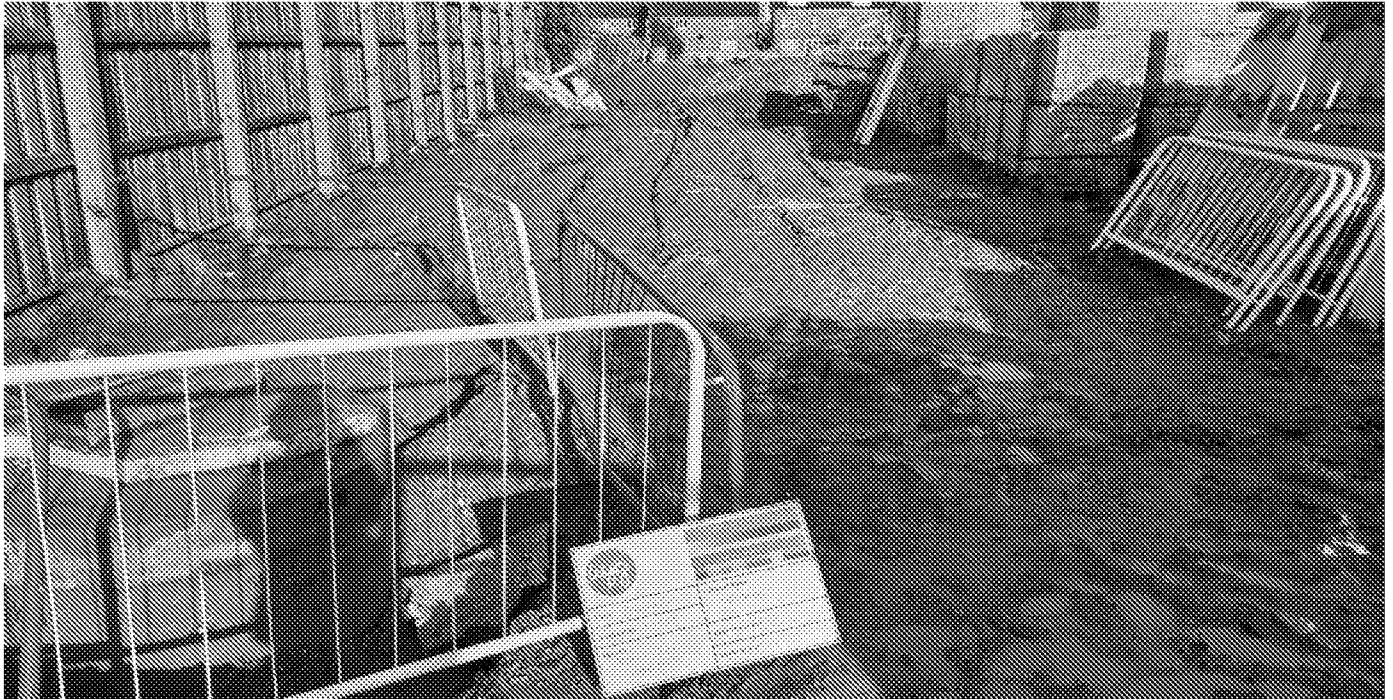
**Plate 29**

14th November 2019 - Plots 22 to 26 Gardens visible at natural surface.

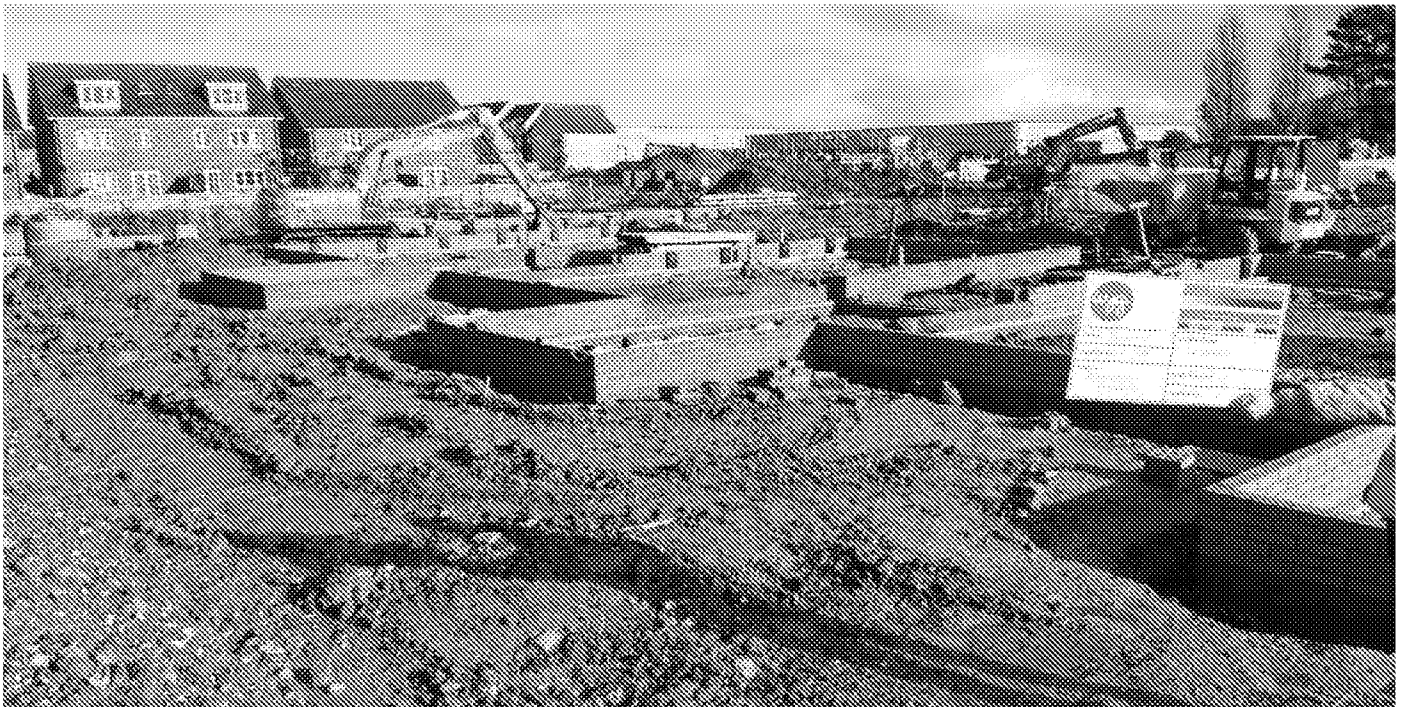
**Plate 30**

14th November 2019 - Plots 29 to 31 visible at natural surface. Including gardens.

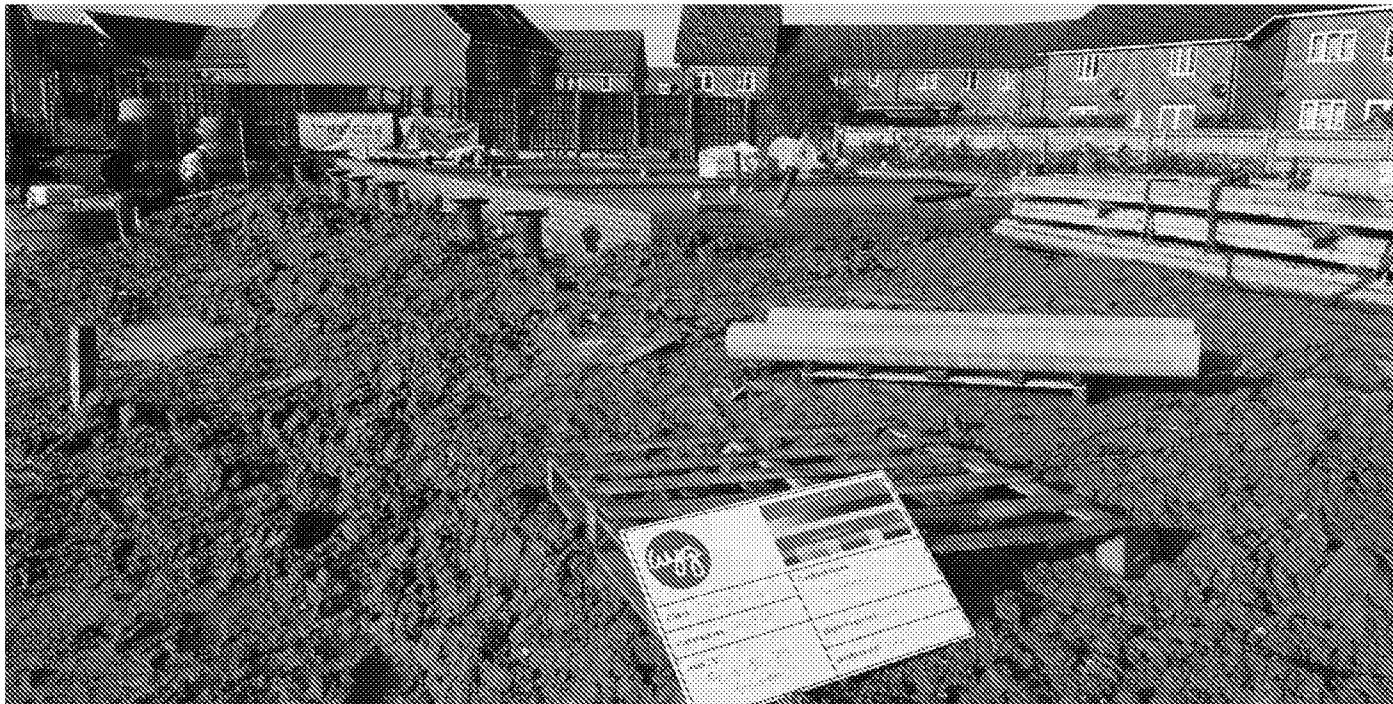
**Plate 31** 14th November 2019 - Plots 32 to 38 visible at natural surface.

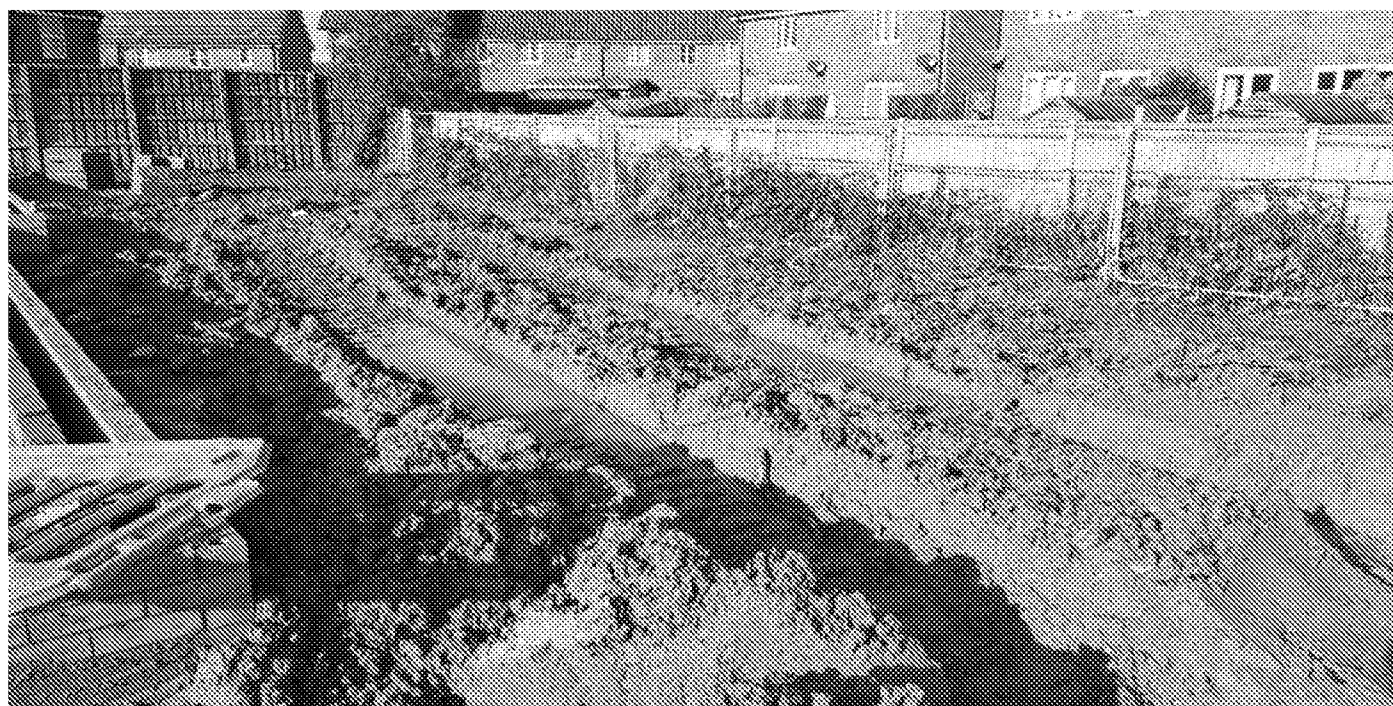
**Plate 32** 14th November 2019 - Plots 32 to 38 gardens visible at natural surface.

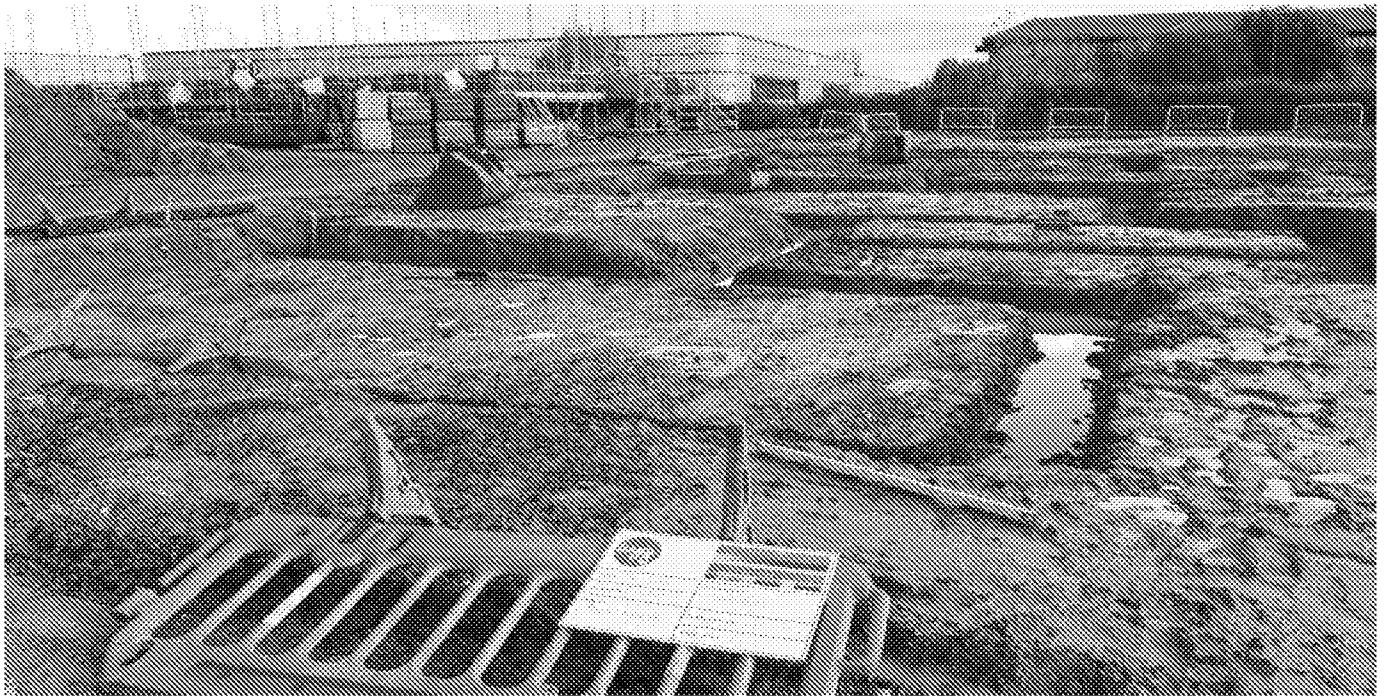
**Plate 33**

14th November 2019 - Plots 53 to 55 visible at natural surface.

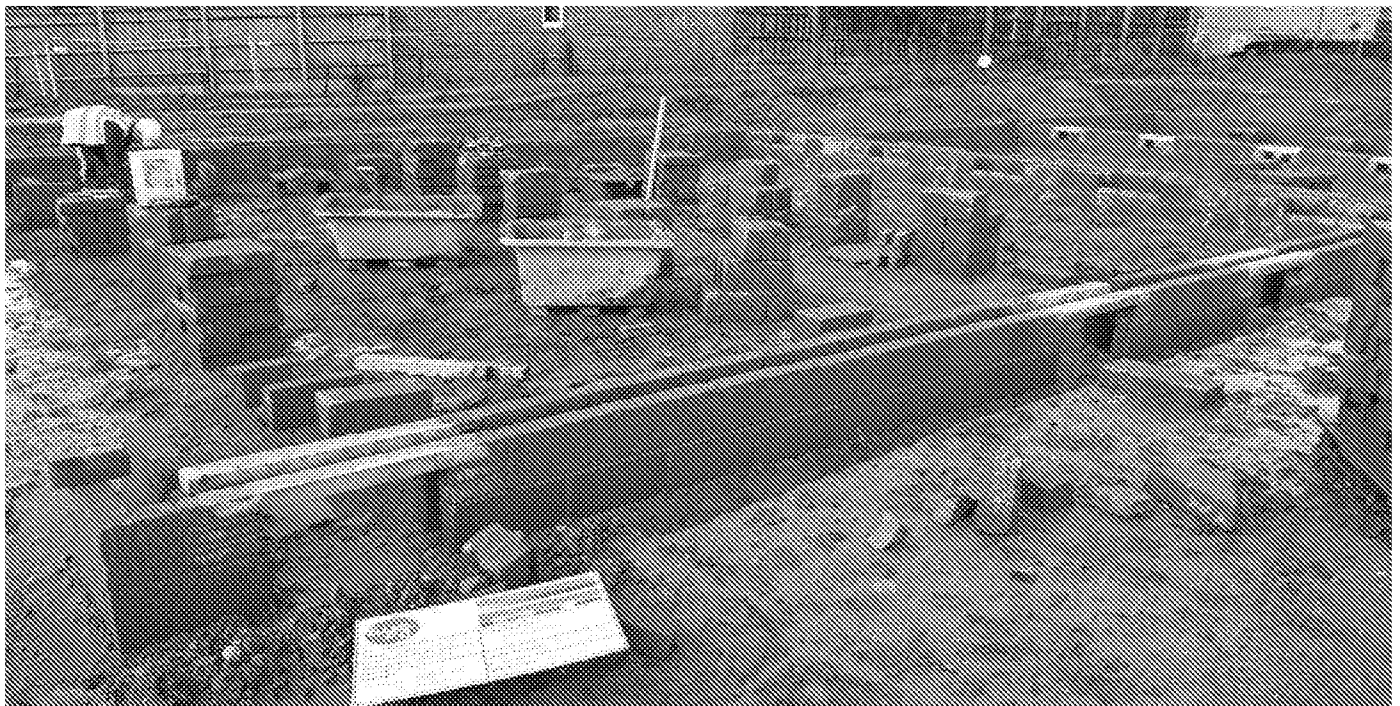
**Plate 34**

14th November 2019 - Plots 58 to 61 visible at natural surface. Including gardens.

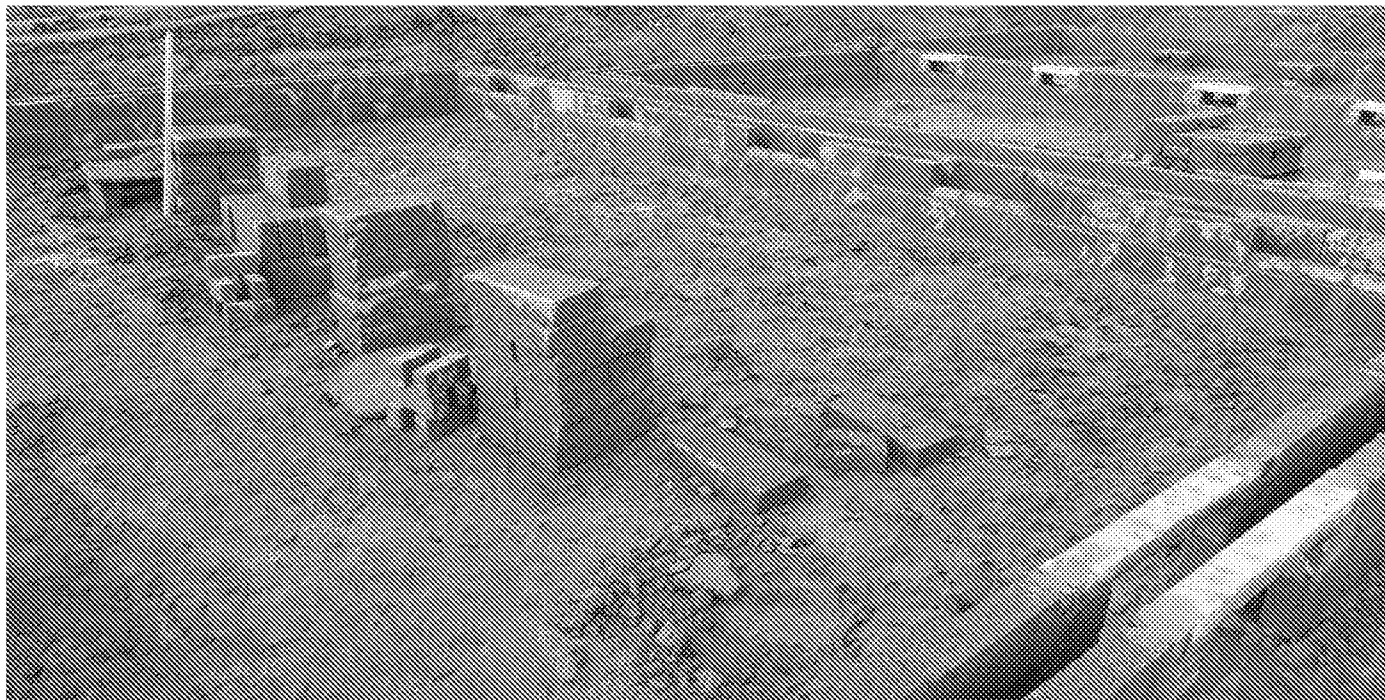
**Plate 35**

14th November 2019 - Close up of Plots 58 to 61 at natural surface.

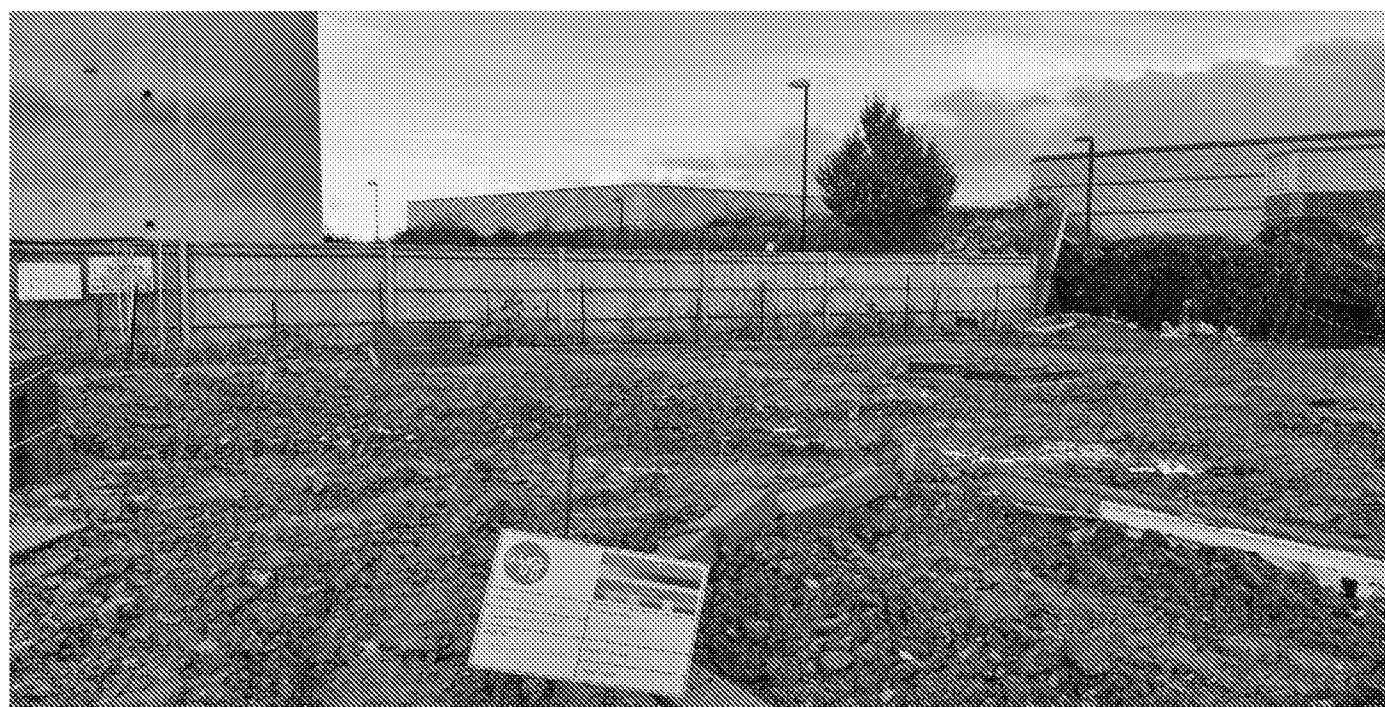
**Plate 36**

14th November 2019 - Carpark in the Northeast corner of site is visible at natural surface (in back corner of photograph).

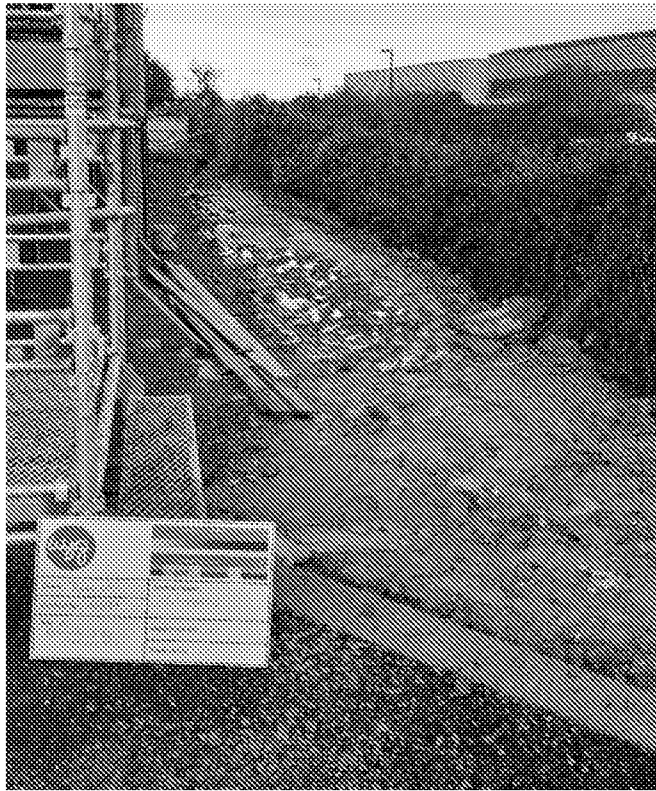
**Plate 37** 14th Novemeber 2019 - Landscape area of Plots 73 to 84 visible at natural surface.

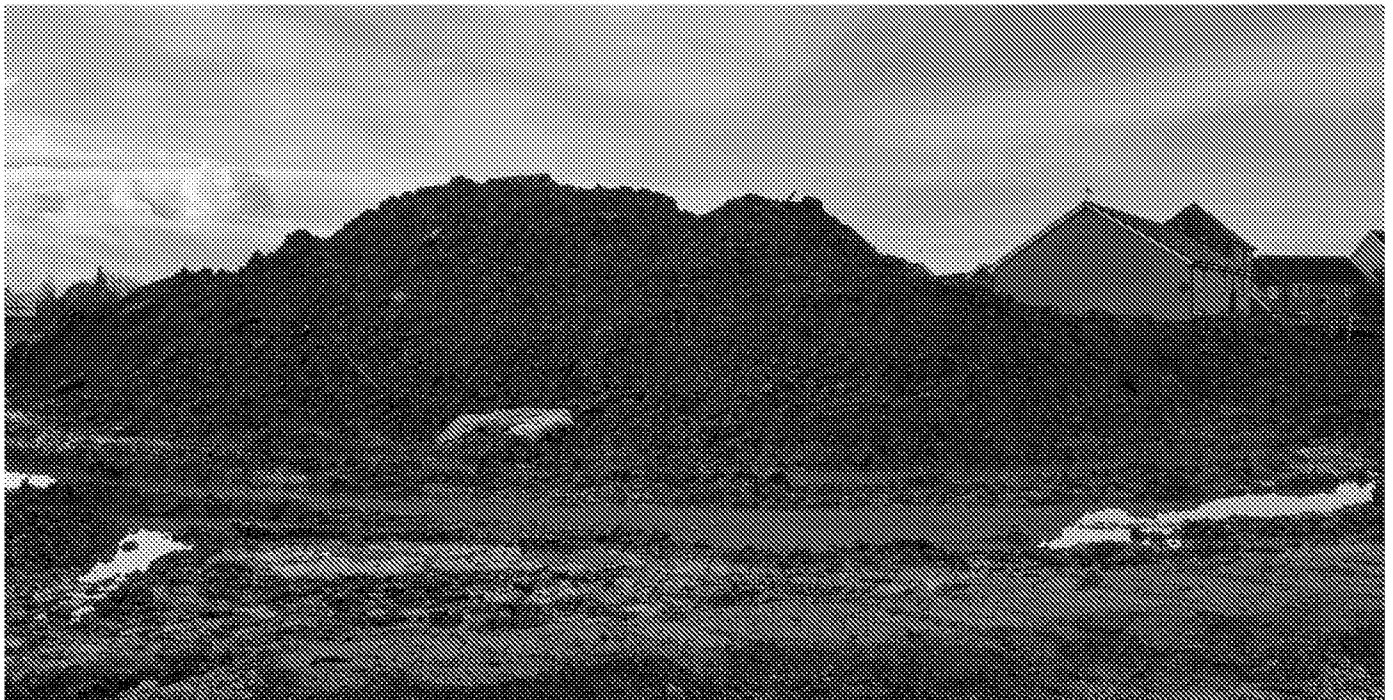
**Plate 38** 14th November 2019 - Northern Public Space is covered by a stockpile.

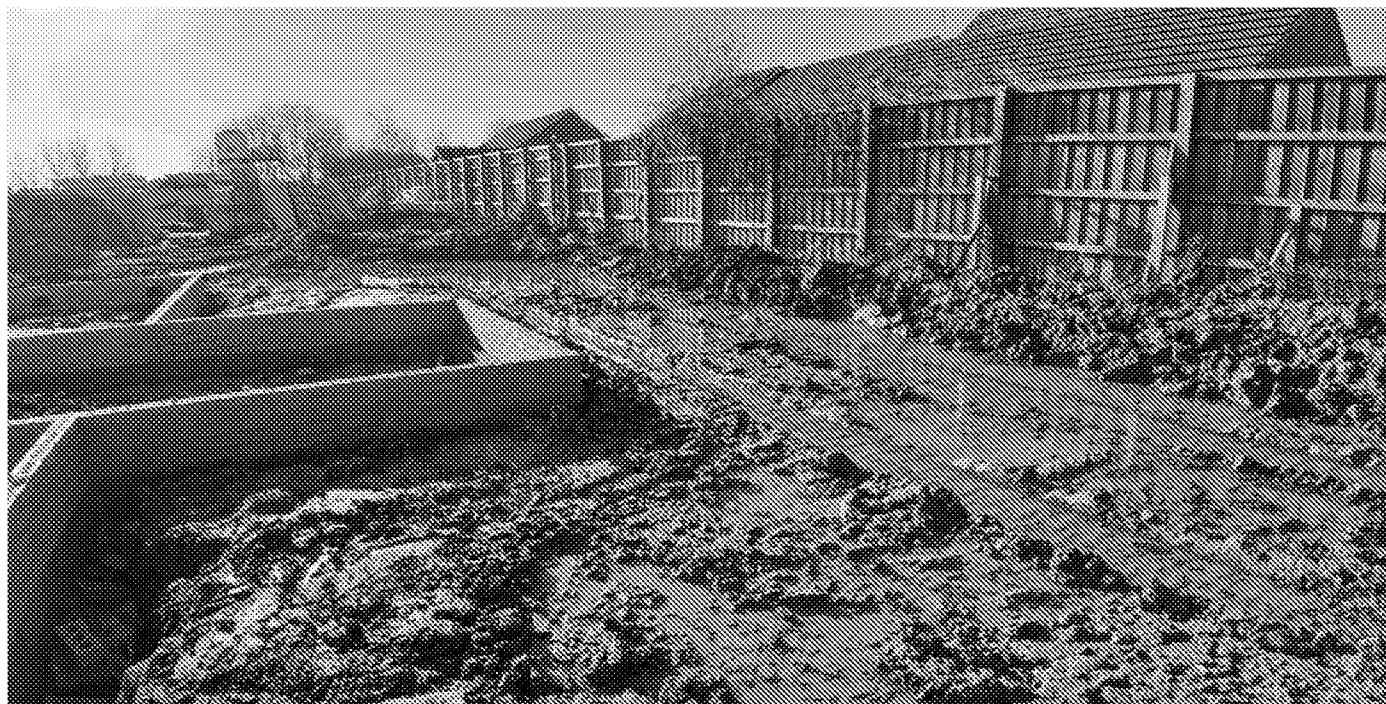
**Plate 39**

21st January 2020 - Plots 27 and 28 at natural surface.
