### **Project**

**Project Name:** DAISY FIELDS.LITTLEHAMPTON.BN17 6LT  
**Project Description:** TO CARRY OUT CCTV SURVEY AT THE ABOVE ADDRESS  
**Project Number:** 02  
**Project Status:** Complete  
**Project Date:** 30/06/2025  
**Inspection Standard:** MSCC5 Sewers & Drainage GB (SRM5 Scoring)

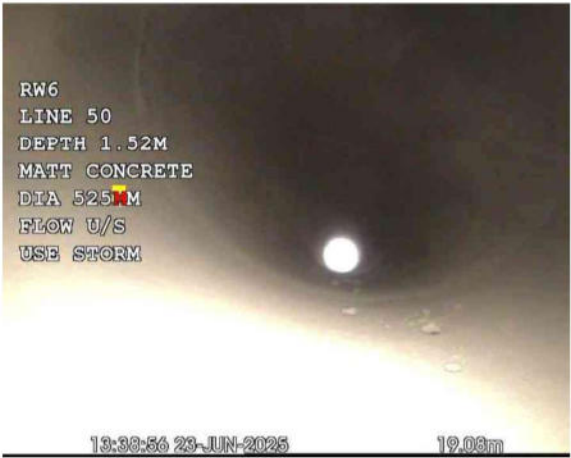
RW  
 6X\_1a452a71-d337-404b-94e5-42f911da25b2\_20250701\_17  
 1301\_750.jpg, 00:02:08, 19.08 m  
 Survey abandoned

| Recommendations: | HPWJ LINE | | | | |

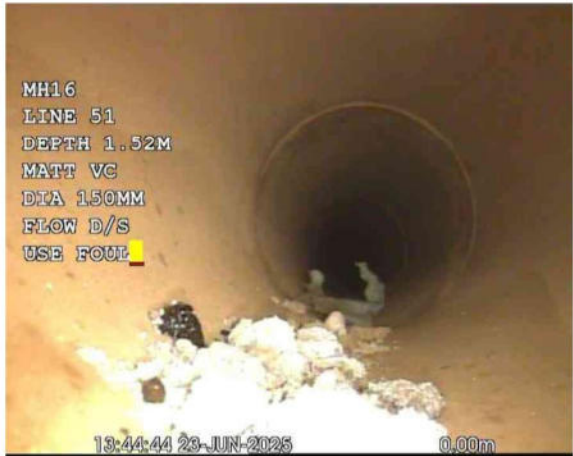
MH  
16X\_831be70e-b5d3-4fd3-a591-6508bf28d573\_20250701\_17  
1316\_109.jpg, 00:00:03, 0.00 m  
Settled deposits, coarse, 10% cross-sectional area loss

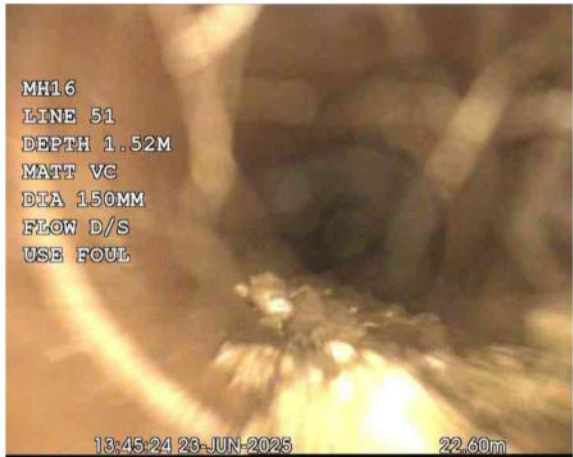
MH  
16X\_ae6637d3-2ee9-4e78-8611-e4a6e2d9159e\_20250701\_1  
71324\_926.jpg, 00:00:44, 22.60 m  
Settled deposits, coarse, 10% cross-sectional area loss

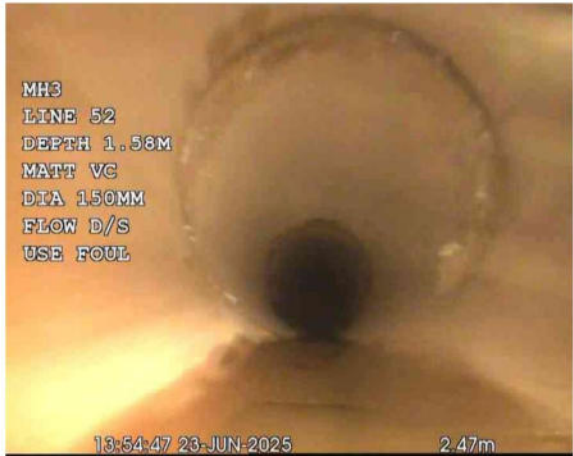
MH  
3X\_3e3b1e92-366c-47b8-9586-a085288d2eb7\_20250701\_17  
1349\_715.jpg, 00:00:09, 2.47 m  
Water level, 5% of the vertical dimension

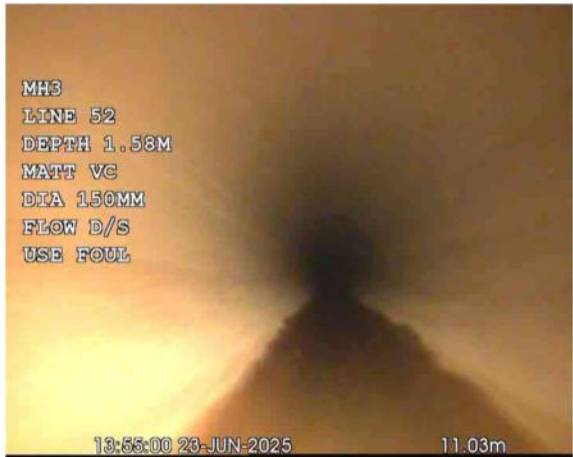
MH  
3X\_802989a5-0534-4b38-8657-062f89b8600b\_20250701\_17  
1352\_112.jpg, 00:00:22, 11.03 m  
Water level, 5% of the vertical dimension
