### 13 South Terrace Floor 3

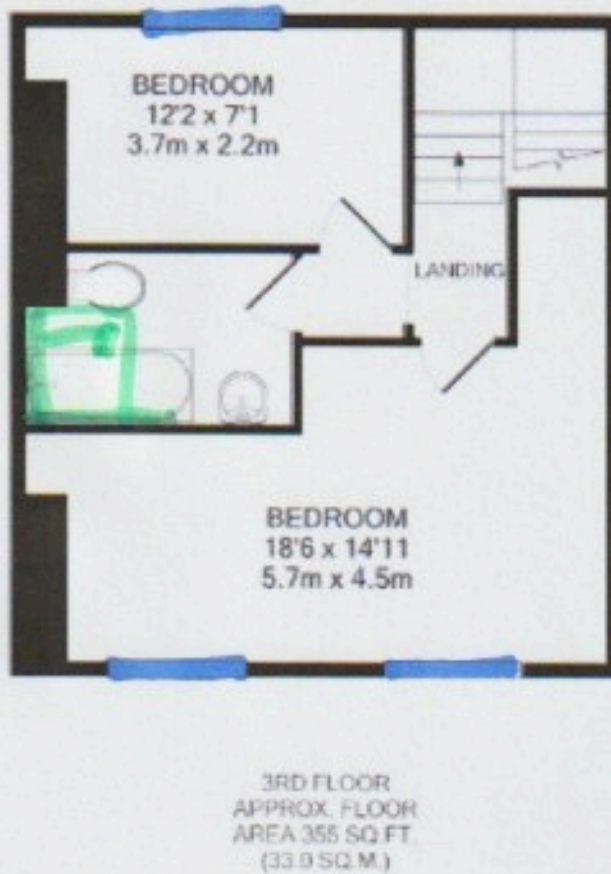
- 3 windows on the top floor are poorly double glazed and need to be replaced with more period symathetic timber windows. [redacted]
- Top floor bathroom – retile & add shower unit. [redacted]
