13 South Terrace Floor 2

### 13 South Terrace Floor 1

### 13 South Terrace Gound Floor

### 13 South Terrace Lower Ground Floor

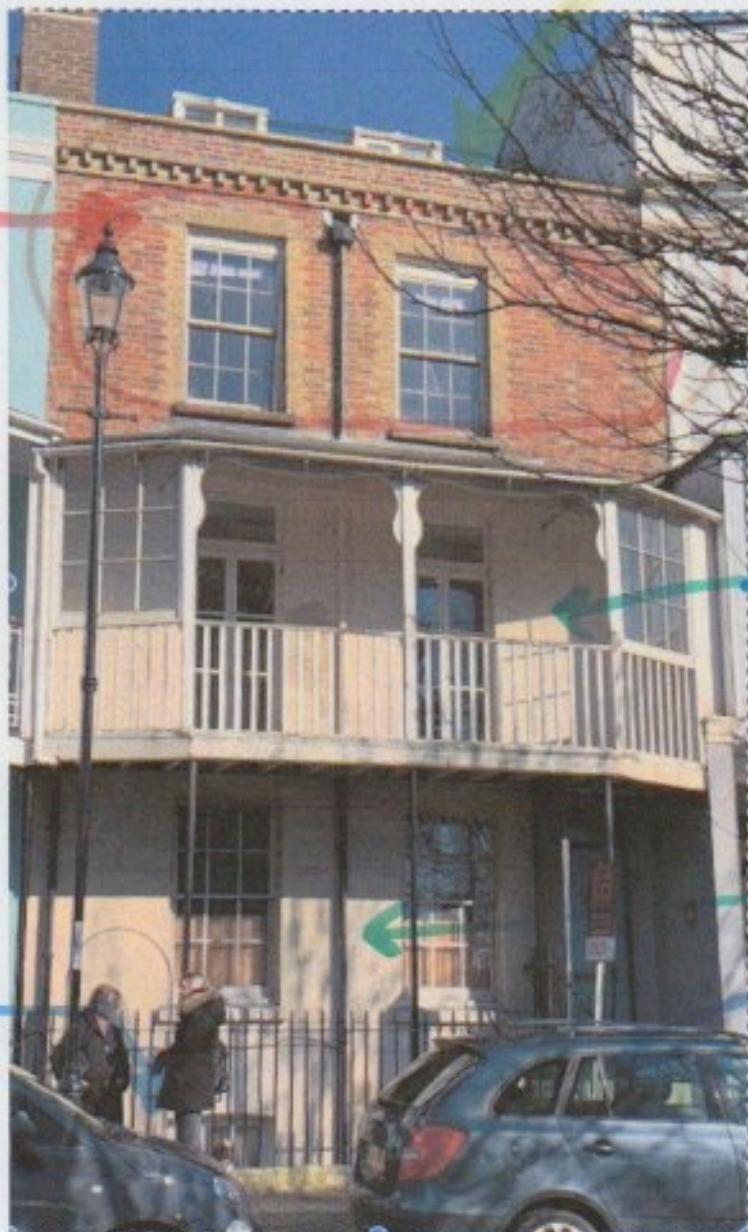
13 S Terrace Planning front external

- Roof - mortar flashing needs to be renewed in lead flashing.
- Re-pointing to the brick work and cornice/dental course to the front
- Render to the front (brick) and rear (flint) walls is poor and requires repairs.
- Repaint front brickwork
- Front steps to the upper floors and steps leading to the lower ground floor should be reformed.

Lead flashing

Repaint  
& repair cornice

repaint.

steps
