## **Road Safety Audit Stage 2**

### **Proposed Site Access**

### **Eldon Way**

Project Title            Lineside Industrial Estate

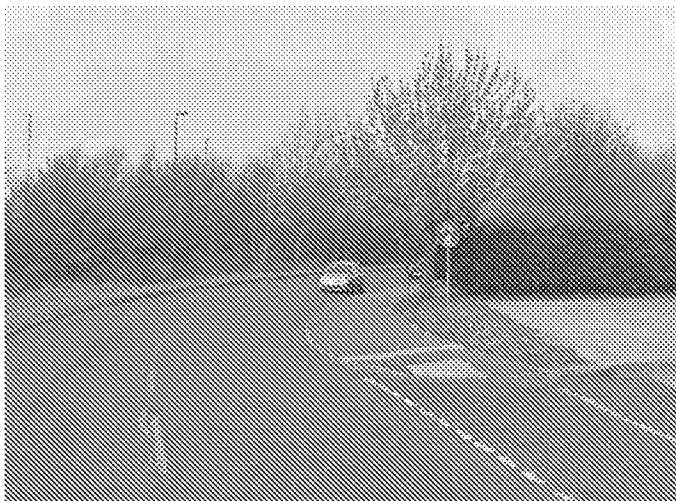
Further, the junction follows a sweeping bend, where the junction for southbound traffic may not be sufficiently visible, see figure 1 below, where forward visibility may be impeded by a hedgerow and tree trunk. A lack of forward visibility and warning of the junction could lead to head on collisions or rear end shunts.

Figure 1: Tree trunk and hedgerow restrict forward visibility on bend.

It is recommended that the junction radii should be eased to provide sufficient carriageway space for all expected movements. It is also recommended that the hedgerow should be cut back and that a 'Side road ahead' sign to Diagram 506.1 should be installed on the approach to the junction.
