# **Tree Works Report, June 2026**

## **Old Granary, Lyminster**

**Report Reference Number: 01083**  
Version: One

Site address:  
Old Granary  
Church Lane  
Lyminster  
BN17 7QL

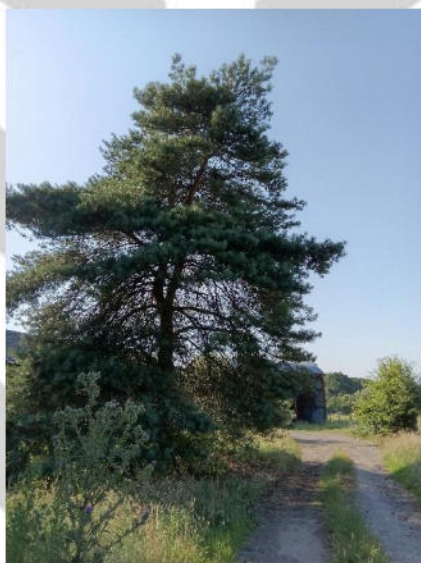
| Tree Number: | T1 | | |

| Condition Comments: | Tree in fair condition, minor deadwood in crown, low crown impeding driveway access | | |

| Works Needed: | Prune back to driveway edge – work to be undertaken within 6 months | | |

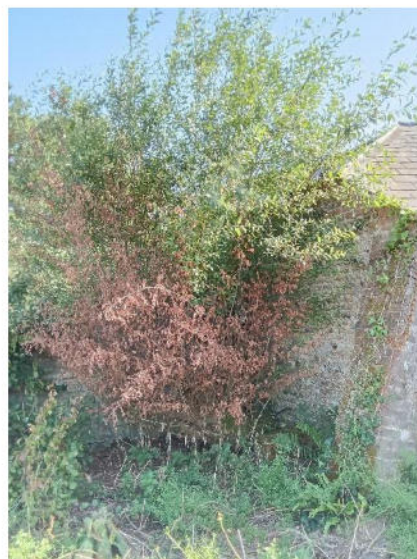
| <b>Tree Number:</b> | T2 | | |

| <b>Condition Comments:</b> | Lower trunk in contact with building | | |

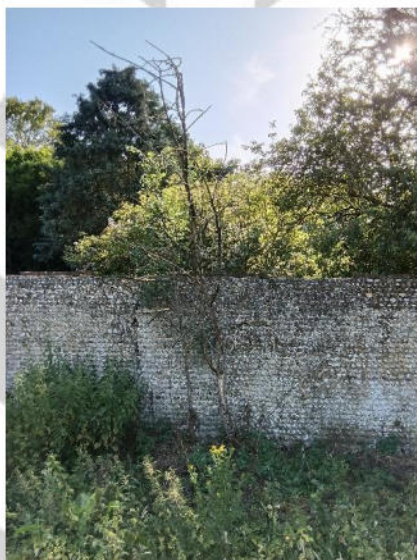
| <b>Tree Number:</b> | T3 | | |

| <b>Condition Comments:</b> | Dead standing, likely Dutch Elm Disease | | |
| <b>Overall Tree Condition:</b> | Dangerous | | |

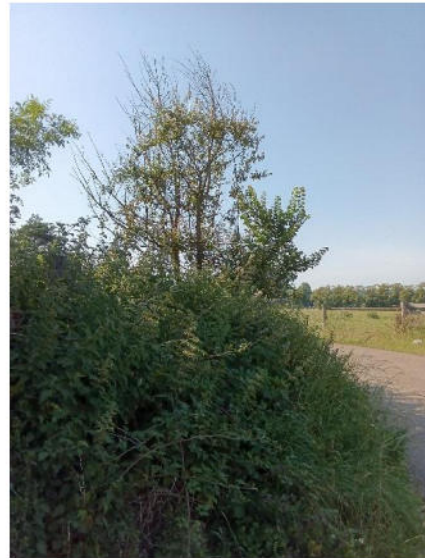
| <b>Tree Number:</b> | T4 | | |

| <b>Condition Comments:</b> | Dead standing, likely Dutch Elm Disease | | |
| <b>Overall Tree Condition:</b> | Dangerous | | |

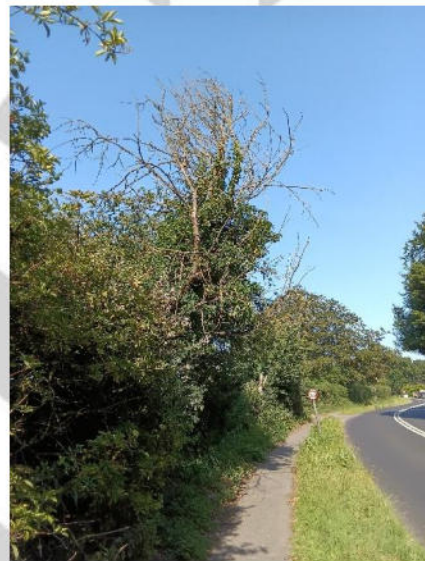
| <b>Tree Number:</b> | T5 | | |

| <b>Condition Comments:</b> | Dead standing, likely Dutch Elm Disease | | |
| <b>Overall Tree Condition:</b> | Dangerous | | |

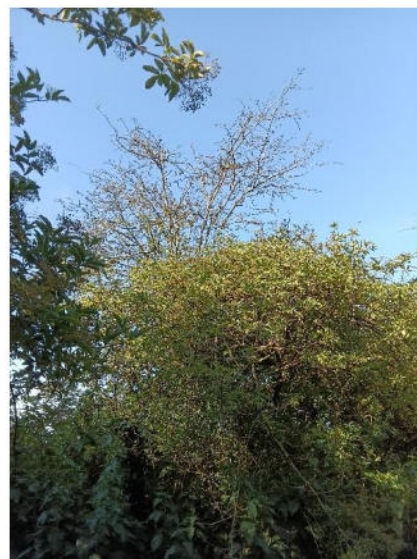
| <b>Tree Number:</b> | T6 | | |

| <b>Condition Comments:</b> | Excessive vegetation inhibiting full inspection, major deadwood parts in crown | | |
| <b>Overall Tree Condition:</b> | Poor | | |

| <b>Works Needed:</b> | Fell and replace with suitable species – work to be undertaken within 3 months | | |

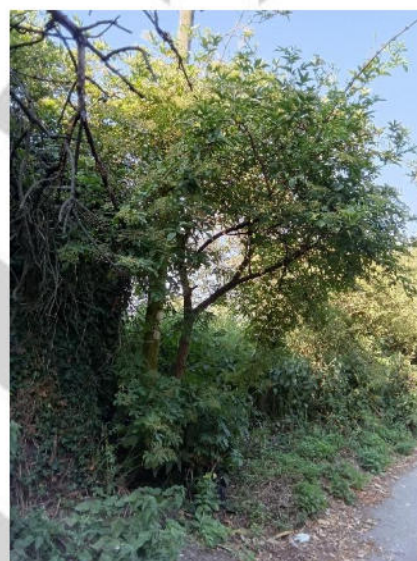
| <b>Tree Number:</b> | T7 | | |

| <b>Condition Comments:</b> | Branching in contact with wall, low crown over pavement | | |

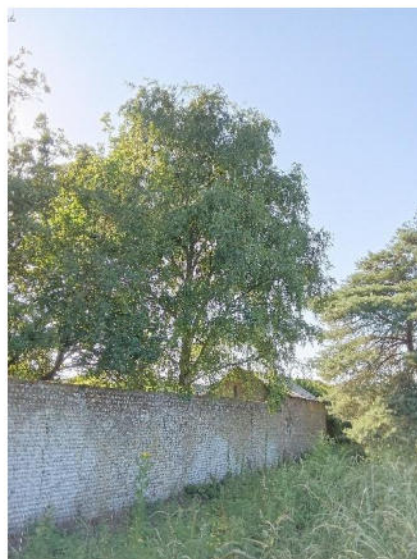
| <b>Tree Number:</b> | T8 | | |

| <b>Condition Comments:</b> | Ivy clad trunk inhibiting full inspection, low branching to west over garden, branching in contact with building | | |

T8 Silver Birch, prune back from building by 2m clearance and crown lift to 4m all-round, removing 3 smaller lower branching back to trunk, to stop damage to building and allow access under tree.

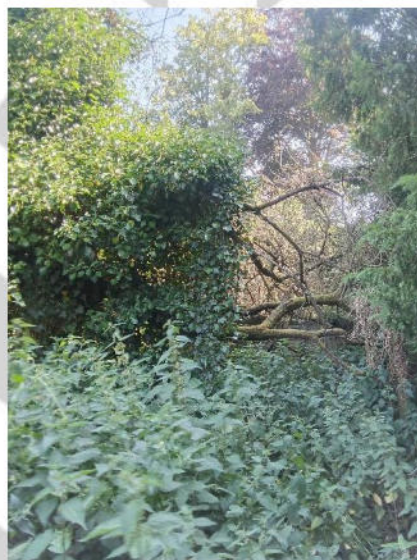
| <b>Tree Number:</b> | T9 | | |

| <b>Condition Comments:</b> | Dead fallen tree resting on wall | | |
| <b>Overall Tree Condition:</b> | Dangerous | | |

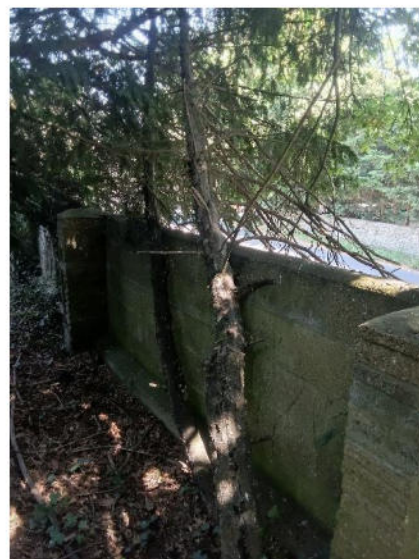
| <b>Tree Number:</b> | T10 | | |

| <b>Condition Comments:</b> | Two dead stems resting on wall | | |
| <b>Overall Tree Condition:</b> | Dangerous | | |

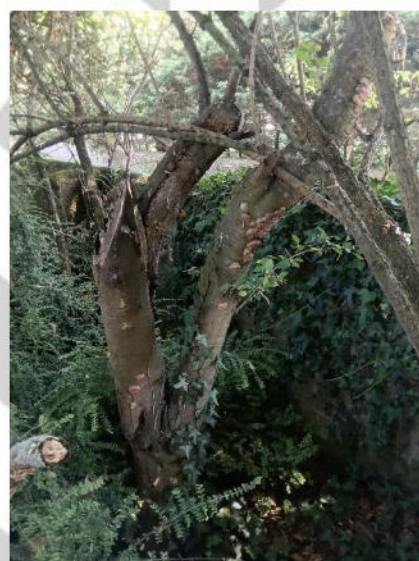
| <b>Tree Number:</b> | T11 | | |

| <b>Condition Comments:</b> | Asymmetric crown over road, split included bark union at lower trunk, <i>Phellinus pomaceus</i> fungus on trunk, likely causing white rot into stems | | |
| <b>Overall Tree Condition:</b> | Poor | | |

T11 Prunus, fell to ground level, works to remove low quality tree with defective parts.

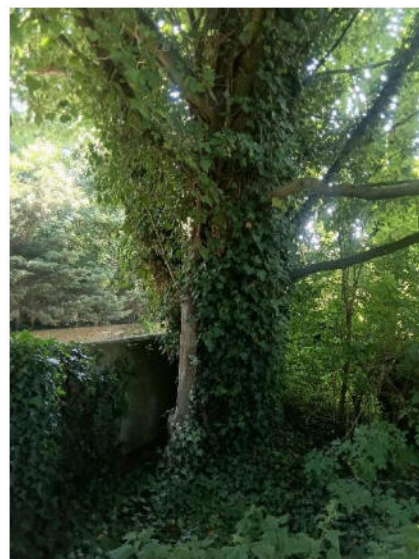
| Tree Number: | T12 | | |

| Condition Comments: | Smaller tree growing within crown of larger tree adjacent to main stem, dead standing | | |
| Overall Tree Condition: | Dangerous | | |

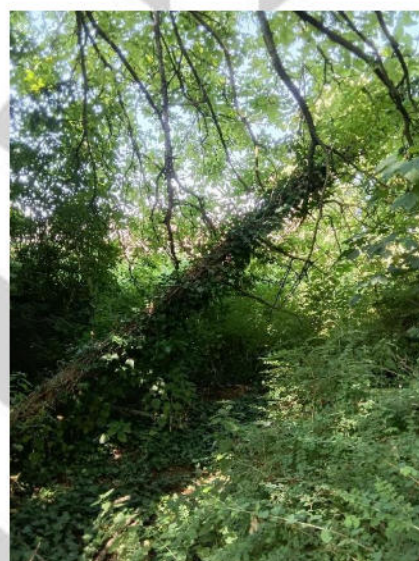
| Tree Number: | T13 | | |

| Condition Comments: | Dead fallen tree resting on crown of adjacent tree | | |
| Overall Tree Condition: | Dangerous | | |

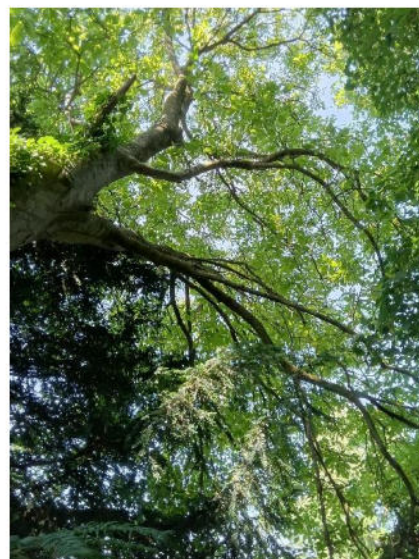
| <b>Tree Number:</b> | T14 | | |

| <b>Condition Comments:</b> | Asymmetric form with heavy lean to north, major deadwood in crown | | |
| <b>Overall Tree Condition:</b> | Poor | | |

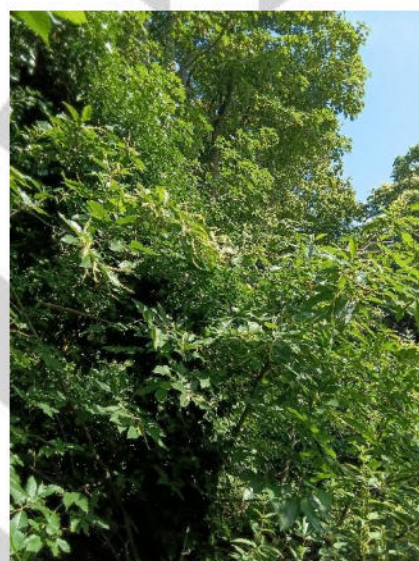
| <b>Tree Number:</b> | T15 | | |

| <b>Condition Comments:</b> | Tree's upper trunk lost, live growth on lower parts | | |
| <b>Overall Tree Condition:</b> | Poor | | |

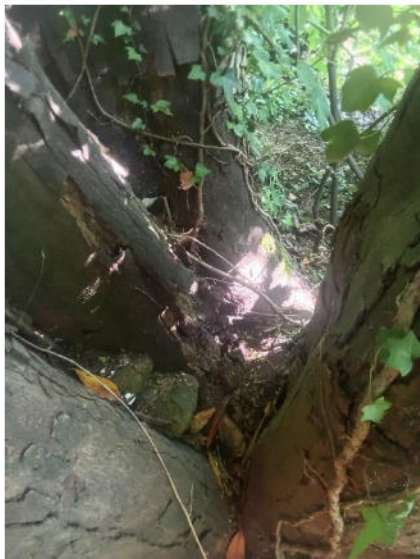
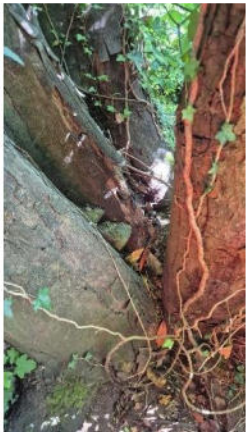
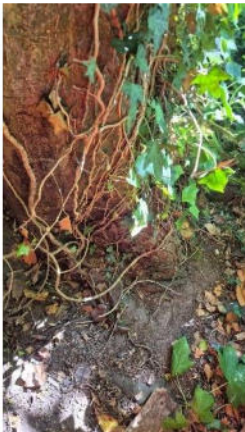
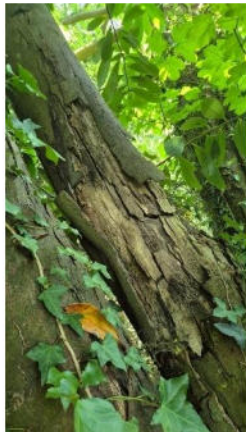
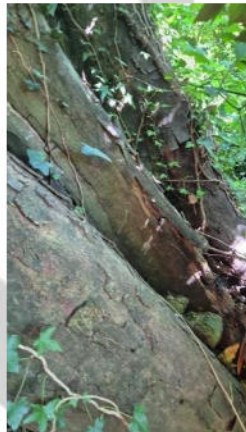
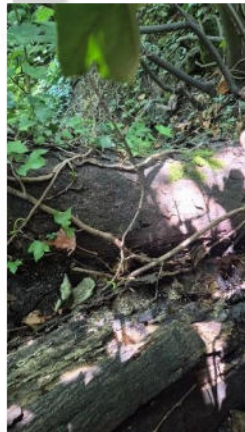
| <b>Condition Comments:</b> | Multi-stemmed tree with dead parts in crown, dead stems, tight include bark unions at base, major decay into base area, collapsed stems, cracking at trunk base, decay fungus at base of all stems of <i>Ganoderma</i> species that is known to cause tree failure | | |
| <b>Overall Tree Condition:</b> | Dangerous | | |

5.1. Tree T16 Sycamore should be felled as soon as reasonably practical, this should be notified to the Local Planning Authority as a 5-day notification to fell the tree.

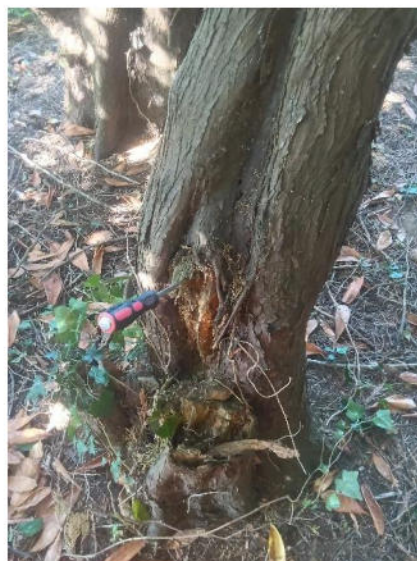
| <b>Tree Number:</b> | T17 | | |

| <b>Condition Comments:</b> | Major decay at base of trunk | | |
| <b>Overall Tree Condition:</b> | Poor | | |

T17 Western Red Cedar, fell to ground level, to remove tree with decay at trunk base.

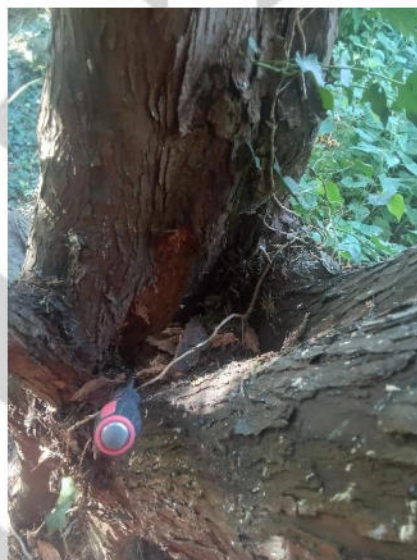
| <b>Tree Number:</b> | T18 | | |

| <b>Condition Comments:</b> | Hollowing of stem, decay at lower trunks, dieback of lower crown | | |
| <b>Overall Tree Condition:</b> | Poor | | |

T18 Western Red Cedar, fell to ground level, to remove tree with hollowing and decay of lower trunks.

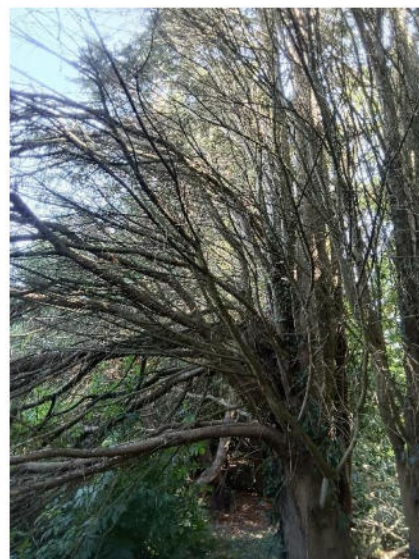
| <b>Tree Number:</b> | T19 | | |

| <b>Condition Comments:</b> | Leaning tree over high target area, dead standing, major broken stem from trunk, dead parts in crown, | | |
| <b>Overall Tree Condition:</b> | Dangerous | | |

T19 Leyland Cypress, fell to ground level, to remove tree with major broken and dead parts.

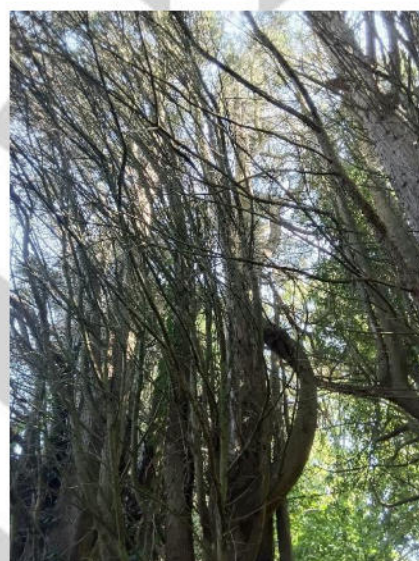
| <b>Tree Number:</b> | T20 | | |

| <b>Condition Comments:</b> | Tree exposed from adjacent tree removal, broken and dead parts in crown | | |
| <b>Overall Tree Condition:</b> | Poor | | |

T20 Leyland Cypress, fell to ground level, to remove tree with major broken and dead parts.

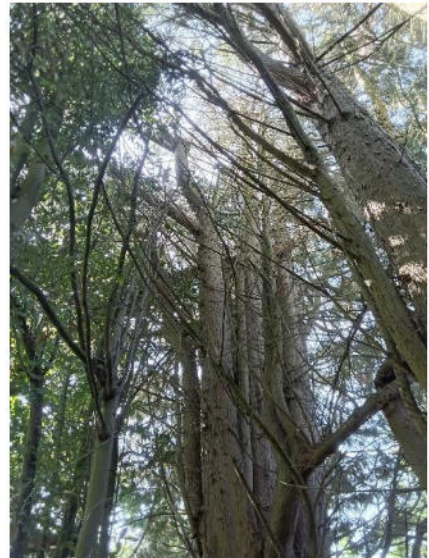
| <b>Tree Number:</b> | T21 | | |

| <b>Condition Comments:</b> | Major broken and suspended stems in crown, major deadwood | | |
| <b>Overall Tree Condition:</b> | Dangerous | | |

- T21 Leyland Cypress, fell to ground level, to remove tree with major broken and dead parts.
- T22 Western Red Cedar, fell to ground level, to remove tree with dead stem and parts in contact with wall.

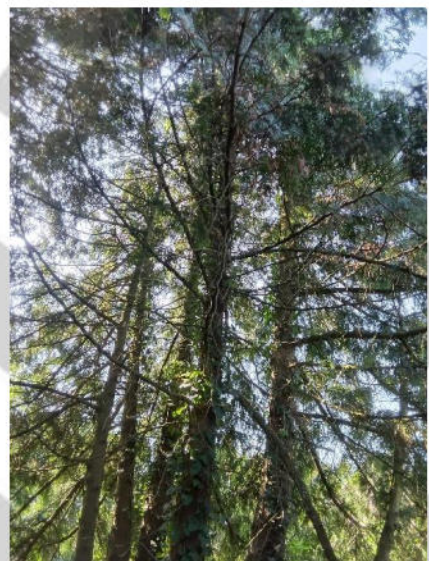
| <b>Tree Number:</b> | T22 | | |

| <b>Condition Comments:</b> | Trunk in contact with wall, dead stem to south, asymmetric stems from base, parts overhanging building | | |
| <b>Overall Tree Condition:</b> | Poor | | |

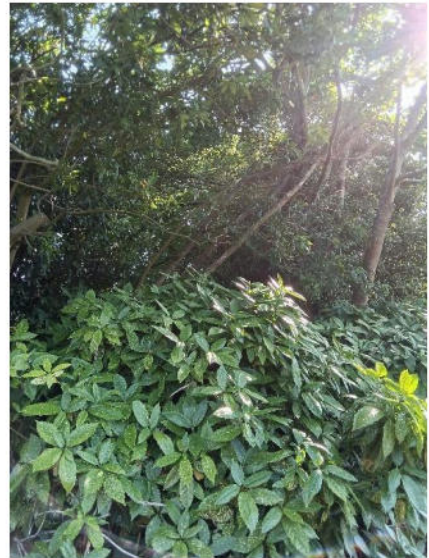
| <b>Tree Number:</b> | T23 | | |

| <b>Condition Comments:</b> | Dead fallen tree resting in adjacent tree | | |
| <b>Overall Tree Condition:</b> | Dangerous | | |

- T23 Unknown, fallen dead tree, fell to ground level, to remove dead parts.
- T24 Holly, fell to ground level, to address tree with damage, deadwood and decay.

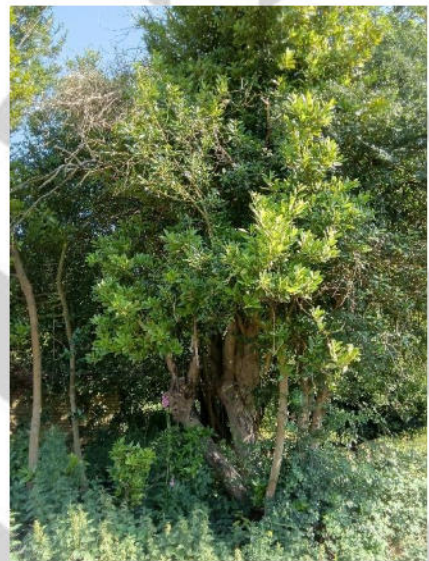
| <b>Tree Number:</b> | T24 | | |

| <b>Condition Comments:</b> | Major deadwood and dieback, damage and decay at lower trunk | | |
| <b>Overall Tree Condition:</b> | Poor | | |

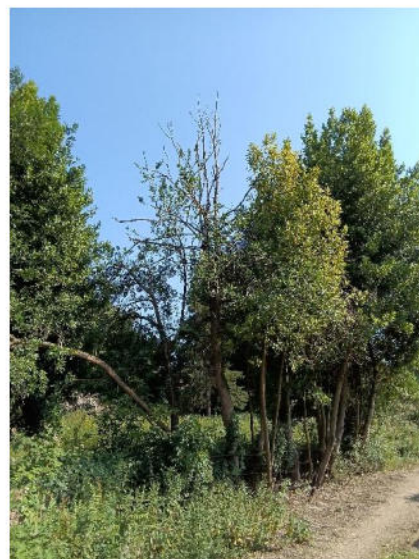
| <b>Tree Number:</b> | T25 | | |

| <b>Condition Comments:</b> | Dead standing | | |
| <b>Overall Tree Condition:</b> | Dangerous | | |

- T25 Holly, fell to ground level, dead standing, to remove dead tree.
- T26 Holly, fell to ground level, dead standing, to remove dead tree.
- T27 Lime, fell to ground level, decay into base, works to remove tree with defective parts.

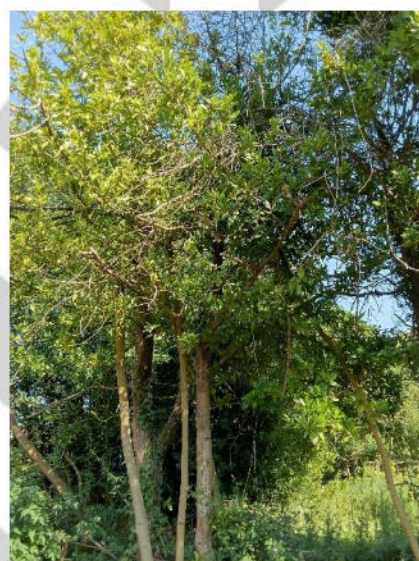
| <b>Tree Number:</b> | T26 | | |

| <b>Condition Comments:</b> | Dead standing | | |
| <b>Overall Tree Condition:</b> | Dangerous | | |

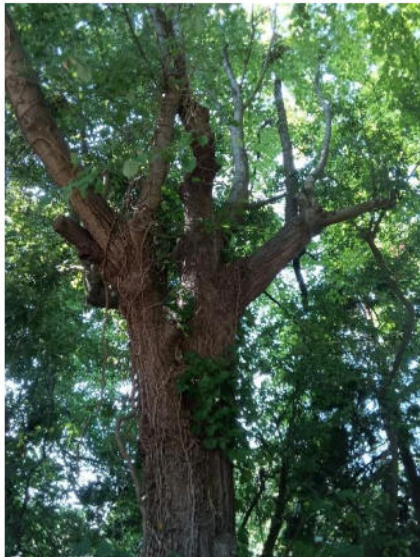
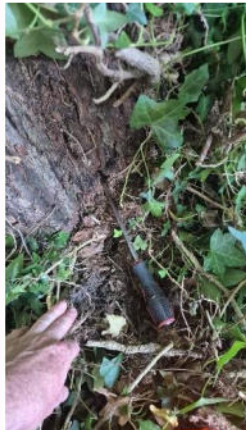
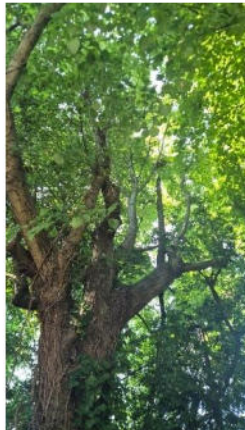
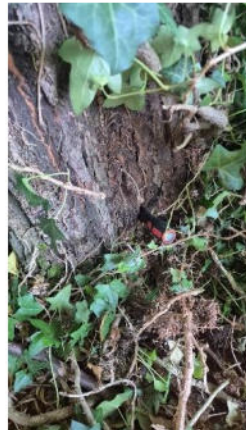
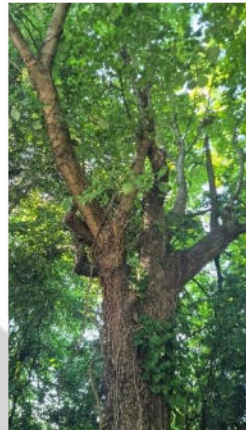
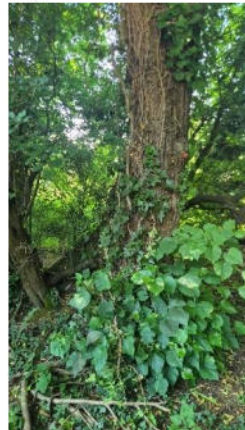
| Tree Number: | T27 | | | |

| Condition Comments: | Tree topped in past, with regrowth forming crown, major decay cavity into trunk base at ground level | | | |
| Overall Tree Condition: | Poor | | | |

| Works Needed: | Fell/Remove down to ground level – work to be undertaken within 2 months | | | |

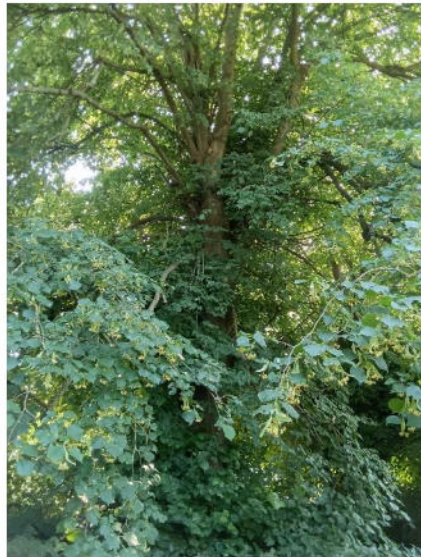
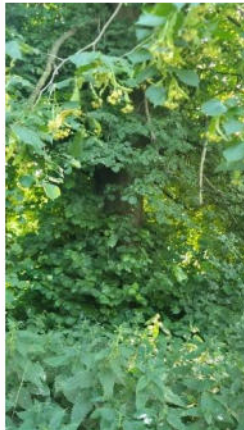
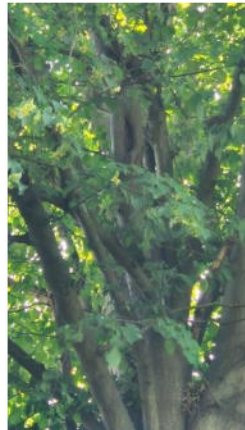
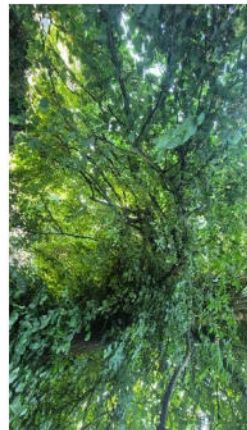
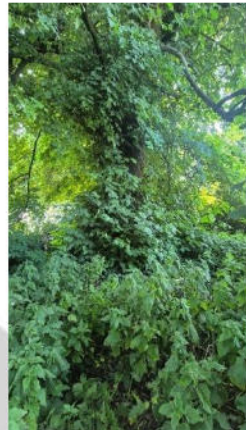
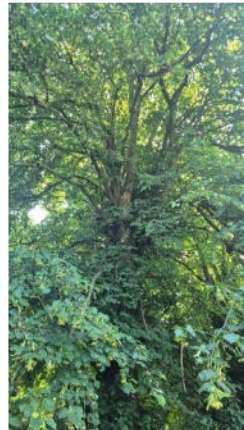
| Condition Comments: | Large dominant tree, epicormic growth dense around lower trunk unable to fully inspect, deadwood in crown, dense lower crown over road, damage to branching with decay into branches, excessive vegetation inhibiting full inspection, | | | |
| Overall Tree Condition: | Fair | | | |

| Works Needed: | Clear epicormic growth from around trunk and inspect, crown lift to 6m to remove dense lower branching, remove deadwood, aerial assessment stem and branch unions in crown, assess branching from within crown and remove compromised parts, – work to be undertaken within 3 months | | | |

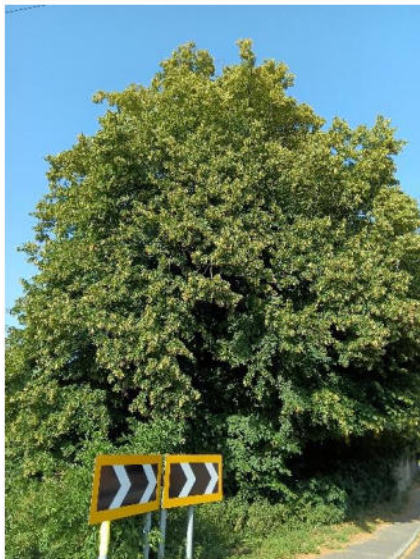
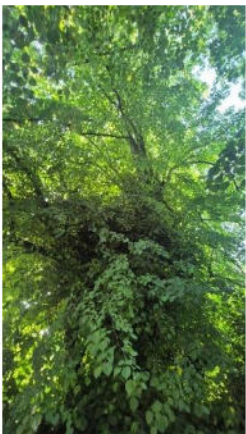
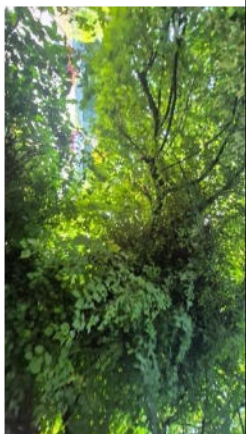
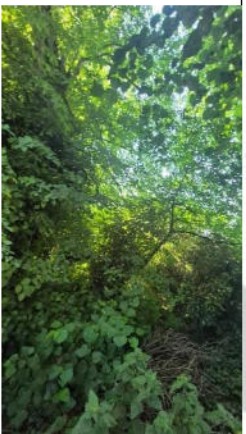
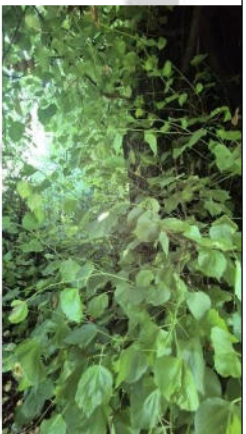
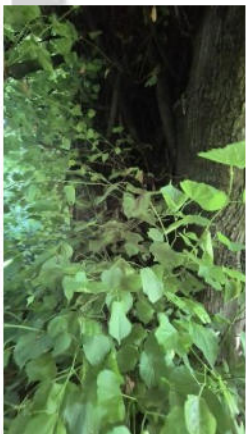
| <b>Condition Comments:</b> | Large dominant tree, epicormic growth dense around lower trunk unable to fully inspect, deadwood in crown. dense lower crown over road, damage to branching with decay into branches, excessive vegetation inhibiting full inspection, multi-stemmed tree unable to fully inspect | | |
| <b>Overall Tree Condition:</b> | Poor | | |

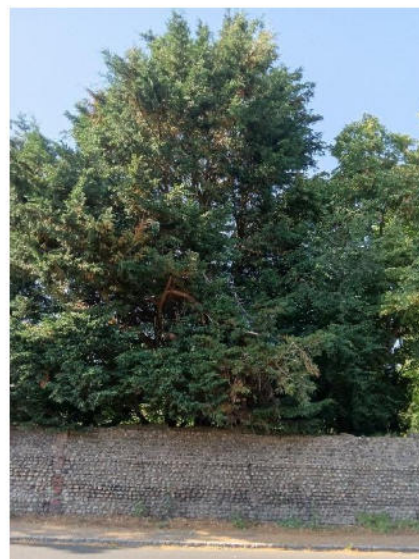
| <b>Tree Number:</b> | T30 | | |

| <b>Condition Comments:</b> | Broken branching over pavement and road | | |

- T30 Leyland Cypress, prune remove broken branching on southern sector back to trunk, to remove defective parts.
- T31 Laurel, fell to ground level, tree of poor form with parts collapse, to address current and developing defects.

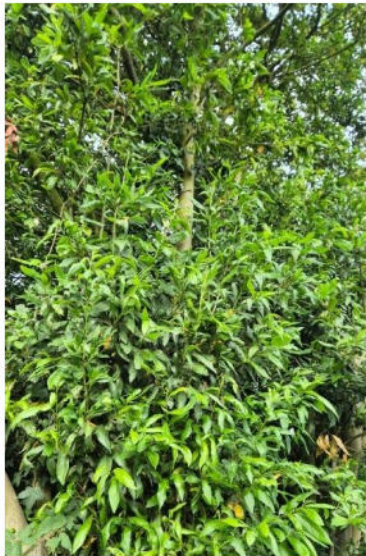
| Tree Number: | T31 | | |

| Condition Comments: | Collapsed major dead parts, growing from bank adjacent to fence | | |
| Overall Tree Condition: | Poor | | |

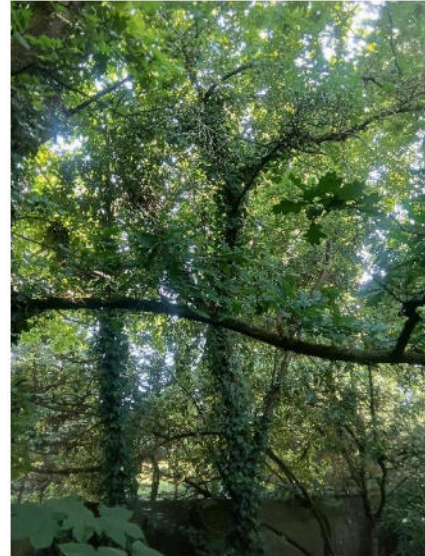
| Tree Number: | TG1 | | |

| Condition Comments: | Two trees on boundary, one with large amount of deadwood | | |
| Overall Tree Condition: | Poor | | |

- TG1 Unknown (2 trees), fell to ground level, to remove trees of low quality.
