MS07041/DS

18th November 2024

**Structural Appraisal of Existing Brickwork Barn at Broomhurst Farm, Lymminster for
Conversion to Domestic Accommodation**

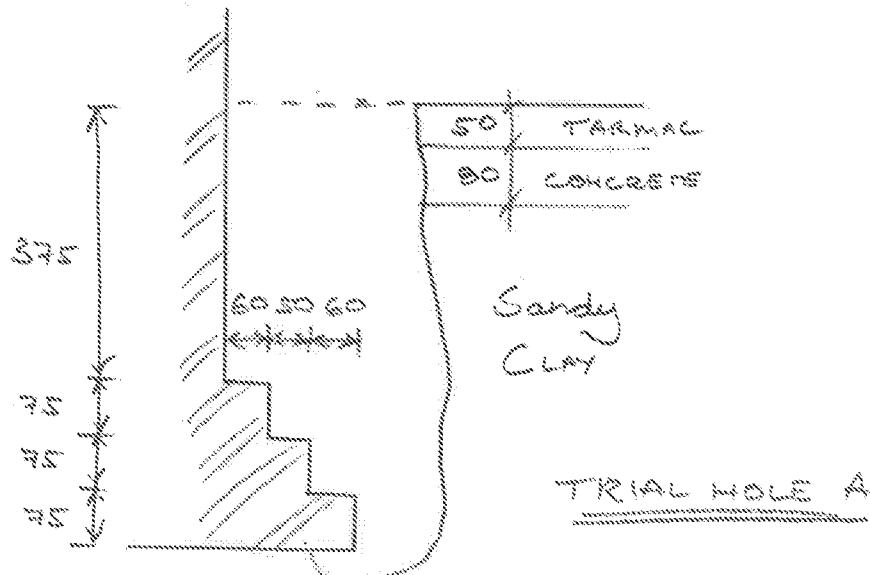
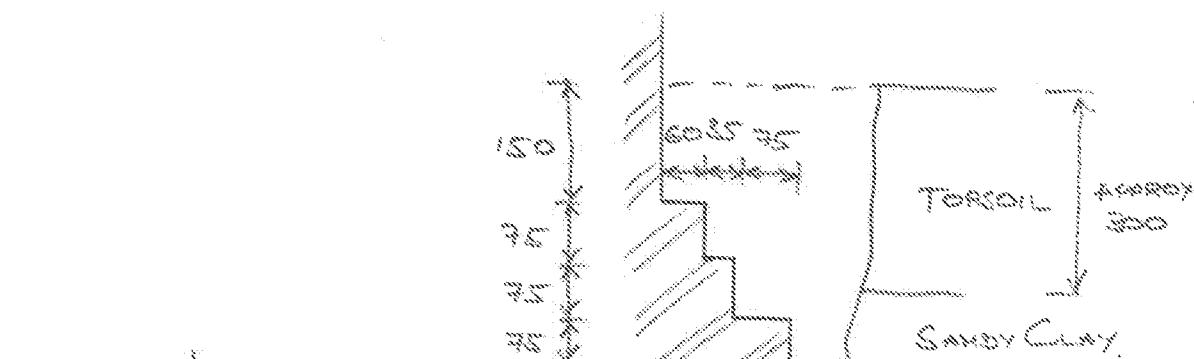
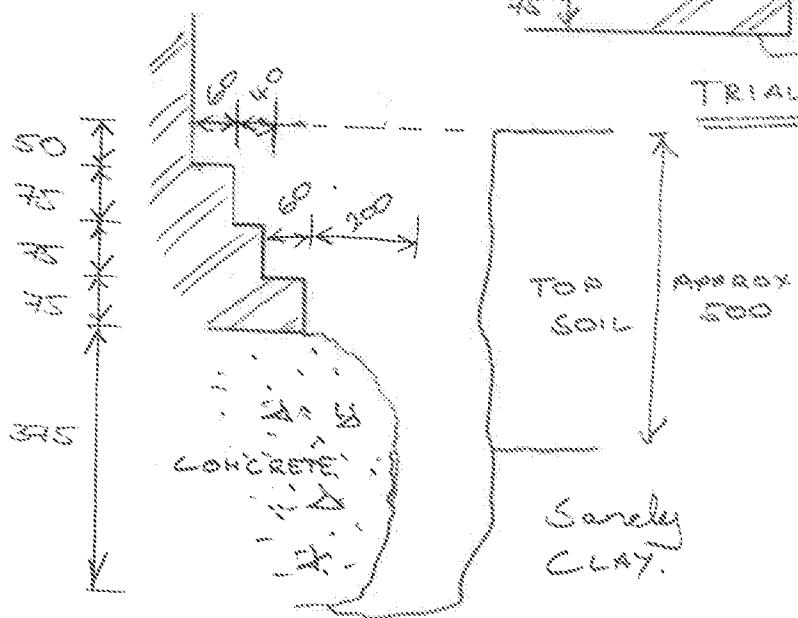
JOB TITLE		DATE
Broomhurst Farm, Lymminster		November 2024
ITEM	JOB NO.	SHEET NO
Trial holes	MS07041	
PREPARED BY	CHECKED BY	
DS

Three trial holes were excavated externally around the building, which showed the footings were between 375mm – 650mm deep with corbelled out brickwork for the main brickwork barn and corbelled bricks with concrete under for the infill link brickwork (see attached section sketches of the trial holes). A soil sample was sent for testing the clay content and the attached result shows the subsoil is on threshold between low and medium plasticity clay.

The existing foundations are between 375mm and 650mm deep, which are a little shallow compared to current requirements for foundations bearing onto low to medium plasticity clay subsoil (750mm to 900mm depth). Given there are no trees in close proximity to the existing barn and that the plastered finishes can be supported off new internal floor slab bearing onto new internal foundations, it is likely only small areas of underpinning would be necessary.
