## Asbestos Demolition Report

Roseland  
The Causeway  
Arundel

Reference: C-02177

**Scope of Works:** To carry out a demolition survey to all areas of bungalow and workshop. All works to conform with HSG264 & internal company procedures.

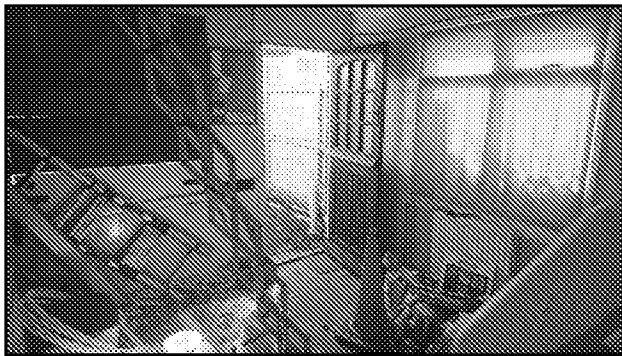
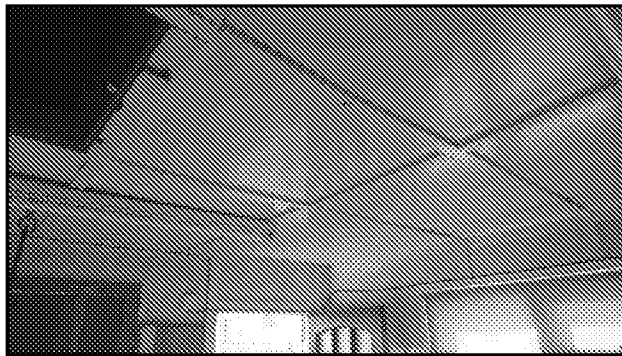
| Condition | Good Condition | | 0 | | |
| Substrate | nailed to timber | Accessibility | Medium | | |
| Comments | brick walls found within partition cavity.<br>nailed to timber | | | | |

| Recommendation | Remove - NON-Licensed Material Removal by an asbestos contractor. This material is not licensed however may still be notifiable to the HSE prior to removal works taking place. All works must conform to the Control of Asbestos Regulations 2012. | | | | |

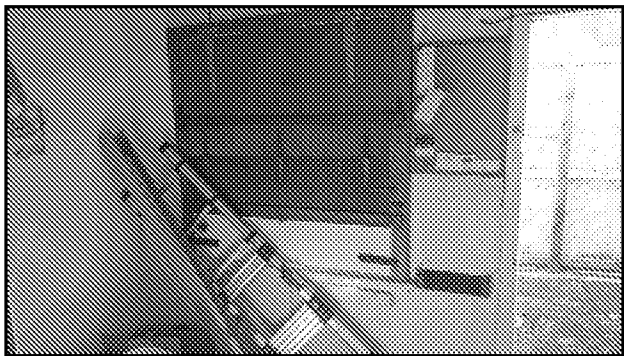
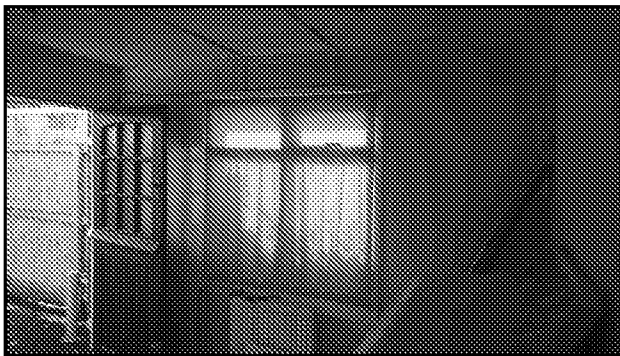
| Condition | Good Condition | | 0 | | |
| Substrate | nailed to timber | Accessibility | High | | |
| Comments | nailed to timber | | | | |

| Recommendation | Remove - NON-Licensed Material Removal by an asbestos contractor. This material is not licensed however may still be notifiable to the HSE prior to removal works taking place. All works must conform to the Control of Asbestos Regulations 2012. | | | | |

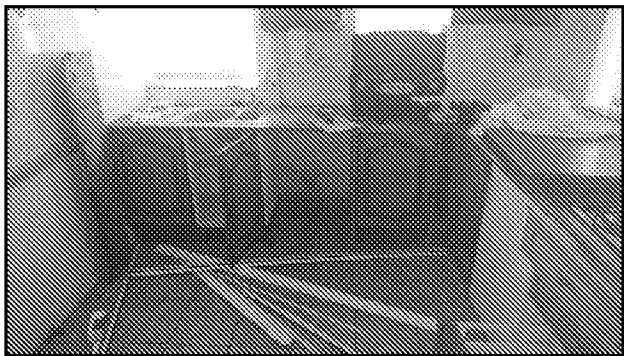
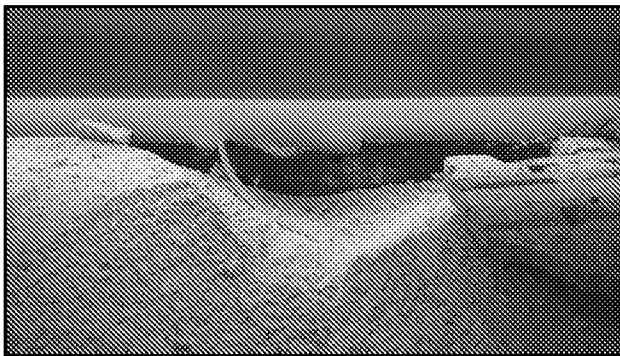
| Substrate | bonded to brick | Accessibility | - | | |
| Comments | modern grg insulating board partition wall between bathroom and kitchen with mmmf insulation within.<br>bonded to brick | | | | |

| Recommendation | No action required | | | | |

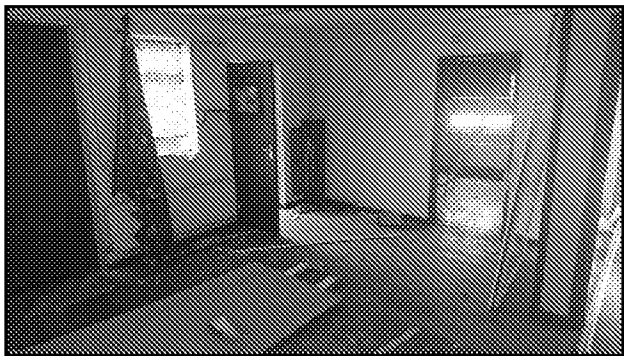
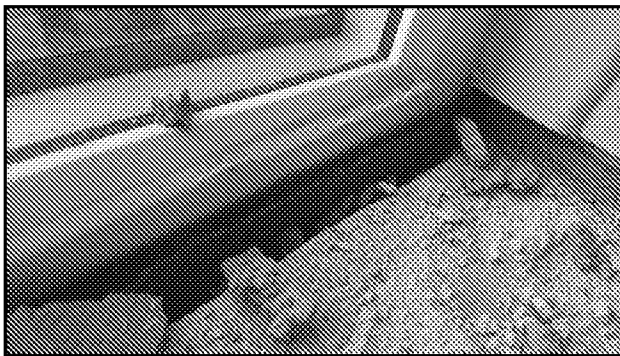
| Substrate | bonded to brick | Accessibility | - | | |
| Comments | no suspect materials found within floor void, modern cement cladding to steel between room 2 and 4.<br>bonded to brick | | | | |

| Recommendation | <b>No action required</b> | | | | |

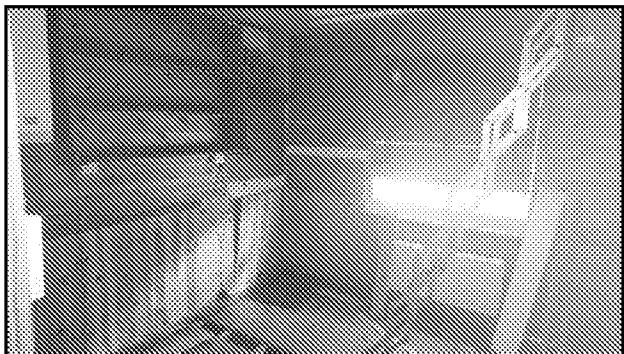
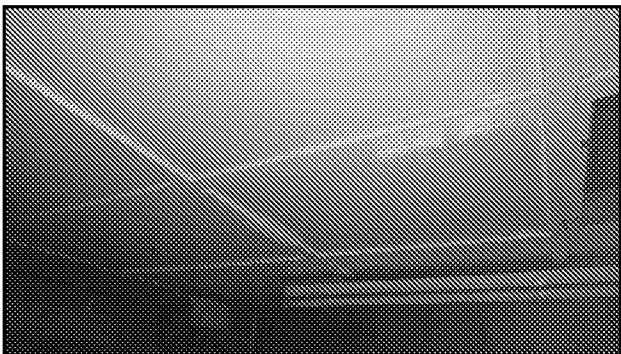
| Condition | Good Condition | | 0 | | |
| Substrate | nailed to timber | Accessibility | Medium | | |
| Comments | nailed to timber | | | | |

| Recommendation | Remove - NON-Licensed Material Removal by an asbestos contractor. This material is not licensed however may still be notifiable to the HSE prior to removal works taking place. All works must conform to the Control of Asbestos Regulations 2012. | | | | |

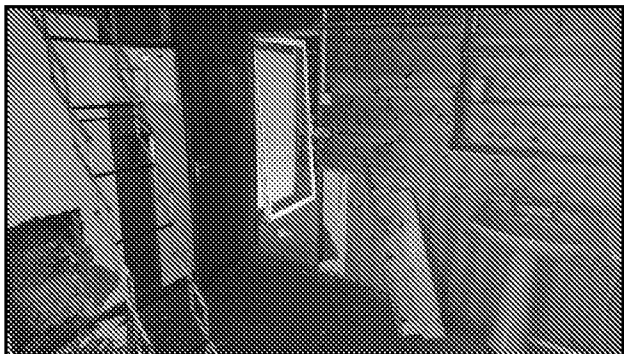
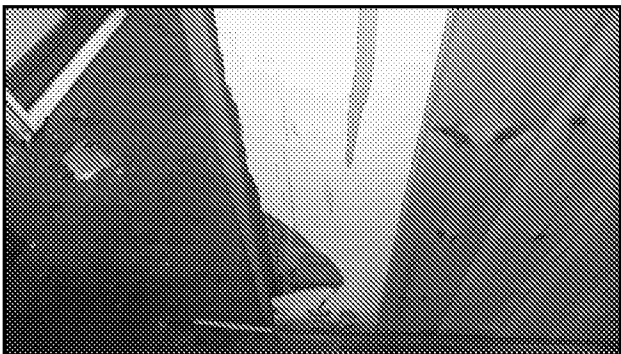
| Condition | Good Condition | | 0 | | |
| Substrate | nailed to timber | Accessibility | Medium | | |
| Comments | nailed to timber | | | | |

| Recommendation | Remove - NON-Licensed Material Removal by an asbestos contractor. This material is not licensed however may still be notifiable to the HSE prior to removal works taking place. All works must conform to the Control of Asbestos Regulations 2012. | | | | |

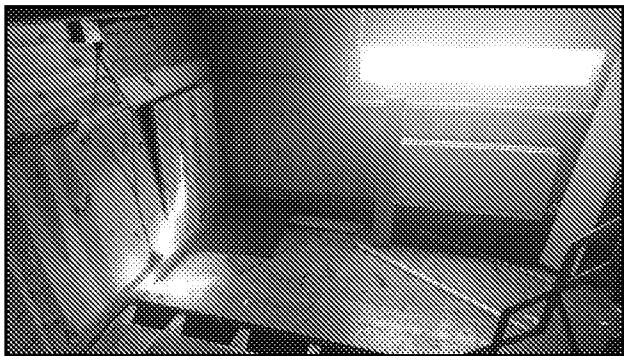
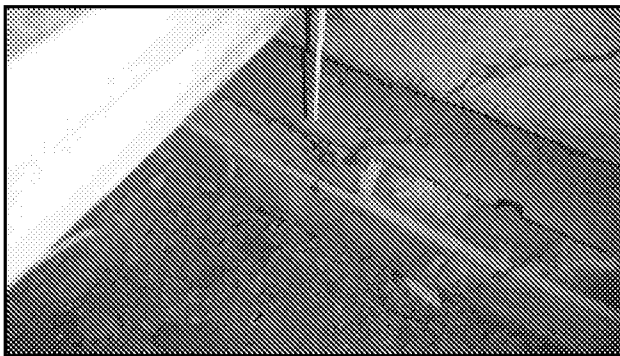
| Substrate | bonded to brick | Accessibility | - | | |
| Comments | bonded to brick | | | | |

| Recommendation | No action required | | | | |

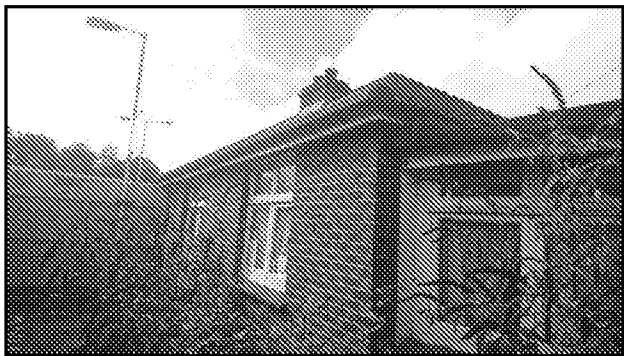
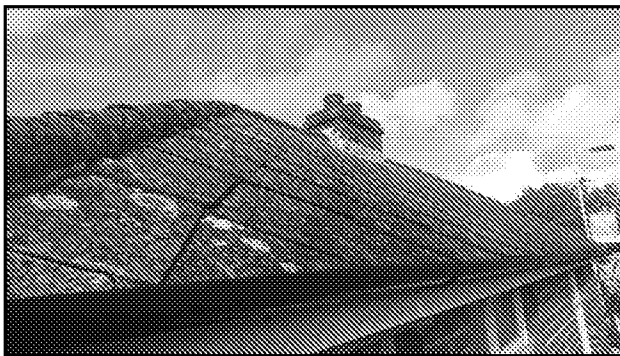
| Condition | Good Condition | | 0 | | |
| Substrate | nailed to timber | Accessibility | Medium | | |
| Comments | plastic and cast iron rainwater goods, modern flat roofing, timber soffits.<br>nailed to timber | | | | |

| Recommendation | Remove - NON-Licensed Material Removal by an asbestos contractor. This material is not licensed however may still be notifiable to the HSE prior to removal works taking place. All works must conform to the Control of Asbestos Regulations 2012. | | | | |

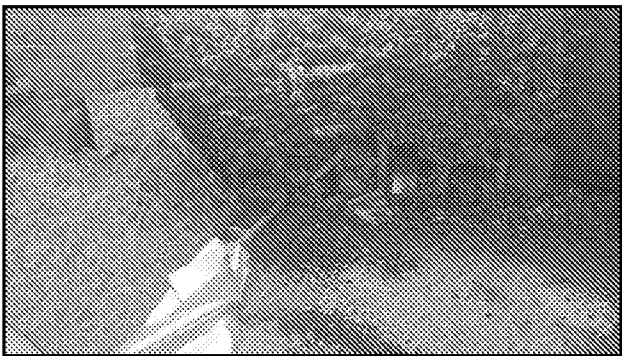
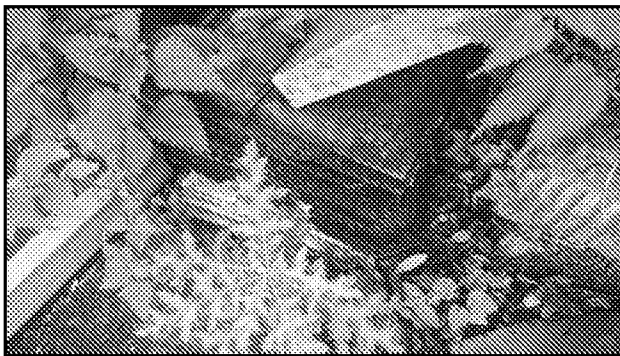
| Condition | Good Condition | | 0 | | |
| Substrate | debris | Accessibility | High | | |
| Comments | debris | | | | |

| Recommendation | Remove - NON-Licensed Material Removal by an asbestos contractor. This material is not licensed however may still be notifiable to the HSE prior to removal works taking place. All works must conform to the Control of Asbestos Regulations 2012. | | | | |

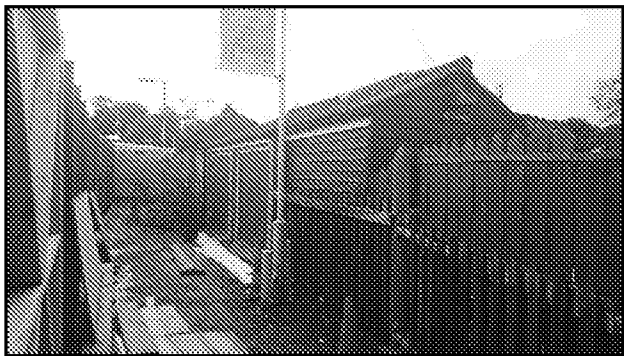
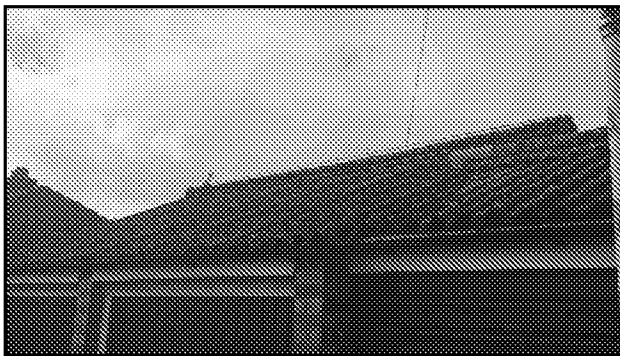
| Condition | Good Condition | | 0 | | |
| Substrate | bolted to timber | Accessibility | Medium | | |
| Comments | bolted to timber | | | | |

| Recommendation | Remove - NON-Licensed Material Removal by an asbestos contractor. This material is not licensed however may still be notifiable to the HSE prior to removal works taking place. All works must conform to the Control of Asbestos Regulations 2012. | | | | |

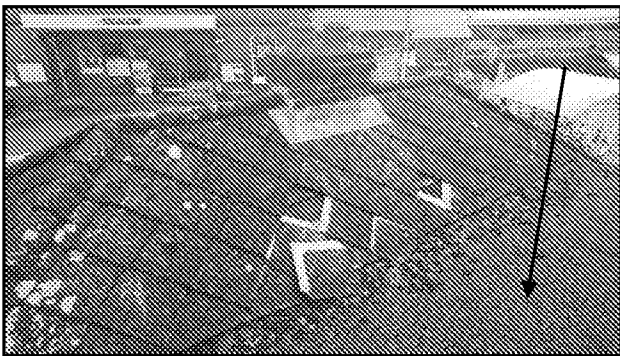
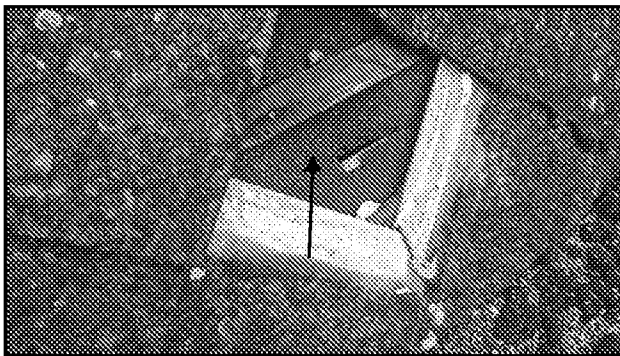
| Substrate | nailed to timber | Accessibility | - | | |
| Comments | bitumen was seen to be beneath cement roof tiles.<br>nailed to timber | | | | |

| Recommendation | No action required | | | | |
