## Asbestos Demolition Report

Roseland  
The Causeway  
Arundel

Reference: C-02177

**Scope of Works:** To carry out a demolition survey to all areas of bungalow and workshop. All works to conform with HSG264 & internal company procedures.

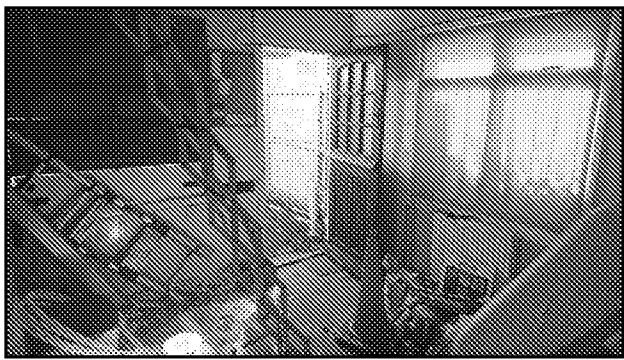
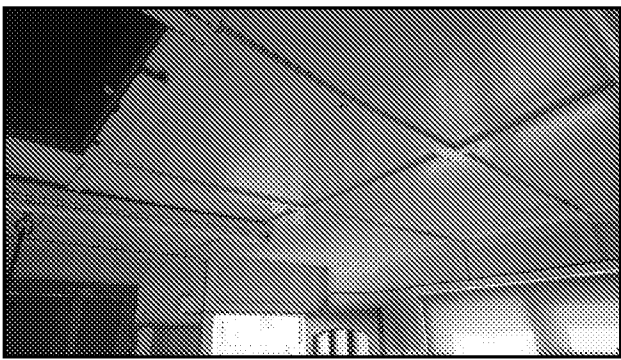
| Condition | Good Condition | | 0 | | |
| Substrate | nailed to timber | Accessibility | Medium | | |
| Comments | brick walls found within partition cavity.<br>nailed to timber | | | | |

| Recommendation | Remove - NON-Licensed Material Removal by an asbestos contractor. This material is not licensed however may still be notifiable to the HSE prior to removal works taking place. All works must conform to the Control of Asbestos Regulations 2012. | | | | |

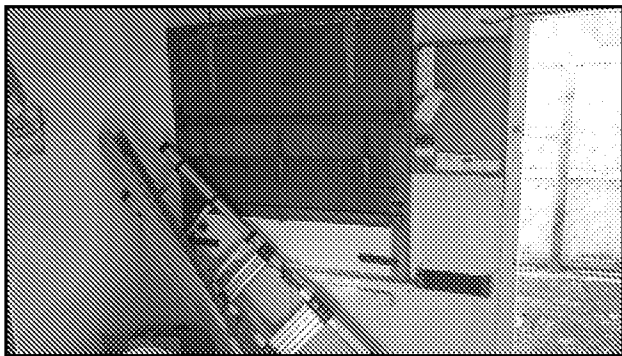
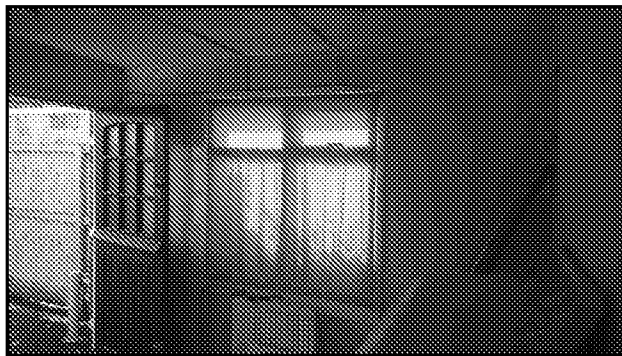
| Condition | Good Condition | | 0 | | |
| Substrate | nailed to timber | Accessibility | High | | |
| Comments | nailed to timber | | | | |

| Recommendation | Remove - NON-Licensed Material Removal by an asbestos contractor. This material is not licensed however may still be notifiable to the HSE prior to removal works taking place. All works must conform to the Control of Asbestos Regulations 2012. | | | | |

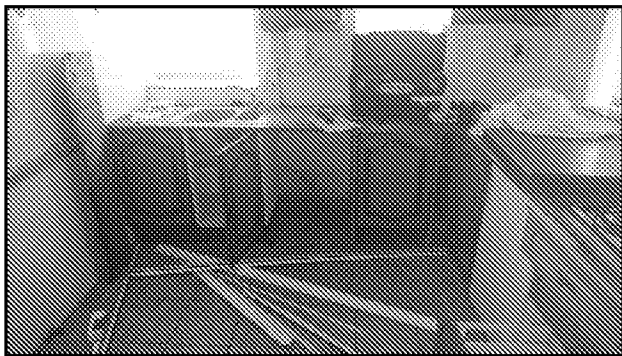
| Comments | modern grg insulating board partition wall between bathroom and kitchen with mmmf insulation within.<br>bonded to brick | | | | |

| Recommendation | No action required | | | | |

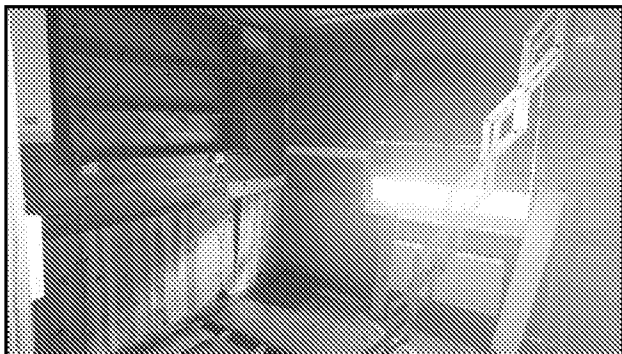
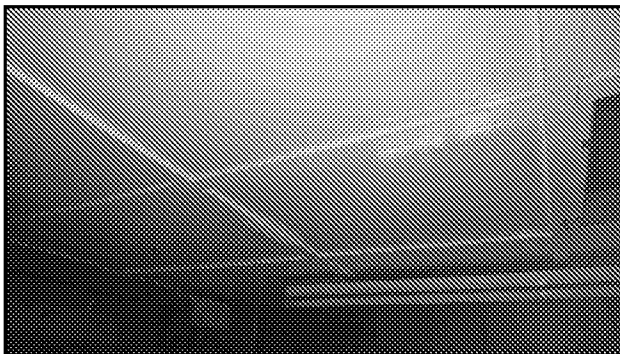
| Condition | Good Condition | | 0 | | |
| Substrate | nailed to timber | Accessibility | Medium | | |
| Comments | nailed to timber | | | | |

| Recommendation | Remove - NON-Licensed Material Removal by an asbestos contractor. This material is not licensed however may still be notifiable to the HSE prior to removal works taking place. All works must conform to the Control of Asbestos Regulations 2012. | | | | |

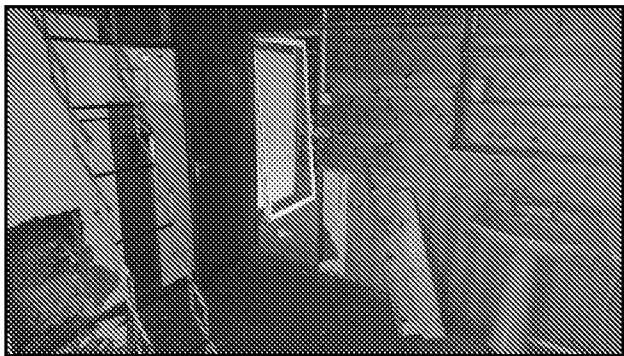
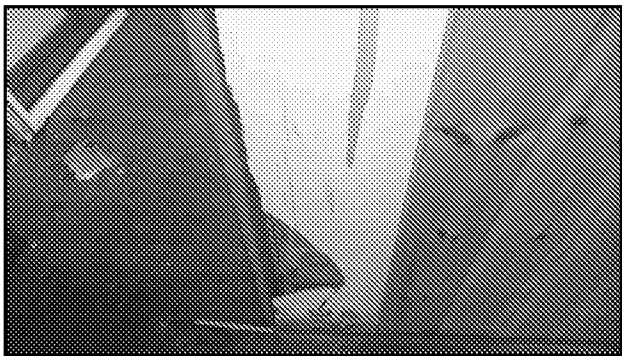
| Condition | Good Condition | | 0 | | |
| Substrate | nailed to timber | Accessibility | Medium | | |
| Comments | nailed to timber | | | | |

| Recommendation | Remove - NON-Licensed Material Removal by an asbestos contractor. This material is not licensed however may still be notifiable to the HSE prior to removal works taking place. All works must conform to the Control of Asbestos Regulations 2012. | | | | |

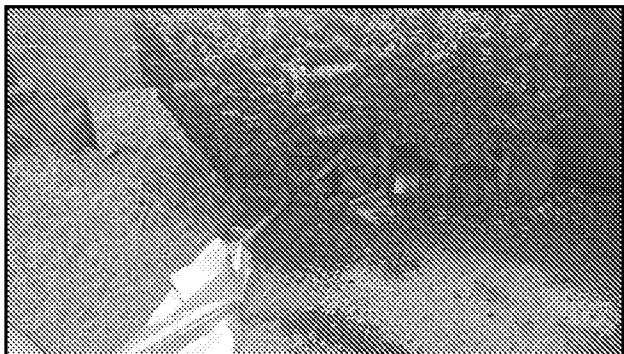
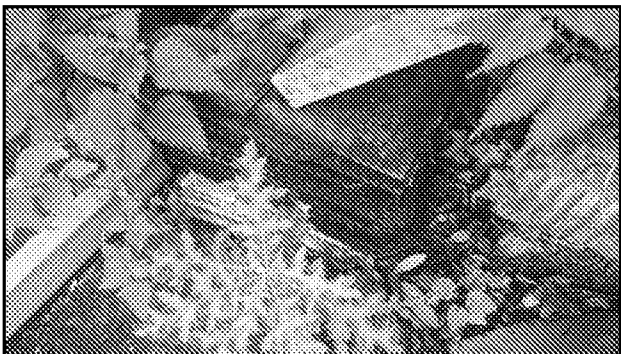
| Condition | Good Condition | | 0 | | |
| Substrate | debris | Accessibility | High | | |
| Comments | debris | | | | |

| Recommendation | Remove - NON-Licensed Material Removal by an asbestos contractor. This material is not licensed however may still be notifiable to the HSE prior to removal works taking place. All works must conform to the Control of Asbestos Regulations 2012. | | | | |
