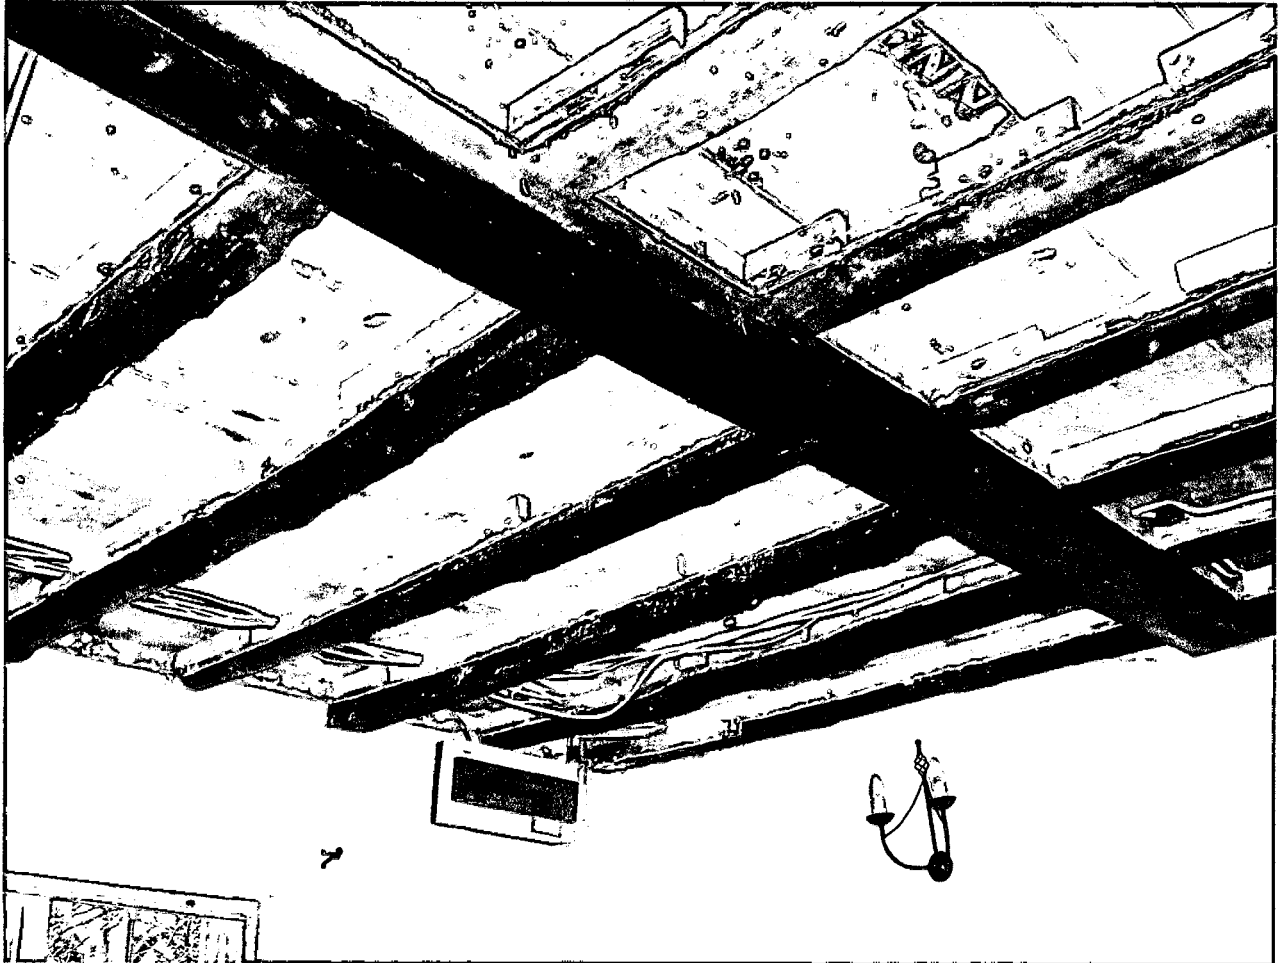
**Photograph 01**

General view of ceiling joist layout showing primary beam and non pairing of joists.

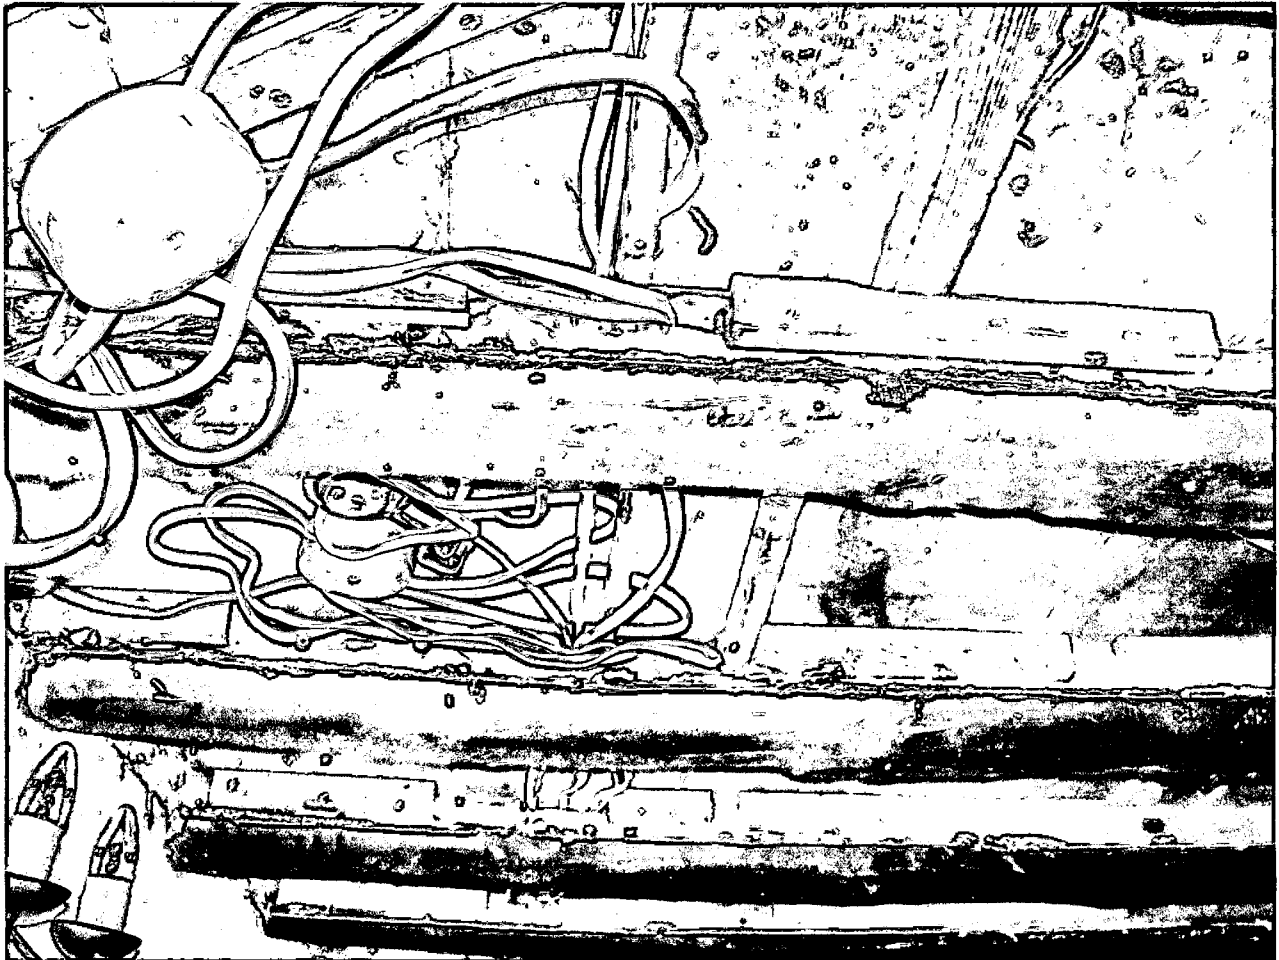
**Photograph 05**

Extensive cutting away of joists to accommodate service cables.

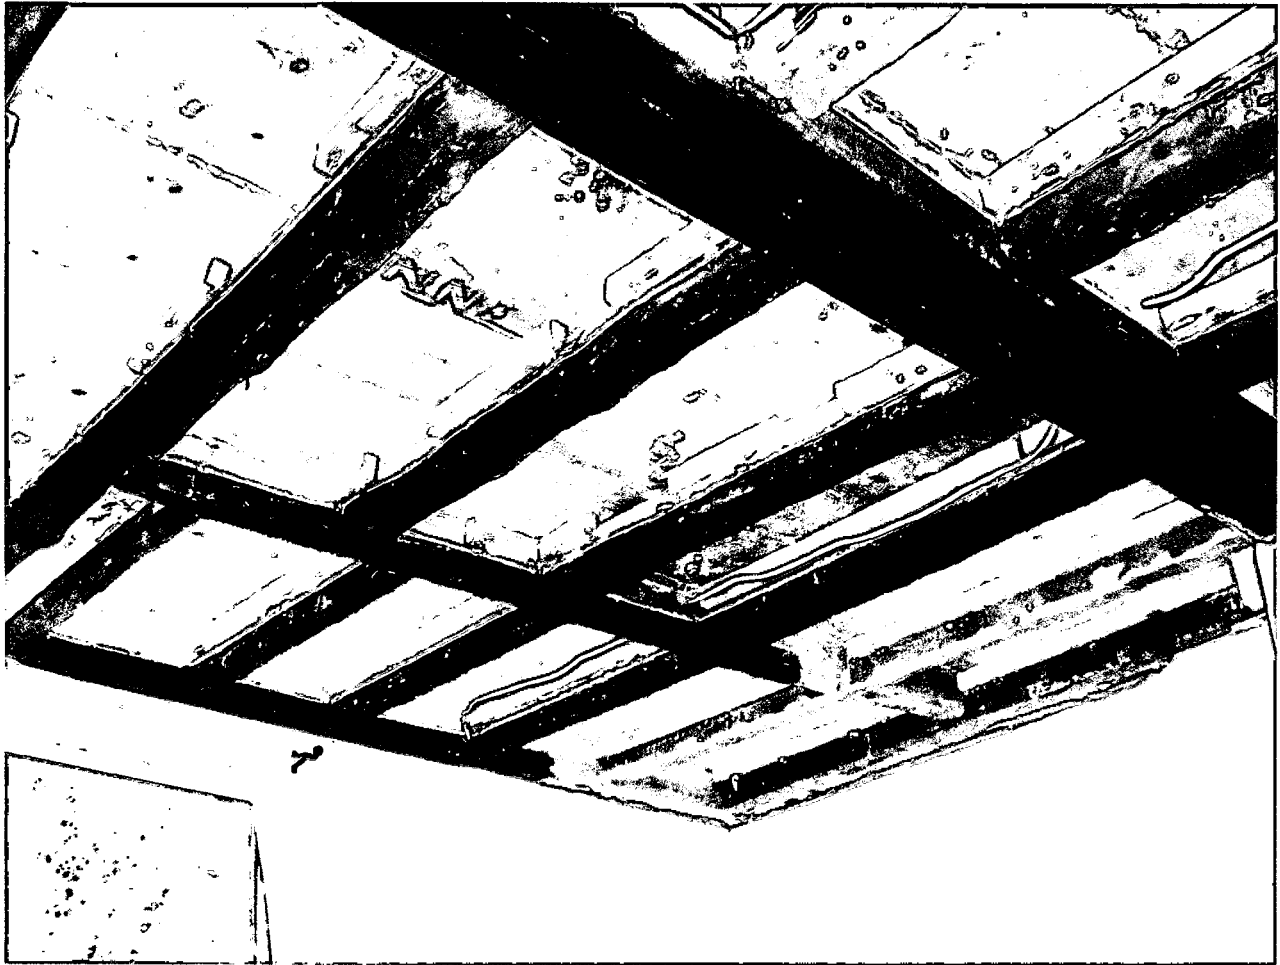
**Photograph 06**

Area of modern sawn softwood joists which have been used to infill the space of an earlier staircase.
