**REASONS FOR PROPOSED TREE WORK**

**T1/470 Holm oak along the southern boundary wall:**

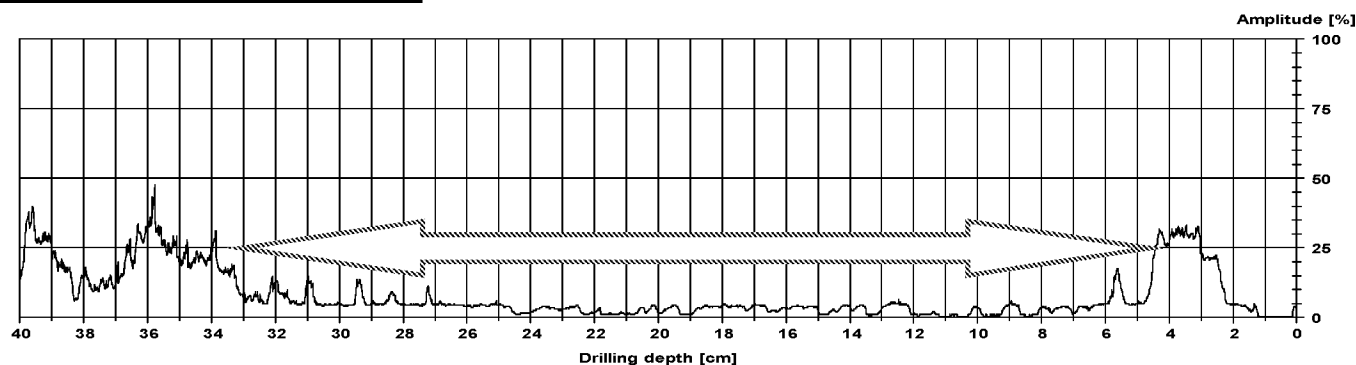
#### Resi Drill Trace 1 – ground level drilling south to north

| No | Tag No | Species | Stem Dia. | Height | Crown Spread | Age Class | Comments | Action Required | Priority |
|---|---|---|---|---|---|---|---|---|---|
| 6 | 475 | Swedish whitebeam | 450 | 10-15 | 5-10 | M | <i>Ganoderma australe</i> fungal fruiting body on north side at ground level<br>Desiccated fructifications at ground level on the south through to west side; a dull tone is audible when tapped with a nylon headed mallet<br>Resi assessment was carried out<br>Leaf size appears small in high crown. | Fell | HS1 |

The drill trace indicates an area incipient decay from 4cm through to 34cm with a further dip between 36cm and 39cm

- Fell
- Leave a low stump
