**Asbestos Survey Type**

Demolition & Refurbishment

6 Alleyne Way  
Elmer Sands  
Middleton By Sea

801/AHKA/062

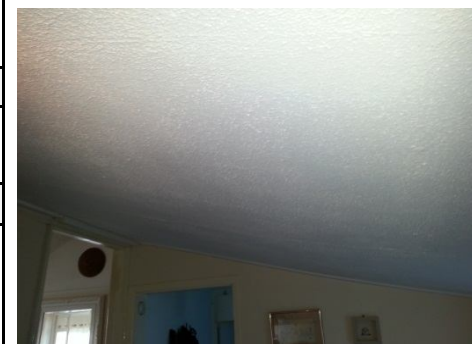
| Item No | 001 | Location No | G.07 | Location | Kitchen |

| Textured coating to ceiling | N/A | N/A | N/A | N.A.D.I.S | |

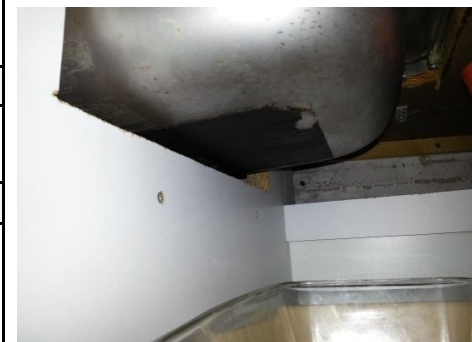
| Item No | 002 | Location No | G.07 | Location | Kitchen |

| Sink pad | N/A | N/A | N/A | N.A.D.I.S | |

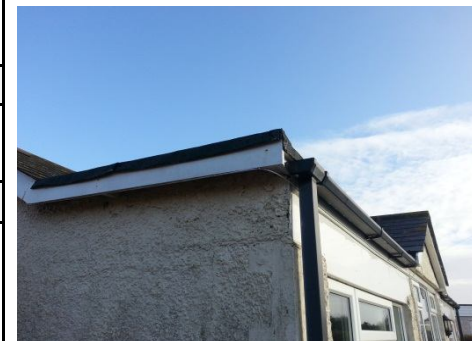
| Item No | 003 | Location No | EX01 | Location | Exterior |

| Item No | 003 | Location No | EX01 | Location | Exterior |
|---|---|---|---|---|---|
| Roof felt | N/A | N/A | N/A | N.A.D.I.S | |

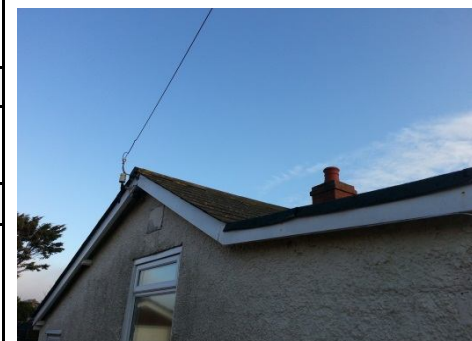
| Item No | 004 | Location No | EX01 | Location | Exterior |

| Item No | 004 | Location No | EX01 | Location | Exterior |
|---|---|---|---|---|---|
| Roof tiles | 1- Low (Plastics,Resins,Mastics) | 1 - Low (Scratches, Surface Marks, Broken Edges) | 1 -Low (Cement, Painted AIB, Enclosed Lagging) | 1 - Chrysotile | |

| Sample No. | Sample Ref. | Location | Asbestos Detected | Asbestos Type |
|---|---|---|---|---|
| 4 | BS166286 | Exterior. Roof tile | Yes | Chrysotile |

| Item No | 004 | Location No | EX01 | Location | Exterior |
|---|---|---|---|---|---|
| Management Option | Remove | Extent | >40 | M2 | |

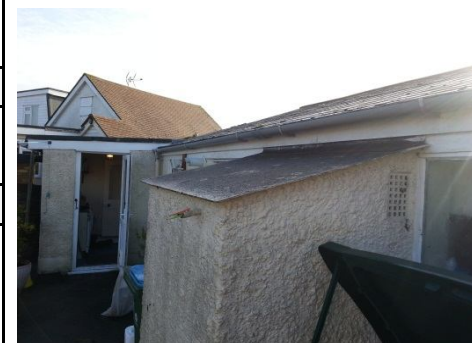
| Item No | 005 | Location No | OB1 | Location | Coal Shed |

| Item No | 005 | Location No | OB1 | Location | Coal Shed |
|---|---|---|---|---|---|
| Cement roof | 1- Low (Plastics,Resins,Mastics) | 1 - Low (Scratches, Surface Marks, Broken Edges) | 1 -Low (Cement, Painted AIB, Enclosed Lagging) | 1 - Chrysotile | |

| Sample No. | Sample Ref. | Location | Asbestos Detected | Asbestos Type |
|---|---|---|---|---|
| 5 | BS166287 | Coal shed. Cement roof | Yes | Chrysotile |

| Item No | 005 | Location No | OB1 | Location | Coal Shed |
|---|---|---|---|---|---|
| Management Option | Remove | Extent | 1 | M2 | |

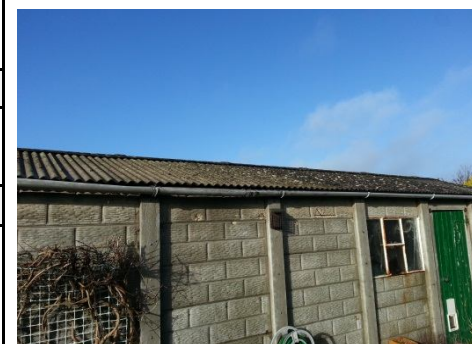
| Item No | 006 | Location No | OB2 | Location | Garage |

| Item No | 006 | Location No | OB2 | Location | Garage |
|---|---|---|---|---|---|
| Cement roof | 1- Low (Plastics,Resins,Mastics) | 1 - Low (Scratches, Surface Marks, Broken Edges) | 1 -Low (Cement, Painted AIB, Enclosed Lagging) | 1 - Chrysotile | |

| Sample No. | Sample Ref. | Location | Asbestos Detected | Asbestos Type |
|---|---|---|---|---|
| 6 | BS166288 | Garage. Cement roof | Yes | Chrysotile |

| Item No | 006 | Location No | OB2 | Location | Garage |
|---|---|---|---|---|---|
| Management Option | Remove | Extent | 24 | M2 | |

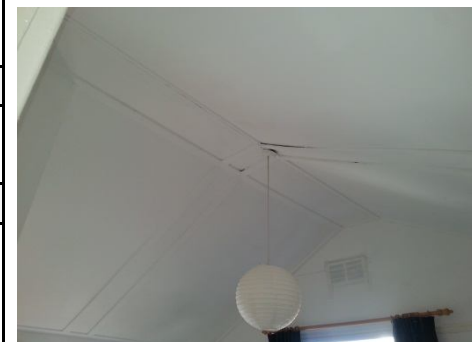
| Item No | Vis 001 | Location No | G.01 | Location | Bedroom 1 |

| Item No | Vis 001 | Location No | G.01 | Location | Bedroom 1 |
|---|---|---|---|---|---|
| Cement ceiling | 1- Low (Plastics,Resins,Mastics) | | 0 - No Damage | 1 -Low (Cement, Painted AIB, Enclosed Lagging) | Chrysotile Presumed |

| Item No | Vis 001 | Location No | G.01 | Location | Bedroom 1 |
|---|---|---|---|---|---|
| Management Option | Remove | | Extent | 12 | M2 |

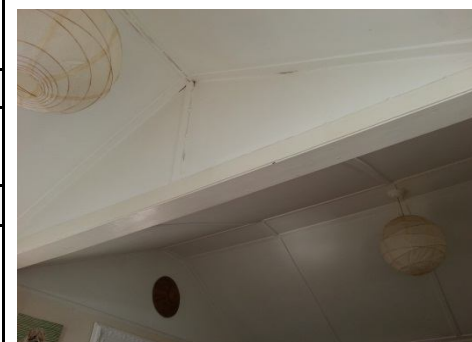
| Item No | Vis 002 | Location No | G.02 | Location | Lounge |

| Item No | Vis 002 | Location No | G.02 | Location | Lounge |
|---|---|---|---|---|---|
| Cement ceiling | 1- Low (Plastics,Resins,Mastics) | | 0 - No Damage | 1 -Low (Cement, Painted AIB, Enclosed Lagging) | Chrysotile Presumed |

| Item No | Vis 002 | Location No | G.02 | Location | Lounge |
|---|---|---|---|---|---|
| Management Option | Remove | | Extent | 20 | M2 |

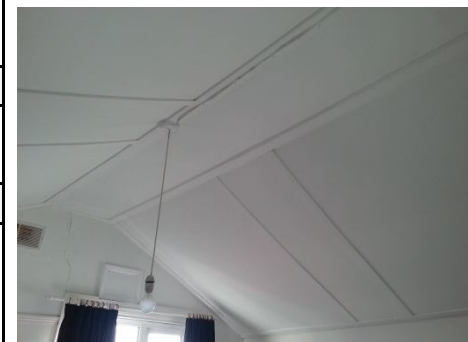
| Item No | Vis 003 | Location No | G.04 | Location | Bedroom 2 |

| Item No | Vis 003 | Location No | G.04 | Location | Bedroom 2 |
|---|---|---|---|---|---|
| Cement ceiling | 1- Low (Plastics,Resins,Mastics) | | 0 - No Damage | 1 -Low (Cement, Painted AIB, Enclosed Lagging) | Chrysotile Presumed |

| Item No | Vis 003 | Location No | G.04 | Location | Bedroom 2 |
|---|---|---|---|---|---|
| Management Option | Remove | | Extent | 10 | M2 |

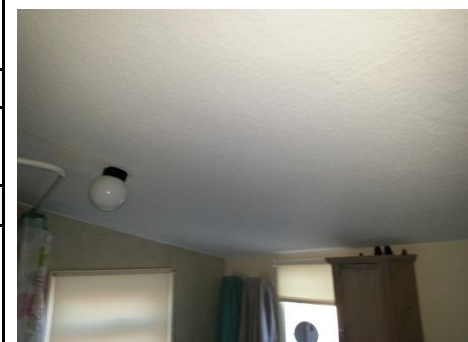
| Item No | Vis 004 | Location No | G.05 | Location | Bathroom |

| Item No | Vis 004 | Location No | G.05 | Location | Bathroom |
|---|---|---|---|---|---|
| Cement ceiling | 1- Low (Plastics,Resins,Mastics) | | 0 - No Damage | 1 -Low (Cement, Painted AIB, Enclosed Lagging) | Chrysotile Presumed |

| Item No | Vis 004 | Location No | G.05 | Location | Bathroom |
|---|---|---|---|---|---|
| Management Option | Remove | | Extent | 6 | M2 |

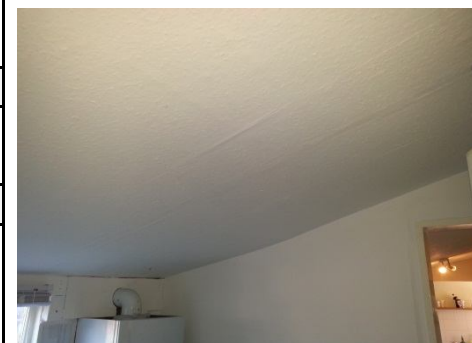
| Item No | Vis 005 | Location No | G.06 | Location | Utility |

| Item No | Vis 005 | Location No | G.06 | Location | Utility |
|---|---|---|---|---|---|
| Cement ceiling | 1- Low (Plastics,Resins,Mastics) | | 0 - No Damage | 1 -Low (Cement, Painted AIB, Enclosed Lagging) | Chrysotile Presumed |

| Item No | Vis 005 | Location No | G.06 | Location | Utility |
|---|---|---|---|---|---|
| Management Option | Remove | | Extent | 3 | M2 |

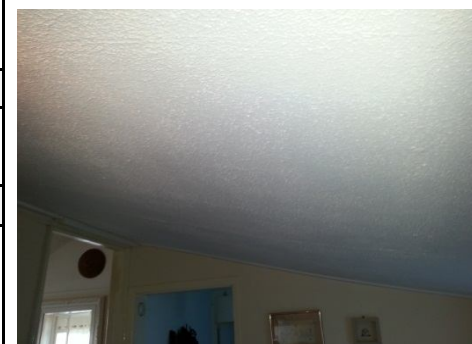
| Item No | Vis 006 | Location No | G.07 | Location | Kitchen |

| Item No | Vis 006 | Location No | G.07 | Location | Kitchen |
|---|---|---|---|---|---|
| Cement ceiling | 1- Low (Plastics,Resins,Mastics) | | 0 - No Damage | 1 -Low (Cement, Painted AIB, Enclosed Lagging) | Chrysotile Presumed |

| Item No | Vis 006 | Location No | G.07 | Location | Kitchen |
|---|---|---|---|---|---|
| Management Option | Remove | | Extent | 12 | M2 |

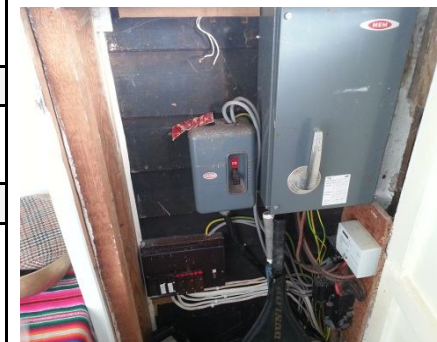
| Item No | No Access | Location No | G.03 | Location | Front Porch |

| Item No | No Access | Location No | G.03 | Location | Front Porch |
|---|---|---|---|---|---|
| Fuse box live | Unknown | Unknown | Unknown | Unknown | Unknown |

| Item No | No Access | Location No | G.03 | Location | Front Porch |
|---|---|---|---|---|---|
| Management Option | Exercise Caution | Extent | 1 | Item | |
