**JPT/JW/5393**  
**September 2002**

**REPORT OF**

**J P TUPPER**

**Subject Matter : Tree Root Damage to the Driveway  
Phoenix House,  
15, East Avenue,  
Middleton-on-Sea.**

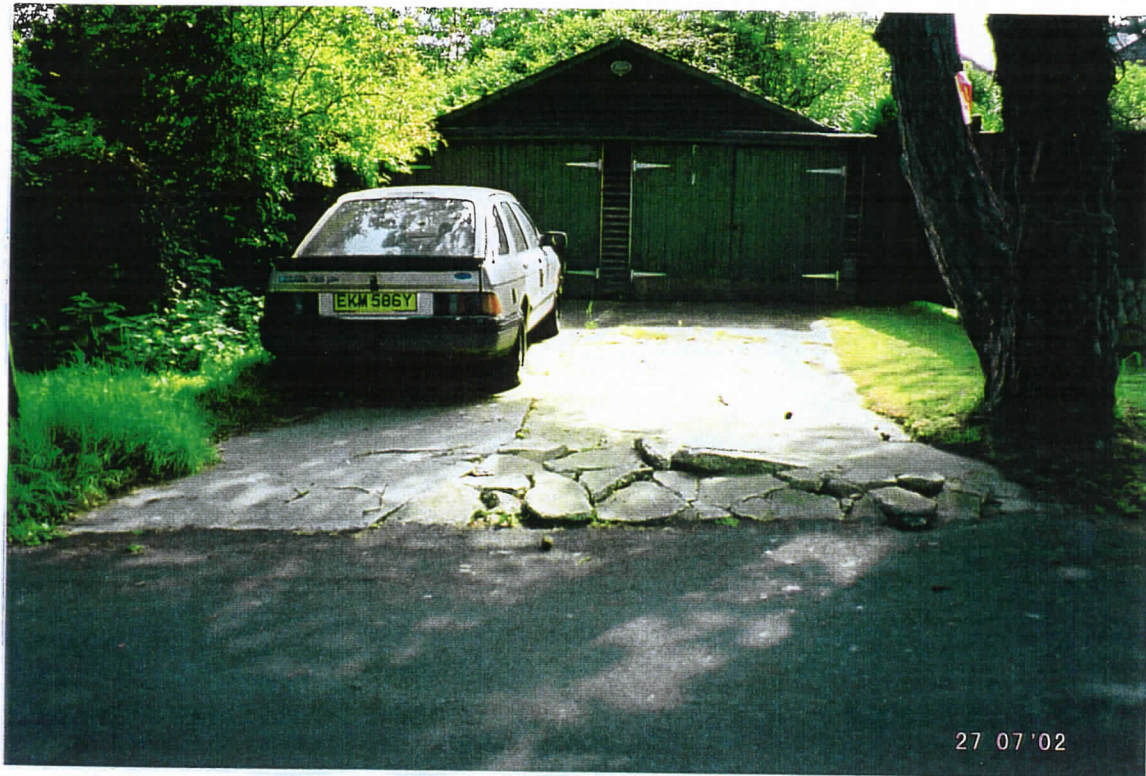
- 3.03.1 The driveway is in two sections (See Sketch and Photograph A).
- 3.03.2 The western section of the driveway is constructed of concrete approximately 50mm thick on a limited hardcore/brick gravel base. An area at the northern end has been lifted and broken.
- 3.03.3 There are some minor cracks not associated with any root action.
- 3.03.4 Second driveway is also in concrete and lies to the East of the damaged concrete driveway. It is also affected to some degree by root action (See Photograph A).

A. General view of twin drive from East Avenue. Severely damaged concrete.

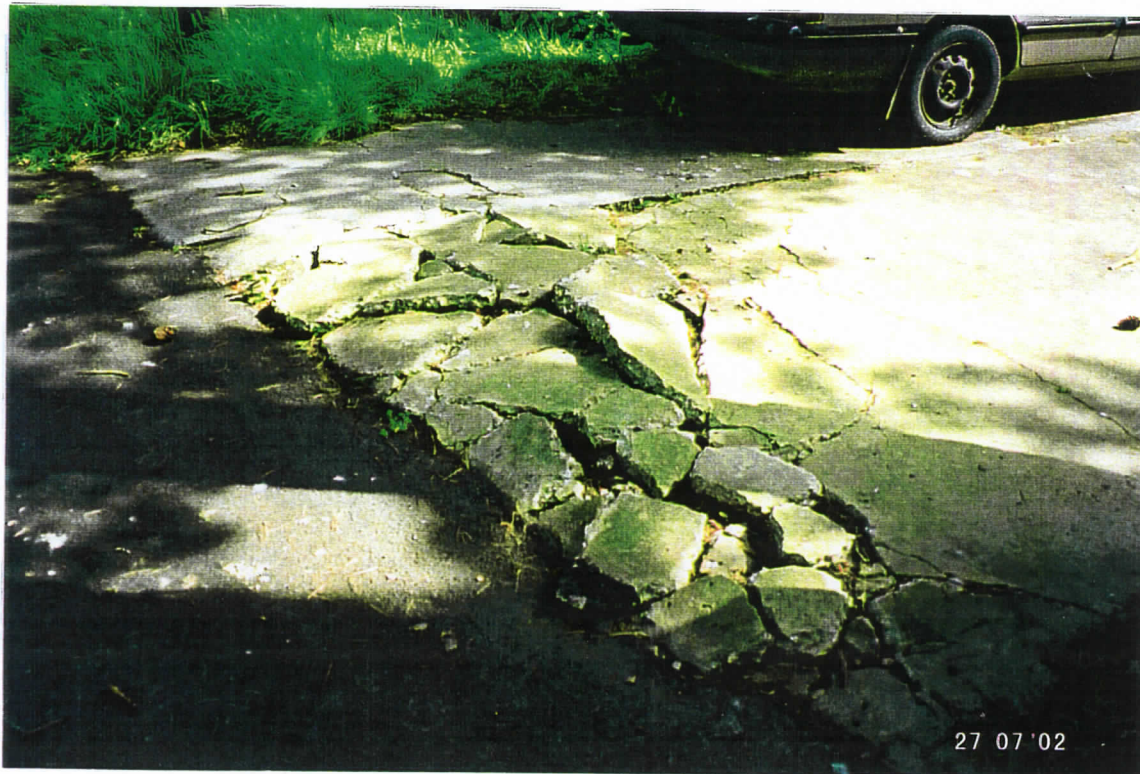
B. Area of damaged driveway.

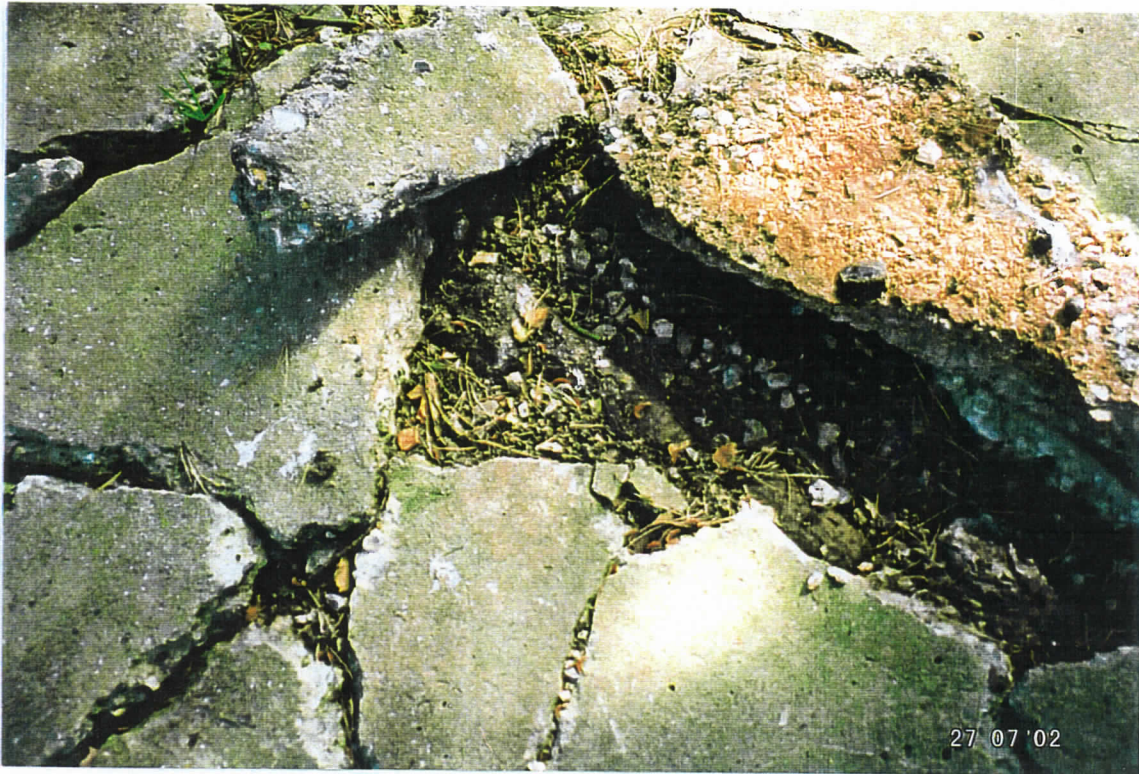
- 4.01 The size and location of the tree roots under the damaged concrete can be traced to the pine tree.
- 4.02 Root extension and action of this type is common and will cause damage to property, foundations, drains, garden walls and paving.
- 4.03 It is clear that the root extension and action has forced up the concrete causing cracking. (See Photographs B & C).
- 4.04 Some parts of the roots are at or above the original level of the concrete drive.
- 4.05 One of the roots is at (or immediately adjacent to) the junction of the drive with the road, making it impossible to feather off any driveway surface to form the junction with the road surface.

**C. Root of pine tree approximately 63mm in diameter forcing up the concrete.**

- 5.05 To repair driveway to original level it will be necessary to remove damaged sections, excavate to an appropriate depth removing all root and organic material and provide a compacted hard-core base plus surface finish. With use of reinforcement or Geogrid the minimum excavation necessary would be to 260mm depth from final surface level.

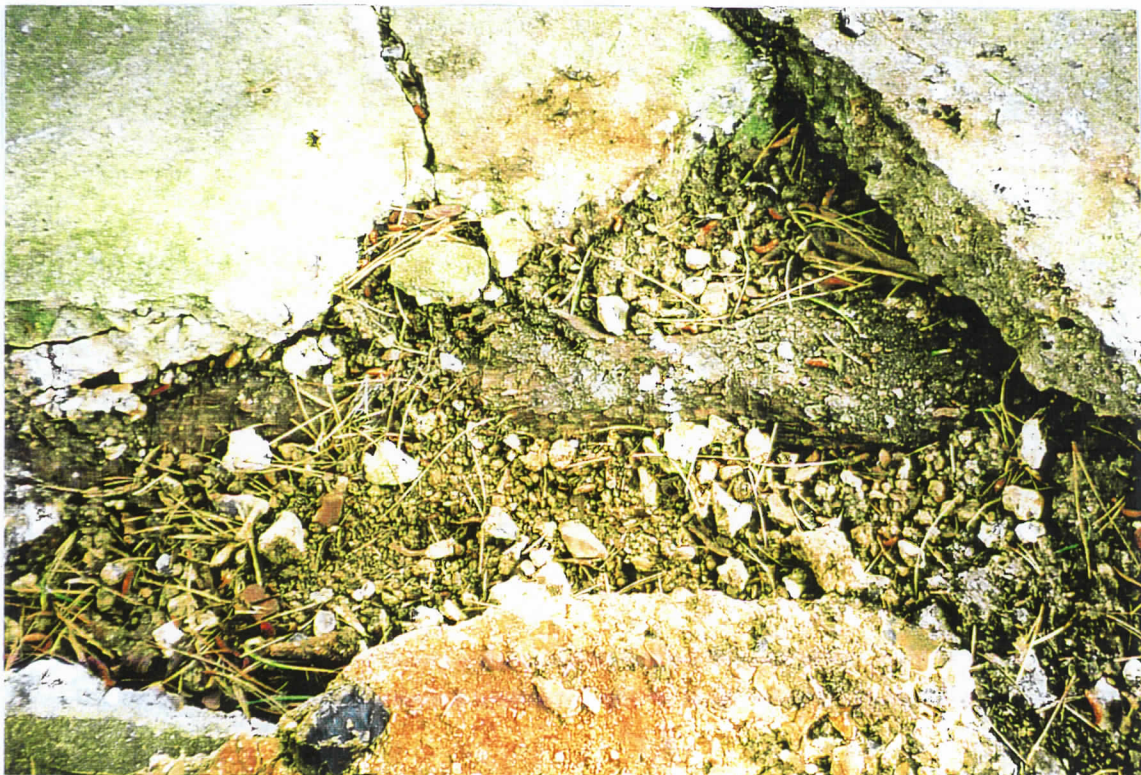
**D. As C nearer pine tree - root 75-80mm diameter.**
