# J. P. Tupper Associates

**SECOND**

**REPORT OF**

| <b>Subject Matter</b> | : | <b>Tree Root Damage to the Driveway<br/>Phoenix House,<br/>15, East Avenue,<br/>Middleton-on-Sea</b> |

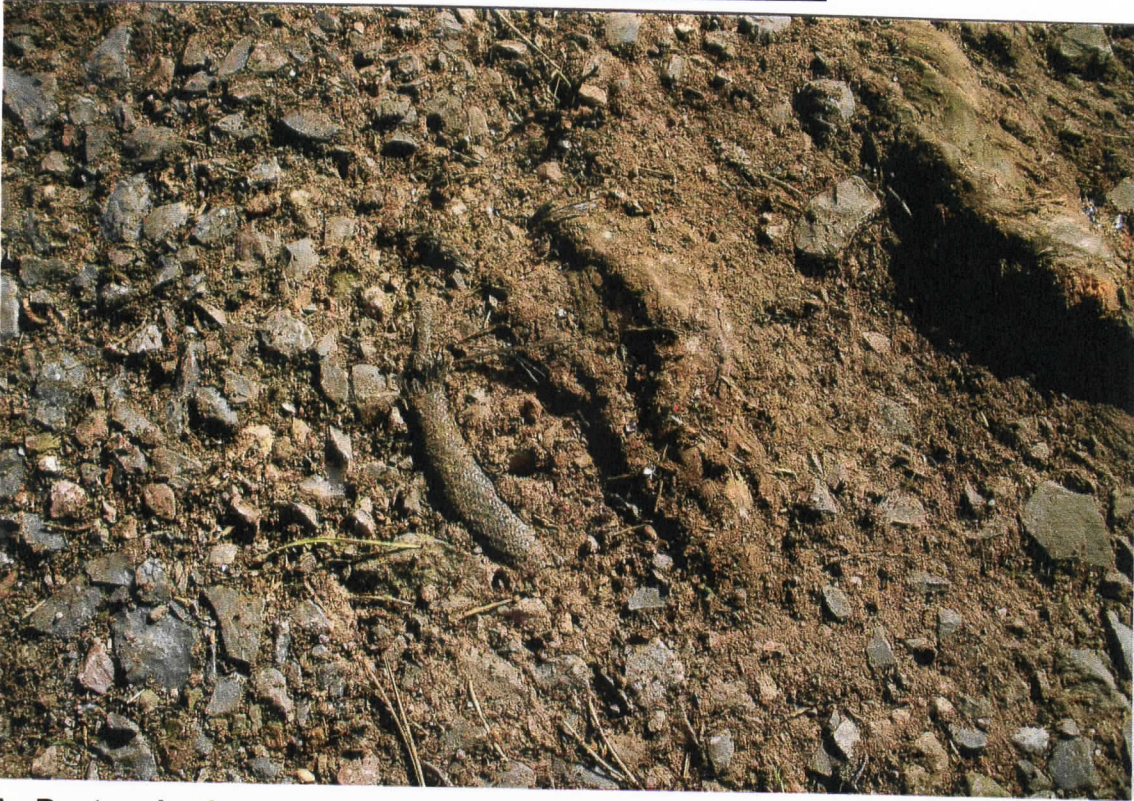
3.03.2      Insofar as it is possible to ascertain, the membrane has been cut to fit around the roots which now project through the surface of the scalplings. (See Photograph A)

- 4.03 It is clear that the root extension and action has forced up the scalplings and it does not appear that the membrane covers the roots. (See Photographs A & C)

**A. Root projection through surface. Roll of projecting membrane left of centre**

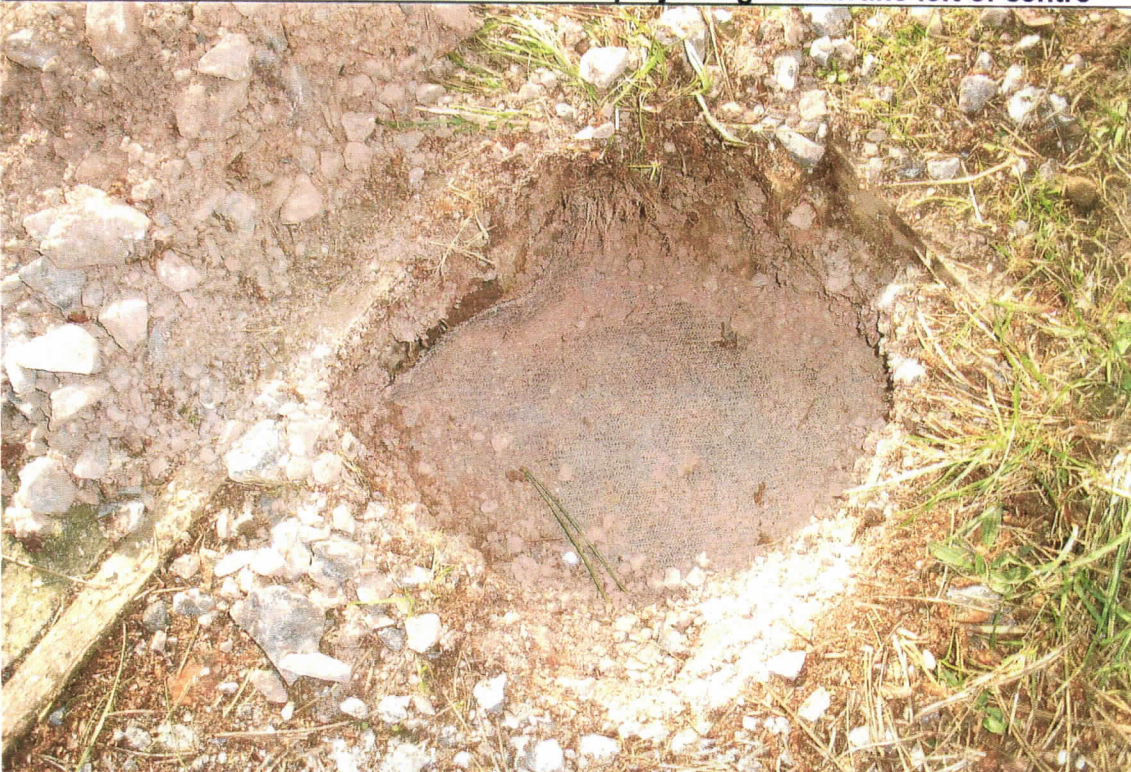
3.03.3      In the area examined the scalplings were approximately 100mm thick and have been consolidated. This would be a normal and adequate base for a crossing of this type on a private road.

**B. Excavation to establish base**

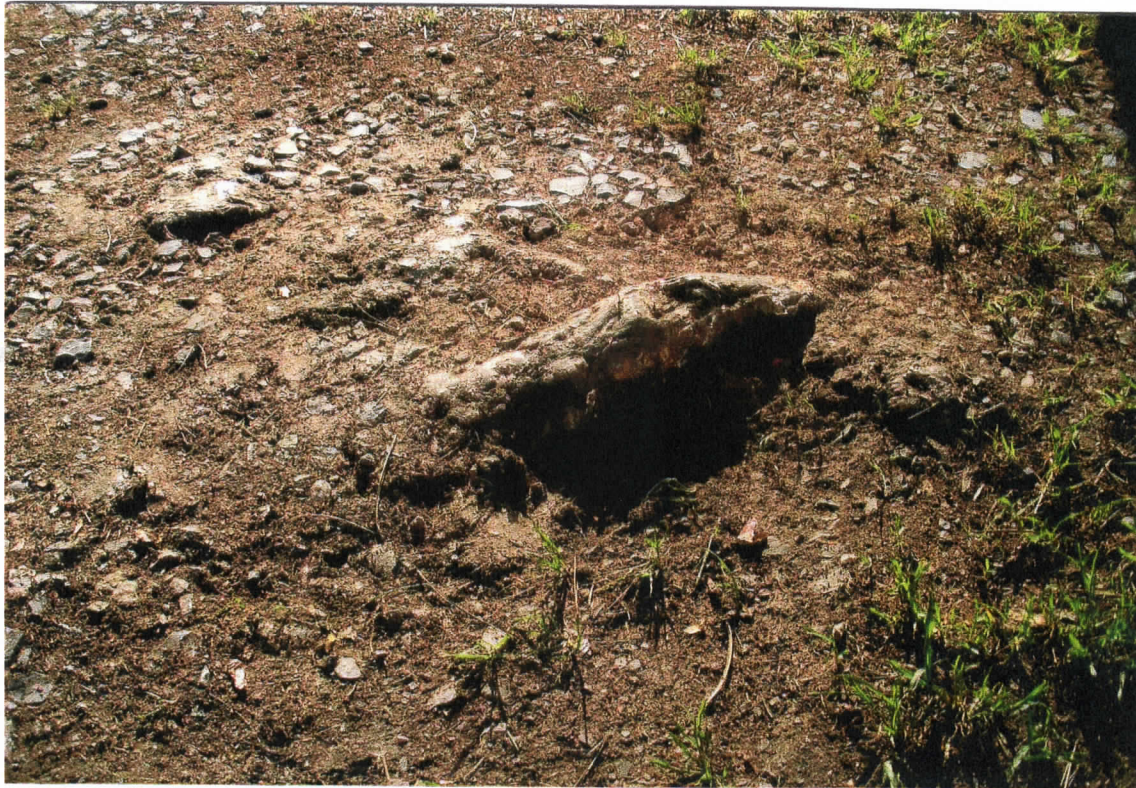
- 4.06 This would also raise the level of the crossing higher than the carriageway.
- 4.07 The accepted hazard on a footway (although this is relating to a public footway and the footway does not exist) is a projection in excess of 19mm above the general grade.

- 4.08 The main root is well above this projected level. (See Photograph C)
- 4.09 As stated there is no footway to the road and therefore persons walking along the road will be on the edge and close to the projecting roots.

**C. Root projection**
