Our ref: PJW/31713

Report on Structural Inspection for West Sussex County Council and Strutt and Parker  
Guernsey Farm, Yapton Road

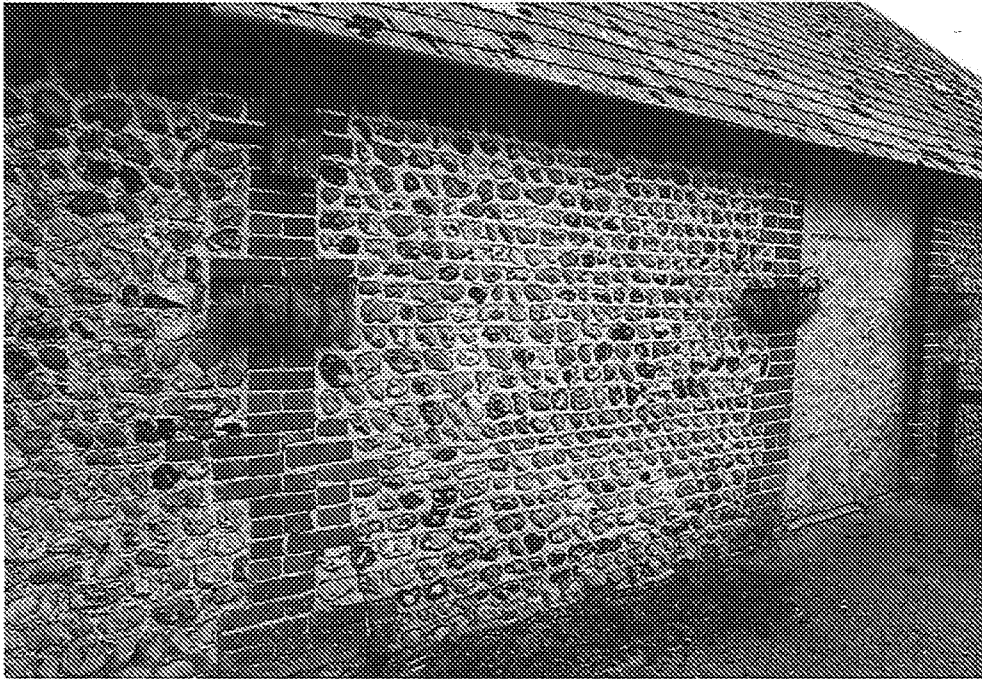
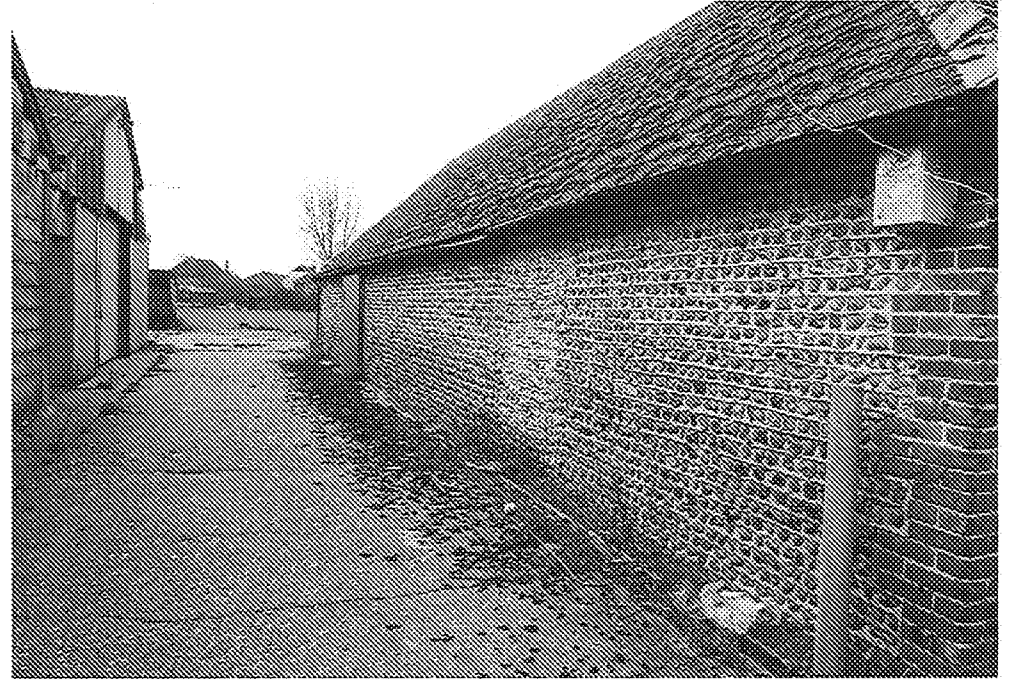
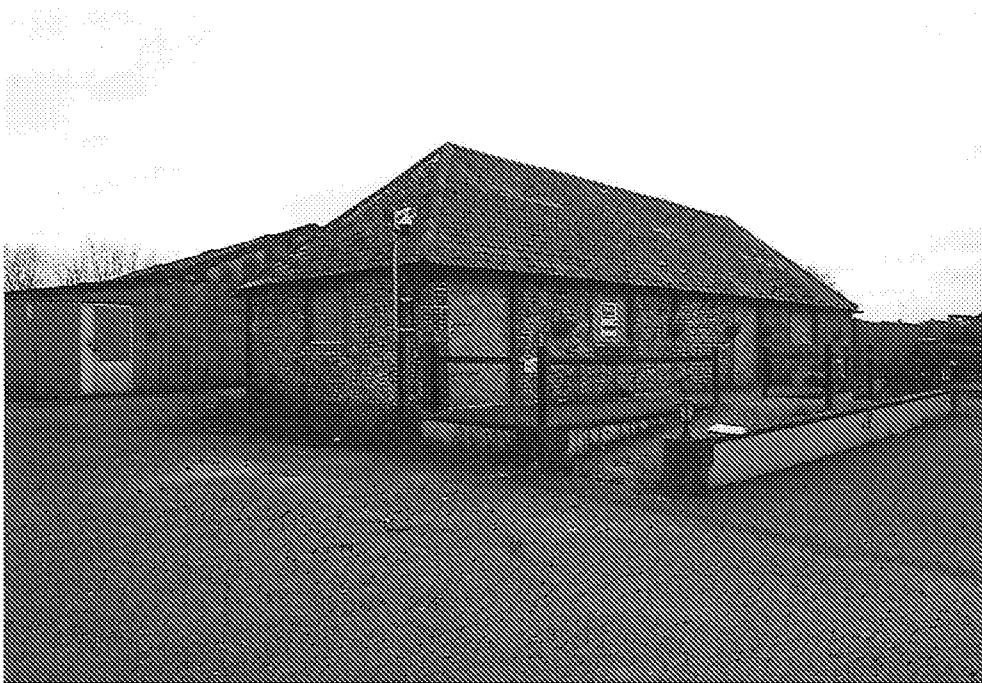
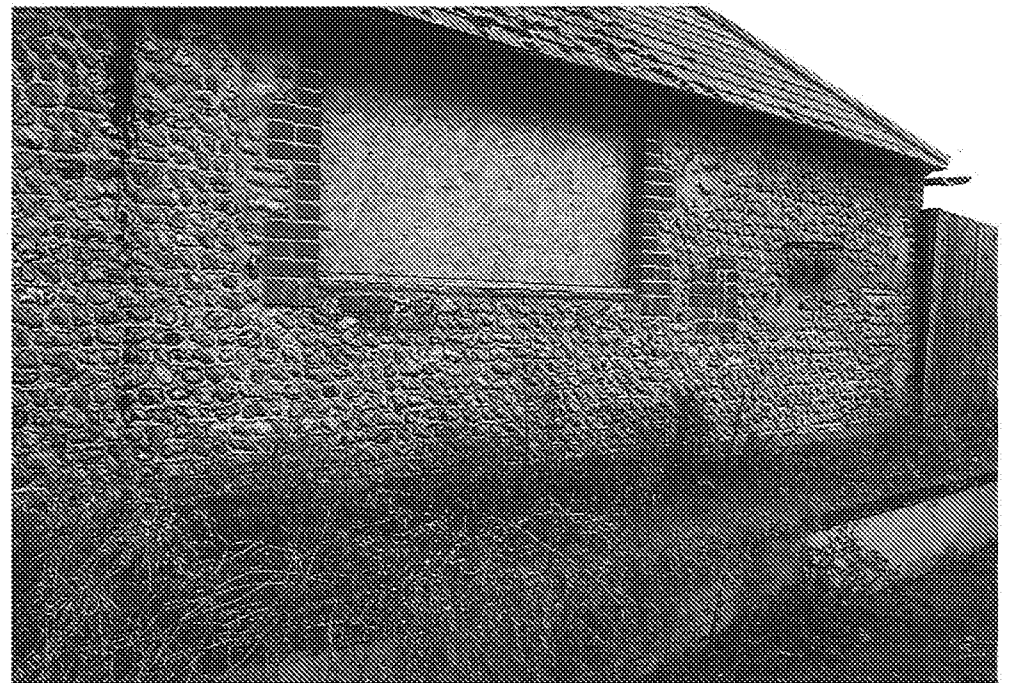
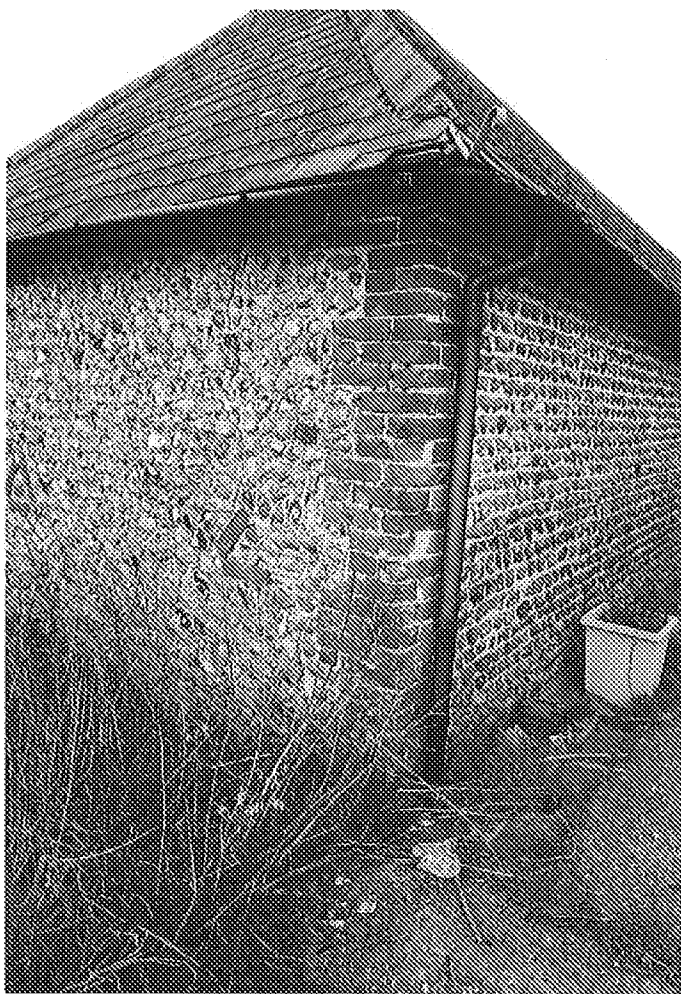
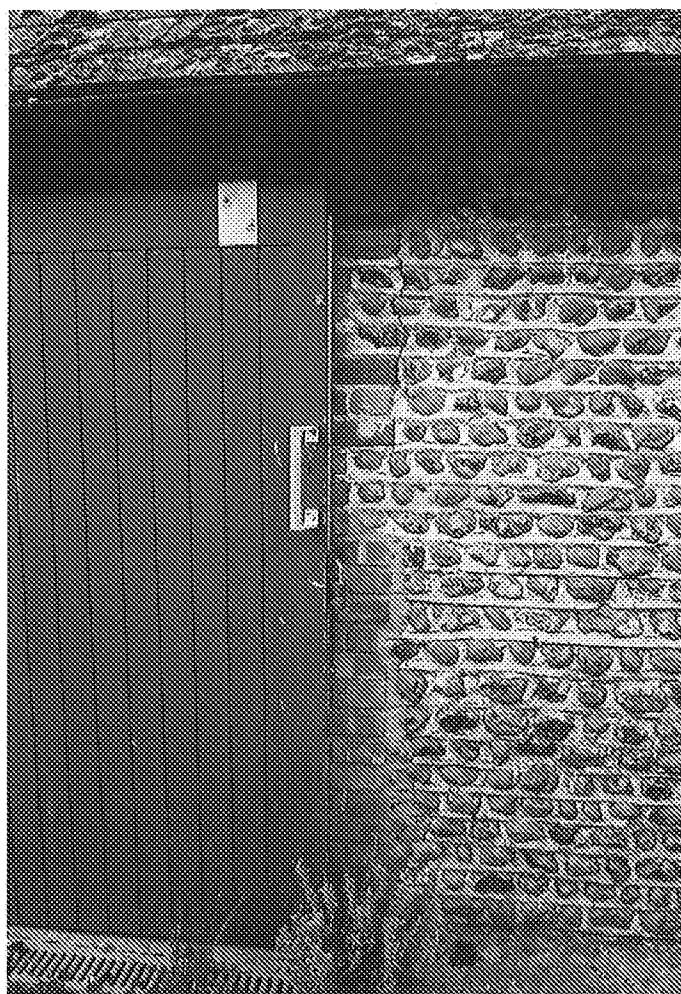
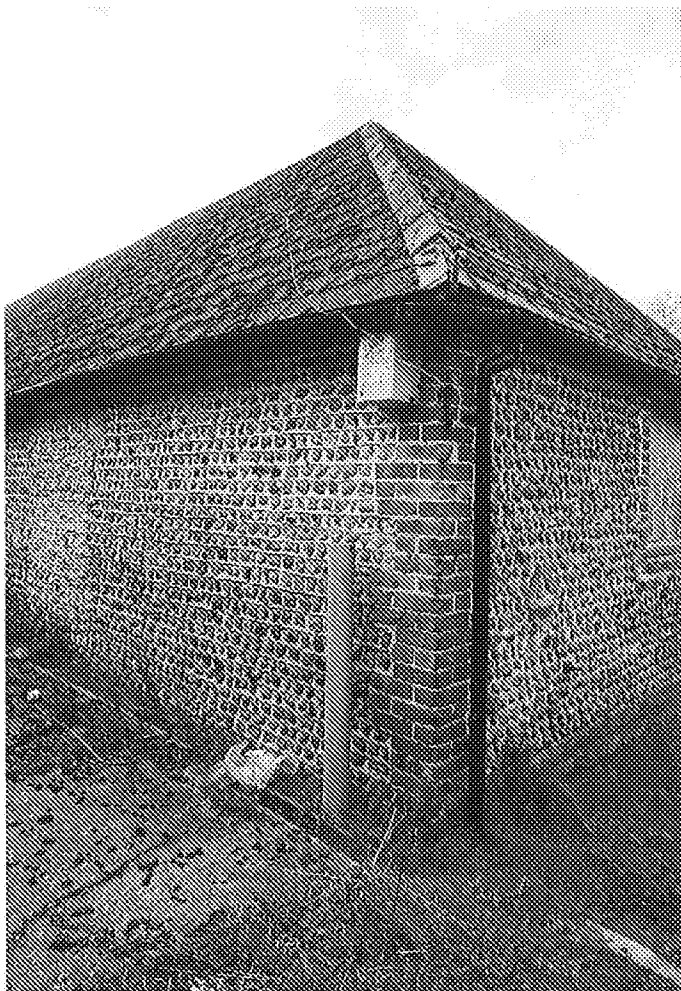
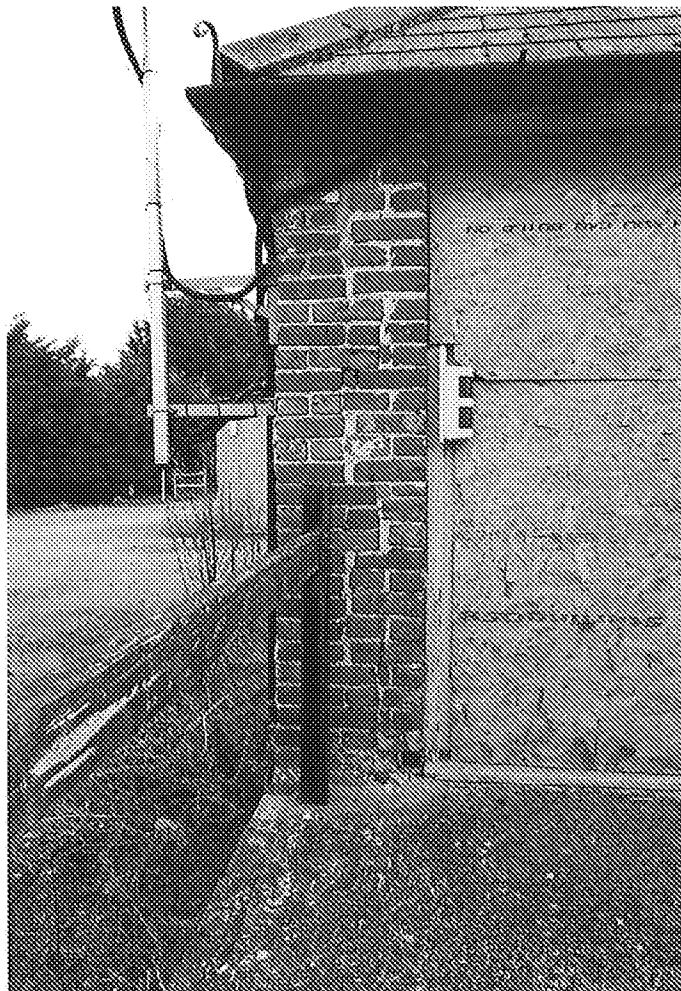
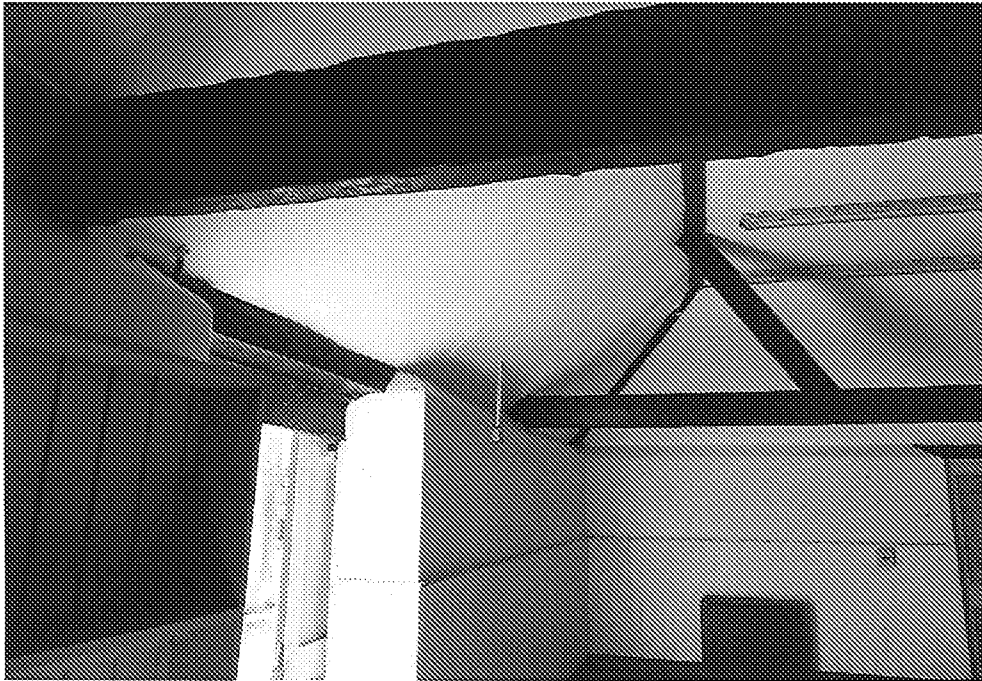
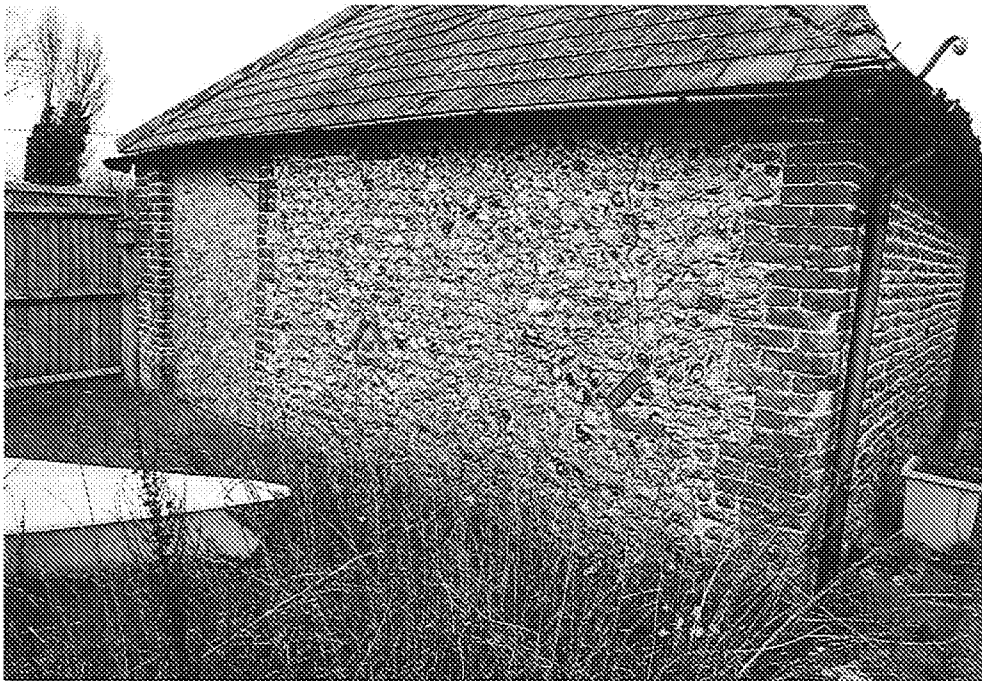
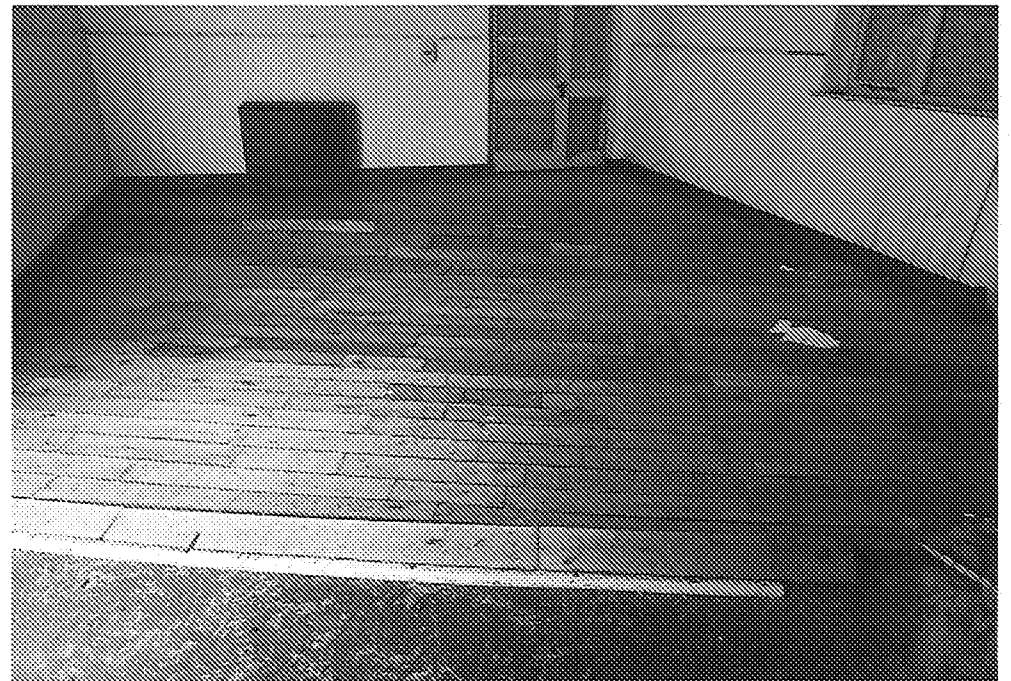
Walls display minor cracking generally at brick reveals and adjacent the sliding door on the west side. Instances of these observations are recorded in the photographic appendix.

Purlins show evidence of a degree of sag minor in nature and typical of traditional roof structures of the era. Associated with this is a minor degree of roof undulation and spread. These matters are all of a nature commonly encountered and which can be readily dealt with as part of any conversion/conservation exercise. At the time of such works comprehensive overhaul can be expected to cover a general condition check of structural timbers including eaves wall plates.

Sheets 1-3 Farm Shop showing general appearance instances of minor cracking and wear to brick quoins: also typical interior roof beams and buckling of timber floor overlay to former sales area south end.

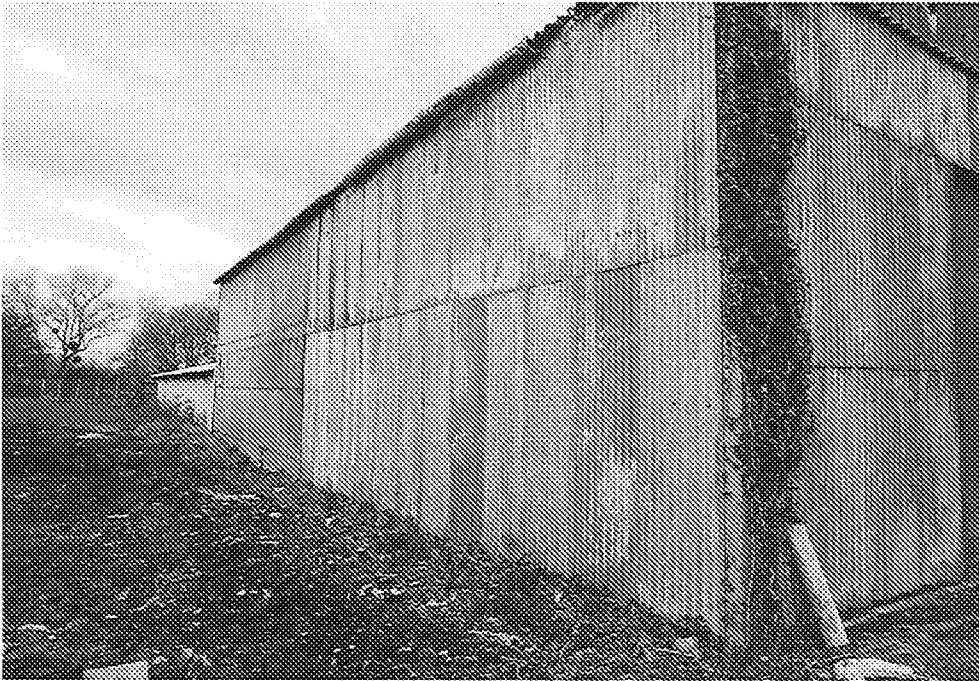
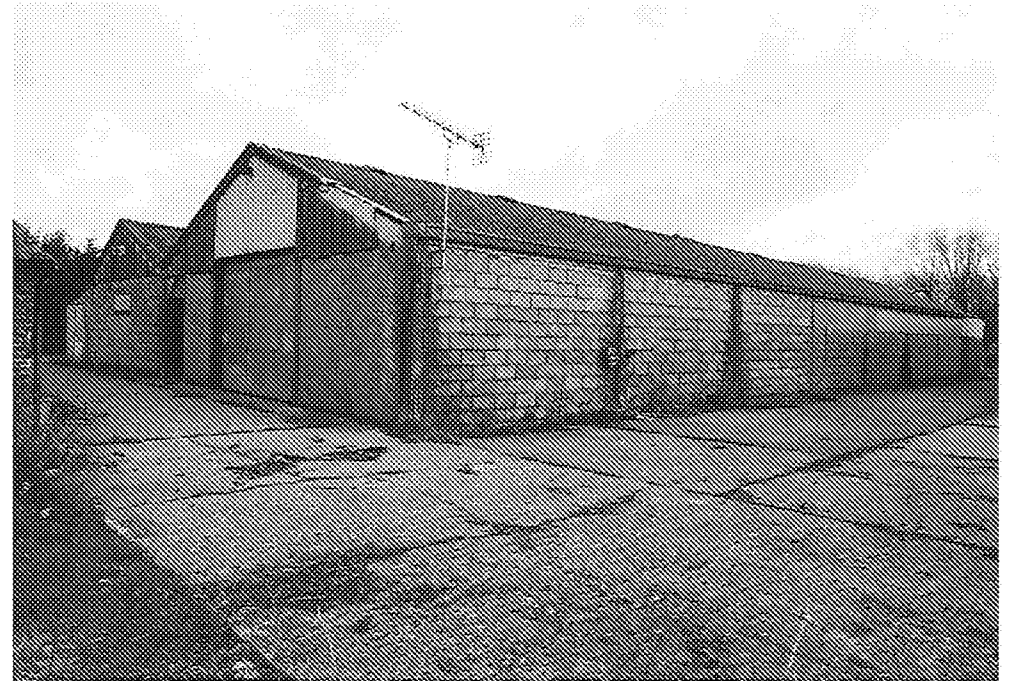
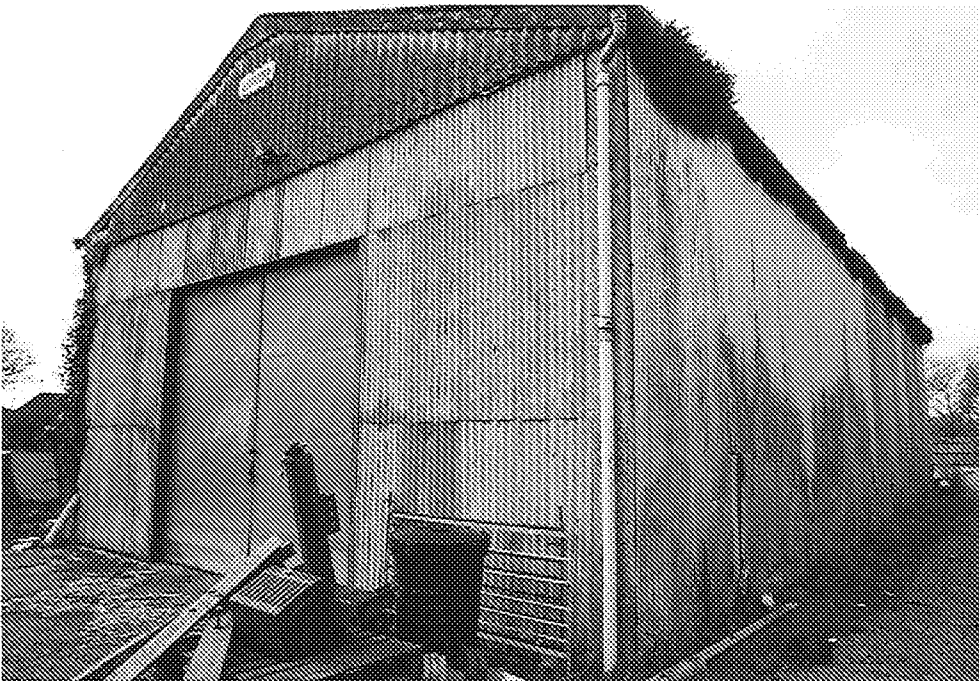
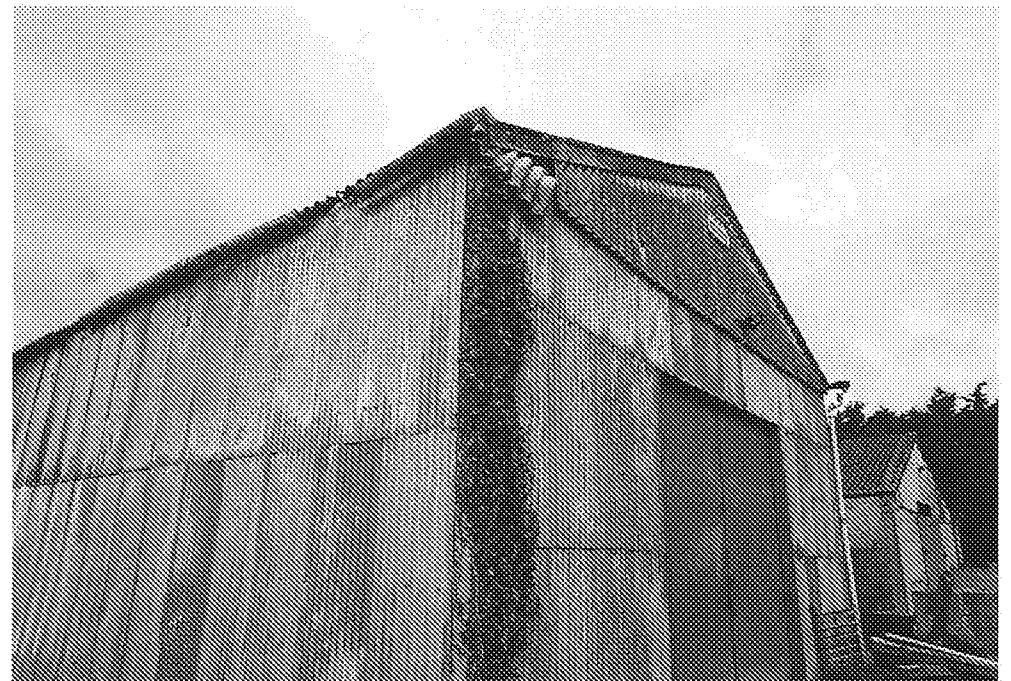
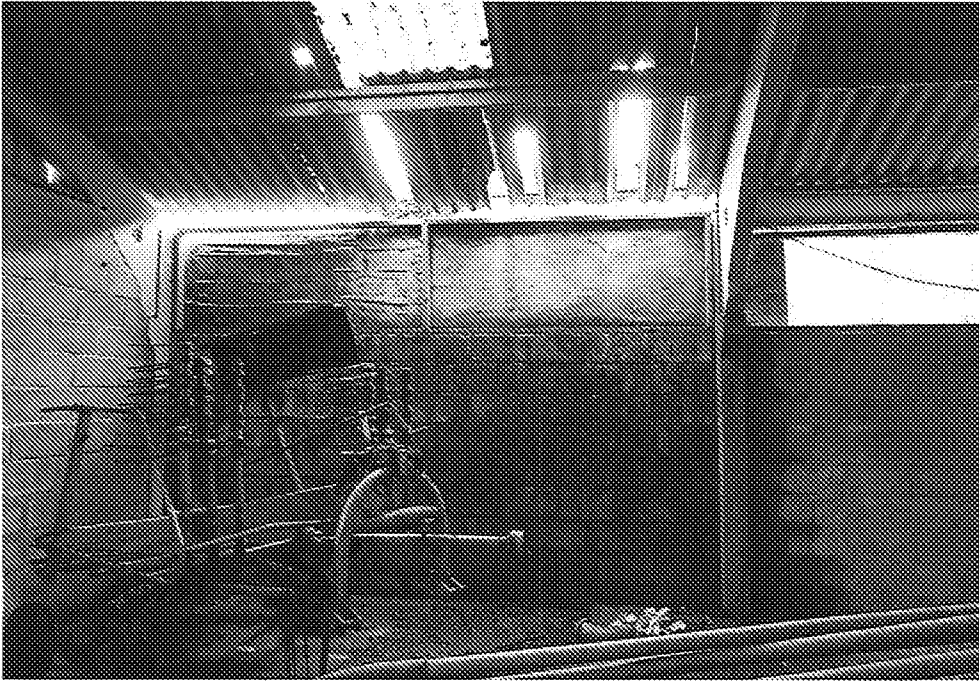
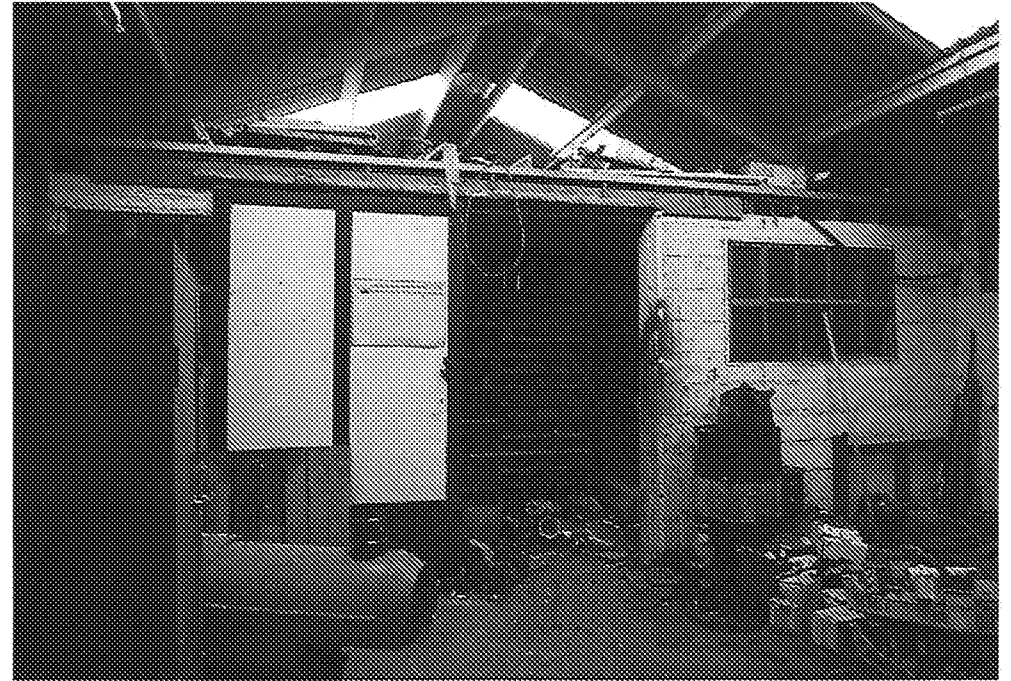
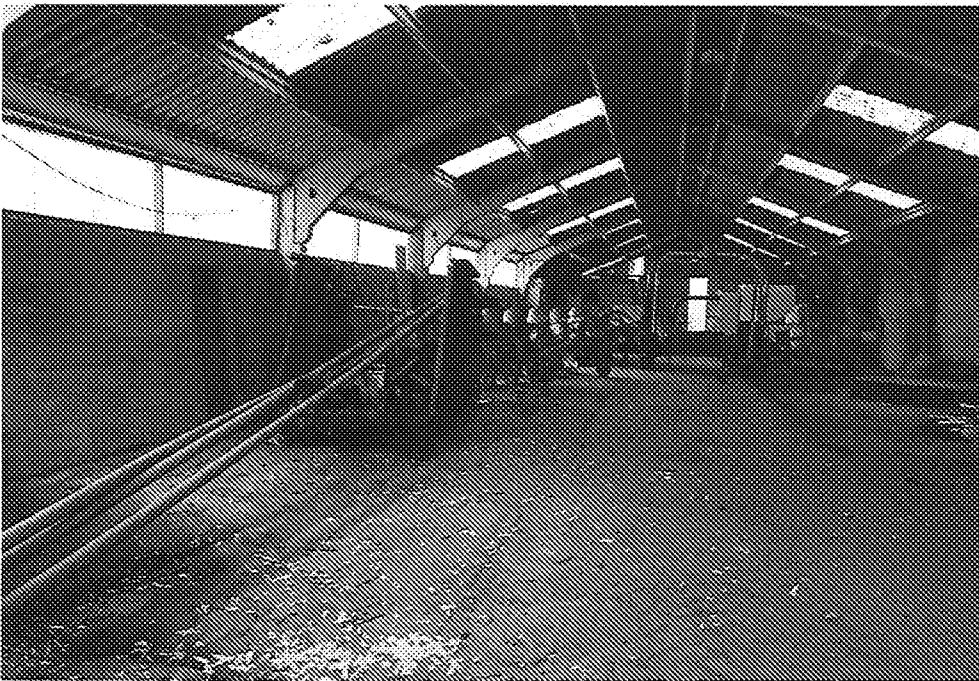
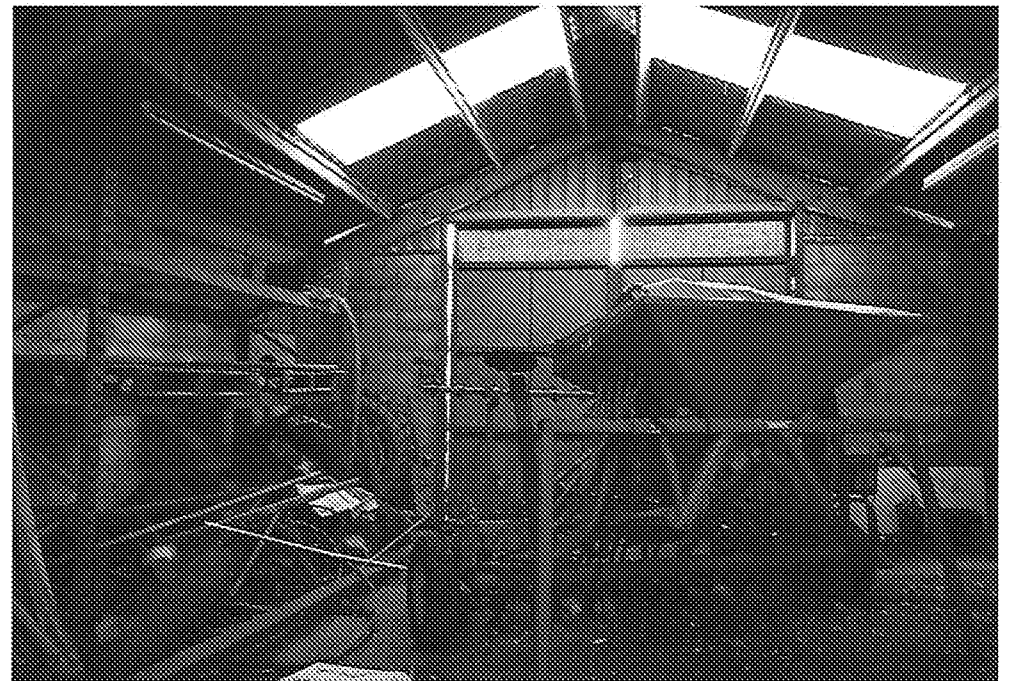
The general appearance of this group of buildings is marred by lack of maintenance to rainwater goods and locally to claddings but the basic structures have performed well to date. Lack of maintenance has also led to ivy growth in places and accessibility of the buildings to pigeons has not helped. It has to be noted that reinforced concrete structures are subject to long term deterioration caused by reinforcement corrosion this linked to a number of factors including concrete quality depth of cover to reinforcement etc. From our general inspection such problems are not evidenced as yet but a more comprehensive inspection to include concrete sampling and testing is advised to enable predictions to be made of ongoing performance expectations and to determine if there is evidence of the onset of concrete spalling due to reinforcement corrosion not so far identified.

Sheets 4-5 Agricultural buildings showing general appearance externally and internally.

It is noted and emphasized that it is possible using specialist products to enhance the durability performance of reinforced concrete structures as would be appropriate depending upon the performance life desired.
