# ST JOHN'S COTTAGE

POLING STREET, POLING, ARUNDEL, WEST  
SUSSEX, BN18 9PS

## TIMBER CONDITION ASSESSMENT

AUGUST 2021

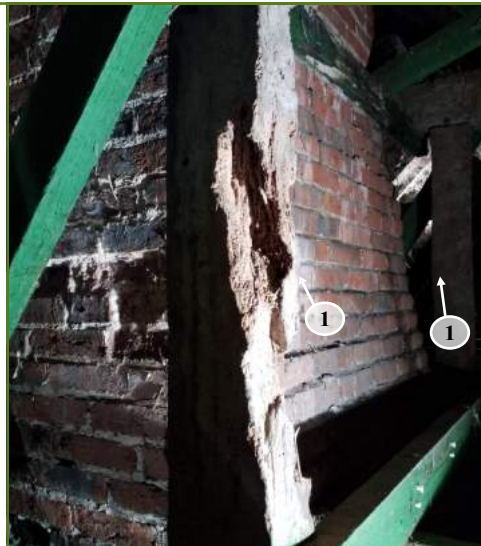
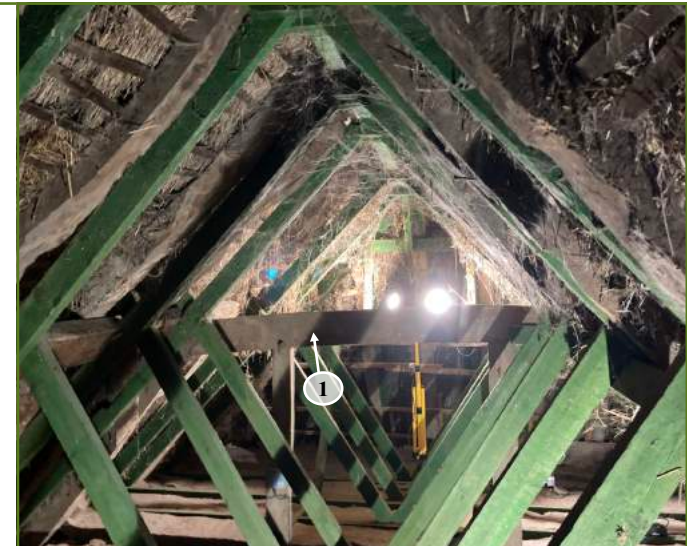
1. Queen posts and Elm collars severely decayed though insect attack.

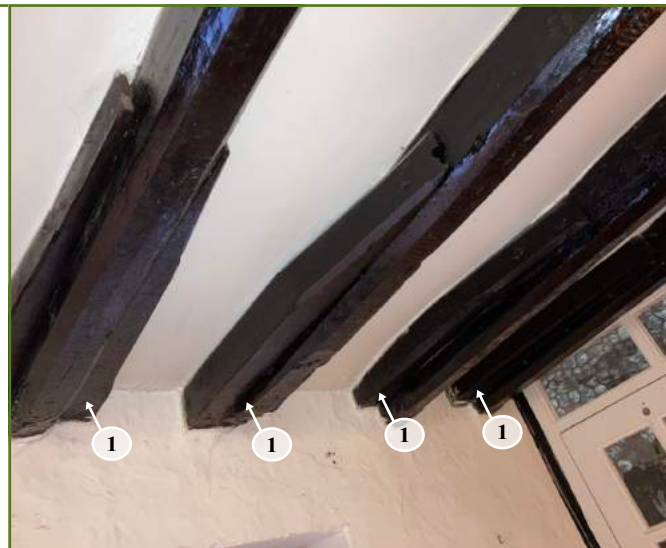
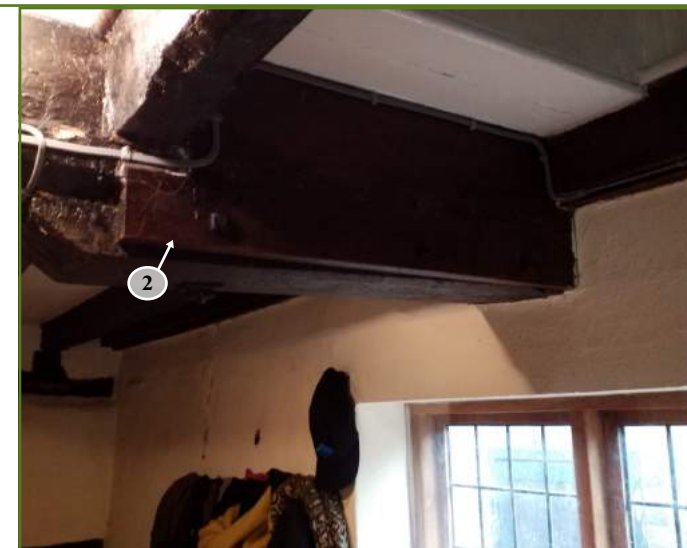
1. Ends of original joists failed. Splint repairs could be improved or joist ends repaired with oak/resin splice with grp reinforcing.
2. Further investigation around splint to spine beam required after the removal of board.
