# ST JOHN'S COTTAGE

POLING STREET, POLING, ARUNDEL, WEST  
SUSSEX, BN18 9PS

## TIMBER CONDITION ASSESSMENT

AUGUST 2021

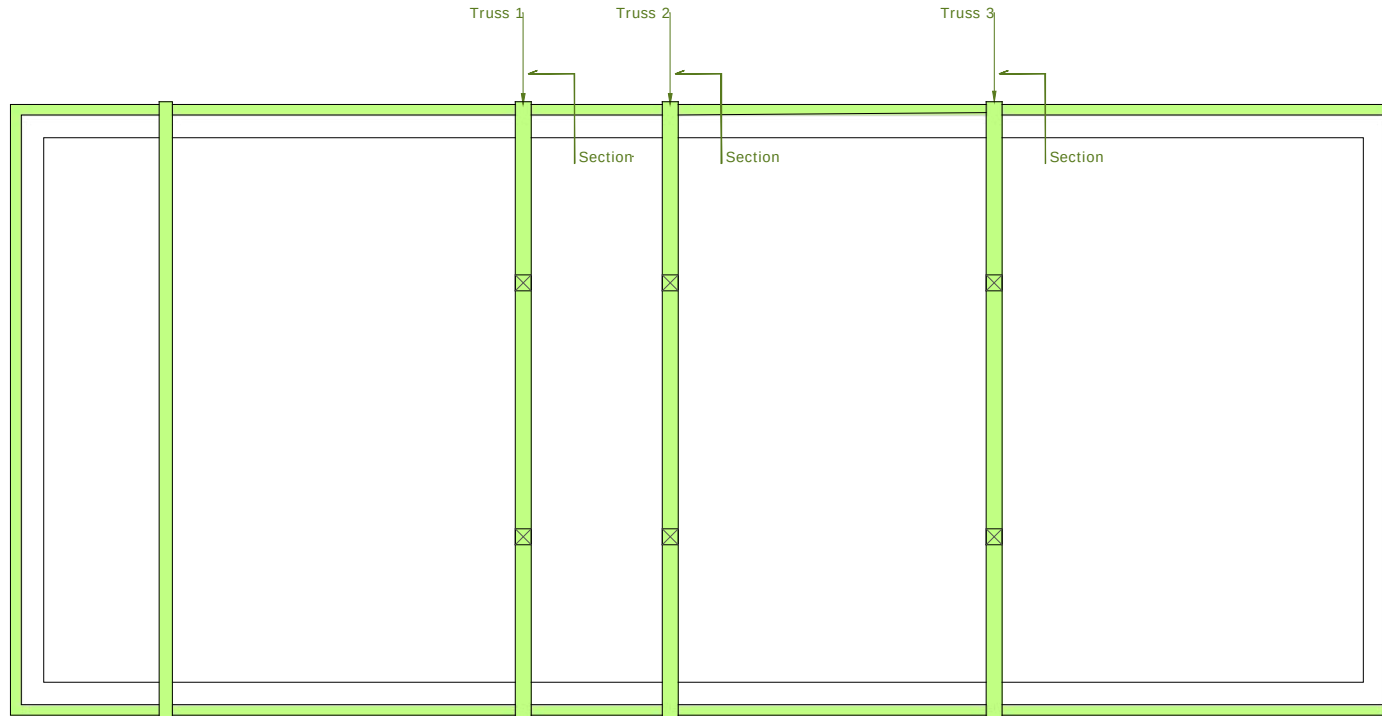
#### Wall Plate Plan

Whilst the most desirable approach is to maximise retention and minimise intervention, this is not always possible. The roof structure has failed and most of it is beyond salvage. It only stands thanks to the additional softwood structure that currently supports the entire roof. The Queen post trusses are the key elements of the roof structure as they contribute to the historic understanding of the building and its construction. None of the trusses, however, are structurally sound and their retention as a feature would only be possible by adding additional tie beams to support the original trusses as a feature behind new structural trusses. This approach, however, would result in significant intervention to the roof and to the ceilings below and it would alter its original form further.

Having considered this and other approaches such as strengthening in order to retain as much original fabric as possible, the removal of the failing elements of the roof and the supporting softwood structure, to be replaced with a new roof structure was considered the most appropriate solution.

The applicant, however, is aware of the significance of the roof and is keen to replicate the original roof form using a traditionally jointed oak frame to ensure its longevity and incorporate the original elements that can be salvaged such as the tie beams, wall plates, the existing purlin, collar, and wind braces. The scheme also proposes to

reinstate the elements that are now lost such as the high-set collars to create the gablets and the missing purlin and wind brace.

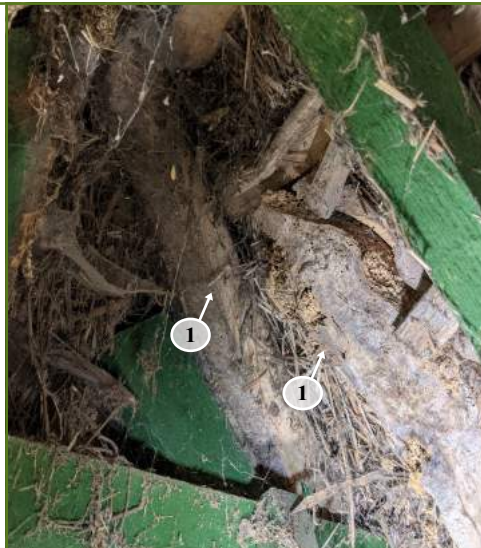
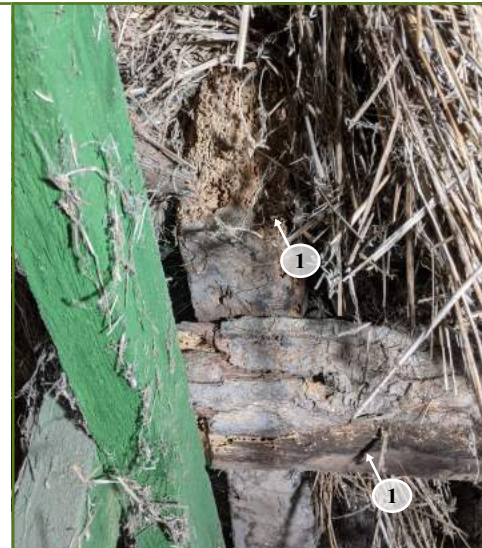
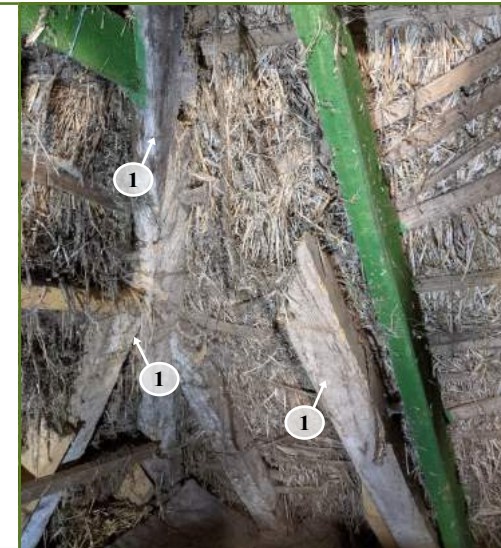
1. All Elm rafters and roof timbers are severely decayed due to insect attack.

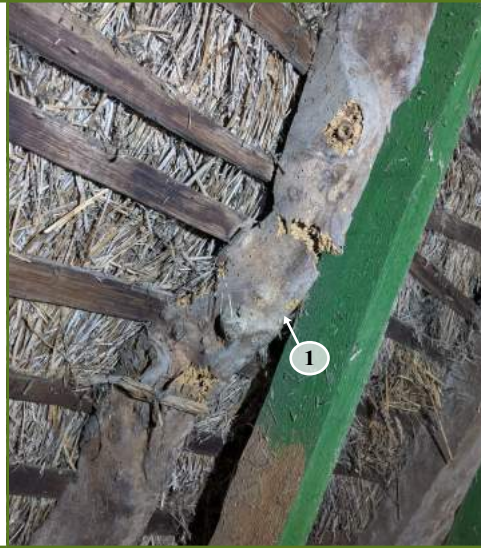
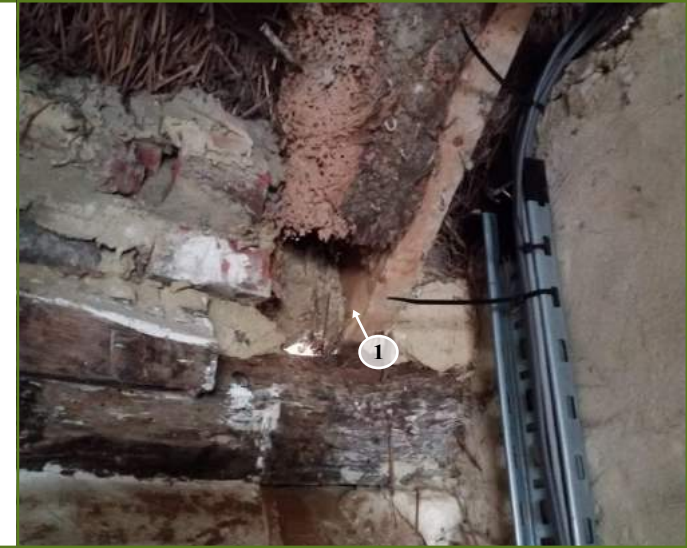
1. Queen posts and Elm collars severely decayed though insect attack.

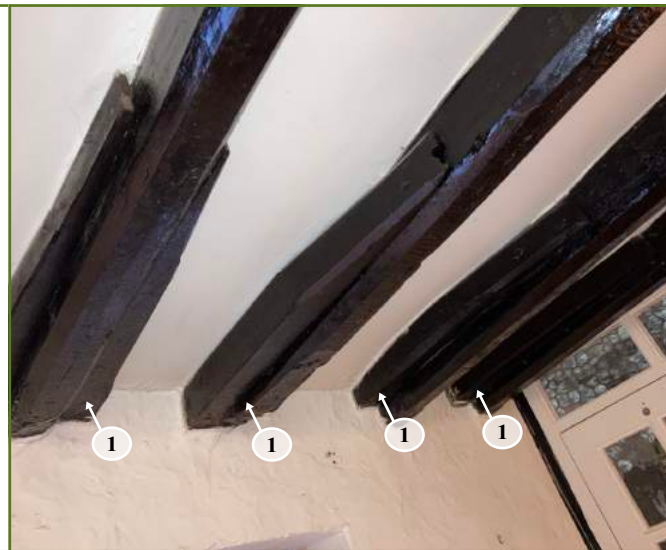
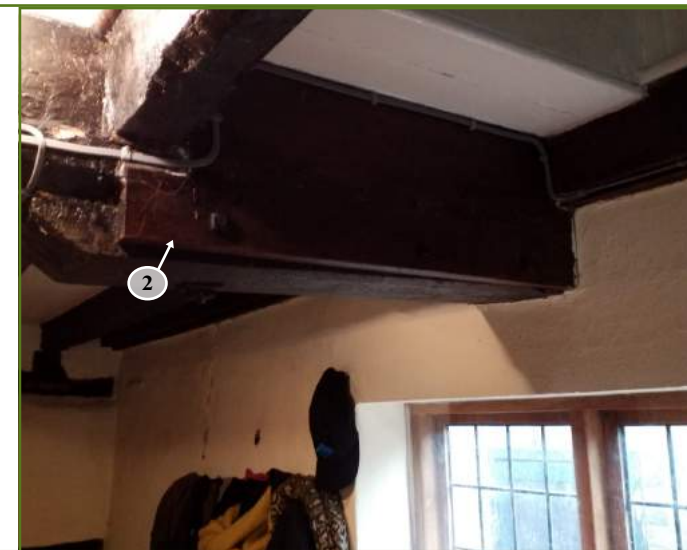
1. Ends of original joists failed. Splint repairs could be improved or joist ends repaired with oak/resin splice with grp reinforcing.
2. Further investigation around splint to spine beam required after the removal of board.

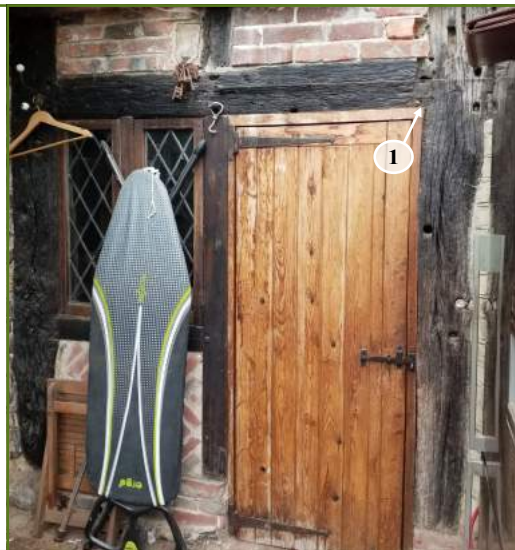
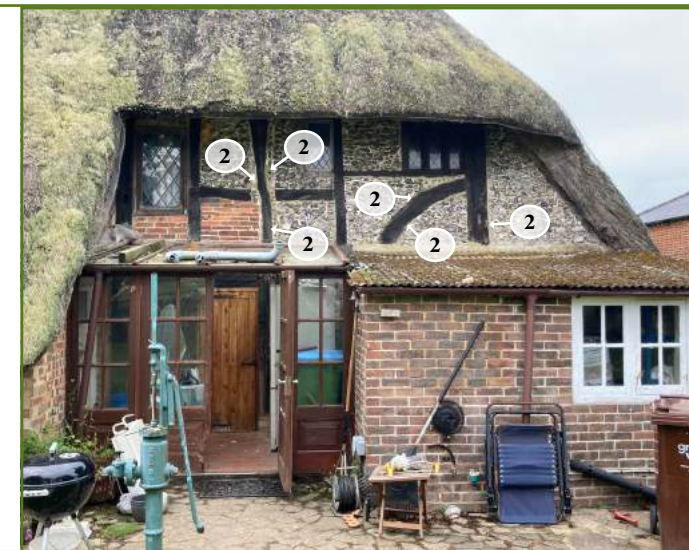
1. Face patch and iron strap required to area of decay around failed tenon.
2. Remove cement mortar around timbers and repoint using lime mortar.
