# ST JOHN'S COTTAGE

POLING STREET, POLING, ARUNDEL, WEST  
SUSSEX, BN18 9PS

## TIMBER CONDITION ASSESSMENT

AUGUST 2021

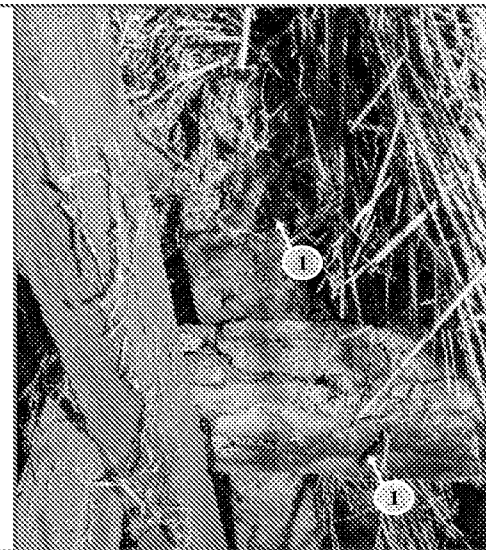
1. All elm rafters and roof timbers are severely decayed due to insect attack.

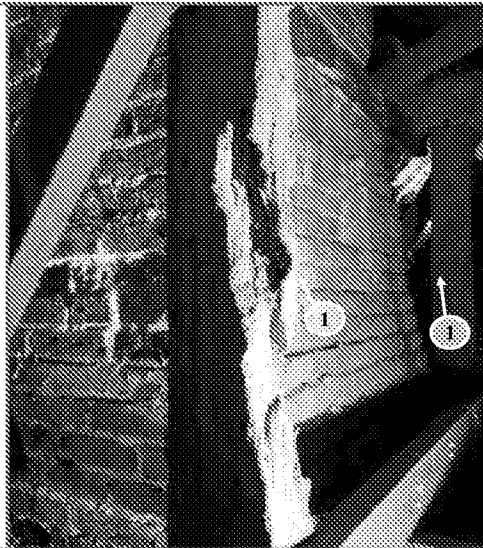
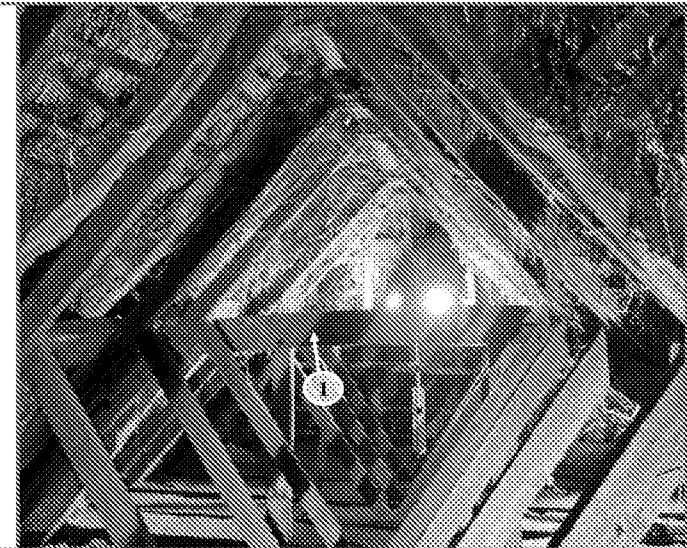
1. Queen posts and Elm collars severely decayed though insect attack.

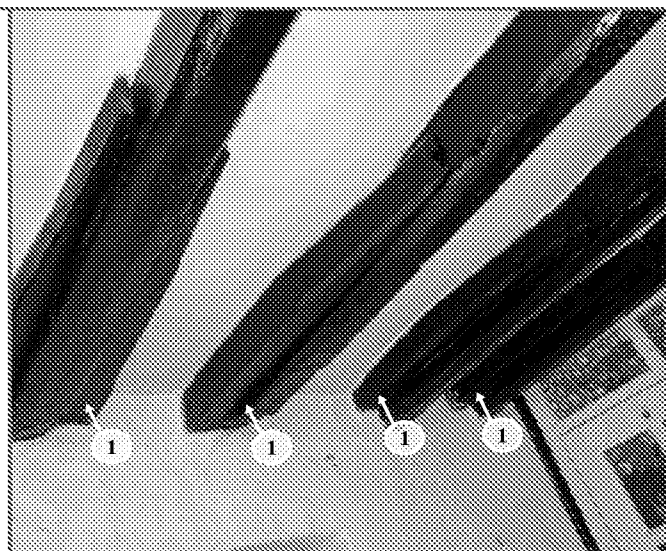
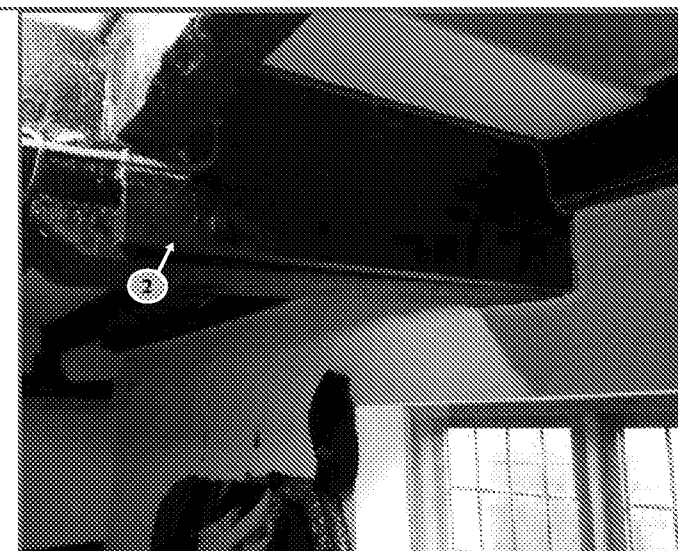
1. Ends of original joists failed. Splint repairs could be improved or joist ends repaired with oak/resin splice with grp reinforcing.
2. Further investigation around splint to spine beam required after the removal of board.

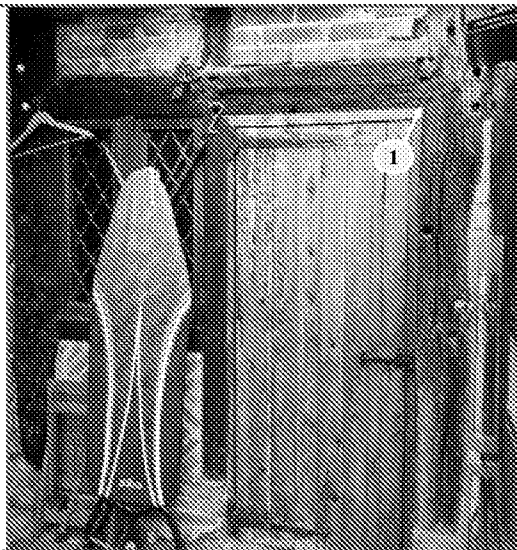
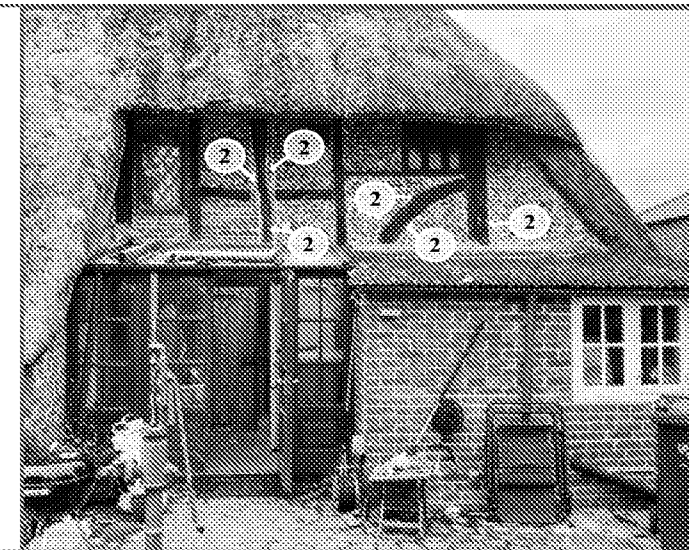
1. Face patch and iron strap required to area of decay around failed tenon.
2. Remove cement mortar around timbers and repoint using lime mortar.
