# ST JOHN'S COTTAGE

POLING STREET, POLING, ARUNDEL, WEST  
SUSSEX, BN18 9PS

## TIMBER CONDITION ASSESSMENT

AUGUST 2021

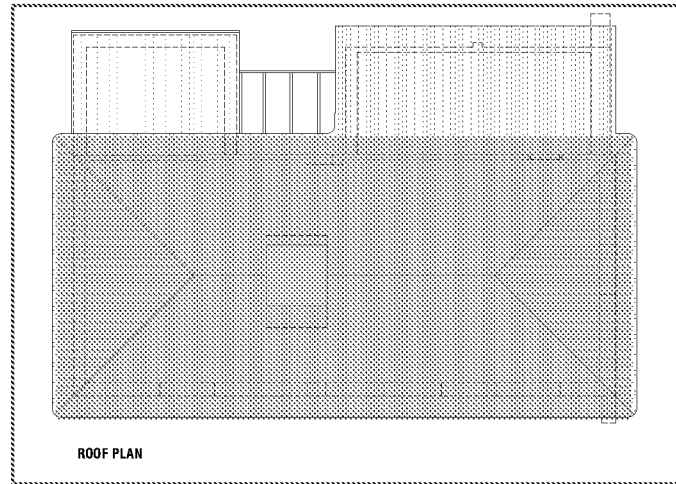
1. All elm rafters and roof timbers are severely decayed due to insect attack.

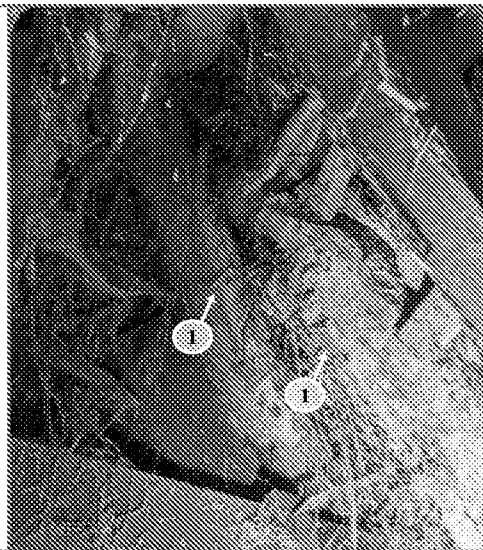
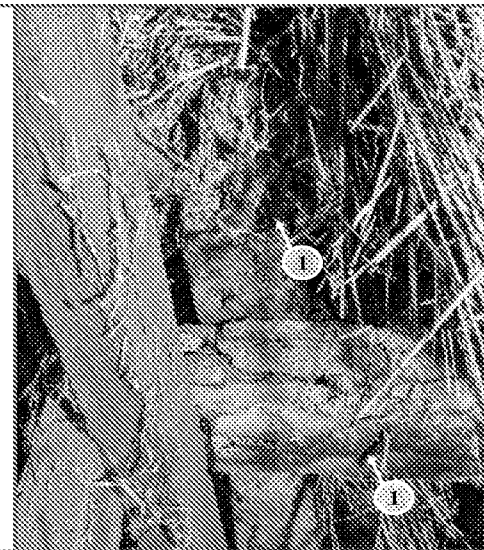
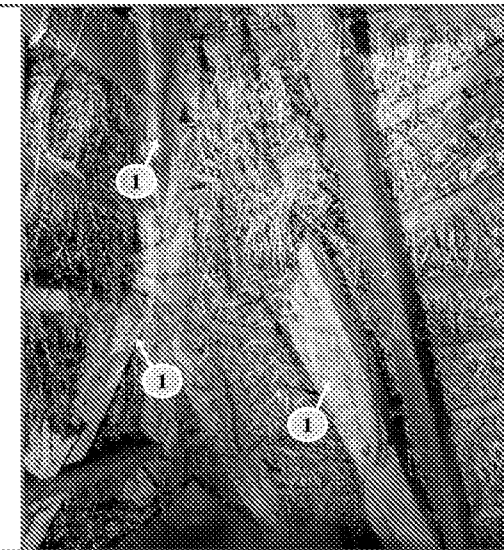
1. All Elm rafters and roof timbers are severely decayed due to insect attack.

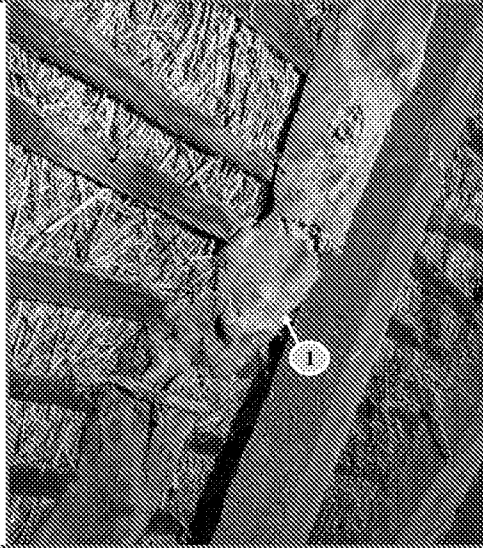
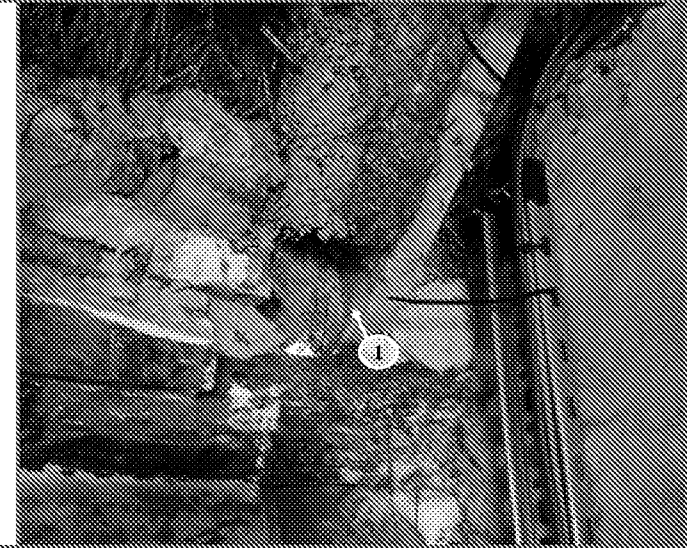
1. Queen posts and Elm collars severely decayed though insect attack.

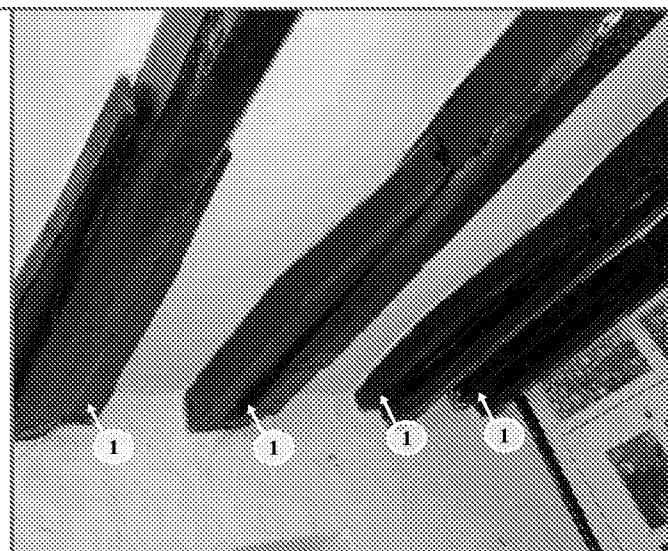
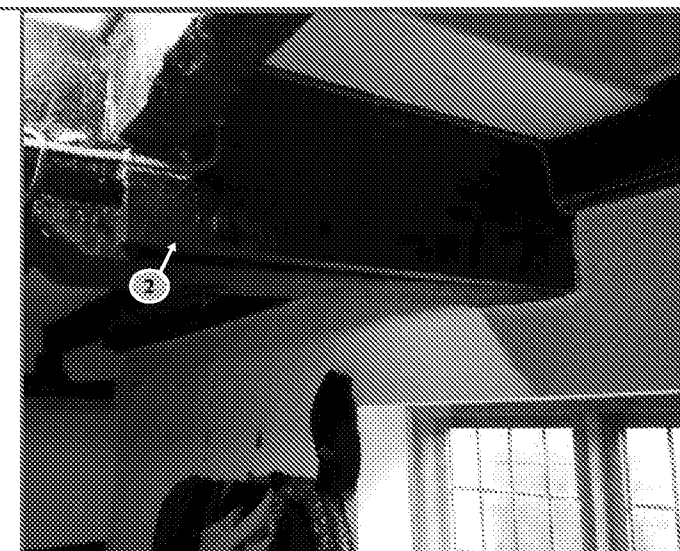
1. Ends of original joists failed. Splint repairs could be improved or joist ends repaired with oak/resin splice with grp reinforcing.
2. Further investigation around splint to spine beam required after the removal of board.

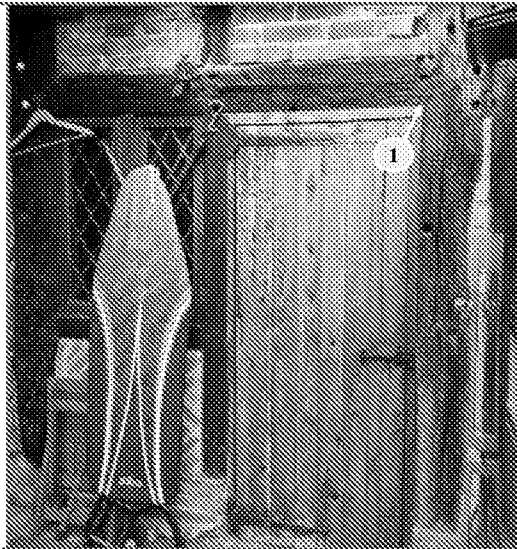
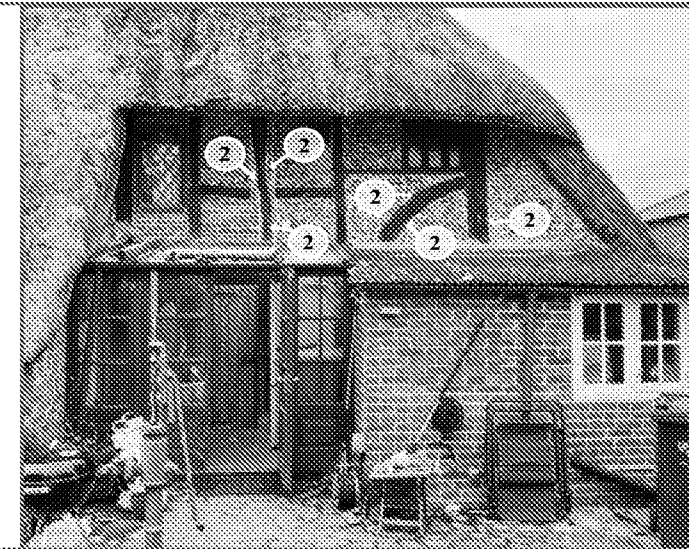
1. Face patch and iron strap required to area of decay around failed tenon.
2. Remove cement mortar around timbers and repoint using lime mortar.
