**Project Name:** 5605C1 Pagham Road

**Project Number:** 5605/C1

**Inspection Standard:** MSCC5 Sewers & Drainage GB (SRM5 Scoring)

# Encompass Geospatial CCTV Outcome Report

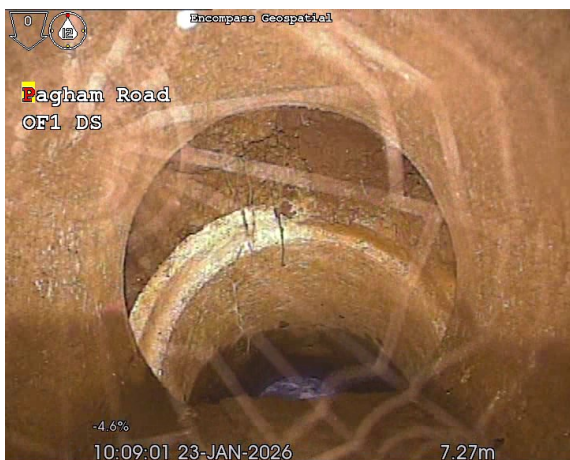
| Section | PLR | Grade | Description |
|---|---|---|---|
| 1 | OF1X | 4 | Joint displaced, large |

| Scale: | 1:66 | Position [m] | Code | Observation | MPEG | Photo | Grade |
|---|---|---|---|---|---|---|---|
| | | 7.27 | JDL | Joint displaced, large | 00:00:35 | OF1X_d58<br>58db7-6e5<br>f-427b-ba8 | 1 / 4 |
| | | 7.27 | SV | Soil visible beyond defect | 00:00:35 | | |

OF1X\_d5858db7-6e5f-427b-ba84-24e1e03b5ca6\_20260126\_081105\_816.jpg, 00:00:35, 7.27 m  
Joint displaced, large

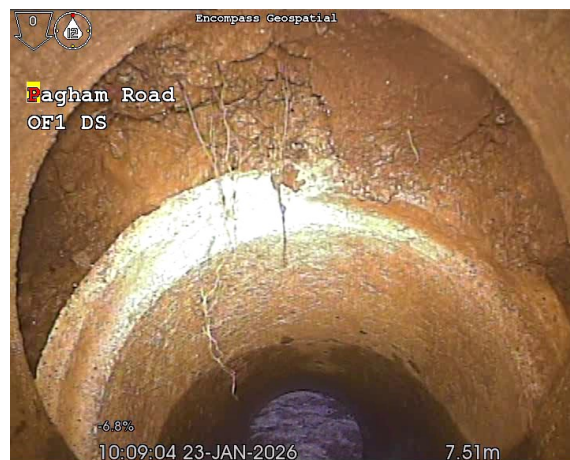
OF1X\_cc650236-f2bc-46f2-88e3-bd0cc907d491\_20260126\_081159\_363.jpg, 00:00:38, 7.51 m  
Finish node, other special chamber, reference: OF1 DS,  
FINISHES INTO THE POND OTHERSIDE OF THE DITCH

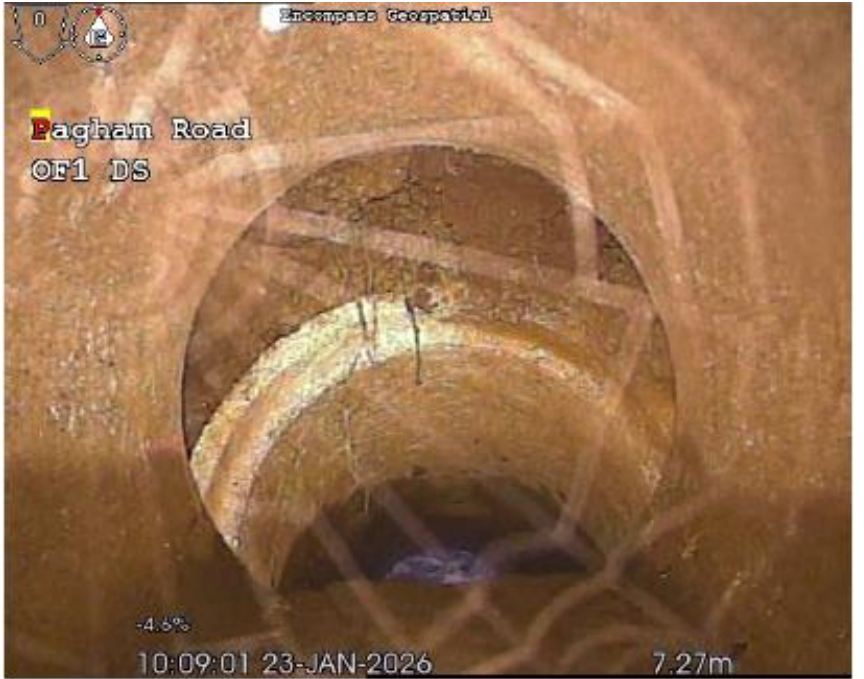
| Pipe reference | Fault & recommended resolution | Image |
|---|---|---|
| OF1 DS | A large, displaced joint was observed. Although the pipe was flowing adequately at the time of the survey, the severity of the displacement indicates that the joint is likely to continue to drop over time. This will eventually result in a complete blockage, preventing any flow. We recommend that this section of pipe be replaced. | |

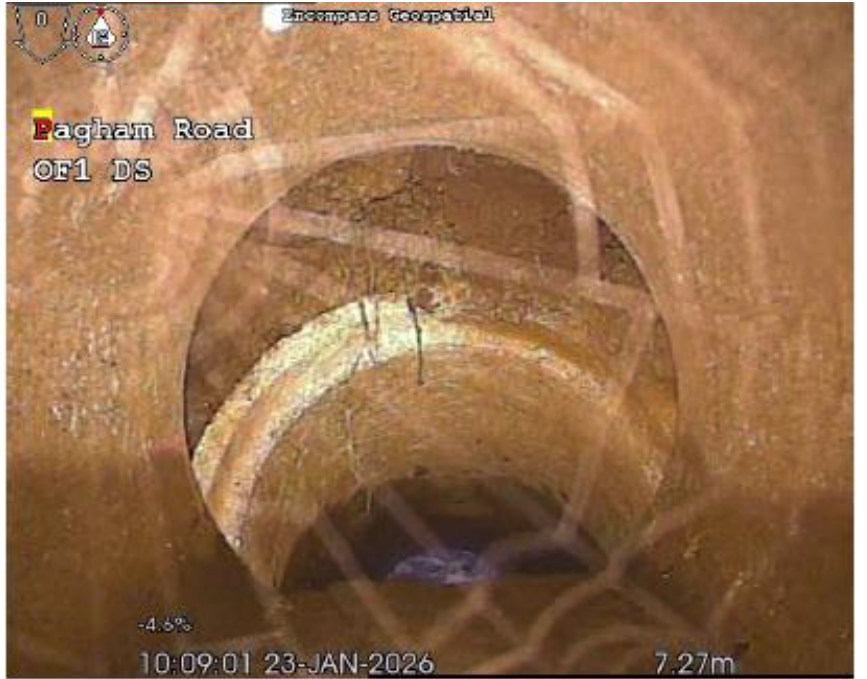
| Pipe reference | Fault & recommended resolution | Image |
|---|---|---|
| OF1 DS | A large, displaced joint was observed. Although the pipe was flowing adequately at the time of the survey, the severity of the displacement indicates that the joint is likely to continue to drop over time. This will eventually result in a complete blockage, preventing any flow. We recommend that this section of pipe be replaced. | |
