# **PRE-DEVELOPMENT ARBORICULTURAL PROTECTION REPORT**

## **31 Lagoon Road, Pagham**

**Reference Number: 0677**  
**Version: One**

**Date: 15 June 2021**

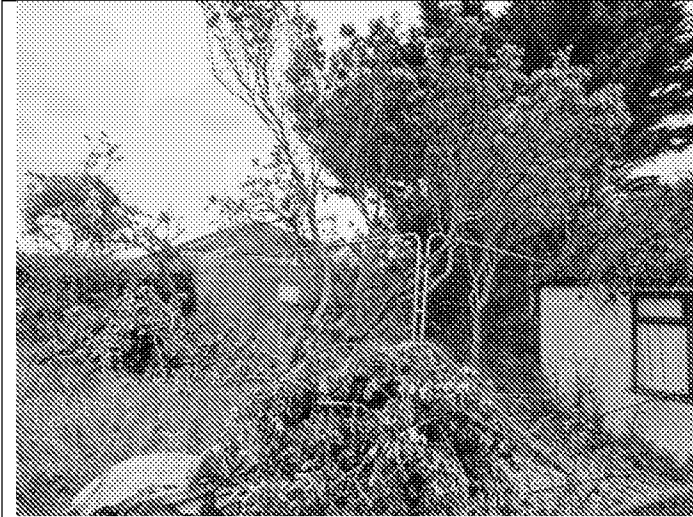
Picture 1 – Overview of area requiring tree protection fencing, with stacked pruned hedging arisings.

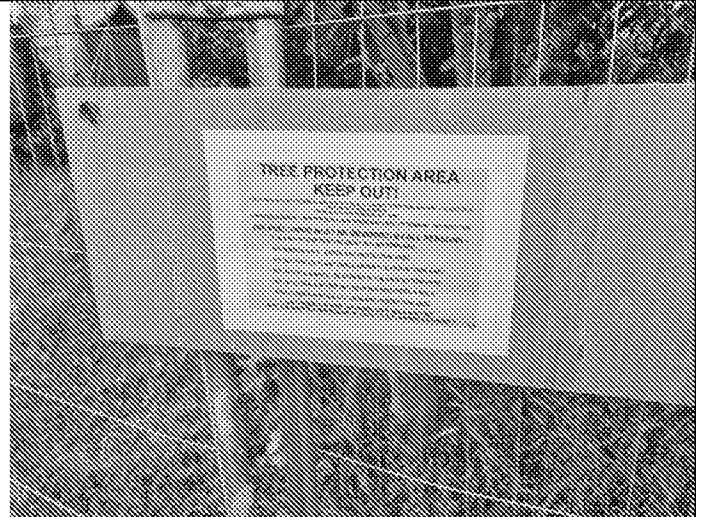
Picture 2 -Signage on fencing

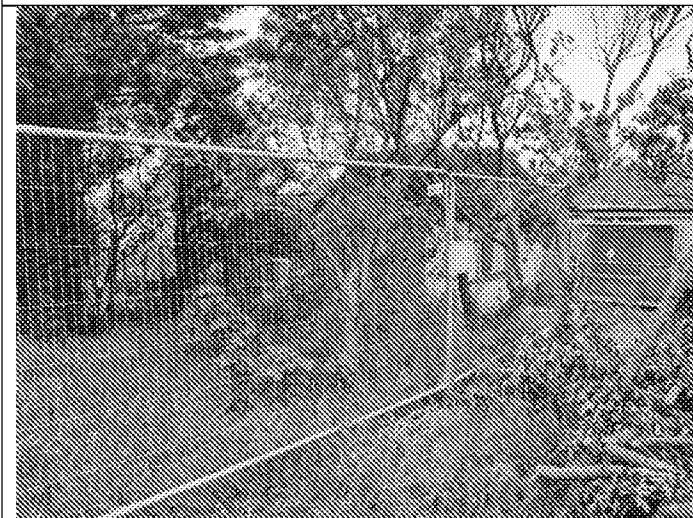
Picture 3 - Area of fencing to include stems of retained trees that were prescribed to be removed

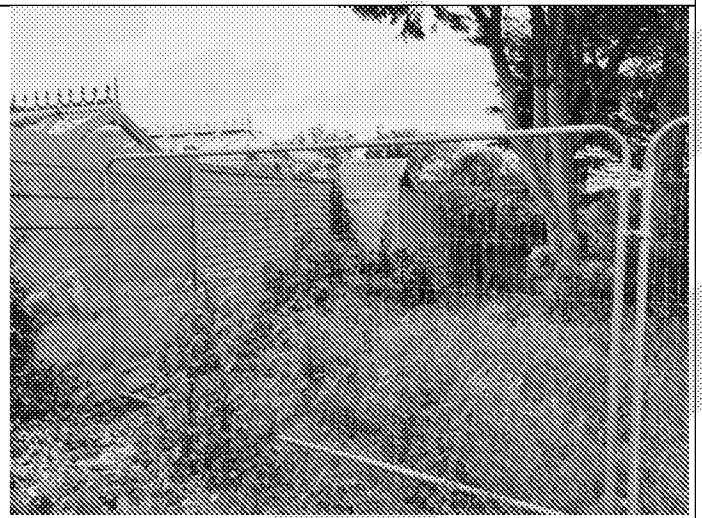
| Tree ID | Common Name/<br>Latin Name | Mitigation required | Checked/notes |
|---|---|---|---|
| #T1 | Leyland Cypress/X<br><i>Cupressocyparis leylandii</i> | <ul style="list-style-type: none"> <li>Protective barrier fencing to be installed on maximum extent of RPA or crown whatever is greater</li> <li>RPA within fenced area to become a construction exclusion zone (CEZ)</li> </ul> | <p>Fencing present around tree, located at 6.5 m from the tree at its closest, this exceeds the requirements.</p> <p>Signage on fencing stating purpose of fencing and stating no access.</p> <p>Fencing staked into ground to resist movement.</p> <p>Fencing of Heras style fencing as is deemed adequate for the project.</p> |

Picture 4 - Showing fencing around T1

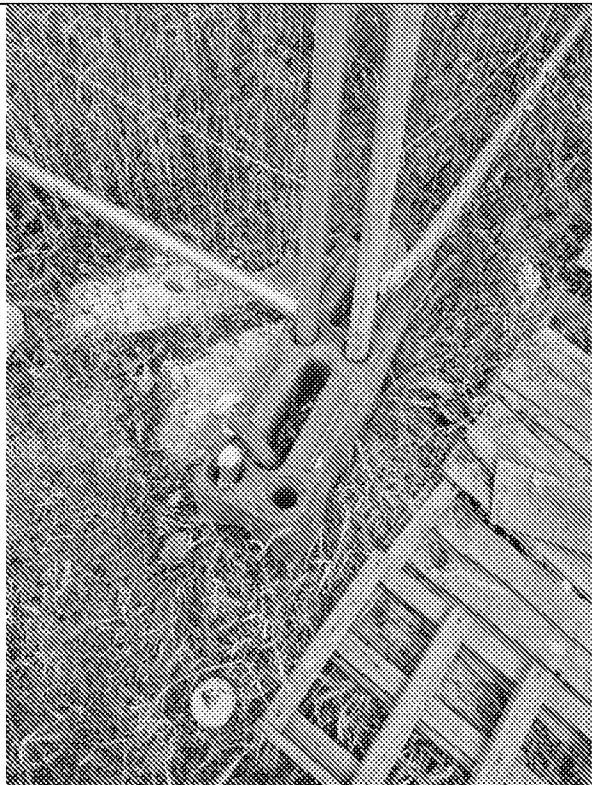
Picture 5 – Example of how fencing feet have been pinned in to location, these lengths are c.40cm long

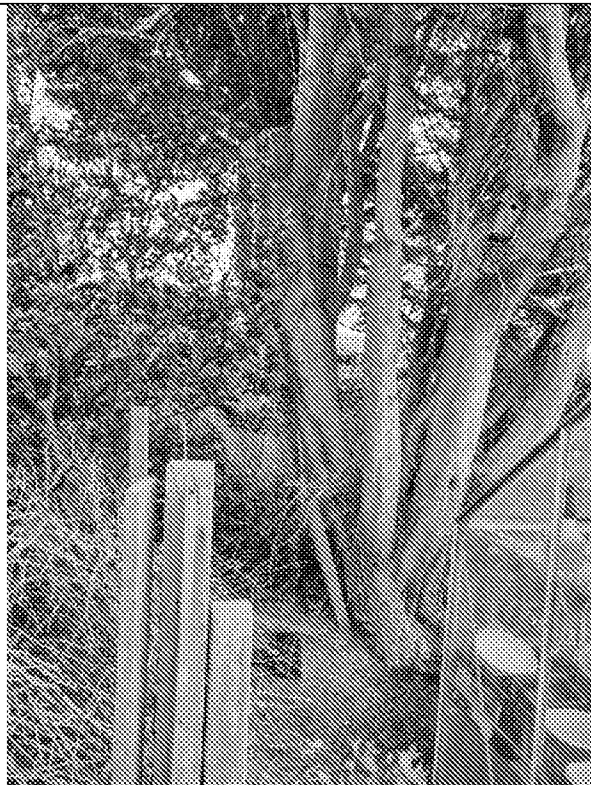
Picture 6 -Group of trees T1, T2, and T3 set back from boundary line

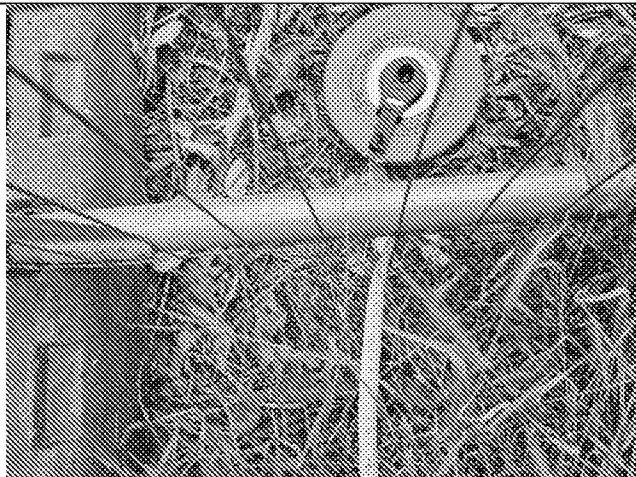
Picture 7 – Distance from T1 to fencing

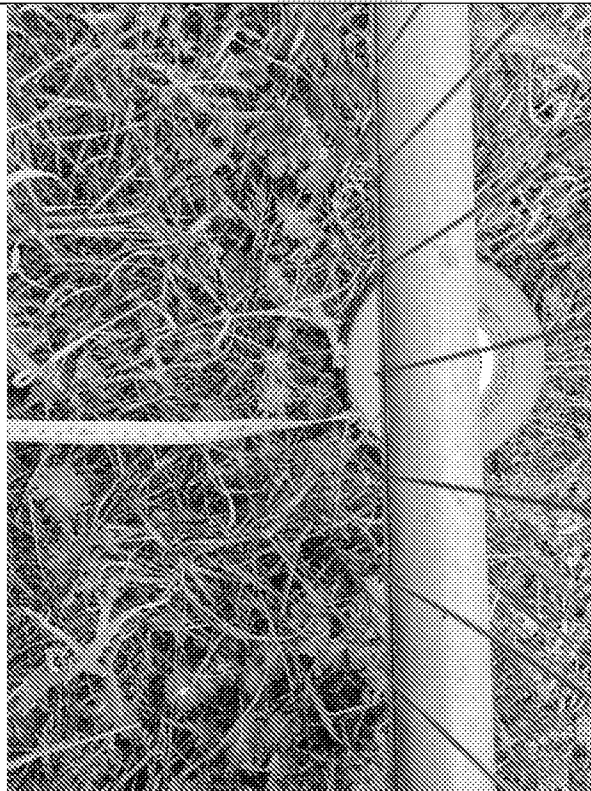
| Tree ID | Common Name/<br>Latin Name | Mitigation required | Checked/notes |
|---|---|---|---|
| T4 | Irish Yew/ <i>Taxus baccata</i> 'Fastigiata' | <ul style="list-style-type: none"> <li>Protective barrier fencing to be installed on maximum extent of RPA or crown whatever is greater</li> <li>RPA within fenced area to become a construction exclusion zone (CEZ)</li> </ul> | <p>Fencing present around tree, located at 4.4m from the tree at its closest, this exceeds the requirements.</p> <p>Signage on fencing stating purpose of fencing and stating no access.</p> <p>Fencing staked into ground to resist movement.</p> <p>Fencing of Heras style fencing as is deemed adequacy for the project.</p> |

Picture 8 - Distance from T4 to fencing
