CULVERT INFORMATION

- Results of CCTV Survey
- Topographical Survey CM24001 with Culvert Plotted
- Overlay of Topographical Survey CM24001 onto Site Plan

Project Name: JJR Designs Ltd - Commonmead Barn

Project Date: 09/05/2024

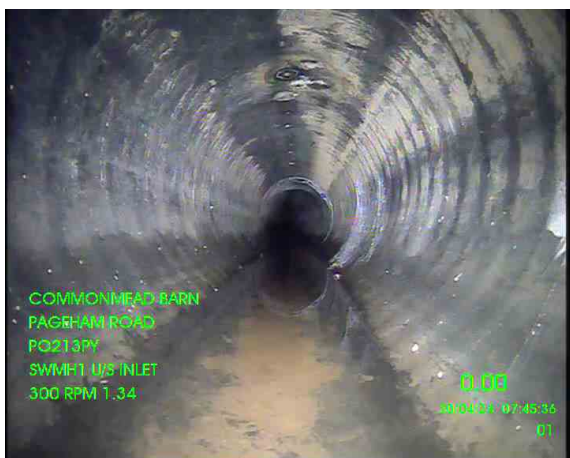
1ec85d76-efed-4169-991b-b132d877e50e.jpg, 00:00:03, 0.00
m
Water level, 0% of the vertical dimension

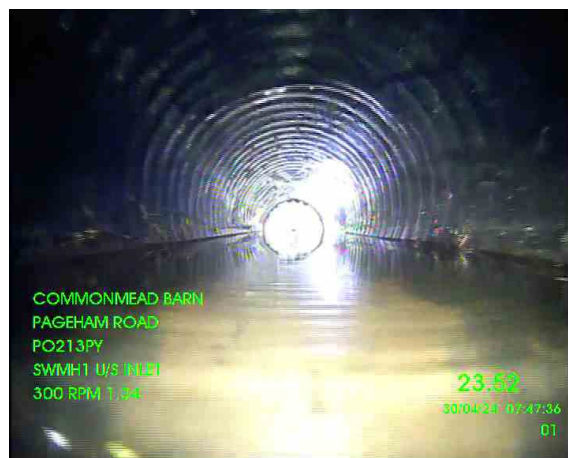
a5e3d87c-1bf5-456f-b9e0-18d7e0212dc6.jpg, 00:02:01, 23.52
m
Water level, 30% of the vertical dimension

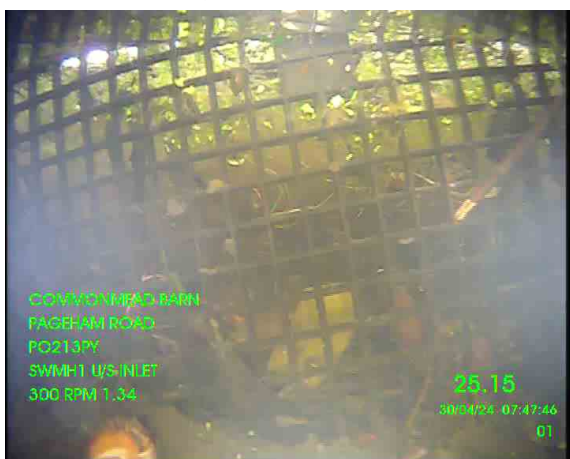
a63c7328-f523-4905-82a1-6a76518d65a0.jpg, 00:02:11, 25.15 m
Finish node, manhole, reference: Inlet

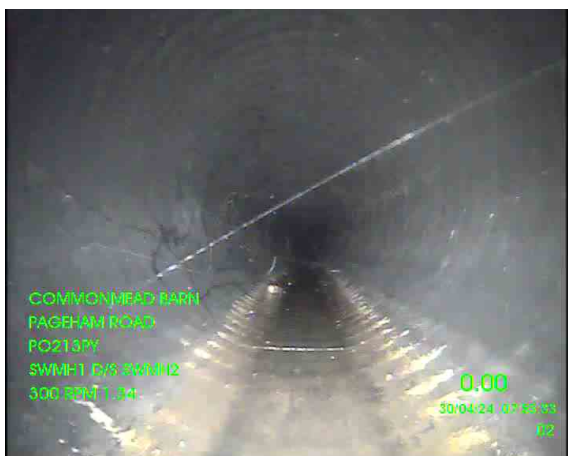
6bf6461b-7c8e-42f1-9c0f-0200ce97ebc2.jpg, 00:00:00, 0.00 m
Water level, 0% of the vertical dimension

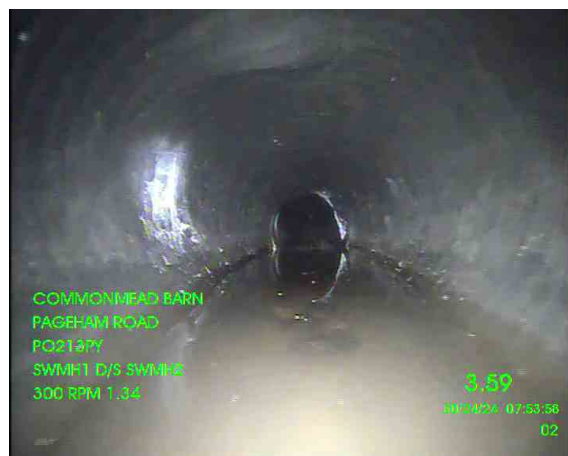
1def6b6a-c51a-4ef5-9ddb-53c38b4145ee.jpg, 00:00:25, 3.59 m
Water level, 15% of the vertical dimension

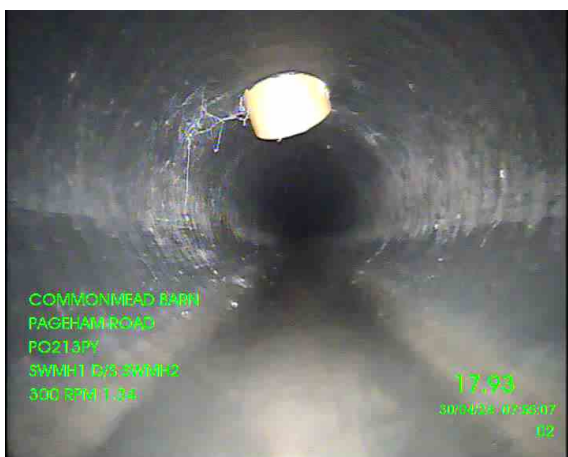
c8d445c6-5c97-4394-a9b1-9c6aadde0601.jpg, 00:01:34, 17.93 m
Connection other than junction at 12 o'clock, 100mm dia

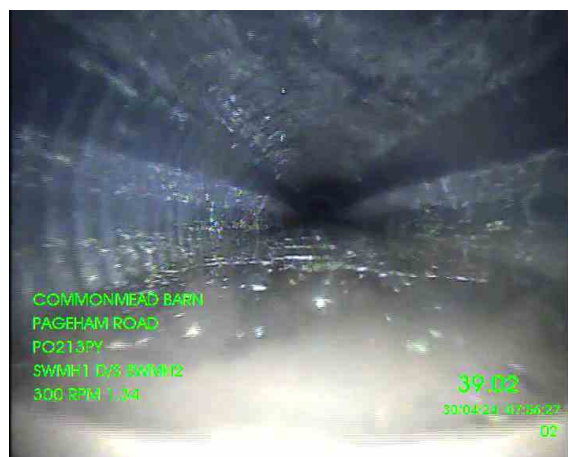
dde9c2f5-2e1c-47c8-bdc5-de7655df30fa.jpg, 00:02:54, 39.02 m
Water level, 45% of the vertical dimension

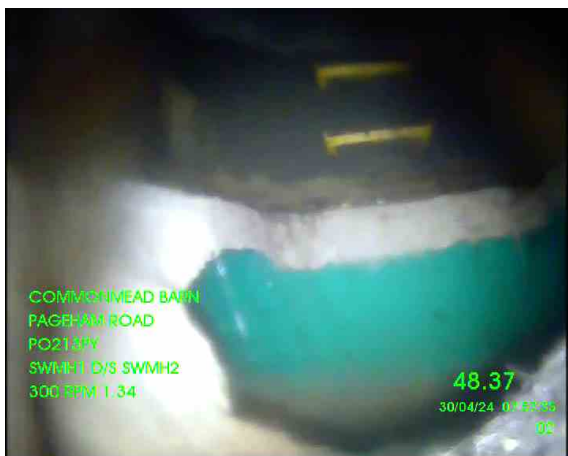
c0898bd0-99c9-4178-8d8b-8708903d90fd.jpg, 00:04:02, 48.37 m
Finish node, manhole, reference: SWMH2
