9<sup>th</sup> May 2025

ABMH Ref: ABF2239/AOB

**Morrells Farmhouse, Lagness, West Sussex  
Structural Assessment Report of 2 Existing Barn Buildings.**

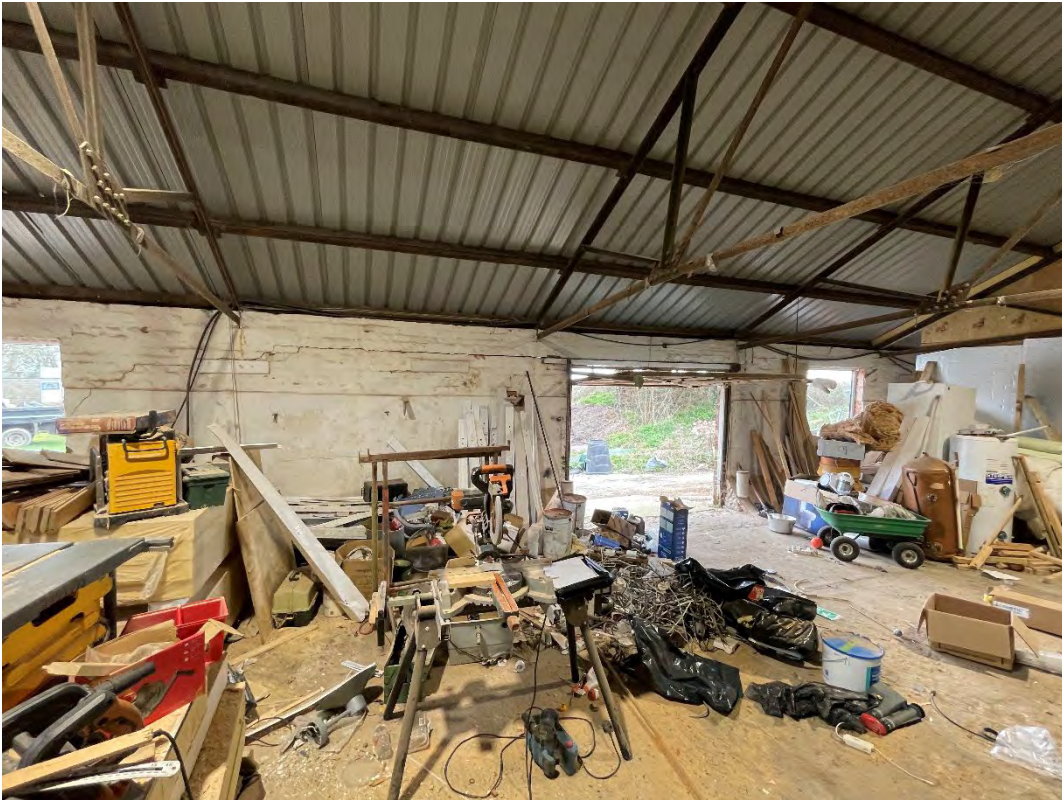
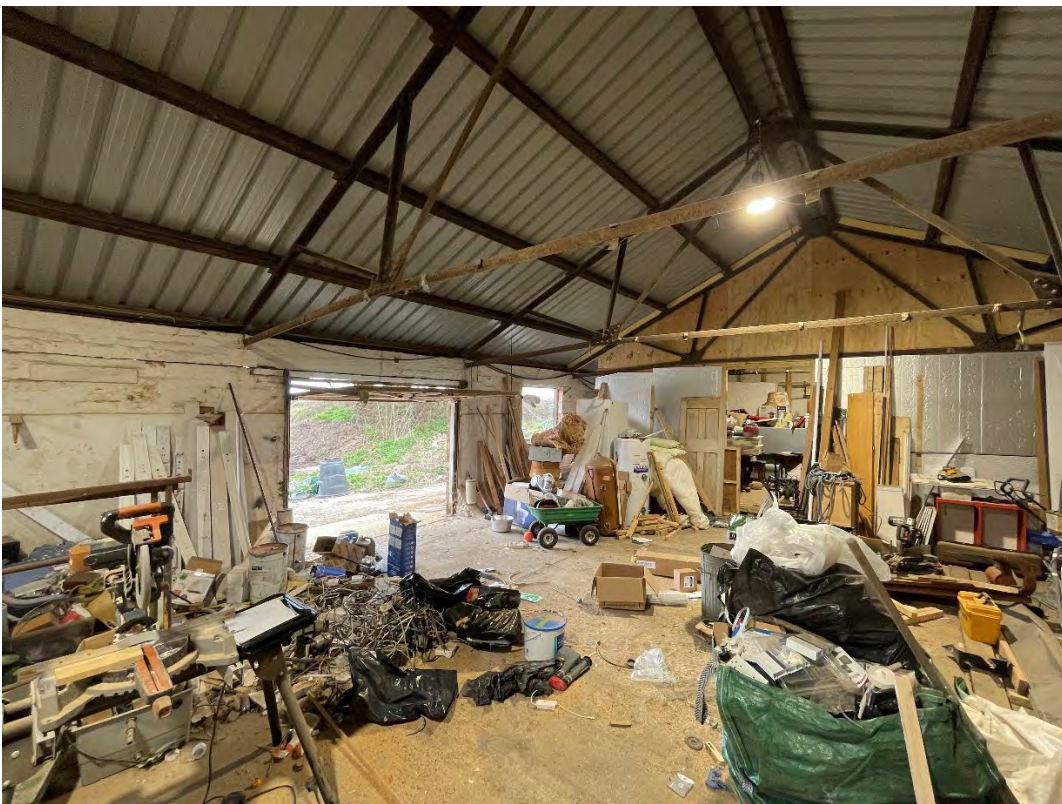
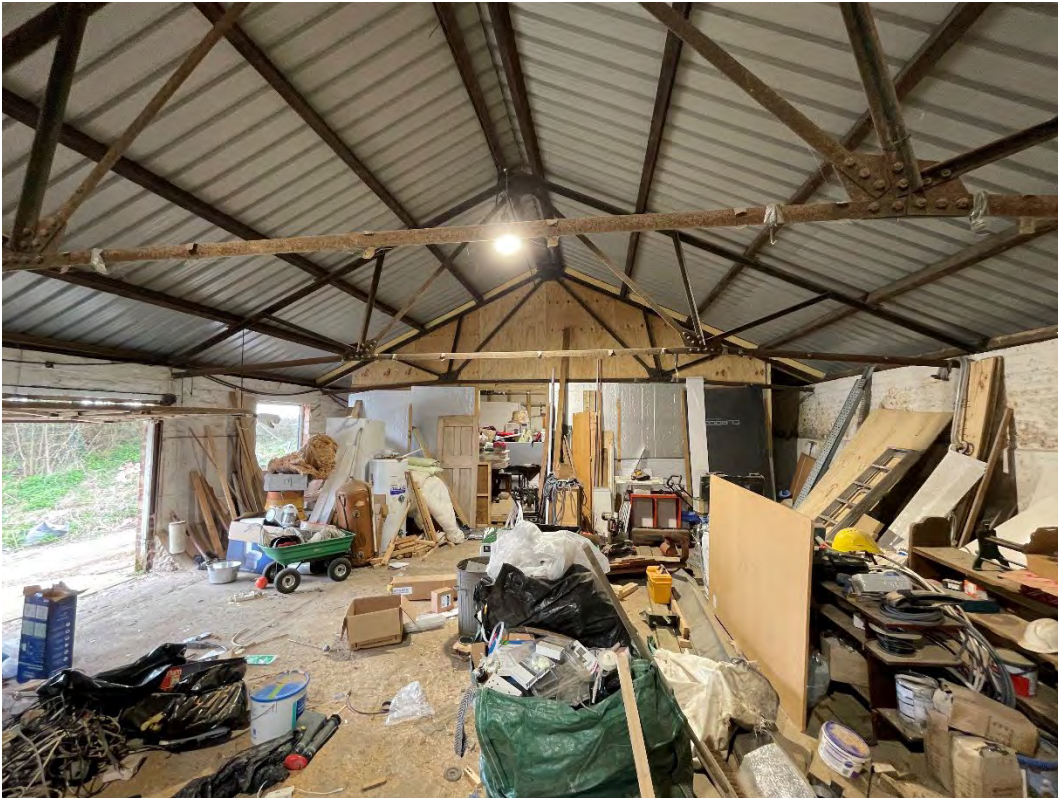
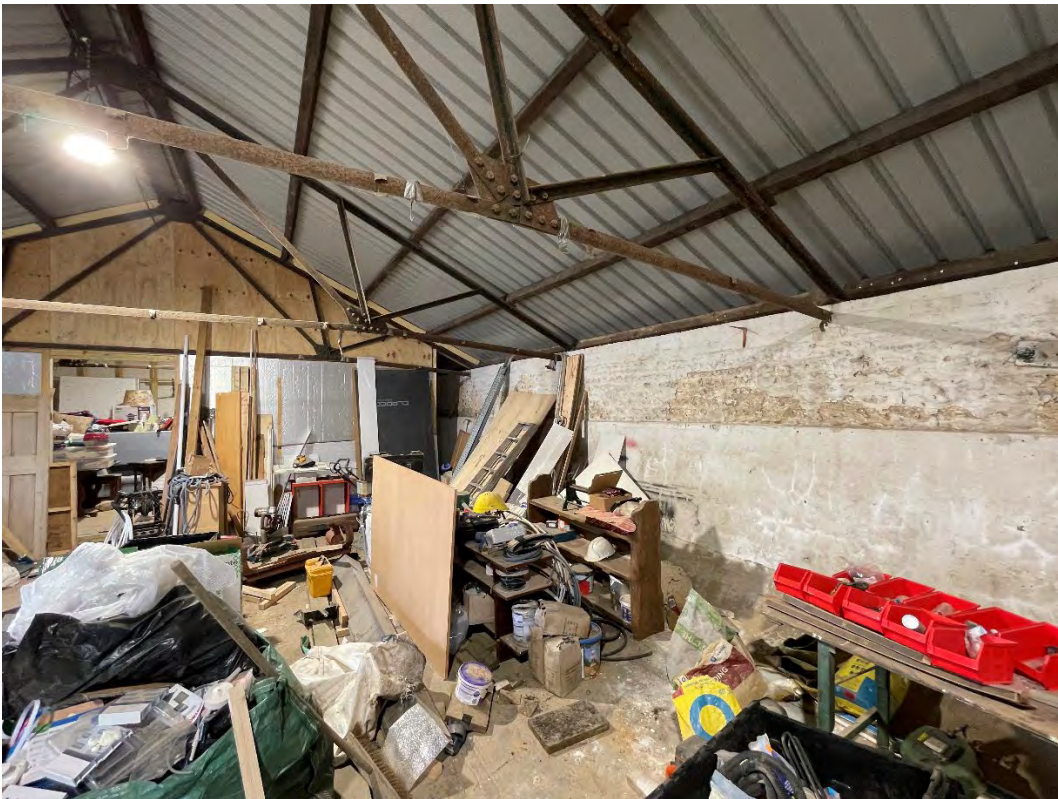
As mentioned above the roof was of a metal truss construction with timber purlins and a metal profile sheet finish. It was noted that there were PV panels situated at the left hand end of the roof at ridge level on both sides of the pitch. The metal trusses were at approximately 3.0m centres and were in good working order with no structural failures present. However, it was noted that in some areas of each truss there was a small amount of corrosion present. The metal truss were supported directly on the rear & front external walls and were built into the external walls too. Each metal truss

supported the ends of 6 timber purlins (3 on each side of the roof), and all purlins that were present seemed to be in good working order with no structural failures present (Refer to picture Nos. 01-04).

The roof to Barn 1 was generally in good condition. The main metal truss supports that present were corroded especially to the bearing ends where they are built into the external wall as some were exposed to the weather externally. We suggest that the trusses are fully brushed clean of all corrosion that is present and treated with anti-rust paint but also painted additionally with bituminous paint to provide future protection against any possible corrosion. Strengthening maybe required to both metal trusses and timber purlins due to possible extra loading from additional finishing materials for the proposed conversion.

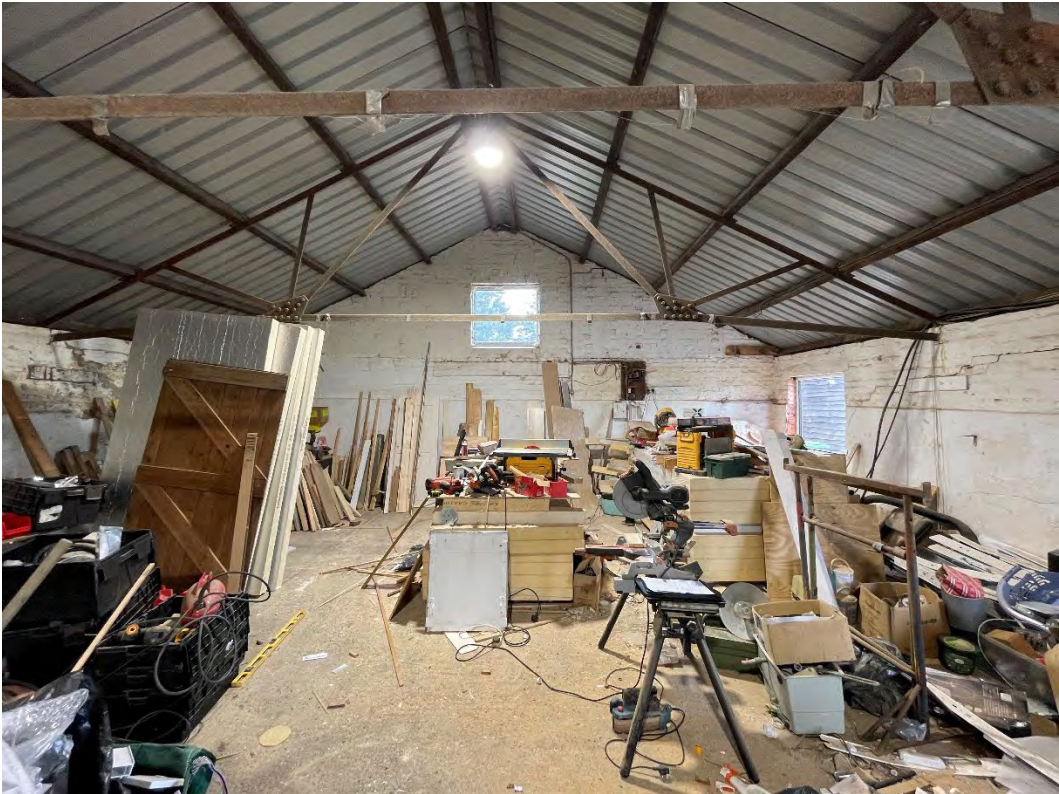
Picture No. 05

The existing ground floor has been assumed as a ground bearing concrete slab. Due to various personal items within the barn not all the slab was visible. However, the floor area that was visible seemed to be in good working order with no structural failures present (Refer to picture No. 05).

The ground floor to Barn 1 and the front part of Barn 2 seemed to be in good working order and was deemed as structural sound. However, in both barns the visual inspection was limited due to the number of equipment/materials present within the buildings. The ground floor to the rear part of Barn 2 was just compacted soil, so we advise that a suitably design ground bearing slab was provided for the proposed conversion works.

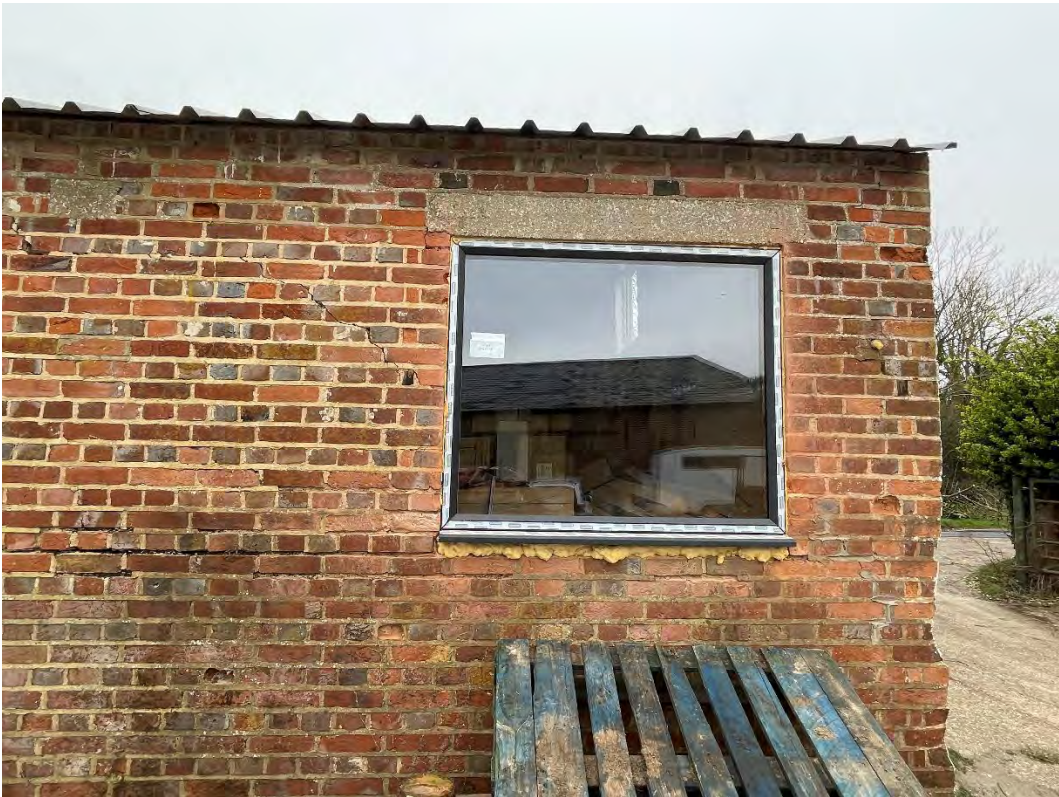
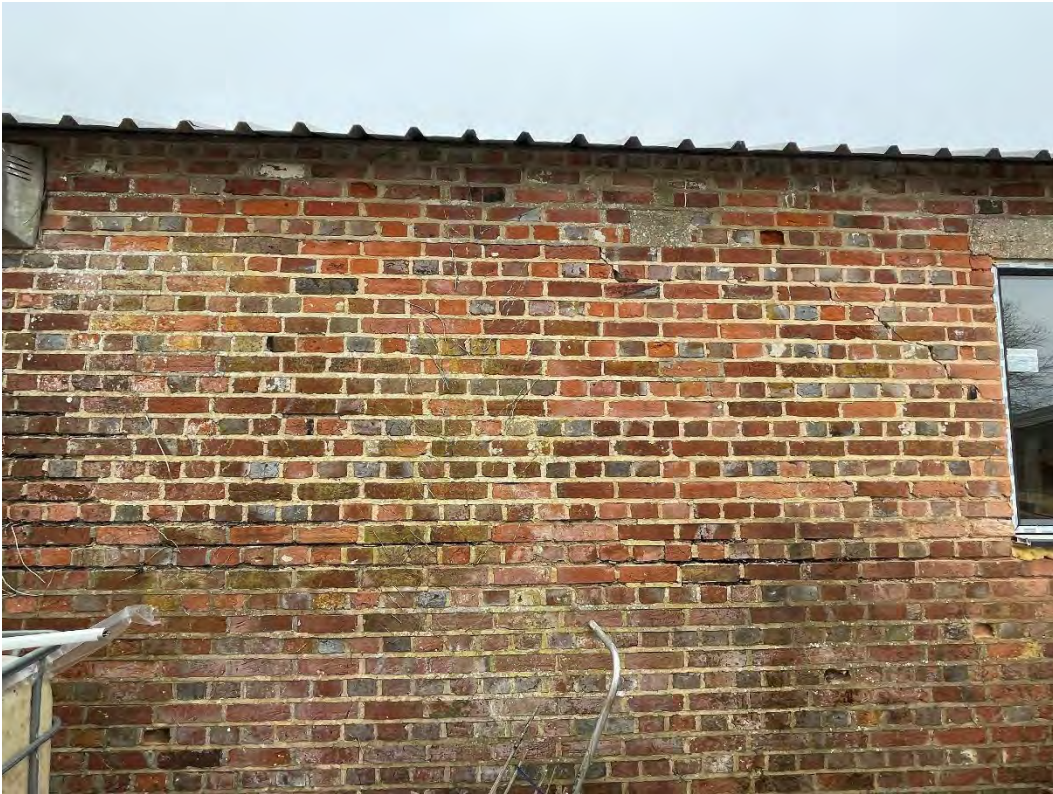
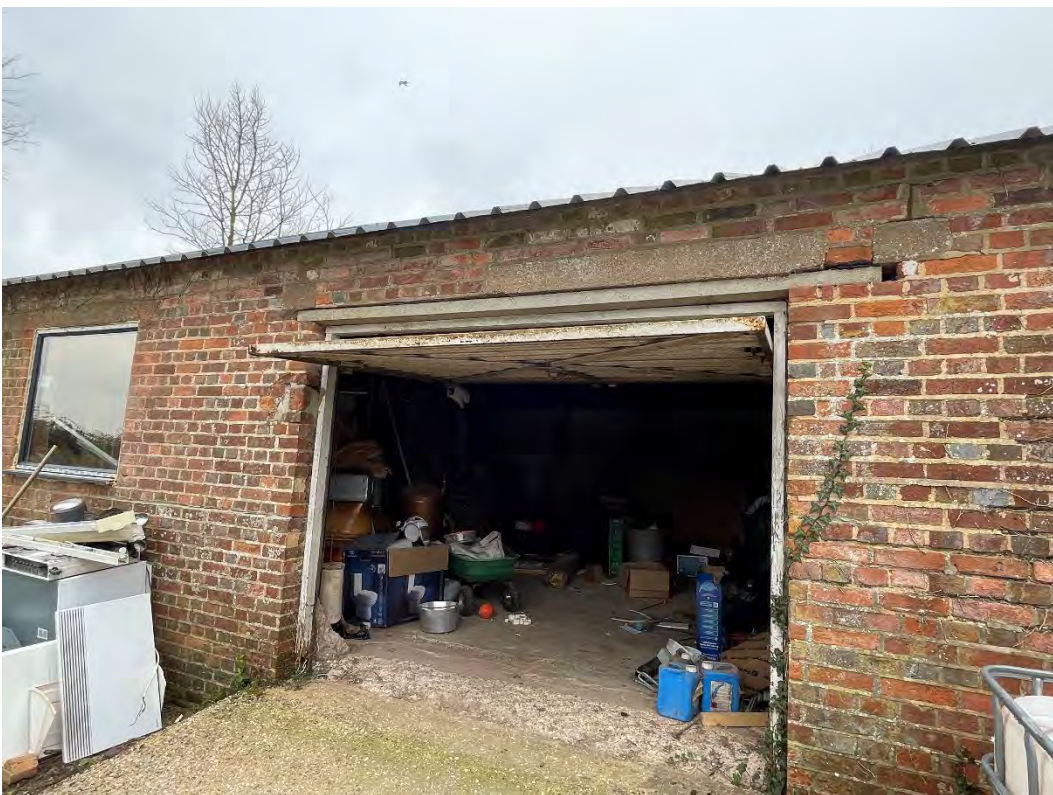
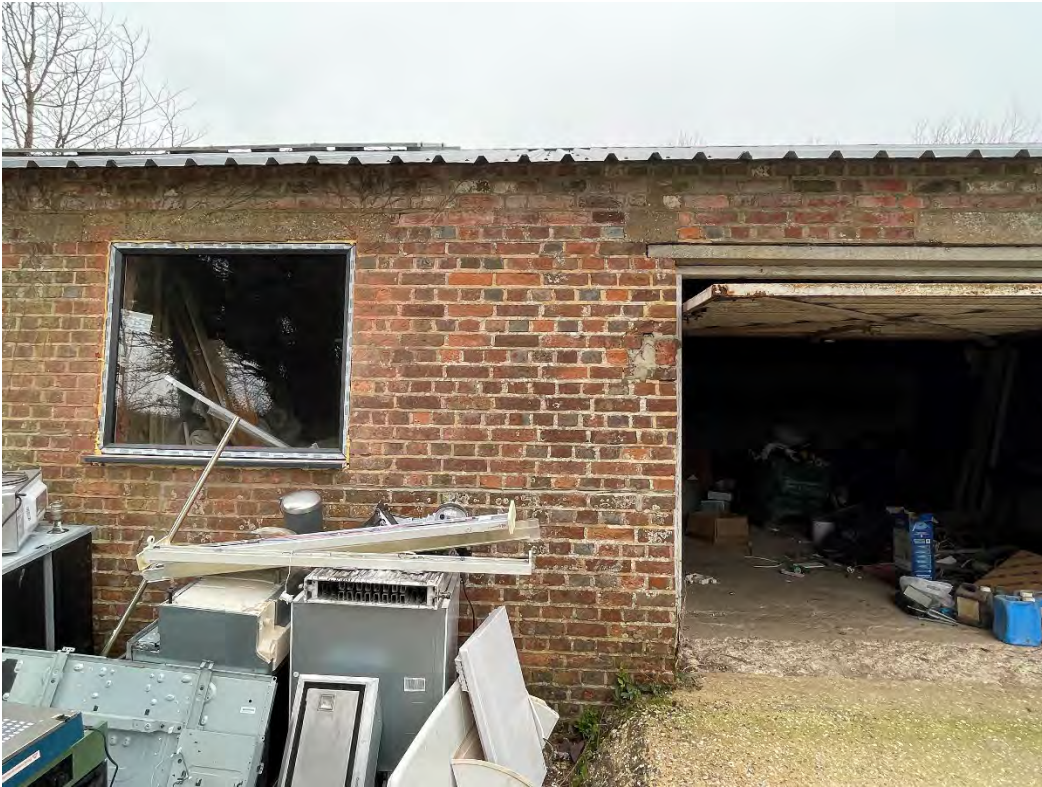
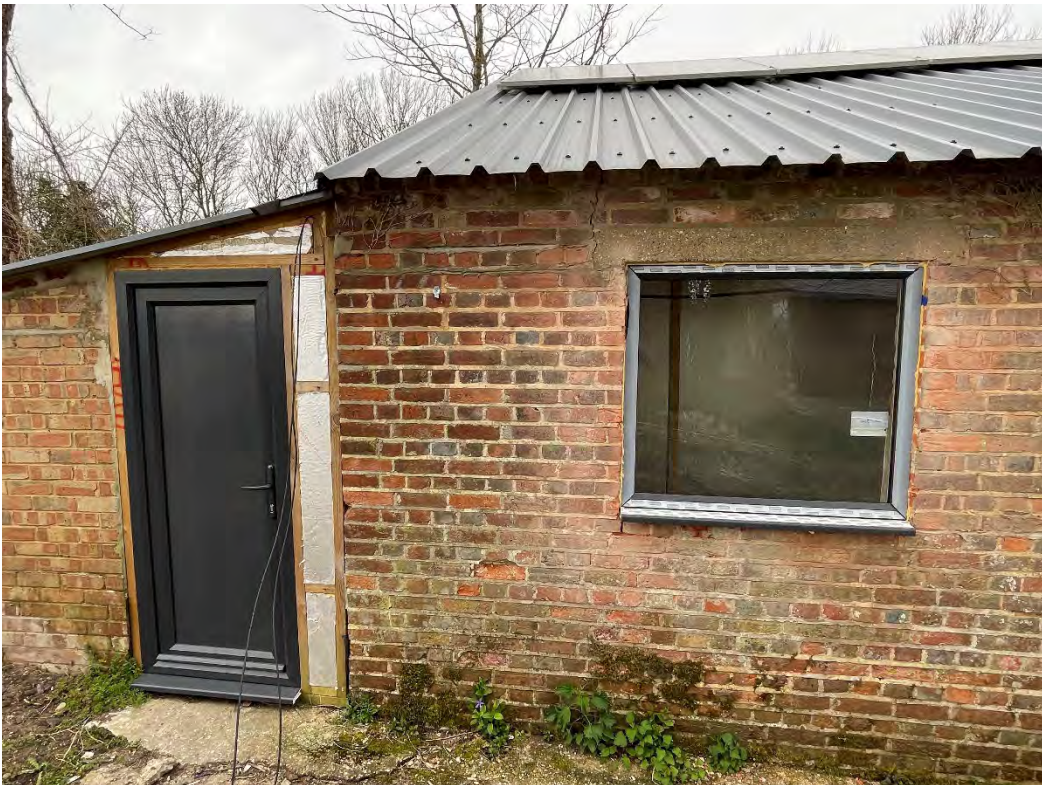
- **Front Elevation** – Externally there are various areas of the wall that have pitted bricks, mortar erosion and 1-3mm cracks within its face. All cracks that were visible were within the top 7 courses and around openings. All cracks externally were also visible internally in the same positions. Concrete lintels over all openings and concrete padstones beneath the bearing ends of the metal trusses, were visible internally & externally. In some areas the ends of the trusses were visible and exposed to the external elements and show signs of corrosion. Most of the cracks visible, we believe, are due to a combination of thermal movement with the masonry but also slight movement within the roof at eaves level. The garage door that was present within the front elevation seemed to be a later addition to the building as the existing opening concrete lintel was still in-situ above the plank lintel that was currently over the garage door. The plank lintel that was over the garage door opening was undersized and was visually bowing due to the weight-span it was supporting (Refer to picture Nos. 06-10).

The external walls to Barn 1 were majority in a good condition. There were cracks noted in the front and side elevations together with pitted brick faces and mortar erosion. We advise that the cracks are remedied with 'Helifix' bars, the pitted bricks are replaced, and all eroded mortar joints are to be re-mortared. Regarding the rear elevation (facing the road), we advise that the damaged left hand corner is rebuilt so that the masonry can be re-keyed into the existing wall so that the structural integrity of the corner is re-established. Also, the wall requires rebuilding in some places with additional strengthening provided, re-mortaring of joints but also, we advise that a waterproof finish is provided to help the longevity of the condition of the wall. It is also advised that a vehicle protection barrier is installed in front and on the corners of the barn to provide further protection against impact damage from vehicles.

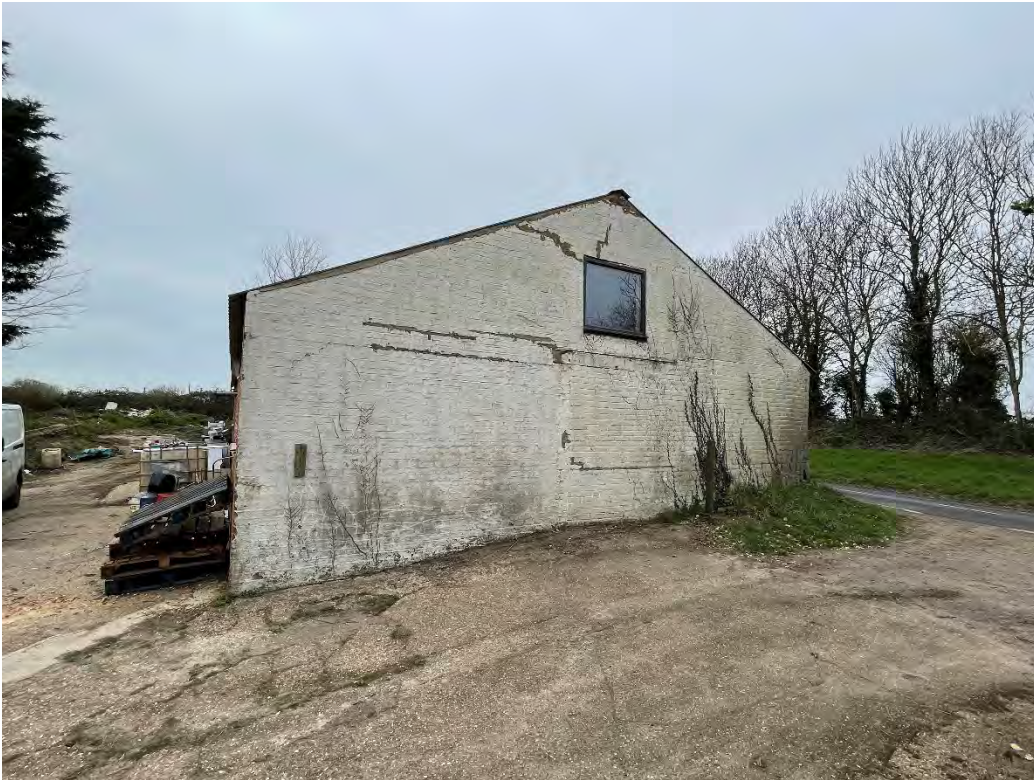
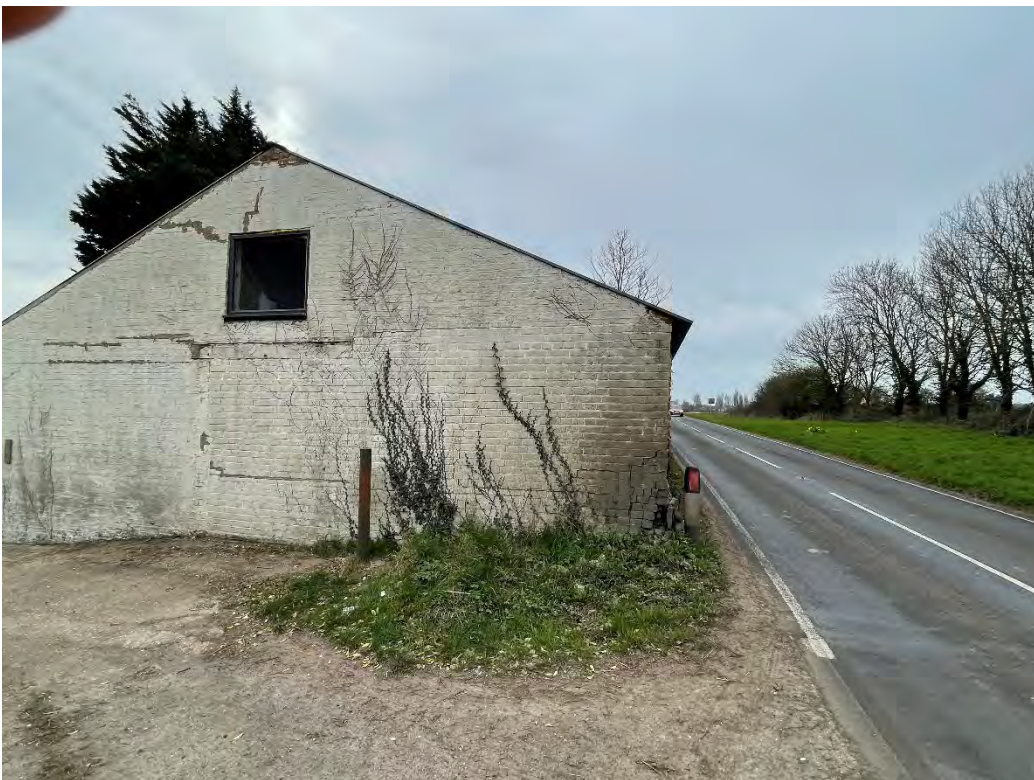
- **Right Hand Side Elevation** – Externally & internally this wall was painted with white masonry paint. Various horizontal cracks were present mid height of the wall and visible internally & externally. It was evident that an existing opening at ground floor level had been bricked up, however, the existing timber lintel was still in-situ. Horizontal cracks near the timber lintel likely result from thermal movement or lintel degradation. Other cracks at this level, on either side of the existing bricked up opening, we believe are caused due to slight movement of the gable wall panel. This movement we believe is due to lack of wall restraint straps. There was also a window opening within the gable wall with visible cracks to the top corners and directly above the opening. In closer inspection we believe that these cracks were due to the lack of lintel support above the window, as it looks like the masonry above the window was built off the window frame. It was also noted at the bottom corner to the right hand side of the wall were loose and falling away together with a diagonal crack. We believe that this is caused by impact damage from a car (Refer to picture Nos. 11 & 12).

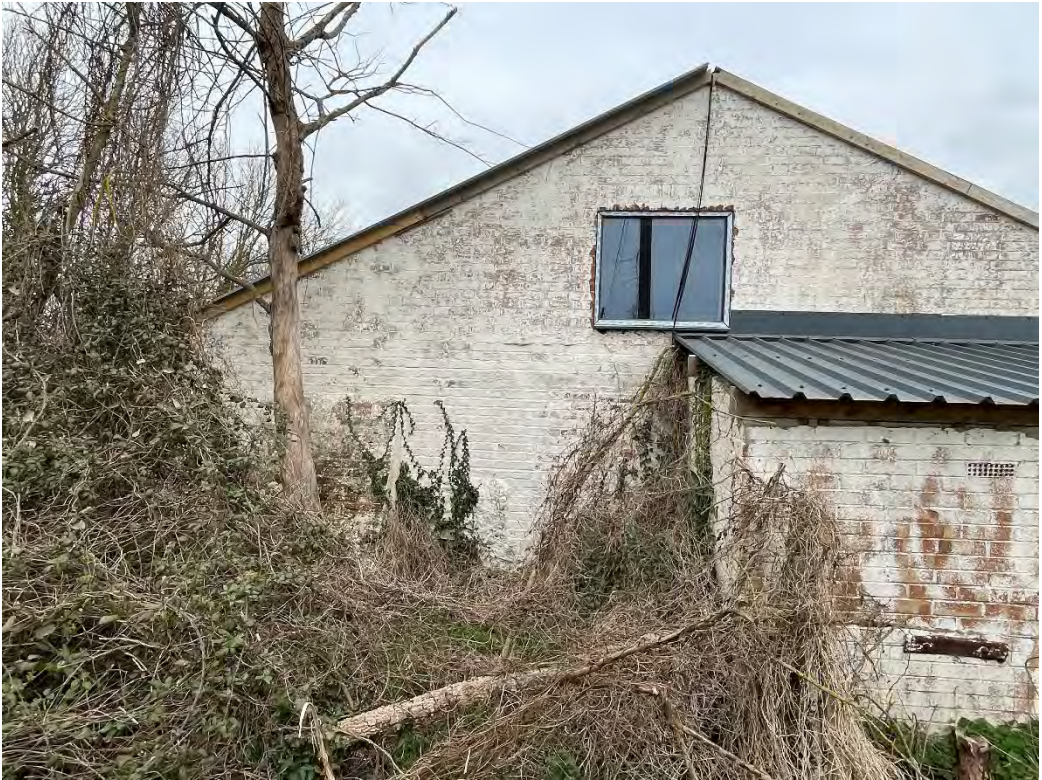
Picture No. 13

- **Left Hand Side Elevation** - Like the right hand side elevation the masonry was painted white. Part of this wall externally was covered by vegetation and a small masonry built store. There was a window within the gable wall and like the other gable wall we believe that no lintel was present above the window. Again, like the opposite side wall it was noted that an existing opening was bricked up with the existing timber lintel still in-situ above the opening. This opening was partly covered by the small store built to the side. A masonry buttress was visible to the left hand side of this elevation; size unfortunately was difficult to ascertain due to the vegetation growth around it. Also, it was not able to inspect the internal face of this wall due to a timber framed storage room that was built at this end of the building (Refer to picture Nos. 13-15).

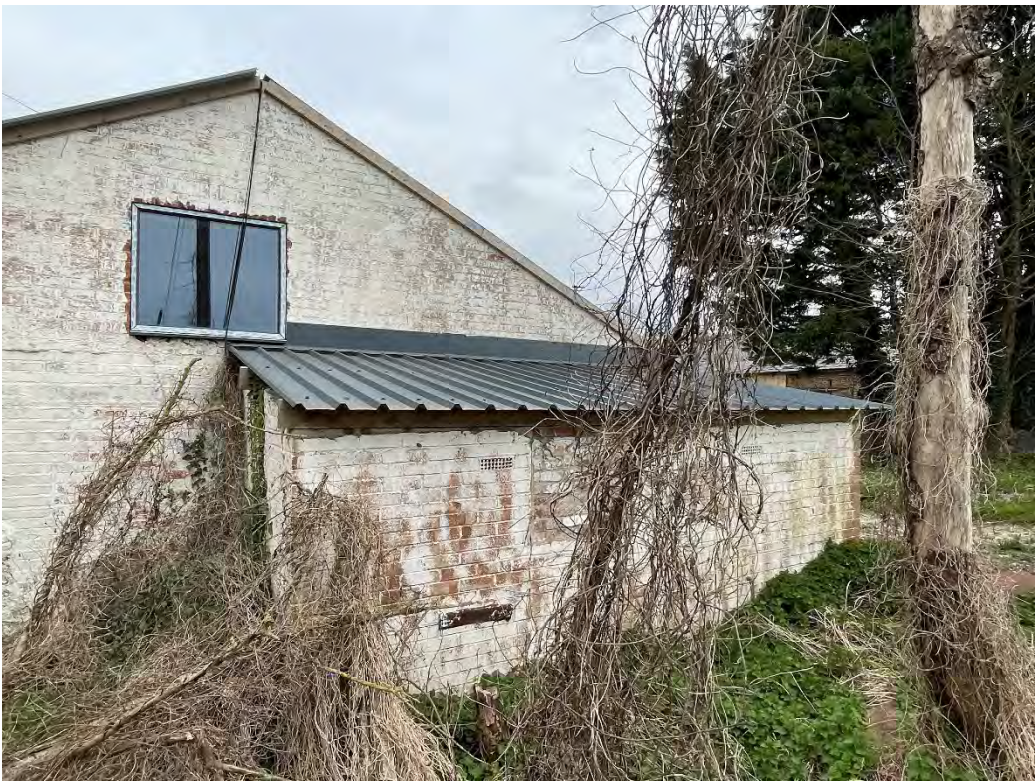
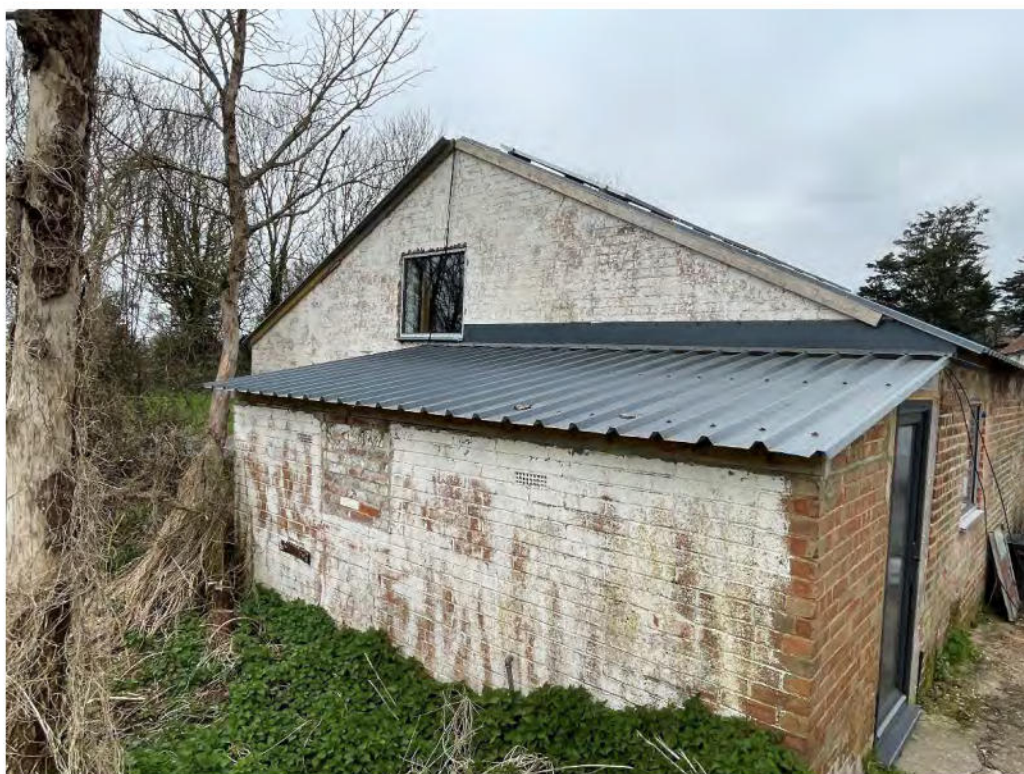
The single storey store had solid 103mm brick masonry external walls with a timber framed inner leaf. The roof was a timber mono pitched roof with a metal profile sheet finish. There was 1 door opening which was situated within the front elevation. All were in good working order with no structural failures present (Refer to picture Nos. 14 & 15).

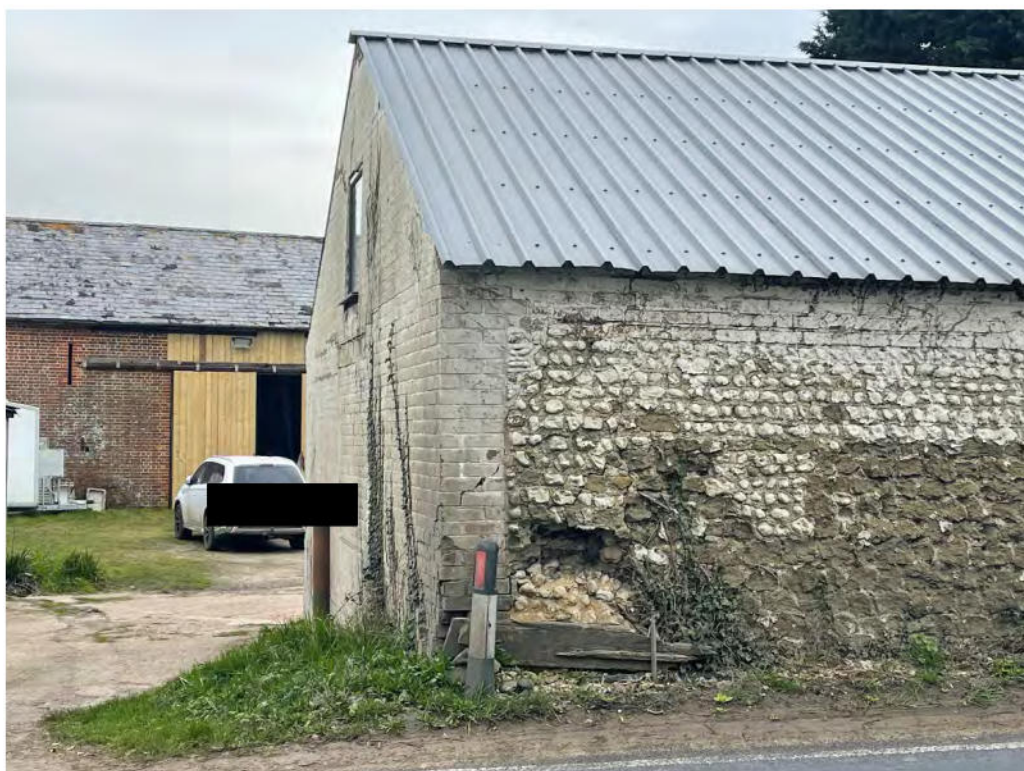
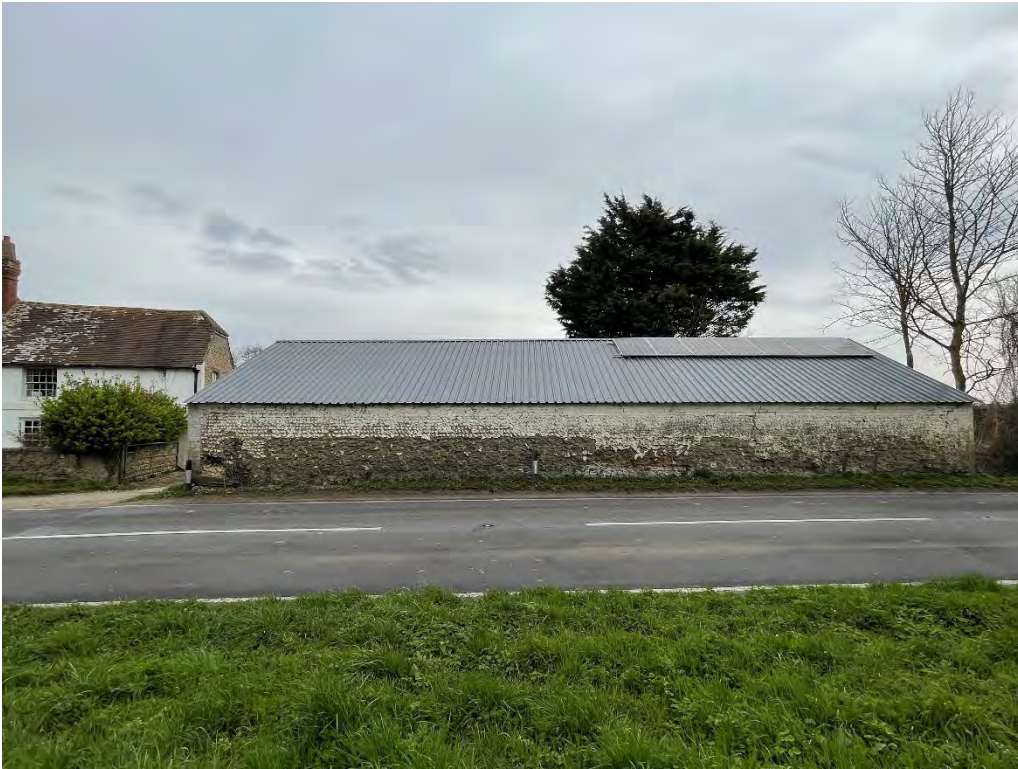
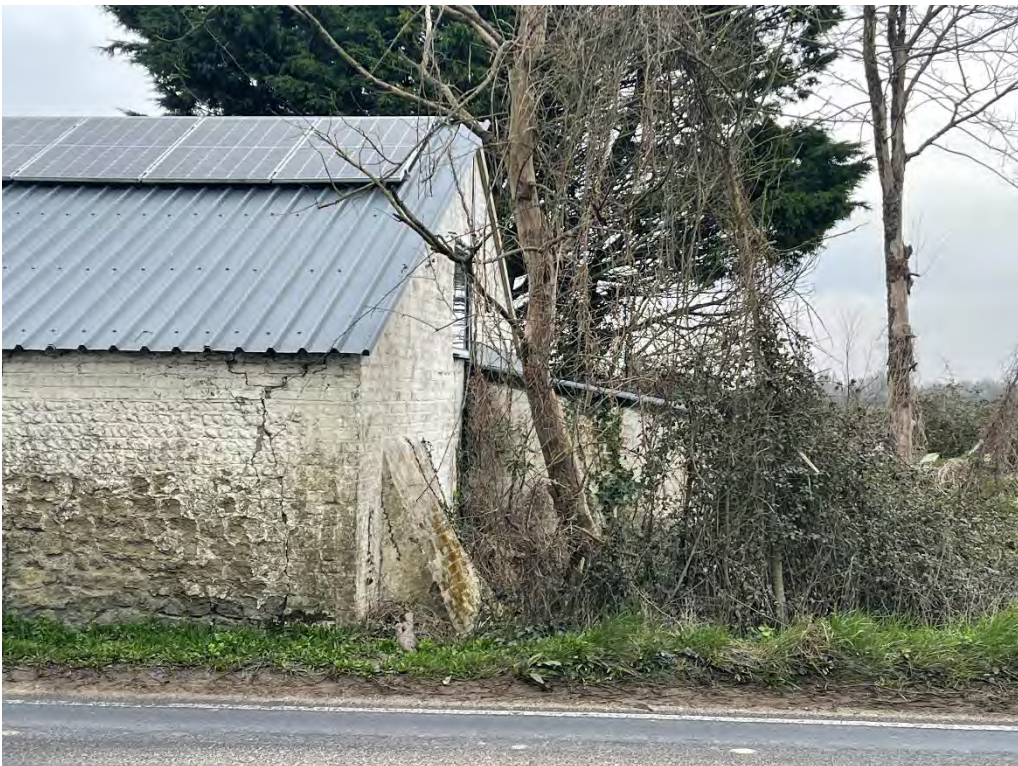
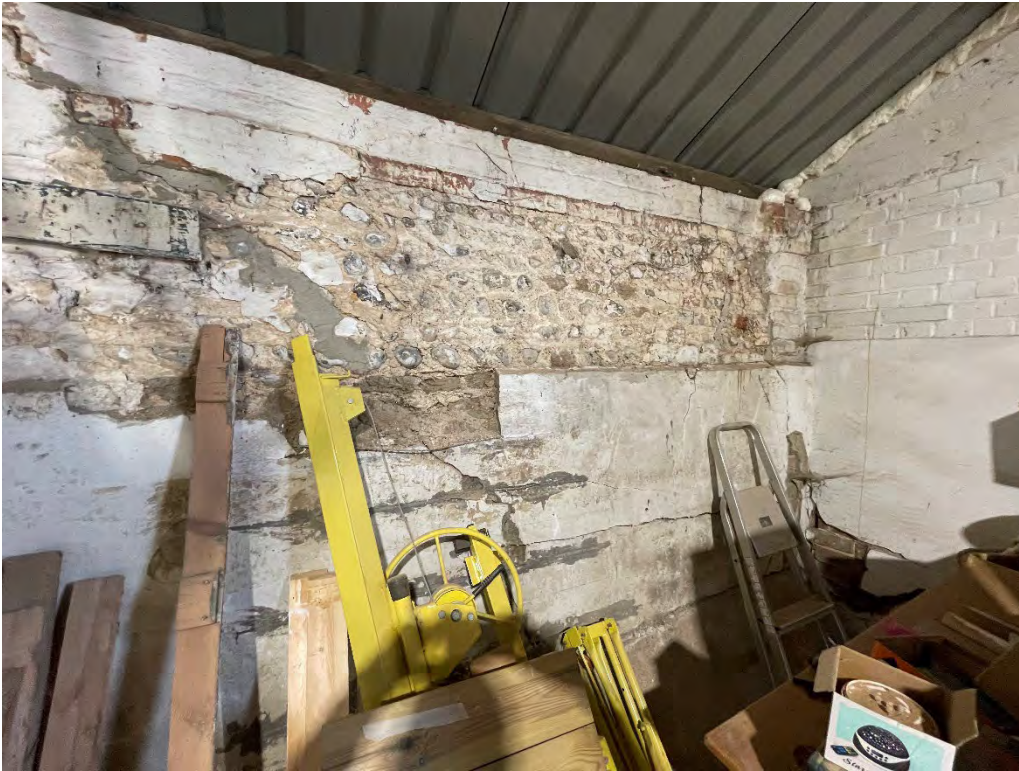
- **Rear Elevation** – The condition of this wall was poor. There were many cracks at varied sizes and in different directions, within the face of the wall externally. There were areas that were pitted, areas that had stone/flint/bricks missing, together with erosion of mortar in most areas. The left hand corner, as stated above, has missing bricks/stonework where we believe is due to impact damage from a car.

In our professional opinion, we believe that this elevation is in such a poor state due to a multiple of things like, slight movement in the roof at eaves level, vibration produce by vehicles on a road directly next to the wall, excessive weathering due to car spray when the road is wet and thermal movement (Refer to picture Nos. 16-19).

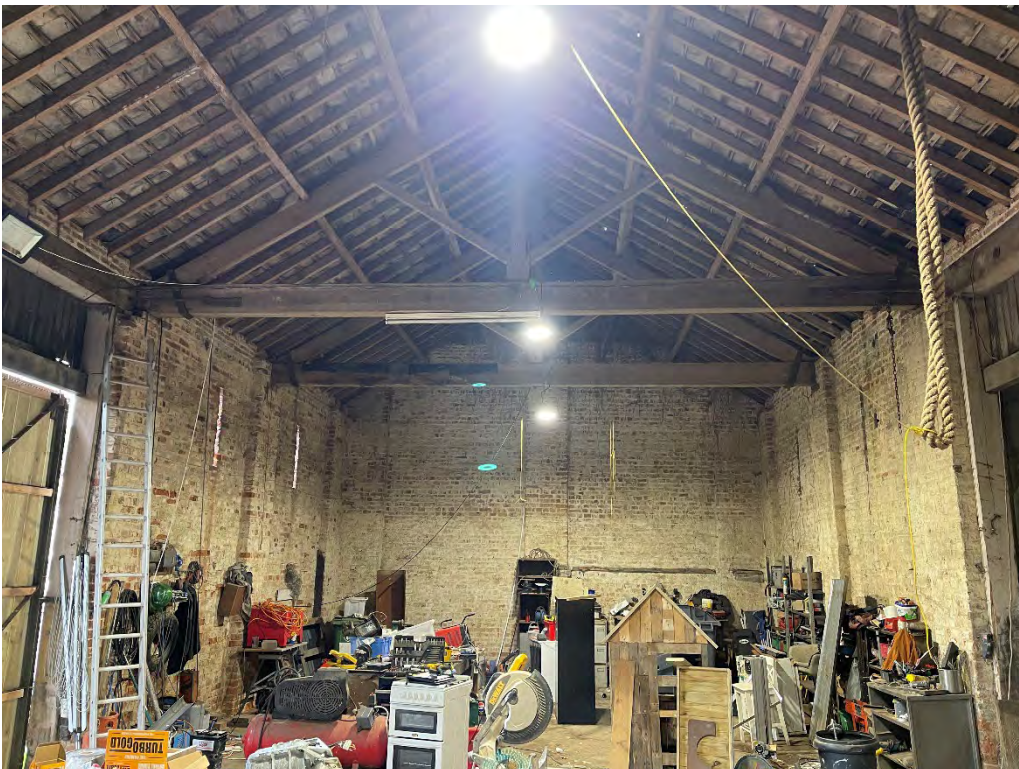
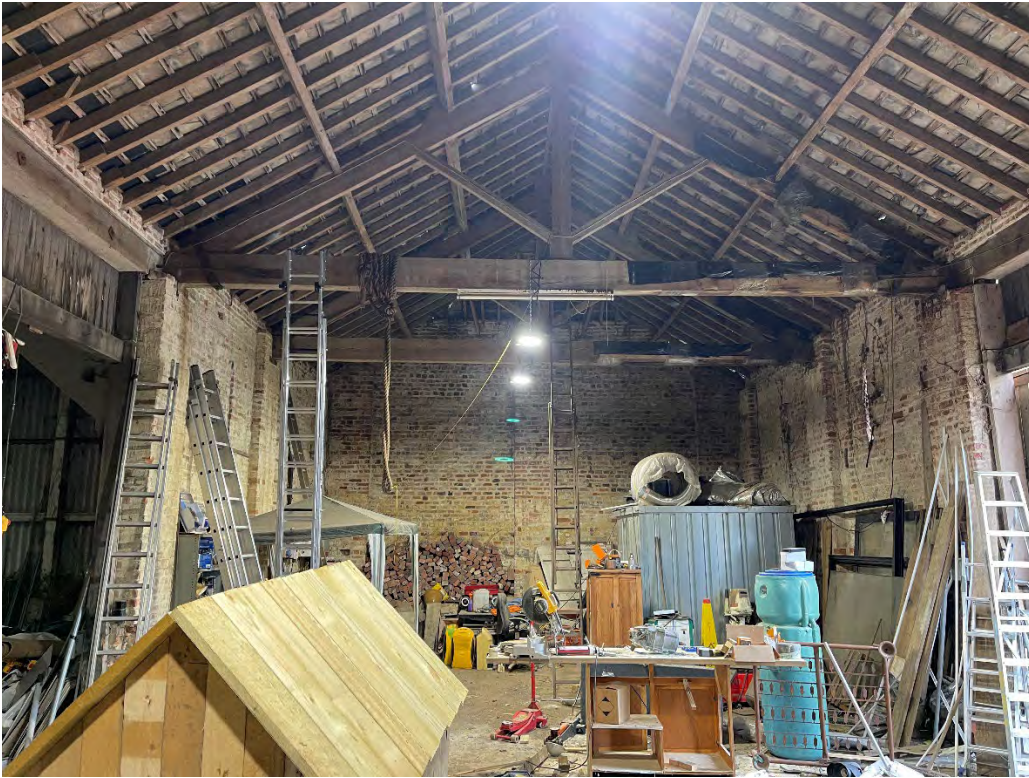
The roof construction to the front barn was a slate tile finish on a traditional timber cut roof which was supported on timber purlins which in turn were supported on traditional king post oak trusses. When viewed from ground level, the timber rafters and purlins seemed to be in good condition with no signs of structural failures present. 2 of the 4 oak trusses present seemed to be in good condition, the other 2 oak trusses seemed to be in an ok condition. These 2 oak trusses seemed to be suffering from a little water damage to the ends of the bottom cord/cord/principal rafter feet (at the front end of the trusses). However, the overall condition of the roof is good with no apparent structural failures identified (Refer to picture Nos. 20 & 21).

The roof to Barn 2 was also in good working order. All oak king post trusses were generally in good condition apart from 2 where their bearing ends which sit within/on the front external wall seem to have a little water damage and may require addressing. As our inspection was at ground level it was hard to depict the actual cause and severity of the damage but as a worst case the ends of the bottom cord and feet of the main principal rafter may require to be cut out and replaced.

Similar to that to Barn 1 roof, strengthening maybe required to the roof timbers and trusses due to possible extra loading from additional finishing materials for the proposed conversion. Also, as our inspection was undertaken at ground level it is advised that more intrusive investigations are undertaken to ascertain the actual condition of all structural roof members to both roofs.

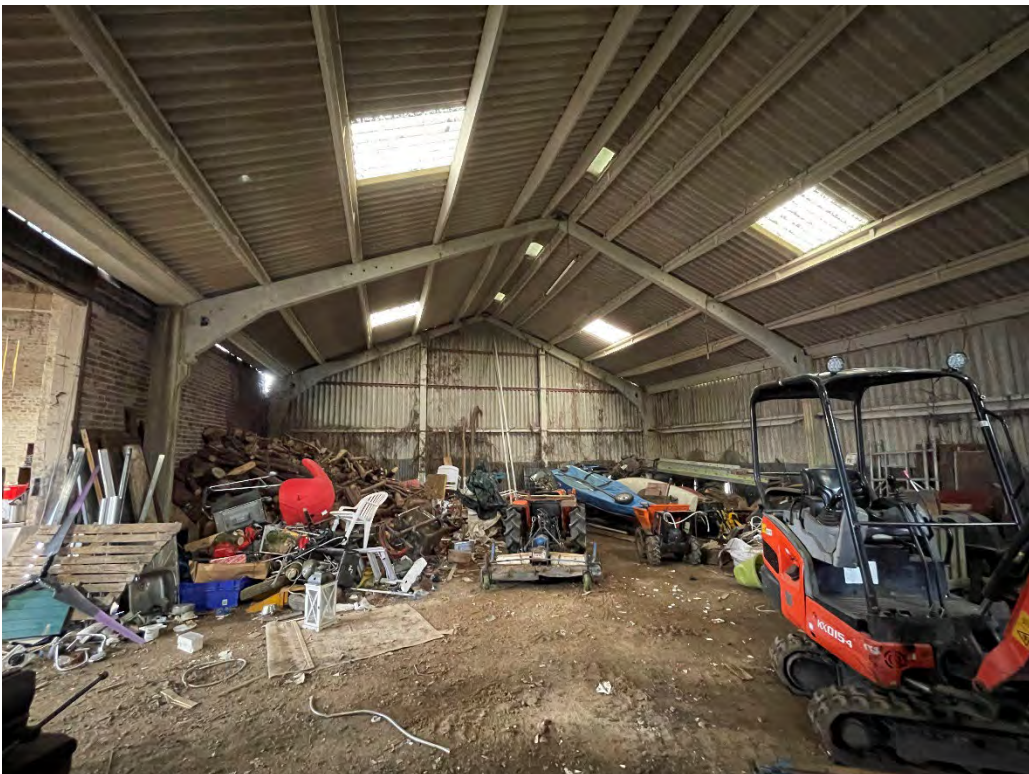
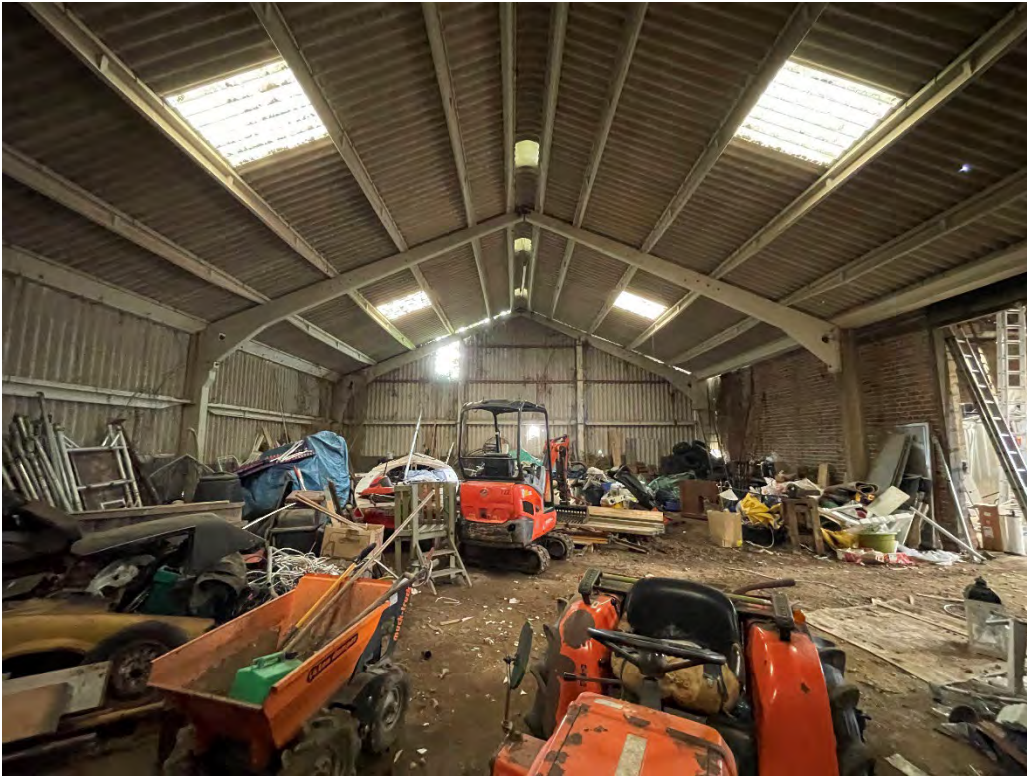
The roof construction to the rear barn was cementitious profile sheets on concrete purlins. All purlins were then supported off the concrete portal frames. The roof is in very good condition with no structural failures present (Refer to picture Nos. 22 & 23).
