9<sup>th</sup> May 2025

ABMH Ref: ABF2239/AOB

**Morrells Farmhouse, Lagness, West Sussex  
Structural Assessment Report of 2 Existing Barn Buildings.**

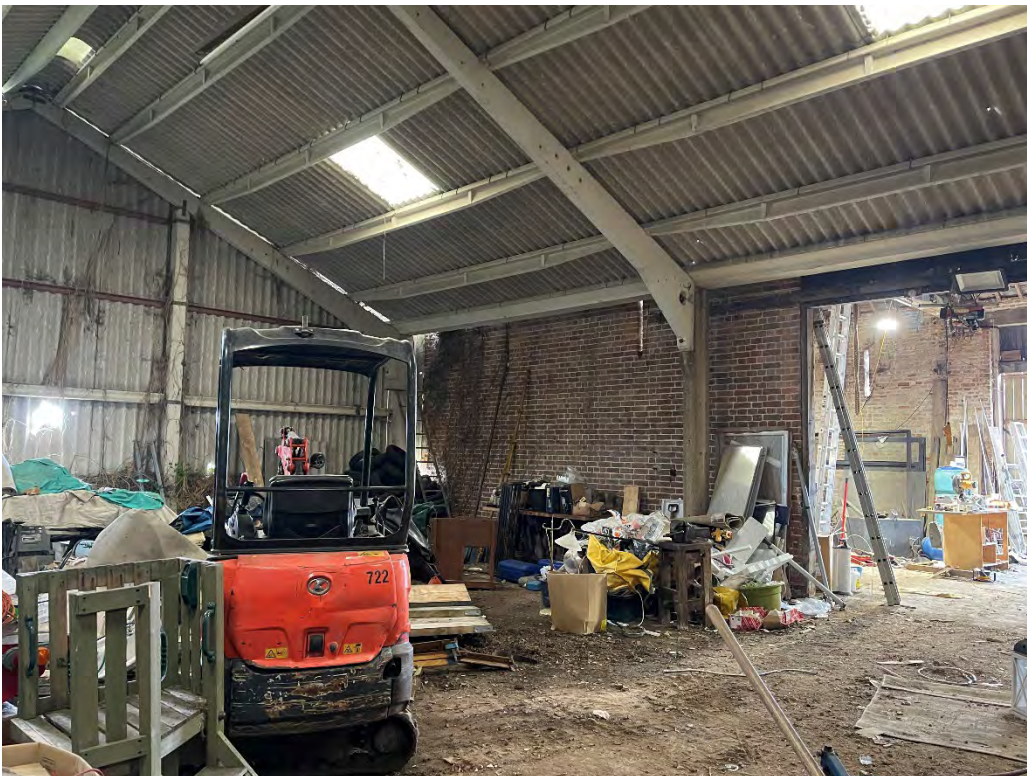
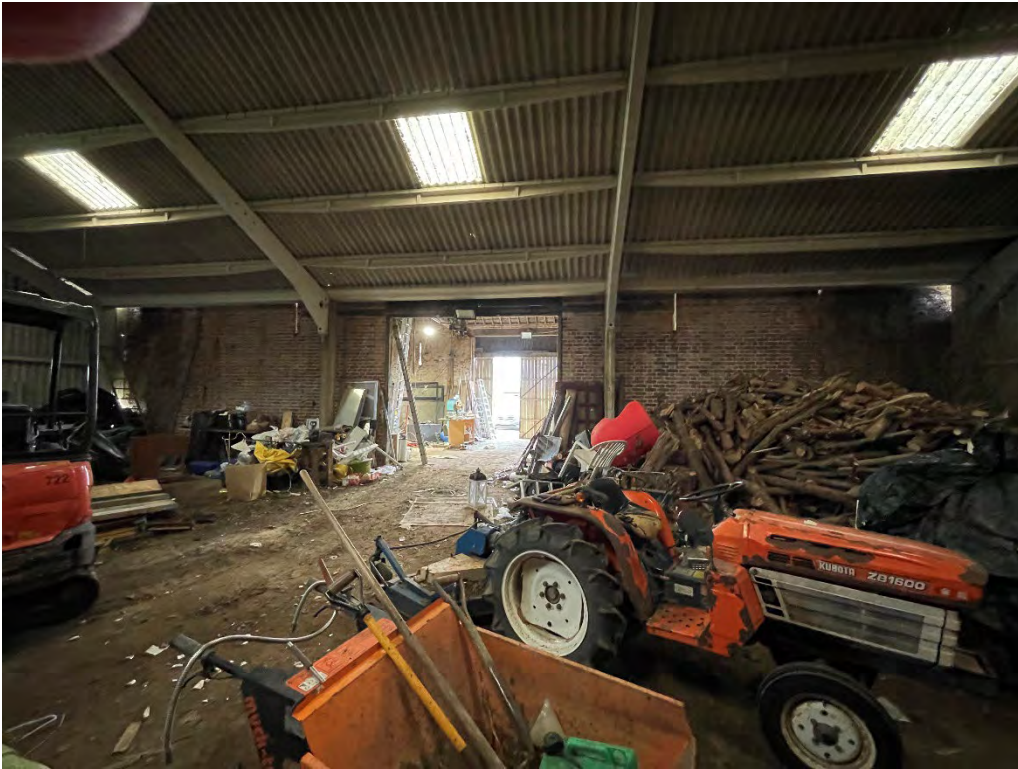
The front part of the barn was assumed as a ground bearing slab, whereas the rear part of the part had no ground floor structural finish, it was just compacted soil. The ground bearing slab that was visible to the front part of the barn seemed to be in good condition with no structural failures present (Refer to picture Nos. 24 & 25).

The ground floor to Barn 1 and the front part of Barn 2 seemed to be in good working order and was deemed as structural sound. However, in both barns the visual inspection was limited due to the number of equipment/materials present within the buildings. The ground floor to the rear part of Barn 2 was just compacted soil, so we advise that a suitably design ground bearing slab was provided for the proposed conversion works.

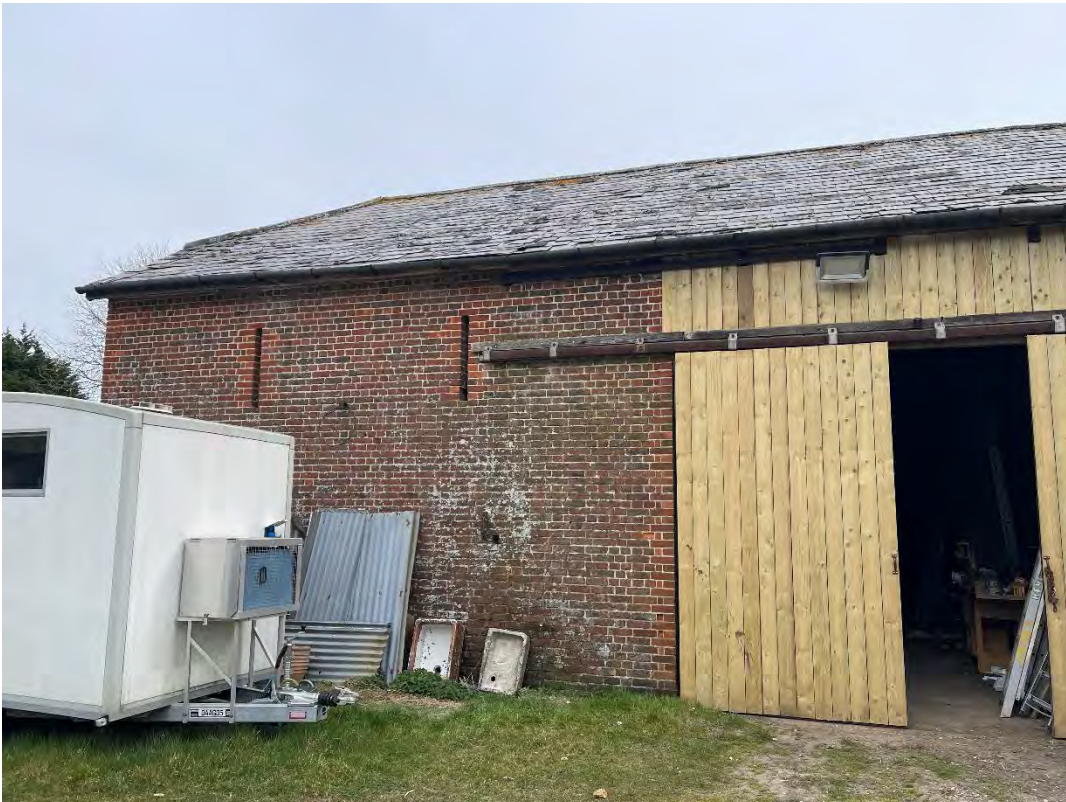
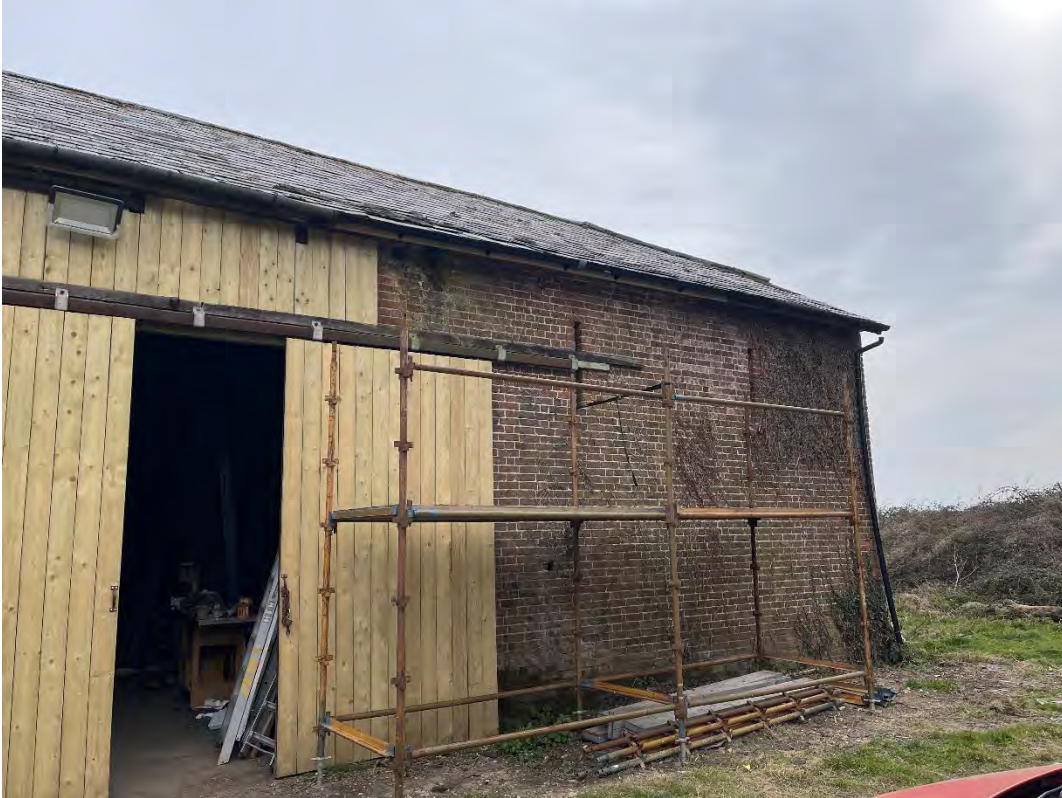
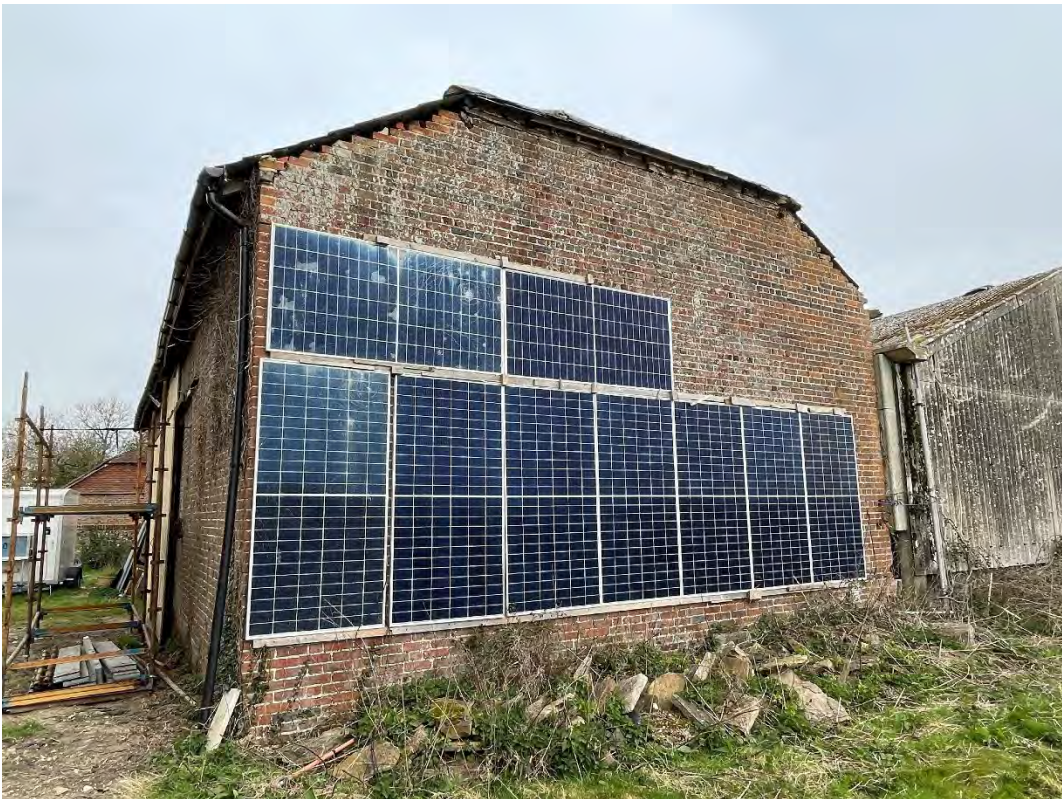
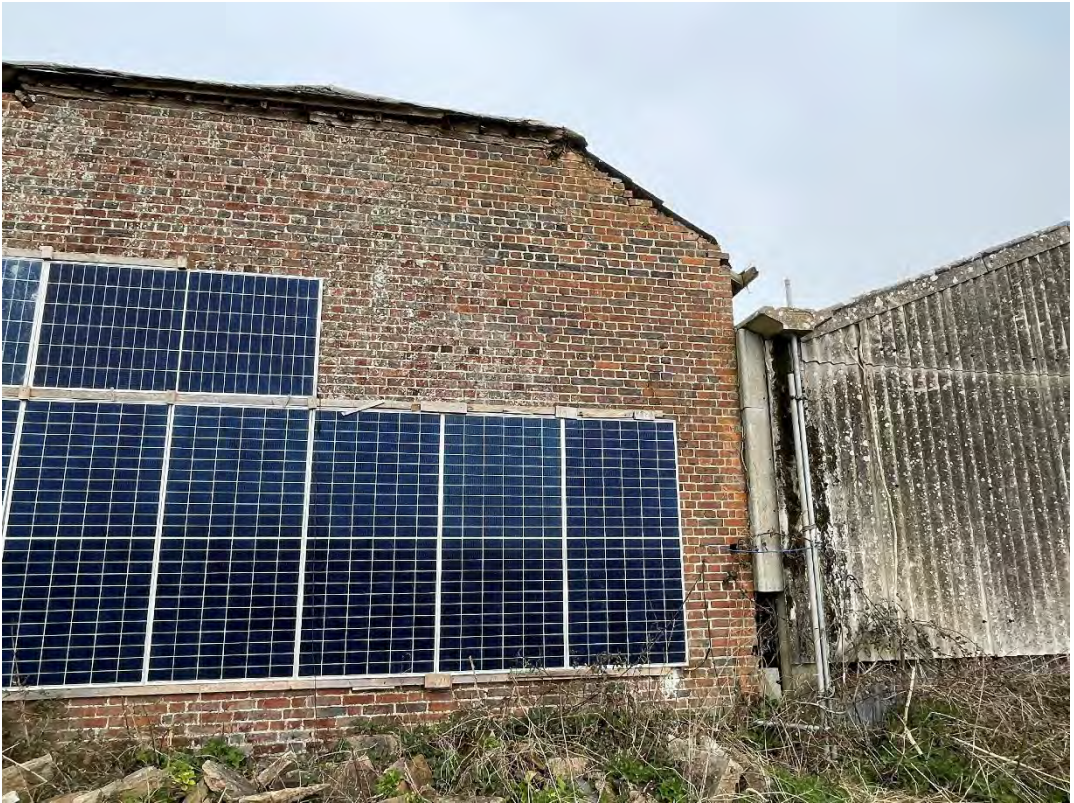
The external walls to the front barn were 280mm wide solid brick masonry, with 750x380mm piers on each side of the barn openings, at corners, centre of gable walls and centre of each wall panel to the front and rear walls. The piers centred on the wall panels to the front and rear walls and on either side of the barn door openings also support the oak truss bearing ends. In between the piers to the front and rear elevations were 100mm wide x 900mm high openings (Refer to picture Nos. 26-29).

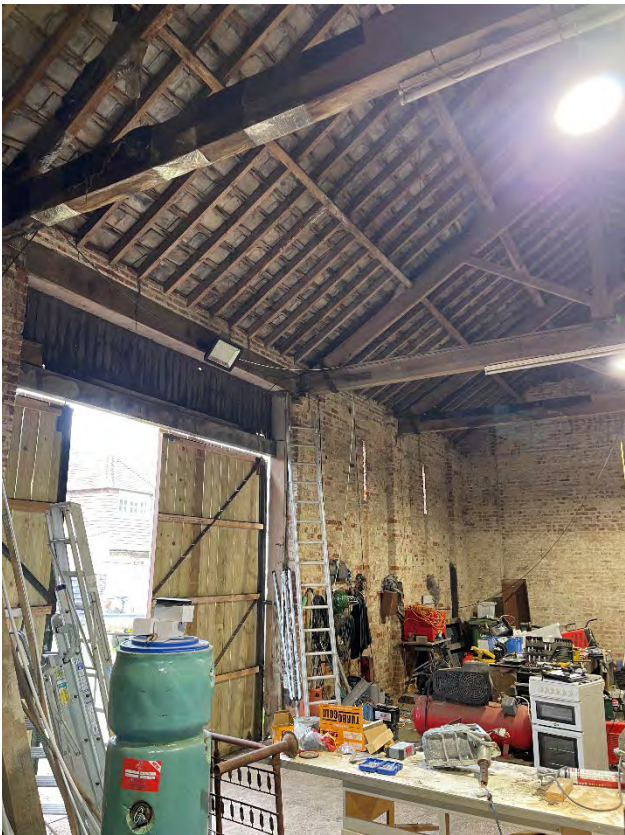
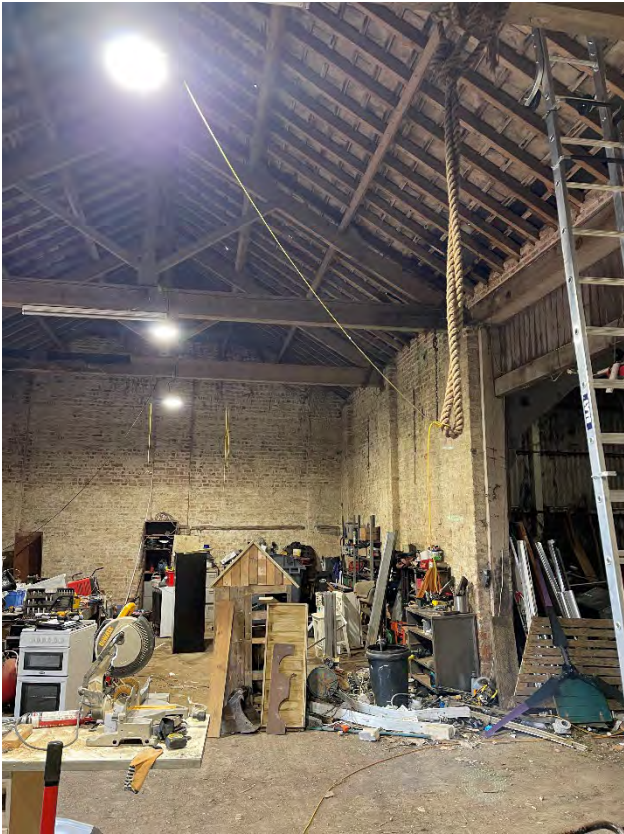
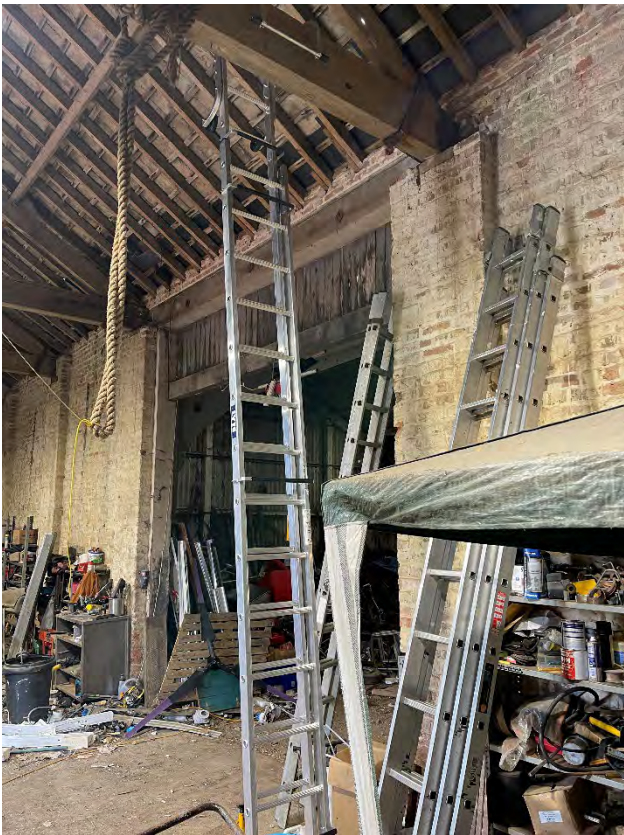
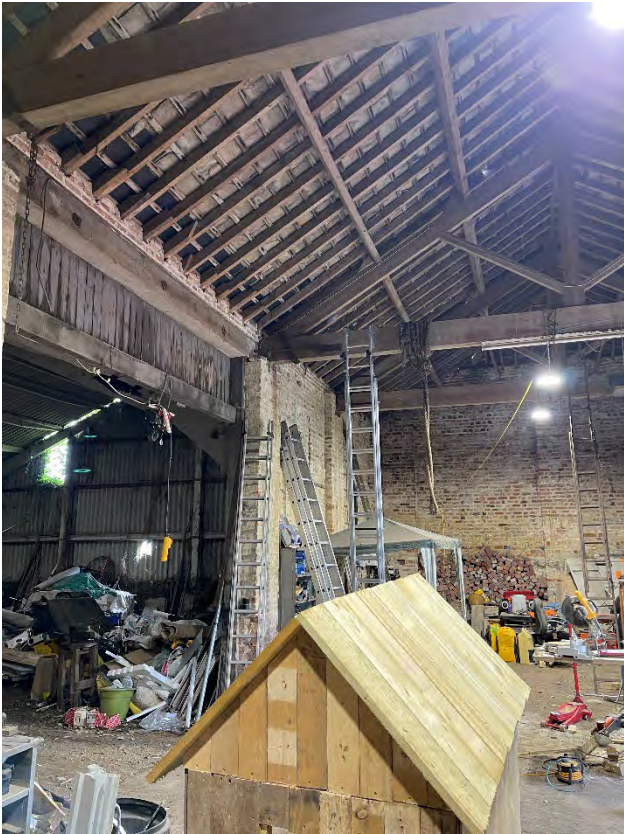
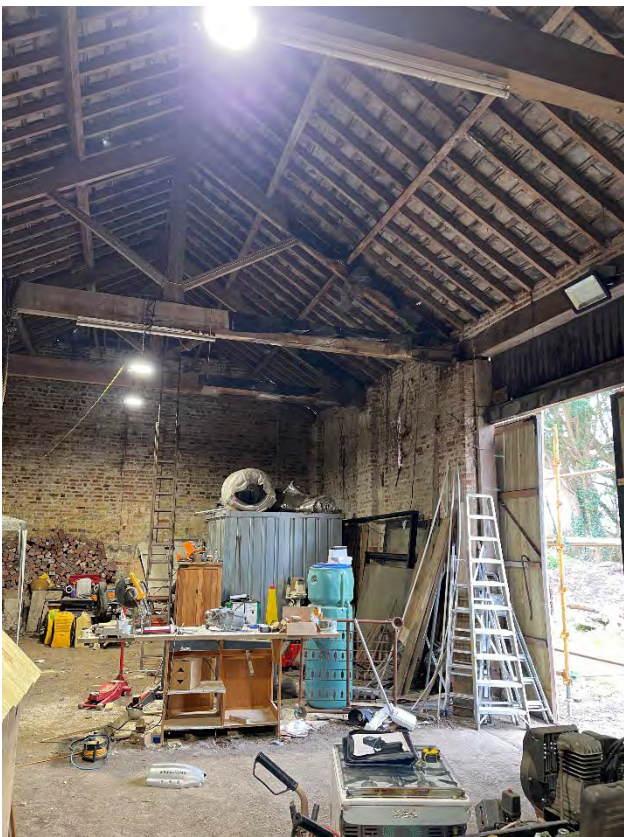
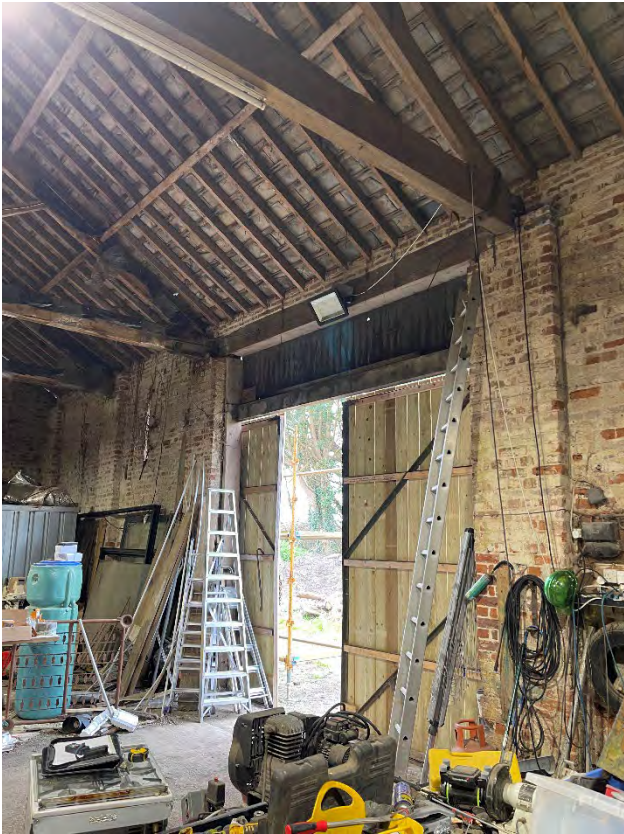
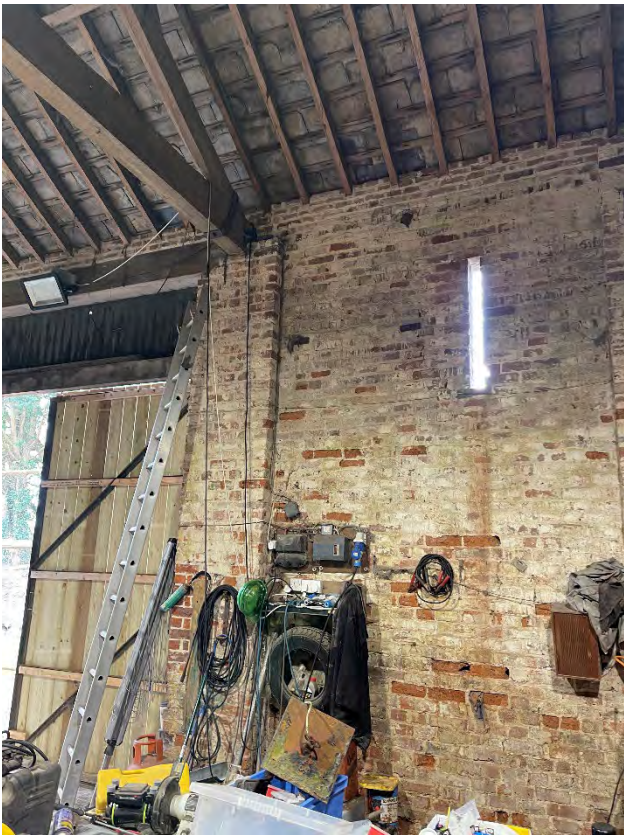
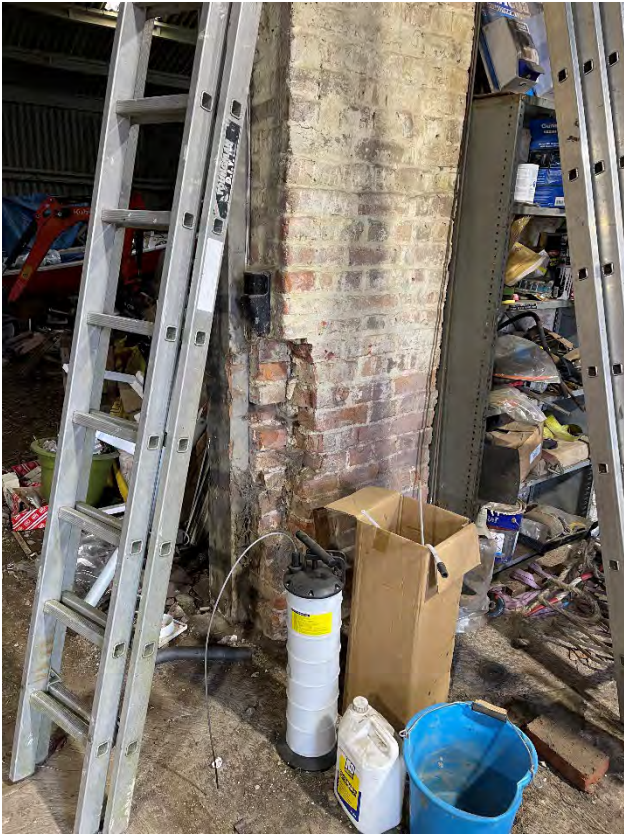
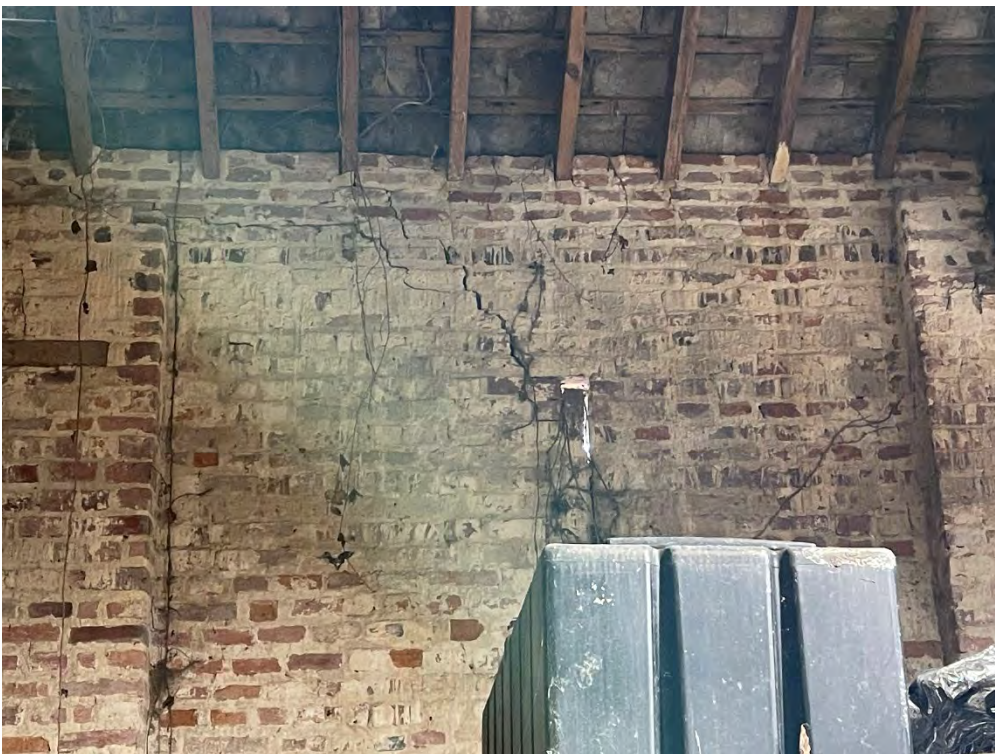
All walls internally were covered with materials so only 60% of the wall areas were visible. It was noted that above the 100x900mm opening on the front wall panel there were 2 diagonal 2-5mm cracks that emanate from the top left hand corner of the opening and terminate at roof level. We believe that these cracks were caused by past vegetation ingress. It was also noted that there was damage to the bottom of the brick pier which is to the side of the rear barn door opening. We believe that this damage was caused by impact from a vehicle. Except for the above mentioned and with that what was visible all external walls externally and internally were in good working order with no structural failures present (Refer to picture Nos. 30-38).

The external walls to Barn 2, for its age, were in a very good condition. There were 2 areas of concern that require addressing. The first area was the small amount of cracking from/above the 100x900mm opening on the front elevation, which we believe may have occurred due to past vegetation ingress (which has now been removed). Our advice to remedy this area is to provide 'Helifix' bars across the cracks to strengthen this area. Then re-mortar where required. The second area was the bricks that were missing to the bottom of the right hand pier (as you look from inside to out) of the rear barn door opening. We believe that these bricks were missing due to impact damage from a vehicle. We advise that the pier is rebuilt locally in this area to ensure the continued structural integrity of the pier.

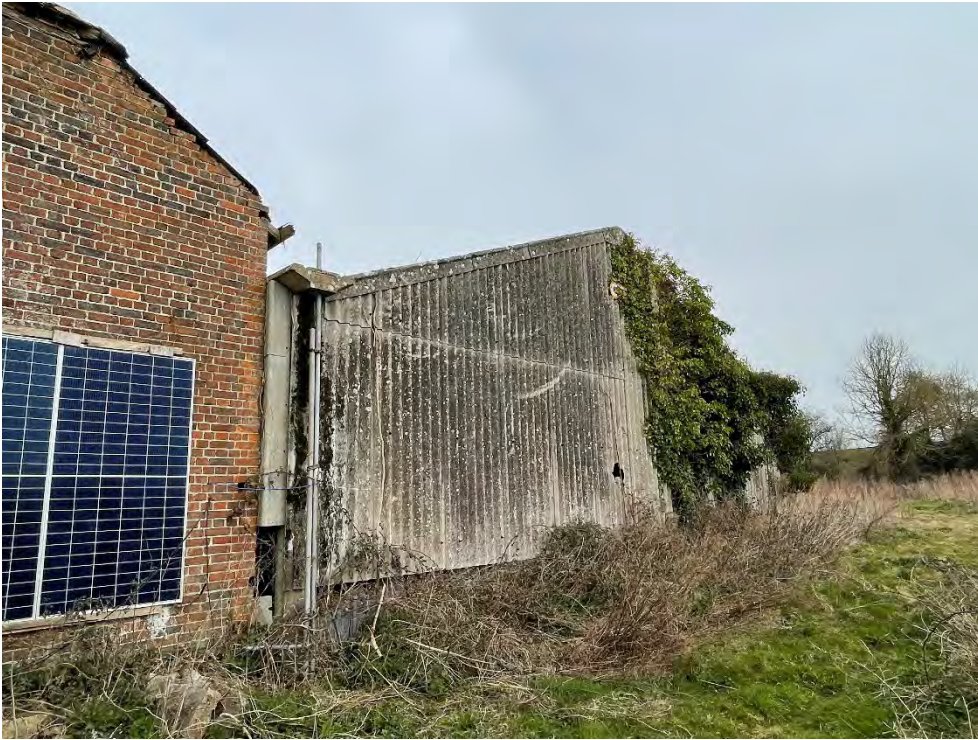
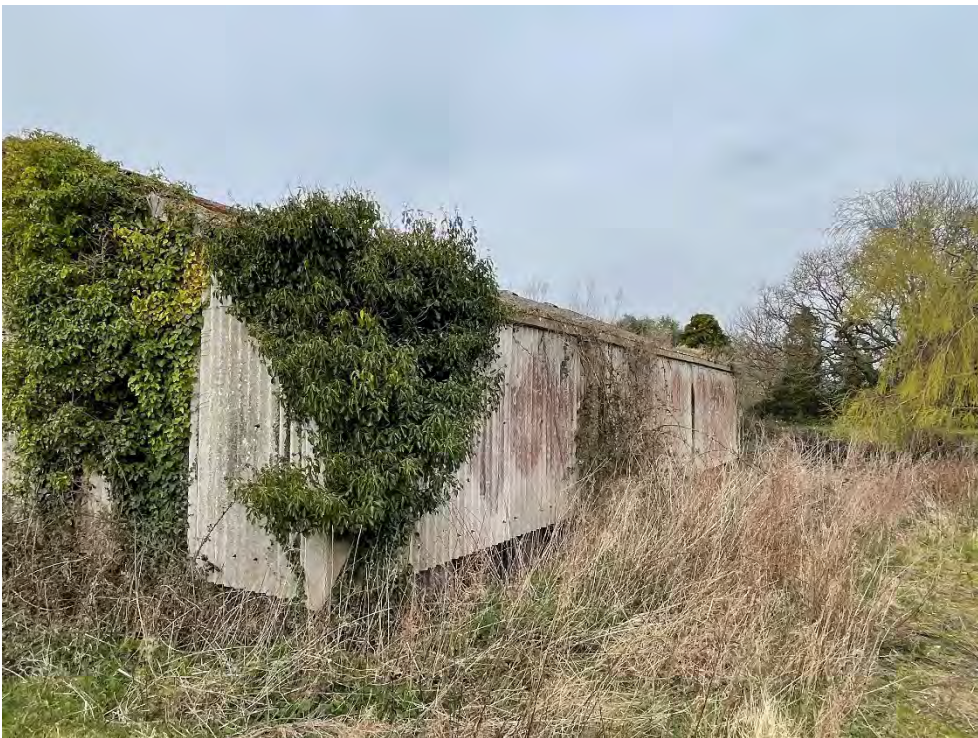
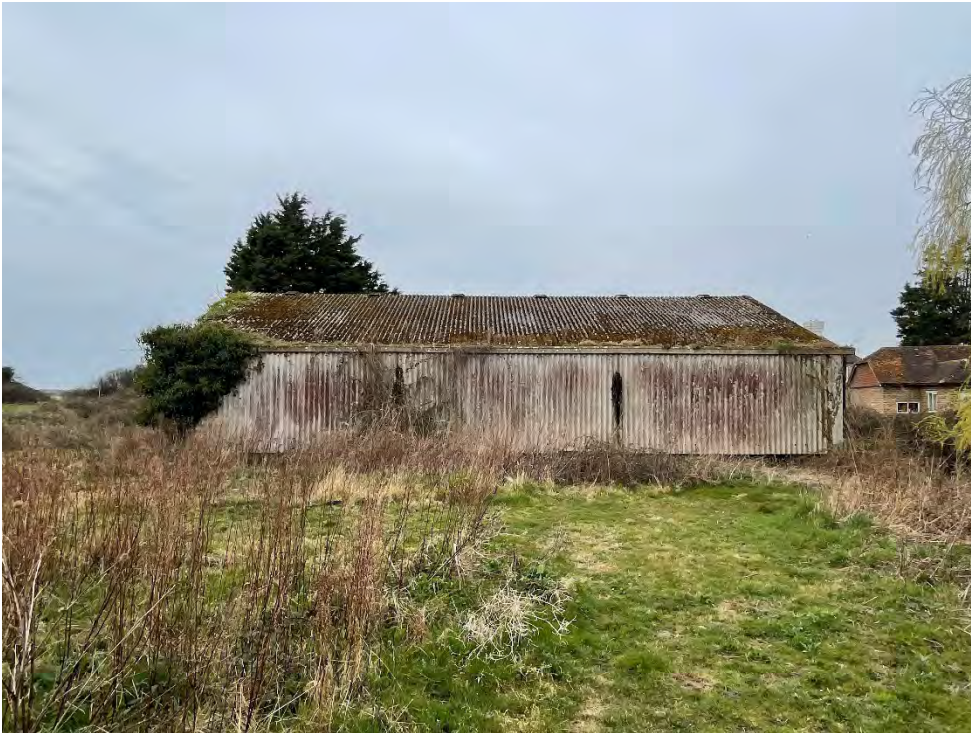
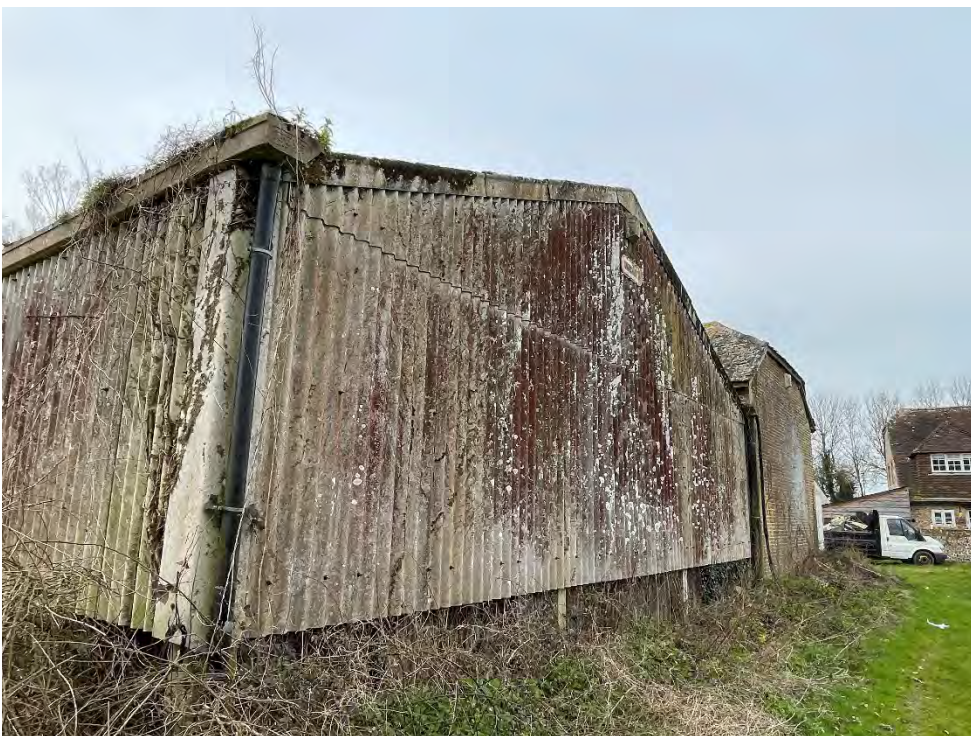
The rear barn, as stated above, was a concrete portal frame. Its external walls consisted of concrete rails that fixed to the portal frames and had a Cementitious profile sheet to the top 2 thirds of the wall with metal profile sheet to the bottom third of the wall. All rails that were visible and present were in good working order with no structural failures present (Refer to picture Nos. 39-42).
