**SITE NAME:** Summer Lane, Pagham  
**REPORT NAME:** Inspection of watercourse along northern boundary  
**DATE:** 02/12/2019  
**REF:** DSM/E4761/17564

## **Introduction**

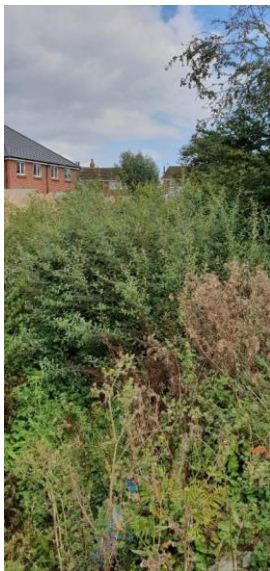
Currently heavily overgrown with vegetation both within and along the banks of the ditch. Evidence of side slopes erosion and resulting in settlement within the base of the ditch.

**Photo 1 -looking east**

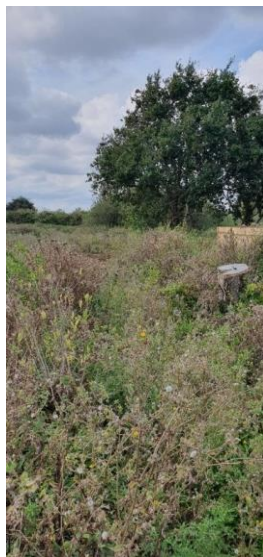
**Photo 2 – looking west**

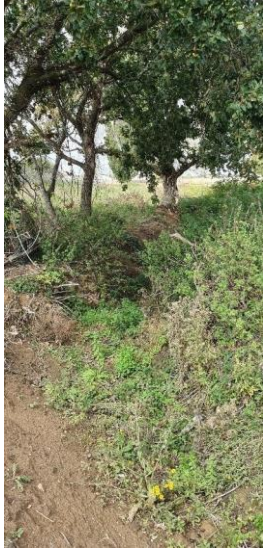
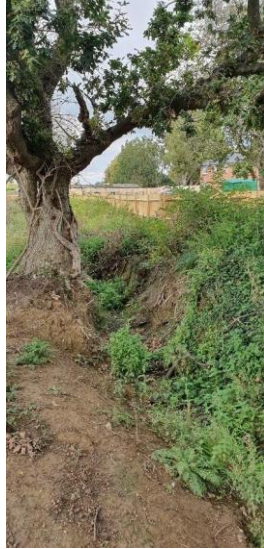
Currently heavily overgrown with vegetation both within and along the banks of the ditch. Evidence of heavy side slopes erosion and resulting in settlement within the base of the ditch. The spoil left by previous excavation works on the site side of the ditch has made the ground uneven.

**Photo 3& 4 -looking north**

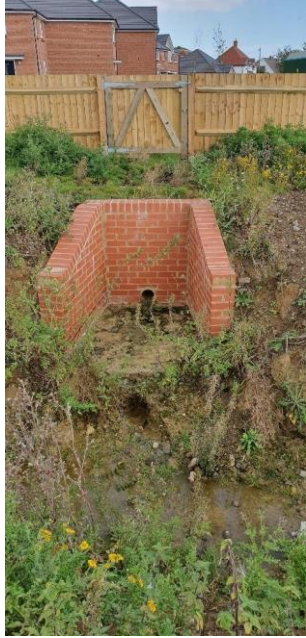
Previous clearance works appear to have caused undermining of the outfall foundation from the Crayfern development site to the north. There is erosion either side of headwall due to unsupported slopes

**Photo 5 -looking east towards Crayfern Development**

The outfalls from the Crayfern development should be assessed for stability by the developers / owners of this apparatus.

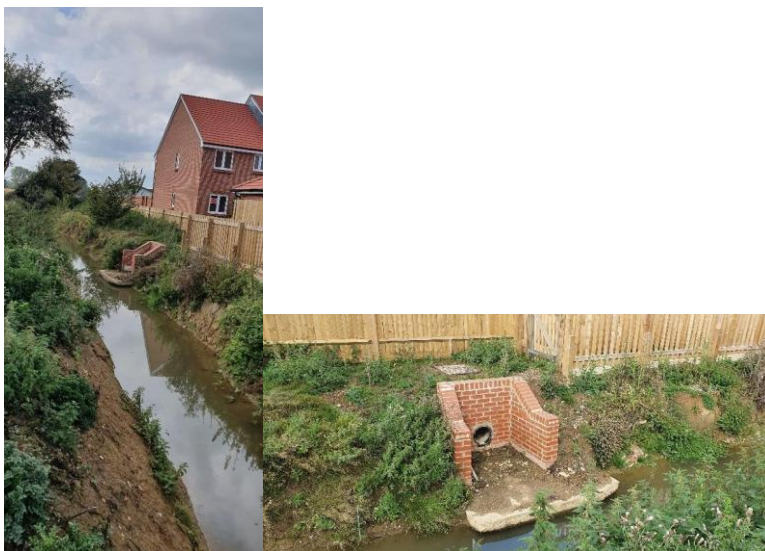
Previous clearance works appear to have caused undermining of outfall foundation and increased erosion. Erosion either side of headwall evident due to unsupported slopes. Ponding water due to base of ditch being below the existing outfall pipe. The ditch is heavily overgrown with vegetation and site side of ditch is very uneven. Erosion appears to be ongoing and likely that slopes have yet to stabilise under gravity

**Photo 6&7 -looking west and north towards Crayfern Development**

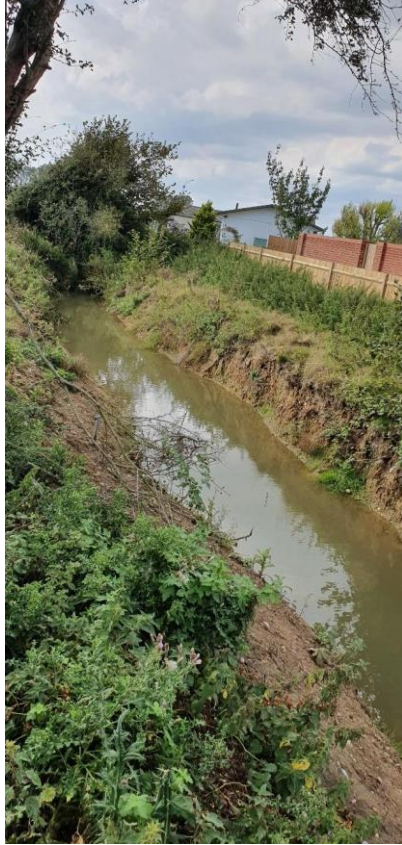
The side slopes of the ditch are heavily eroded and evidence of sedimentation at the base of the ditch. Water is ponding here due to the ditch base being below the existing outfall. The edge of the ditch is uneven as a result of the excavation arisings being placed here without adequate compaction.

Photo 8-looking west

The ditch along the north boundary will require the removal of sedimentation at the base.
