**Project Name:** NEWLANDS BARN.PAGHAM ROAD.CHICHESTER.PO20 1LL  
**Project Description:** TO CARRY OUT CCTV SURVEY AT THE ABOVE ADDRESS  
**Project Number:** 02  
**Project Status:** Complete  
**Project Date:** 10/09/2025  
**Inspection Standard:** MSCC5 Sewers & Drainage GB (SRM5 Scoring)

| Section Item 1: RESEVOIR > MH 1 (RESEVOIRX) ..... | 1 |
| Section Item 2: MH 1 > DITCH (MH 1X) ..... | 3 |
| Section Item 3: MH 1 > DITCH (MH 1X) ..... | 6 |

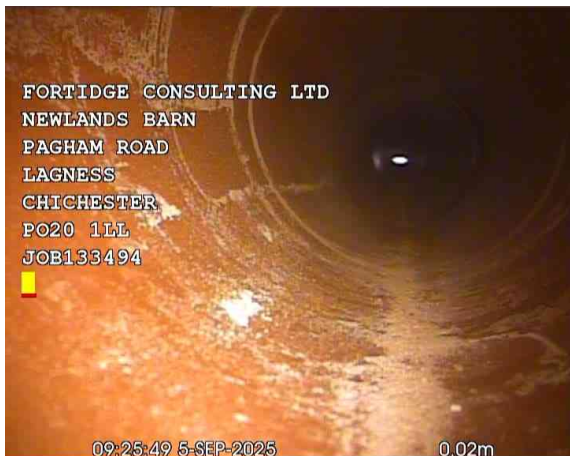
RESEVOIRX\_9fe337a5-89c3-48f7-b02e-262ae1b3612f\_2025  
 0910\_083711\_725.jpg, 00:00:00, 0.00 m  
 Start node, manhole, reference: MH 1

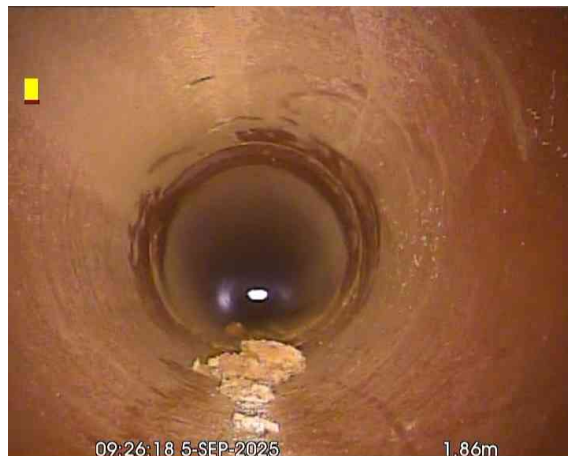
<table><tr><td>0.00</td><td>MH</td><td>Start node, manhole, reference: MH 1</td><td>00:00:00</td><td>RESEVOI<br/>RX_9fe33<br/>7a5-89c3-</td><td></td></tr><tr><td>1.86</td><td>DER</td><td>Settled deposits, coarse, 5% cross-sectional area loss</td><td>00:00:28</td><td>RESEVOI<br/>RX_7b2bf<br/>5ca-8bb9-</td><td>3</td></tr></table>

RESEVOIRX\_7b2bf5ca-8bb9-4040-861a-a01e70100290\_202  
 50910\_083712\_713.jpg, 00:00:28, 1.86 m  
 Settled deposits, coarse, 5% cross-sectional area loss

**Recommendations:** HPWJ LINE

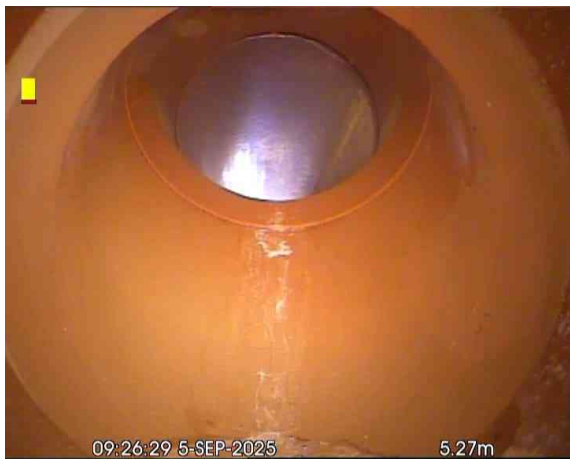
RESEVOIRX\_10982a43-b268-4974-9c2a-bfa0fc3219ce\_2025  
 0910\_083715\_578.jpg, 00:00:40, 5.14 m  
 Line deviates up

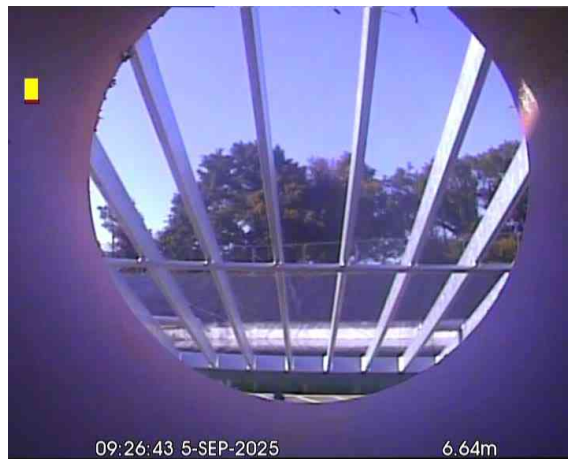
RESEVOIRX\_bdc79af6-eead-4f66-b5d9-a2f8449b14dd\_2025  
 0910\_083717\_304.jpg, 00:00:54, 6.64 m  
 Finish node, outfall, reference: RESEVOIR

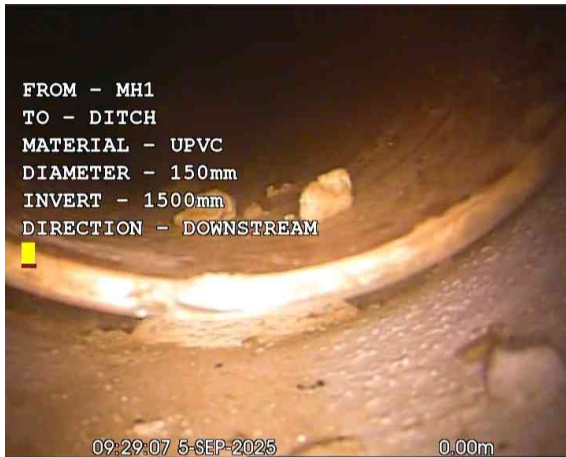
1X\_f757e2f3-1870-403c-a74d-424cd7183964\_20250910\_083  
 732\_263.jpg, 00:00:00, 0.00 m  
 Start node, manhole, reference: MH 1

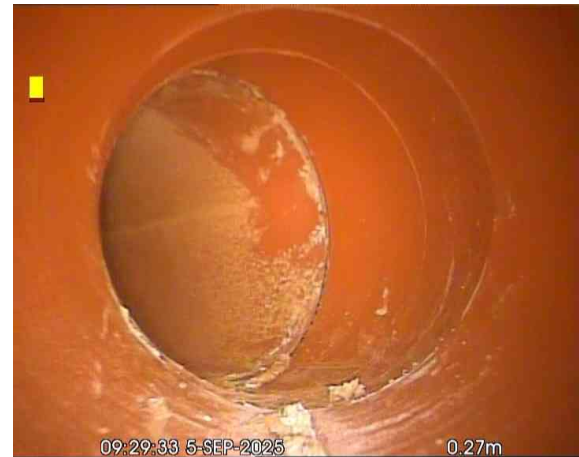
1X\_0b545adb-3ee2-445e-aaaf-3c439fe1e102\_20250910\_083  
 733\_508.jpg, 00:00:26, 0.27 m  
 Line deviates left

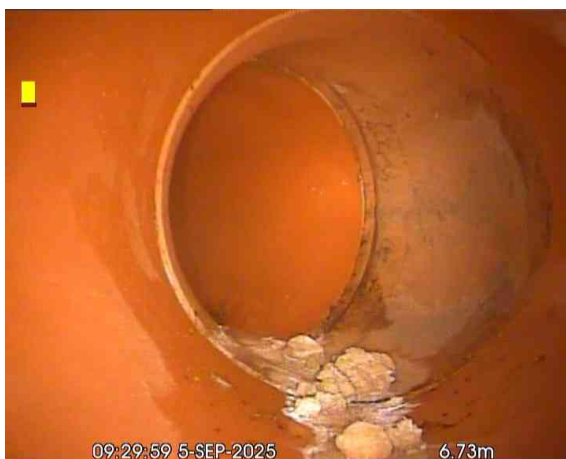
1X\_899adbea-8edf-4685-ba78-cb0eb3b2eaa7\_20250910\_083  
 734\_906.jpg, 00:00:52, 6.73 m  
 Line deviates left

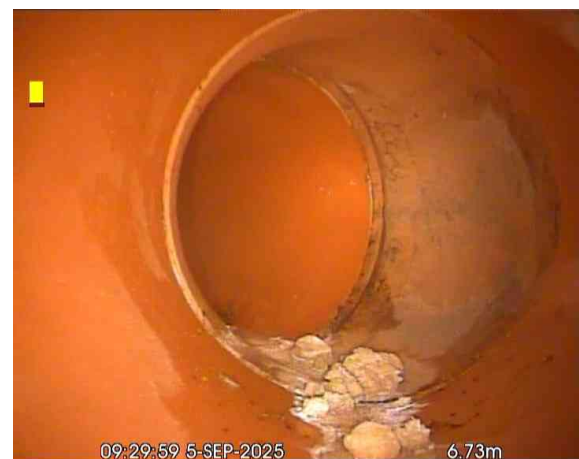
| Scale: | 1:437 | Position [m] | Code | Observation | MPEG | Photo | Grade |
|---|---|---|---|---|---|---|---|
| | | 6.73 | DER | Settled deposits, coarse, 5% cross-sectional area loss | 00:00:52 | MH 1X_400b3bcf-f6eb-4 | 3 |

1X\_400b3bcf-f6eb-4e3d-a49f-2b9b98818e11\_20250910\_0837  
 38\_359.jpg, 00:00:52, 6.73 m  
 Settled deposits, coarse, 5% cross-sectional area loss

| <b>Recommendations:</b> HPWJ LINE | | | | | |

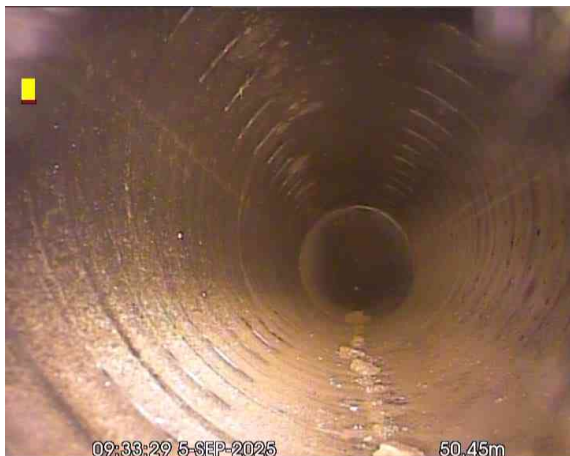
| Scale: | 1:437 | Position [m] | Code | Observation | MPEG | Photo | Grade |
|---|---|---|---|---|---|---|---|
| | | 50.45 | SA | Survey abandoned: OUT OF CABLE ON CAMERA / OVERLAP REQUIRED | 00:04:22 | MH 1X_42f2ea4b-785b-4 | |

1X\_42f2ea4b-785b-4033-9c04-602ced0f548b\_20250910\_083  
 744\_732.jpg, 00:04:22, 50.45 m  
 Survey abandoned

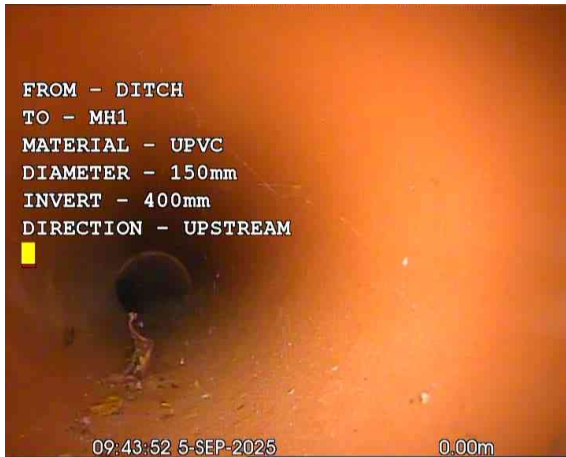
1X\_9f93a144-3e1f-404a-9338-1448f9bd1047\_20250910\_081  
 910\_536.jpg, 00:00:00, 0.00 m  
 Start node, outfall, reference: DITCH

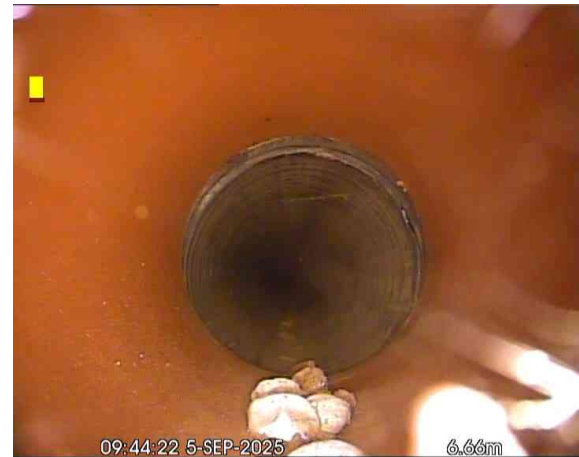
1X\_9f318266-dcf9-4122-a6a5-1def36d53334\_20250910\_0821  
 53\_683.jpg, 00:00:35, 6.66 m  
 Settled deposits, coarse, 5% cross-sectional area loss

**Comments:**
**Recommendations:** HPWJ LINE

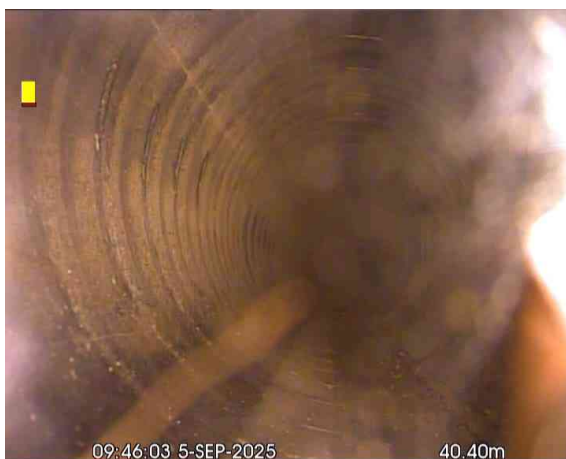
1X\_1a82b788-9620-421c-b9e2-9abaeff47a5d\_20250910\_082  
 152\_264.jpg, 00:02:16, 40.40 m  
 Survey abandoned
