**REPORT ON CONDITION OF  
LISTED BUILDING & ADJACENT BARN AT ENTRANCE TO  
CHURCH FARM HOLIDAY PARK**

**PAGHAM, NR CHICHESTER  
WEST SUSSEX**

CLIENT: BOURNE LEISURE LTD  
PROJECT REF: 2801/GL/MPJ  
ISSUE: ONE/REV.A  
DATE: 22 NOVEMBER 2007

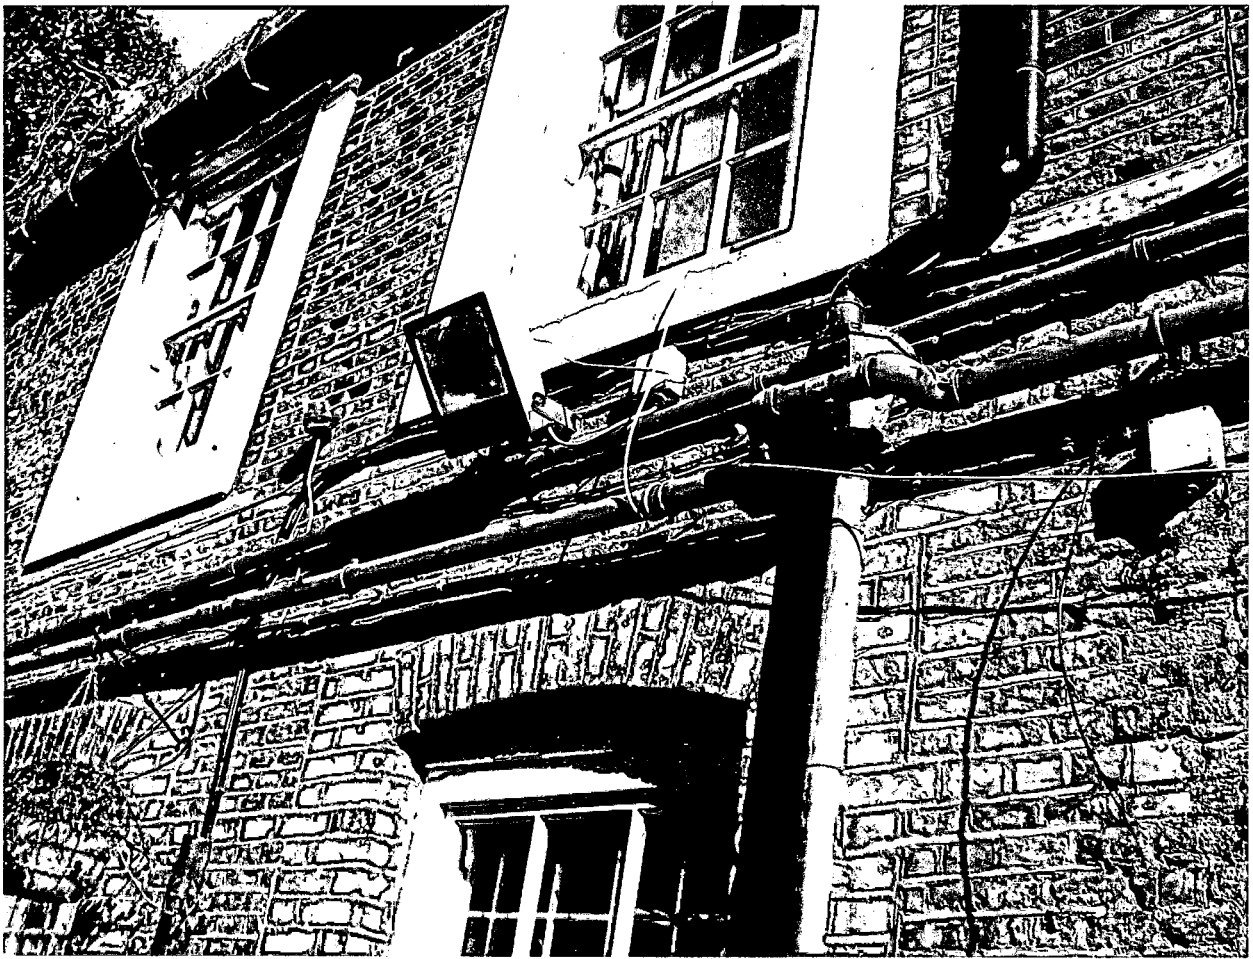
| 4.01.01 | Precast concrete paving is unsympathetic to the existing and original building but allows the construction of a simple access ramp with level threshold at the entrance opening. Paving abuts the building and because a rainwater downpipe discharges on to this area will allow ponding against original brickwork. (See Photograph P01) |

| 4.01.02 | It is not proposed to revise existing external paving at this time. External works to be incorporated in separate application for revised complex/access. Details to be confirmed. |

| 4.01.03 | Ramp to entrance door retained – allow for maximum 25mm threshold step/waterbar in original entrance opening. |

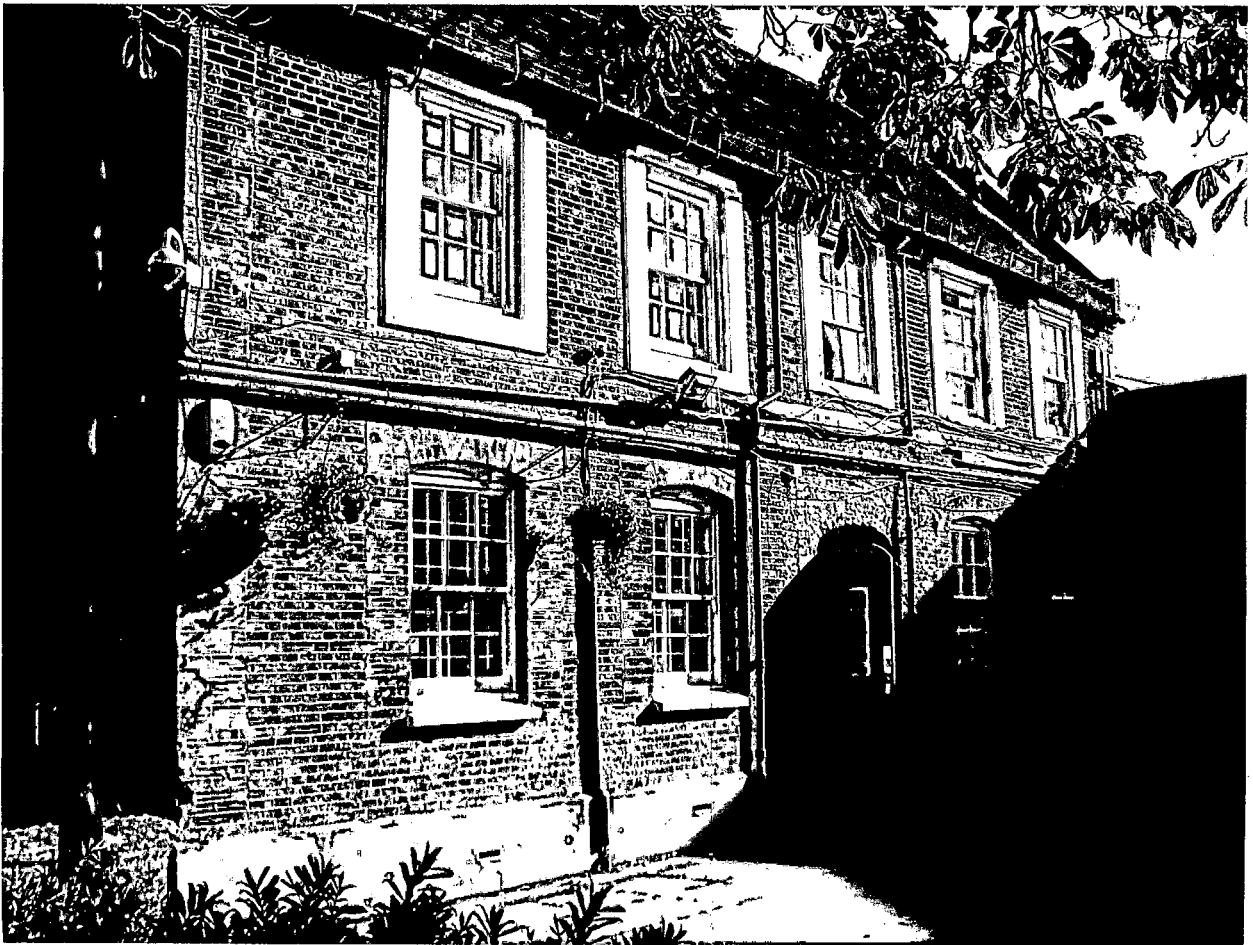
| 4.03.01 | There are numerous services fixed to this elevation. These are inappropriate. (See Photograph PO2) |

| 4.03.02 | Identify all live gas, water and electric, alarm, lighting, telephone and CCTV services and remove those which are redundant. |
| 4.03.03 | Relocate CCTV, alarm and floodlighting to be fixed on adjoining existing building. Positions to be agreed. |
| 4.03.04 | Existing gas and electric services to be removed from elevation and run in service duct or trench. Service risers on the listed building elevation will not be permitted. |
| 4.03.05 | Brickwork damaged by service penetrations or fixings is to be cut out and made good with bricks to match existing as far as possible. |

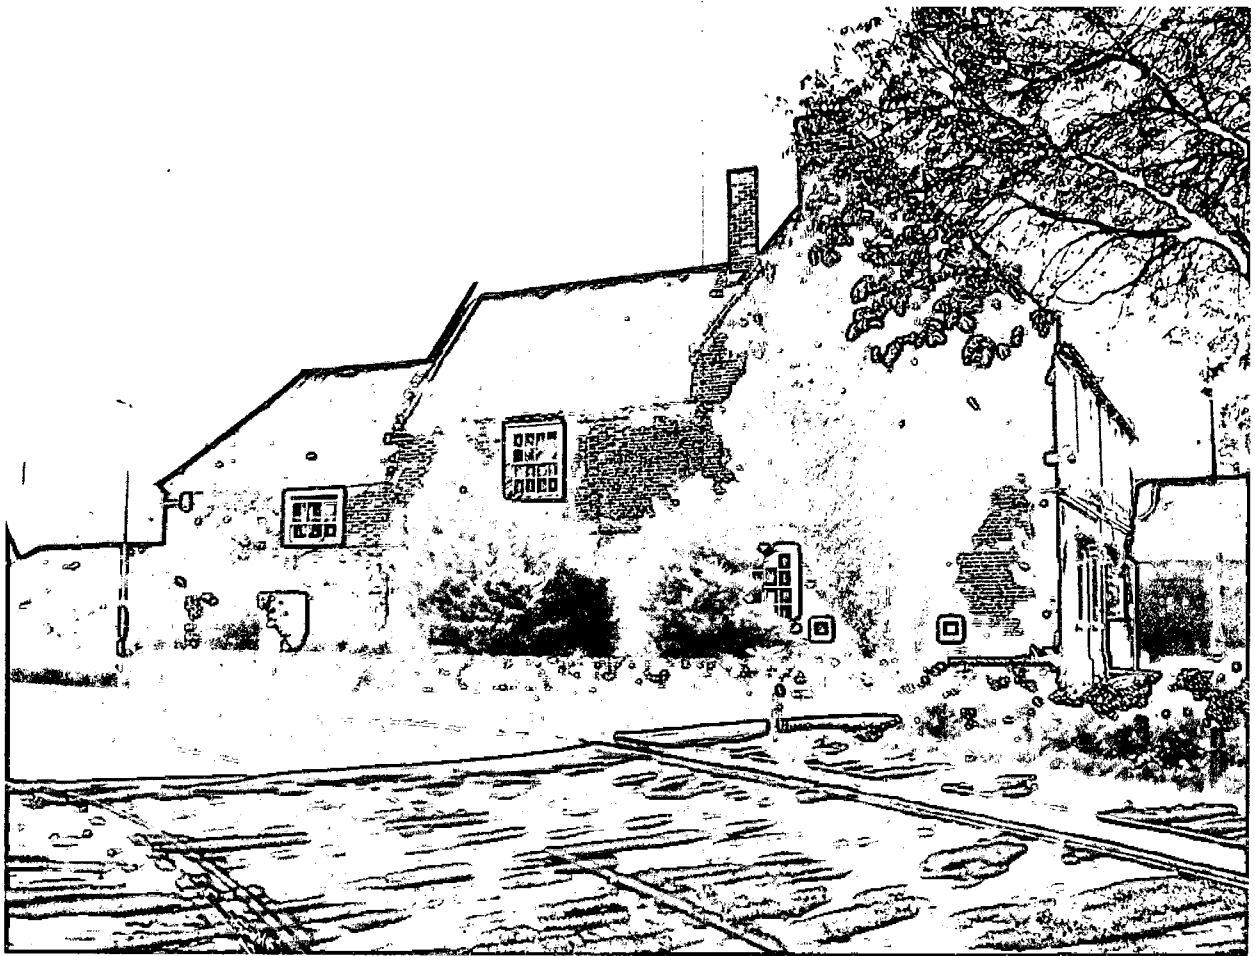
| 05.01.00 | While substantially concealed by conifer and climbing planting, brickwork and flint walling is generally in sound condition. |

| 05.01.01 | Removal of low level planting and cutting back of climbing planting, conifers as agreed on site to allow more detailed assessment of walling condition. Consider installation of chemical damp proof course by specialist if considered necessary. (See Photograph PO3) |

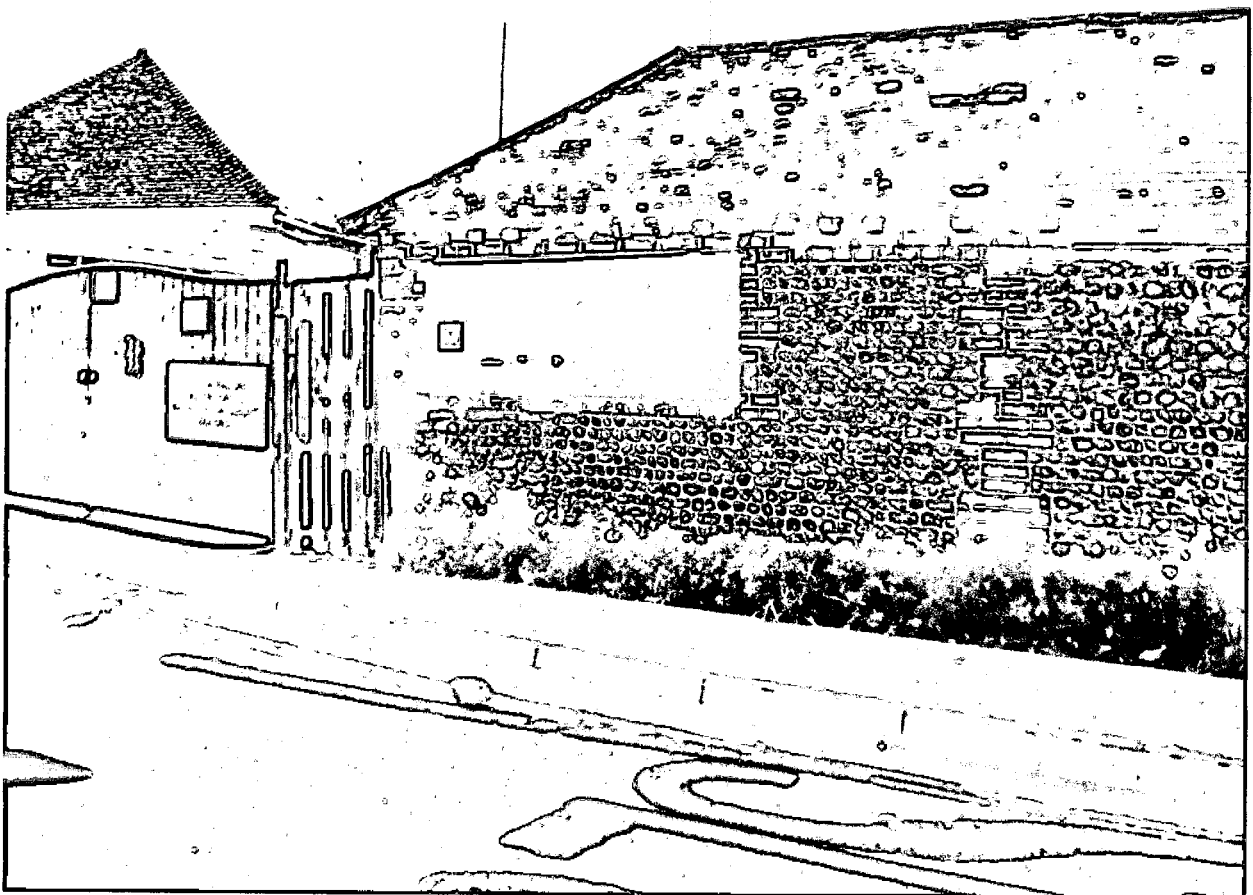
| 05.02.04 | It seems likely that some sanitary ware has been introduced in first floor accommodation. Waste pipework in upvc for same has been punched through walling. Investigate for and remove redundant pipework. |

| 05.02.05 | All damaged brickwork associated with installation of existing or removal of services to be made good. (See Photograph PO6) |

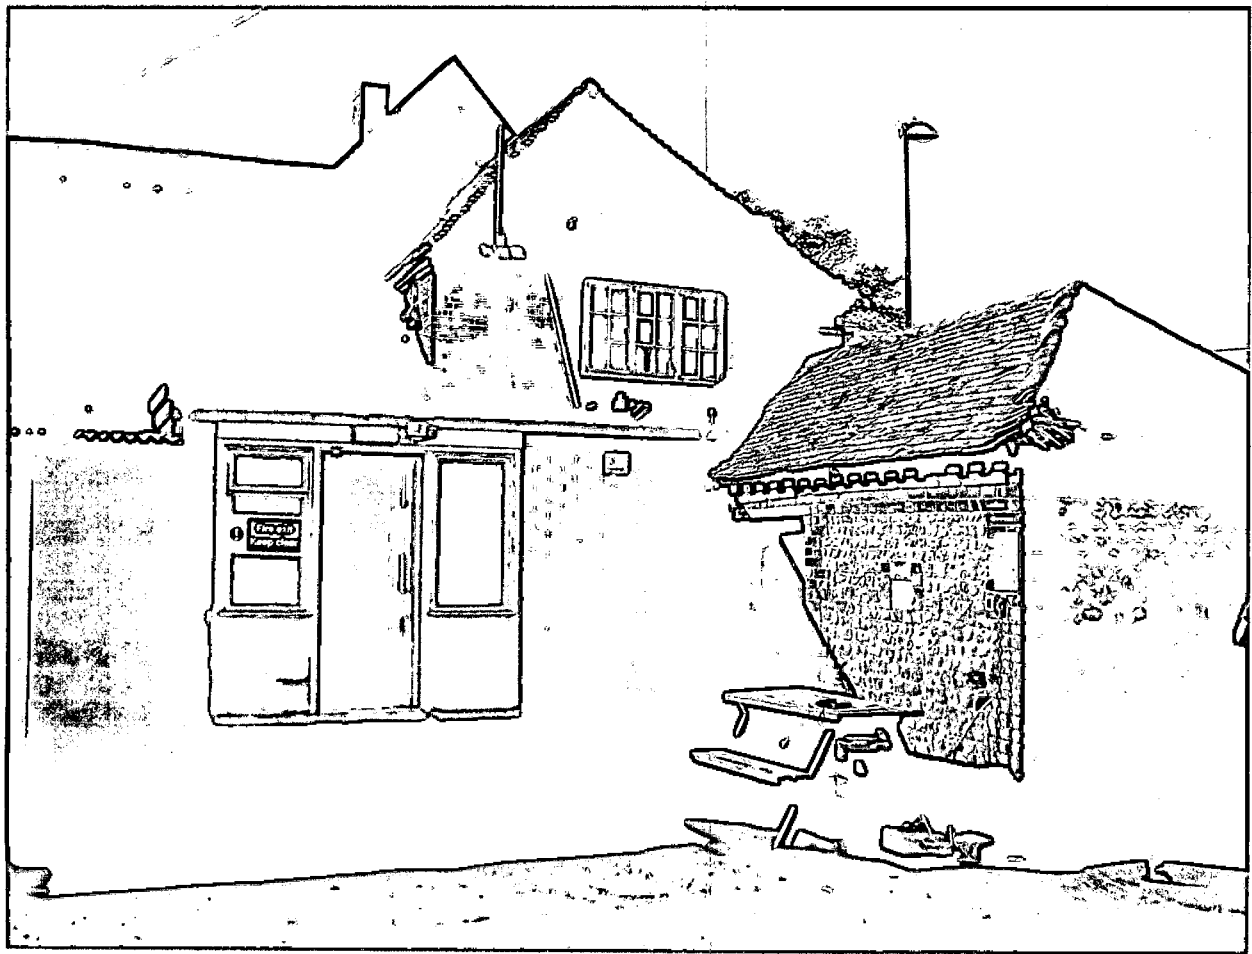
- 08.00.01 There is a fire escape route from first floor accommodation over flat roofs between and around plain tile pitched roofs. Flat roofs are generally built up felt and from visual inspection appear to be in sound condition.  
(Furniture laid out on these roofs risk damaging felt weathering/See Photograph PO7).
- 08.00.02 If flat roof areas are to be used for more than escape purposes, provide and lay promenade tiles, bedded in bitumen all in accordance with manufacturer's instructions. (See Photograph PO9)
- 08.00.03 Pitched roofs to upper stories while appearing sound have significant numbers of slipped, damaged or missing tiles where required repairs are to be made using clay plain tiles to match existing.
- 08.00.04 Box valley and concealed gutters are to be cleared of rubbish and debris.

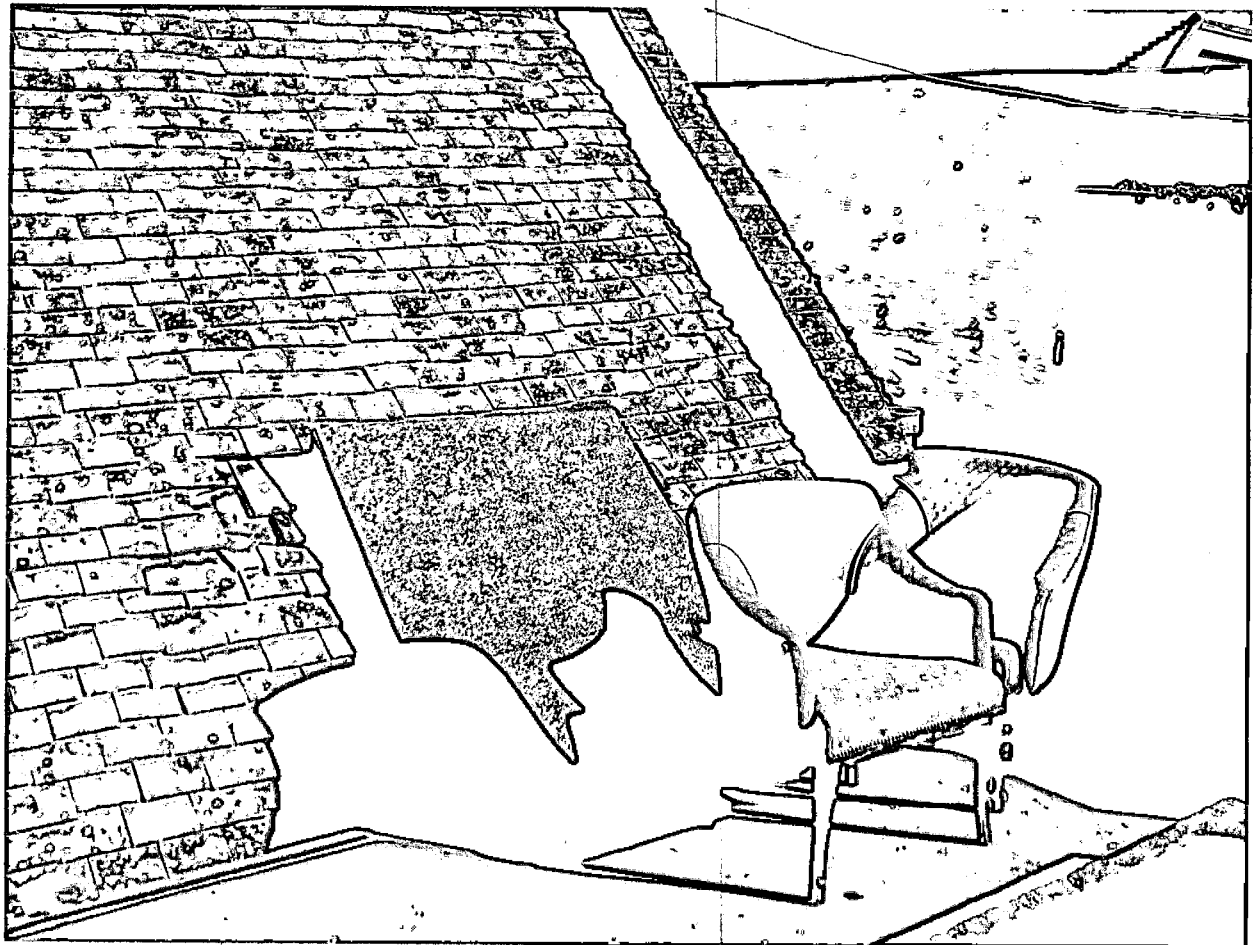
- 07.00.01 Much of the rear elevation is concealed at ground floor level by single storey, flat roofed extensions.  
These extensions provide access to the main accommodation, free standing freezers and plant or machinery associated with the adjoining Central Complex. (See Photograph PO8)
- 07.00.02 Existing electrical and water services are to be investigated and those redundant are to be removed.
- 07.00.03 Flint walling where penetrated by services or otherwise damaged is to be made good.

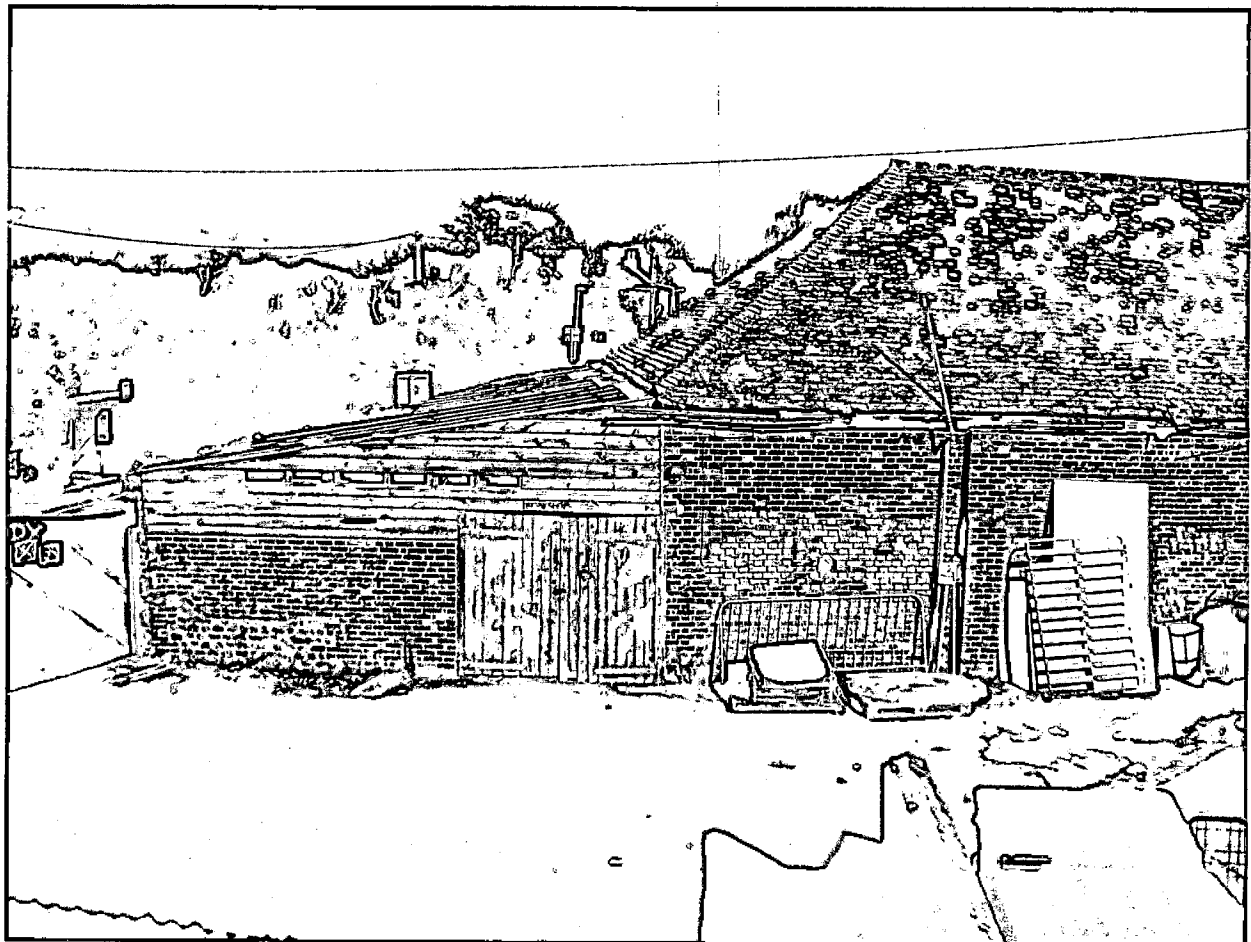
10.00.02 The existing yard elevation adjacent to the access gate is part weatherboarded. Weatherboarding should be removed and replaced with new to match size and section over breather membrane. (See Photograph P10)  
Boarding to be stained black.
