# APPLICATION FOR CONSENT FOR WORK ON A LISTED BUILDING

Mr. C. J. Budgen and Mrs L. V. Budgen  
Morrells Farmhouse  
Lower Bognor Road,

November 2020

# MORELLS FARMHOUSE

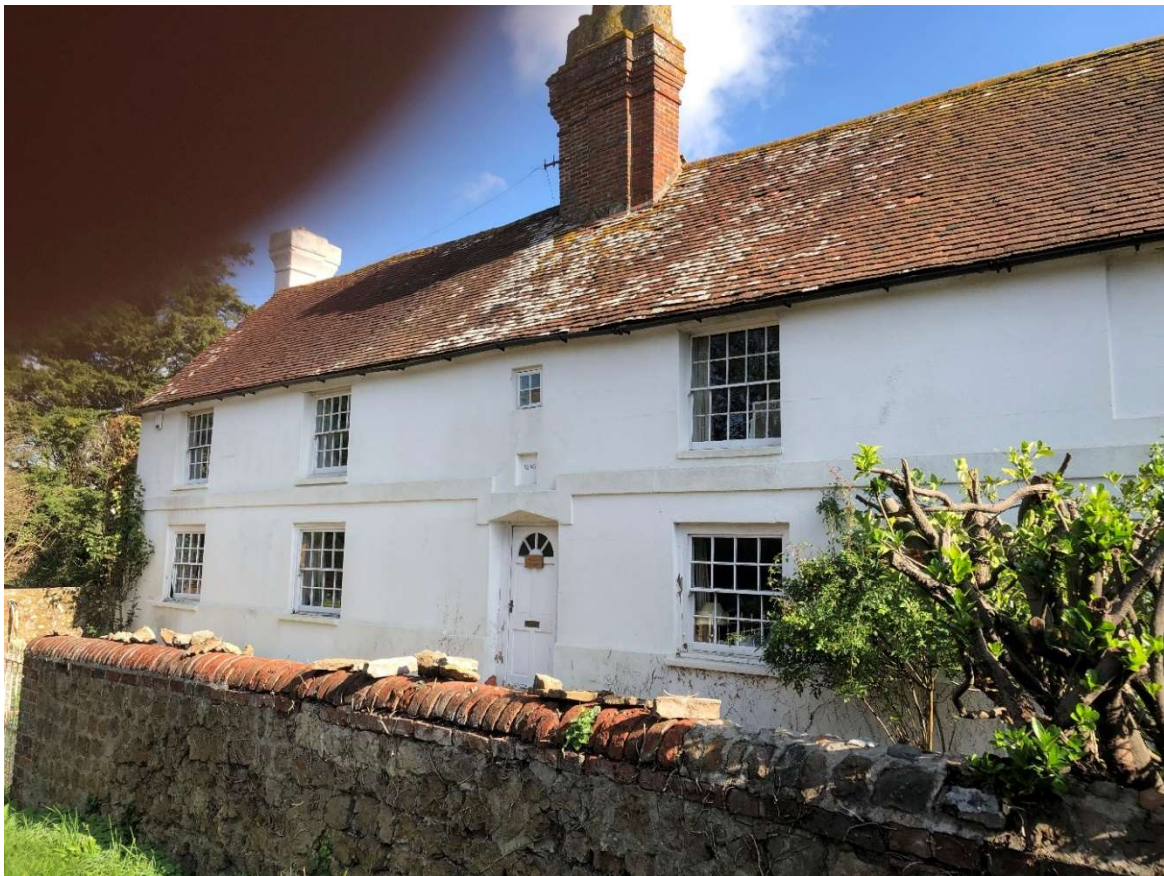
The works described in this application are confined to the following features located on the front (West aspect) of the farmhouse:

- Three ground floor double sash windows.
- Three first floor double sash windows.
- The front door located at the centre of the front wall, and
- One small window located immediately above the front door

These are all as shown on the following photograph.

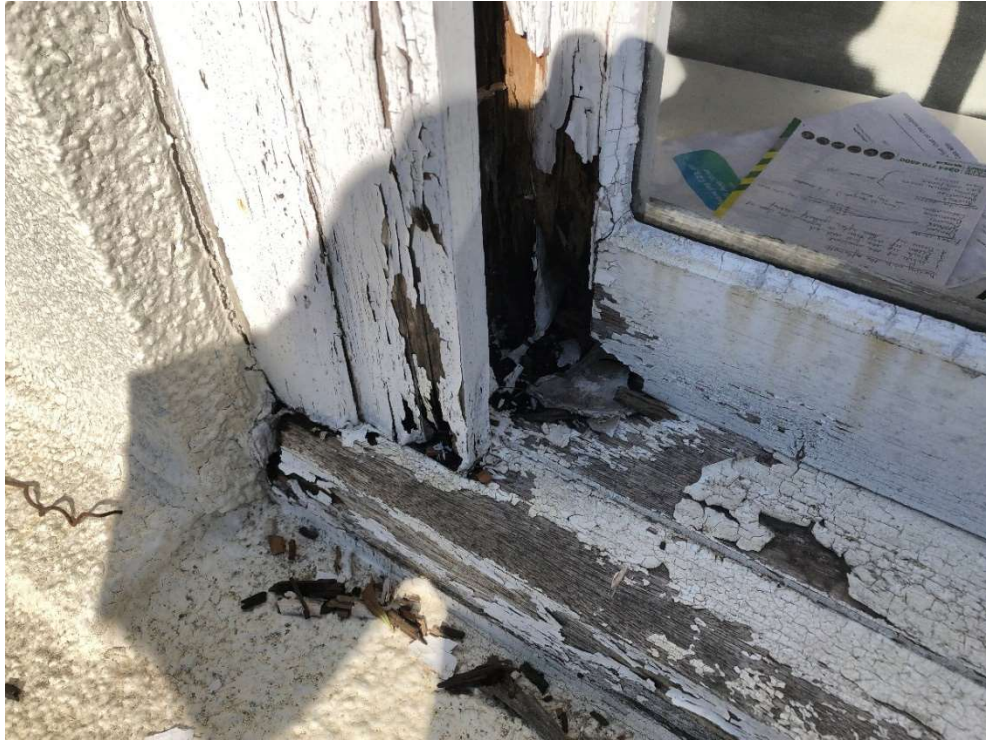
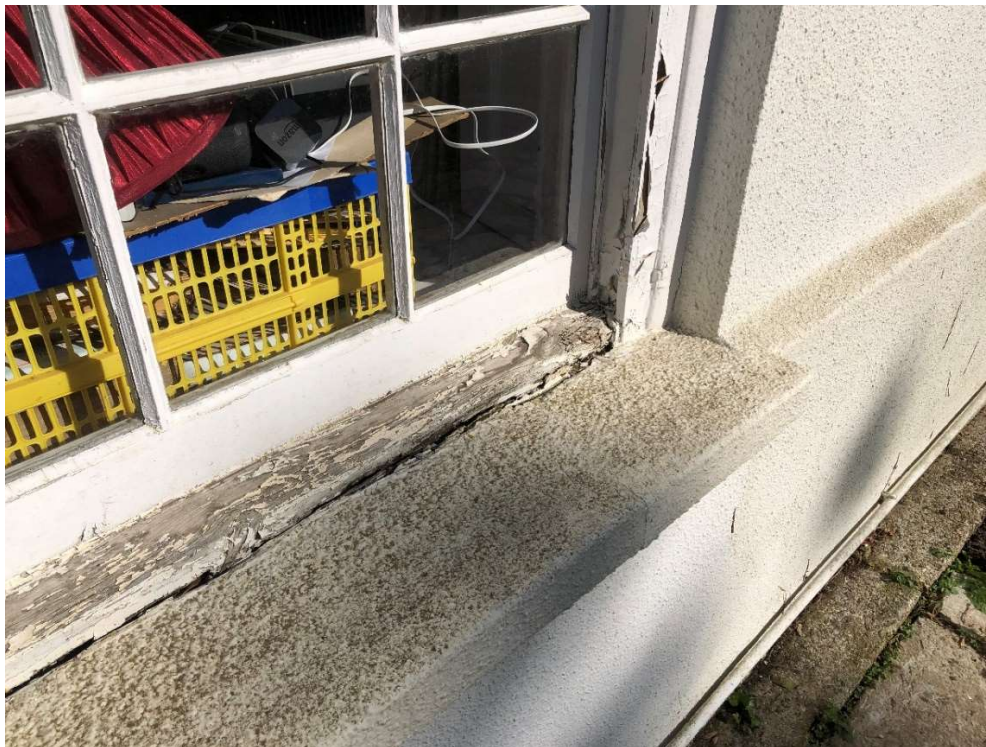
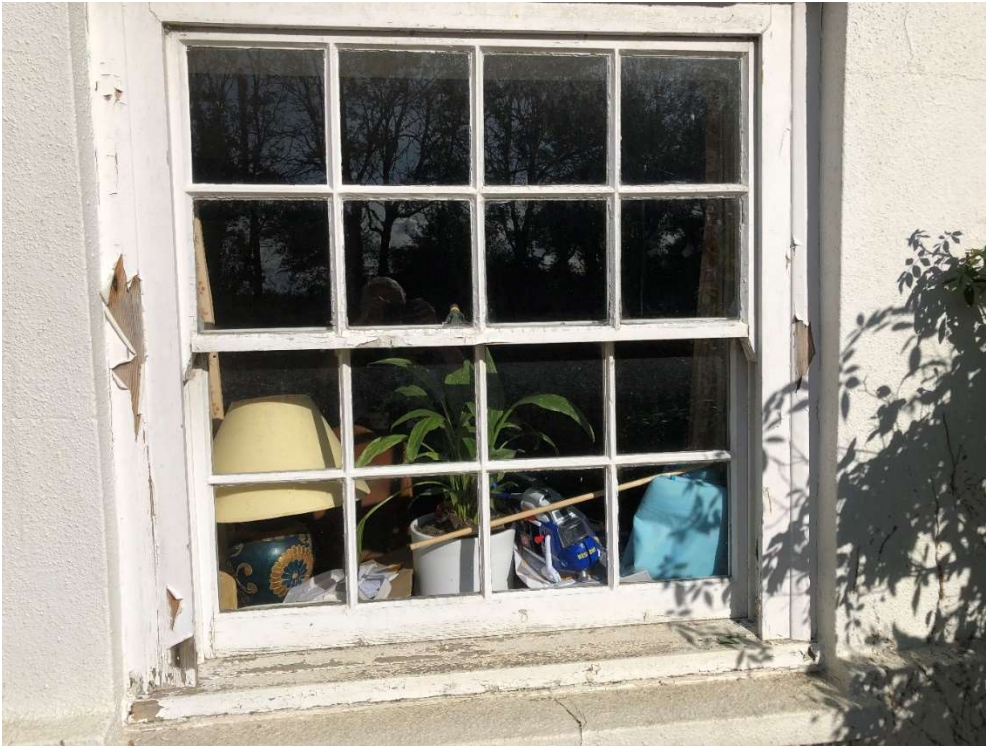
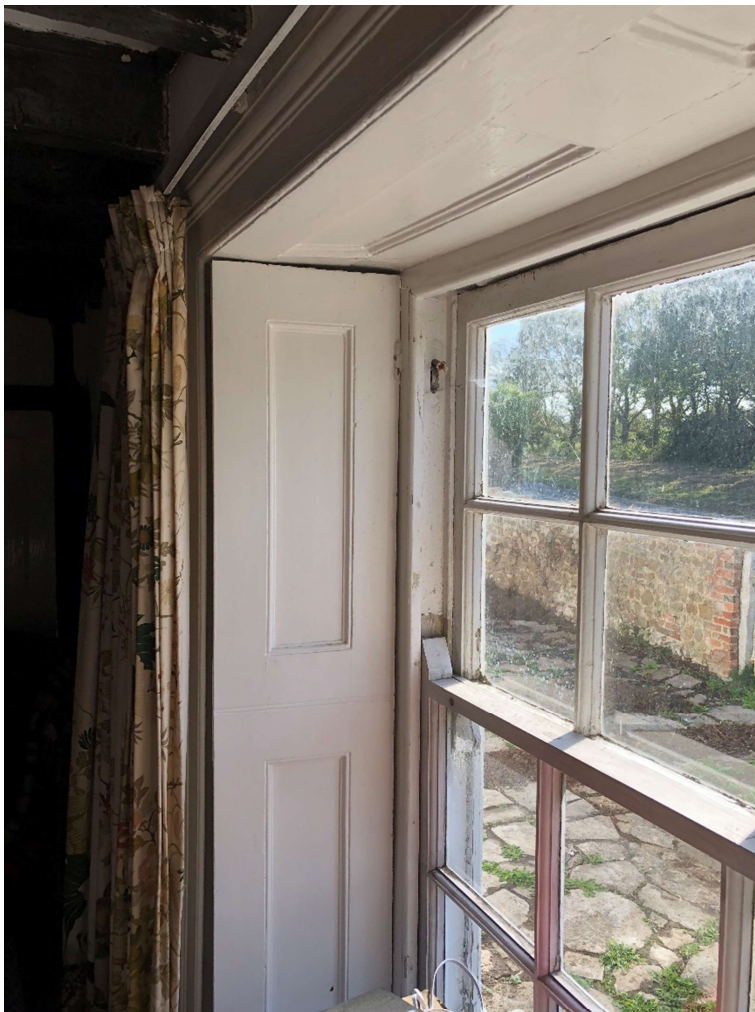
The decorative state of the woodwork on all of the above-mentioned features is in a very poor condition. It is obvious that no maintenance or painting has been carried out over a considerable period of time therefore the paintwork has become seriously degraded. This has resulted in damage ranging from surface degradation of exposed woodwork to the onset of significant rotting which in some locations has resulted in a complete breakdown of the window or frame structure. It is also noted that one sash cord is broken, that the operation of some of the windows is difficult and that their security is questionable.

It is also recognised that single glazing does not meet the energy efficiency standards currently deemed appropriate for historic buildings and therefore consideration is to be given to improving the thermal performance of these windows.

Examples of these conditions are shown in the following photographs.

With regards to the double sash windows the proposed course of works for each window is as follows:

- Lever out the stop and parting beads, disconnect the sash cords and remove both sashes from the window frame.
- Dismantle the sash weight pockets.
- Strip any remaining old paint and determine the condition of the exposed woodwork including the storm moulding, pocket pieces, reveals and architraves. Scarf in new pieces of wood as required and treat less seriously damaged areas with a resin-based wood hardener. Damage to the sill to be addressed by scarfing in appropriate hardwood repair pieces.

- The sashes to be stripped and any damage to the stiles, rails or glazing bars to be repaired using scarfed inserts. Existing glass to be retained.
- Window furniture and sash pulleys and weights to be cleaned and refurbished.

- Glazing putty to be checked and made good as necessary and all woodwork to be painted.
- Windows to be rebuilt, new sash cords to be fitted, appropriate security devices to be attached, final paintwork completed and suitable frame sealant applied where required.

Secondary glazing units to be fitted to the inner faces of the stop beads such that the inner shutters where fitted can be refitted and closed as normal.

With regards to the front door and the single window the proposed course of works is as follows:

- The paintwork to be stripped.
- The exposed woodwork to be examined and any damage to be replaced with scarfed inserts.
- Any degraded wood to be treated with a resin-based wood hardener.
- All woodwork to be repainted and suitable frame sealant applied where required.
- Suitable security devices to be fitted as considered appropriate.
