STARBUCKS,  
RUSTINGTON

Tree Survey Report  
210-R-001

December 2021

Project address: Rustington Retail Park,  
New Road,  
Rustington,  
West Sussex,  
BN16 3RT

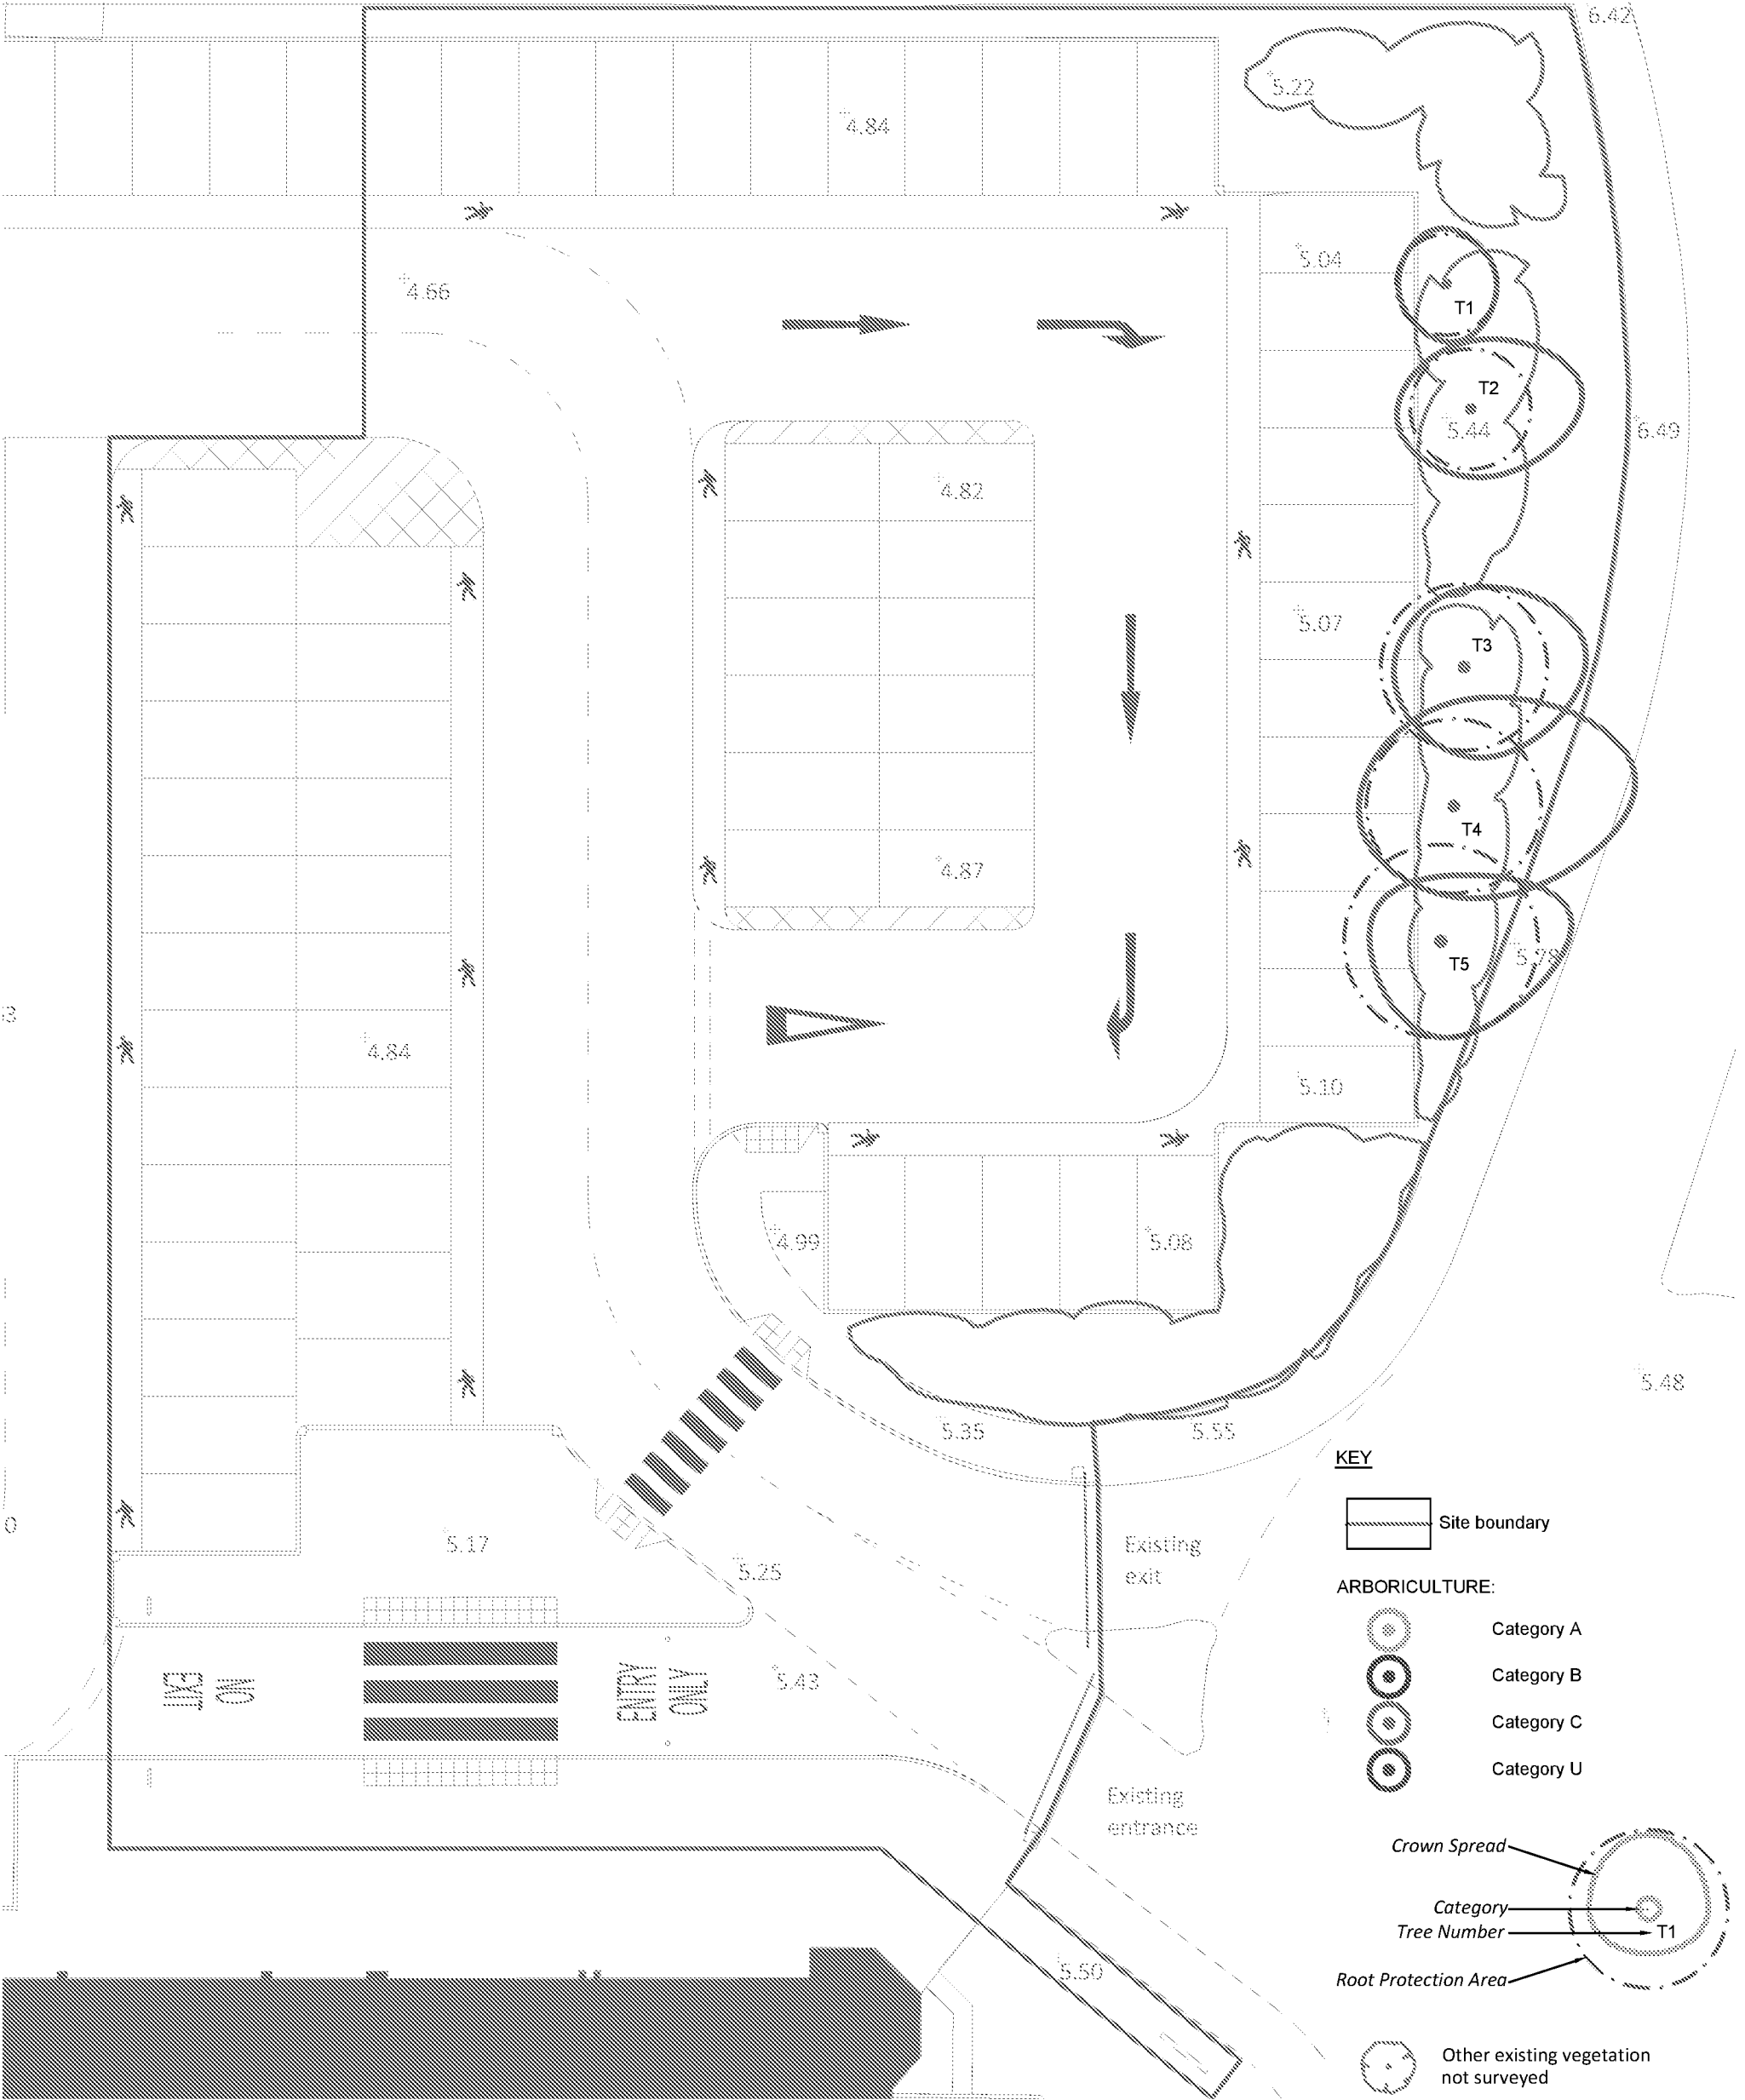
210-001 P1

The Tree Constraints Plan (Appendix B) illustrates the Root Protection Areas (RPAs) for the individual trees identified in the Tree Survey Schedule (Appendix A). This represents the minimum area in m<sup>2</sup> which ideally, should be left undisturbed around each tree were it to be retained. The Tree Constraints Plan also shows a representation of the canopy spread of each tree measured in four cardinal directions. The RPA has been calculated in accordance with Section 4.6 of BS5837:2012 *Trees in relation to design, demolition and construction – Recommendations*.
