| Rustington Convalescent Home<br>Sea Road, BN16 2LZ | | | | |
| Cook House<br>Wall tie replacement / remedial works<br>elevations, sections and details. | | | | |
| DRAWING No. | | 5279 / 56 | | REVISION |

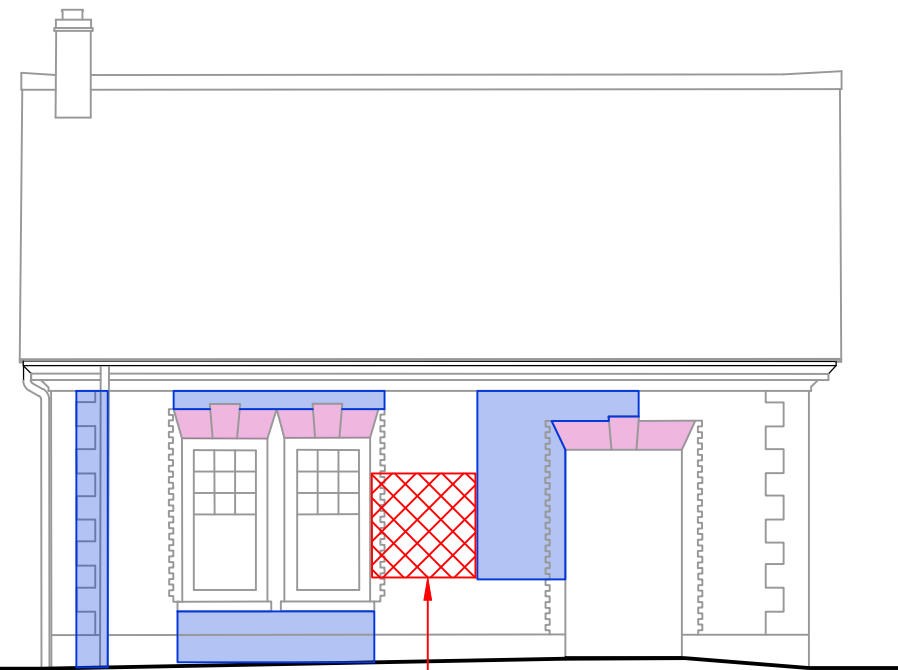
West Elevation

Crack stitching bars installed in accordance with manufacturer's recommendations and details to strengthen masonry around area of significant cracking in panel.

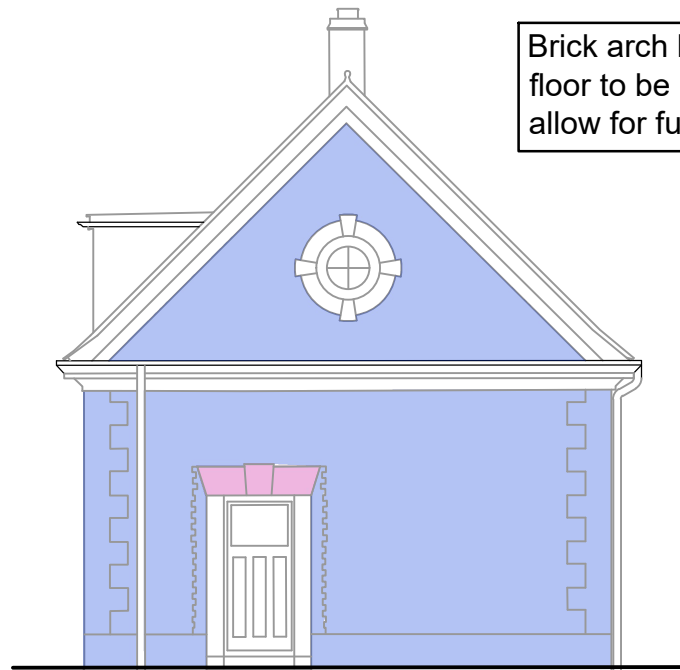
North Elevation

Brick arch lintels at first floor to be uncovered to allow for further inspection
