| Rustington Convalescent Home<br>Sea Road, BN16 2LZ | | | | | | | |
| Laundry Building<br>Superstructure general arrangements,<br>sections and details, including internal<br>remedial work details. | | | | | | | |
| DRAWING No. | | | | 5279 / 61 | | REVISION | |

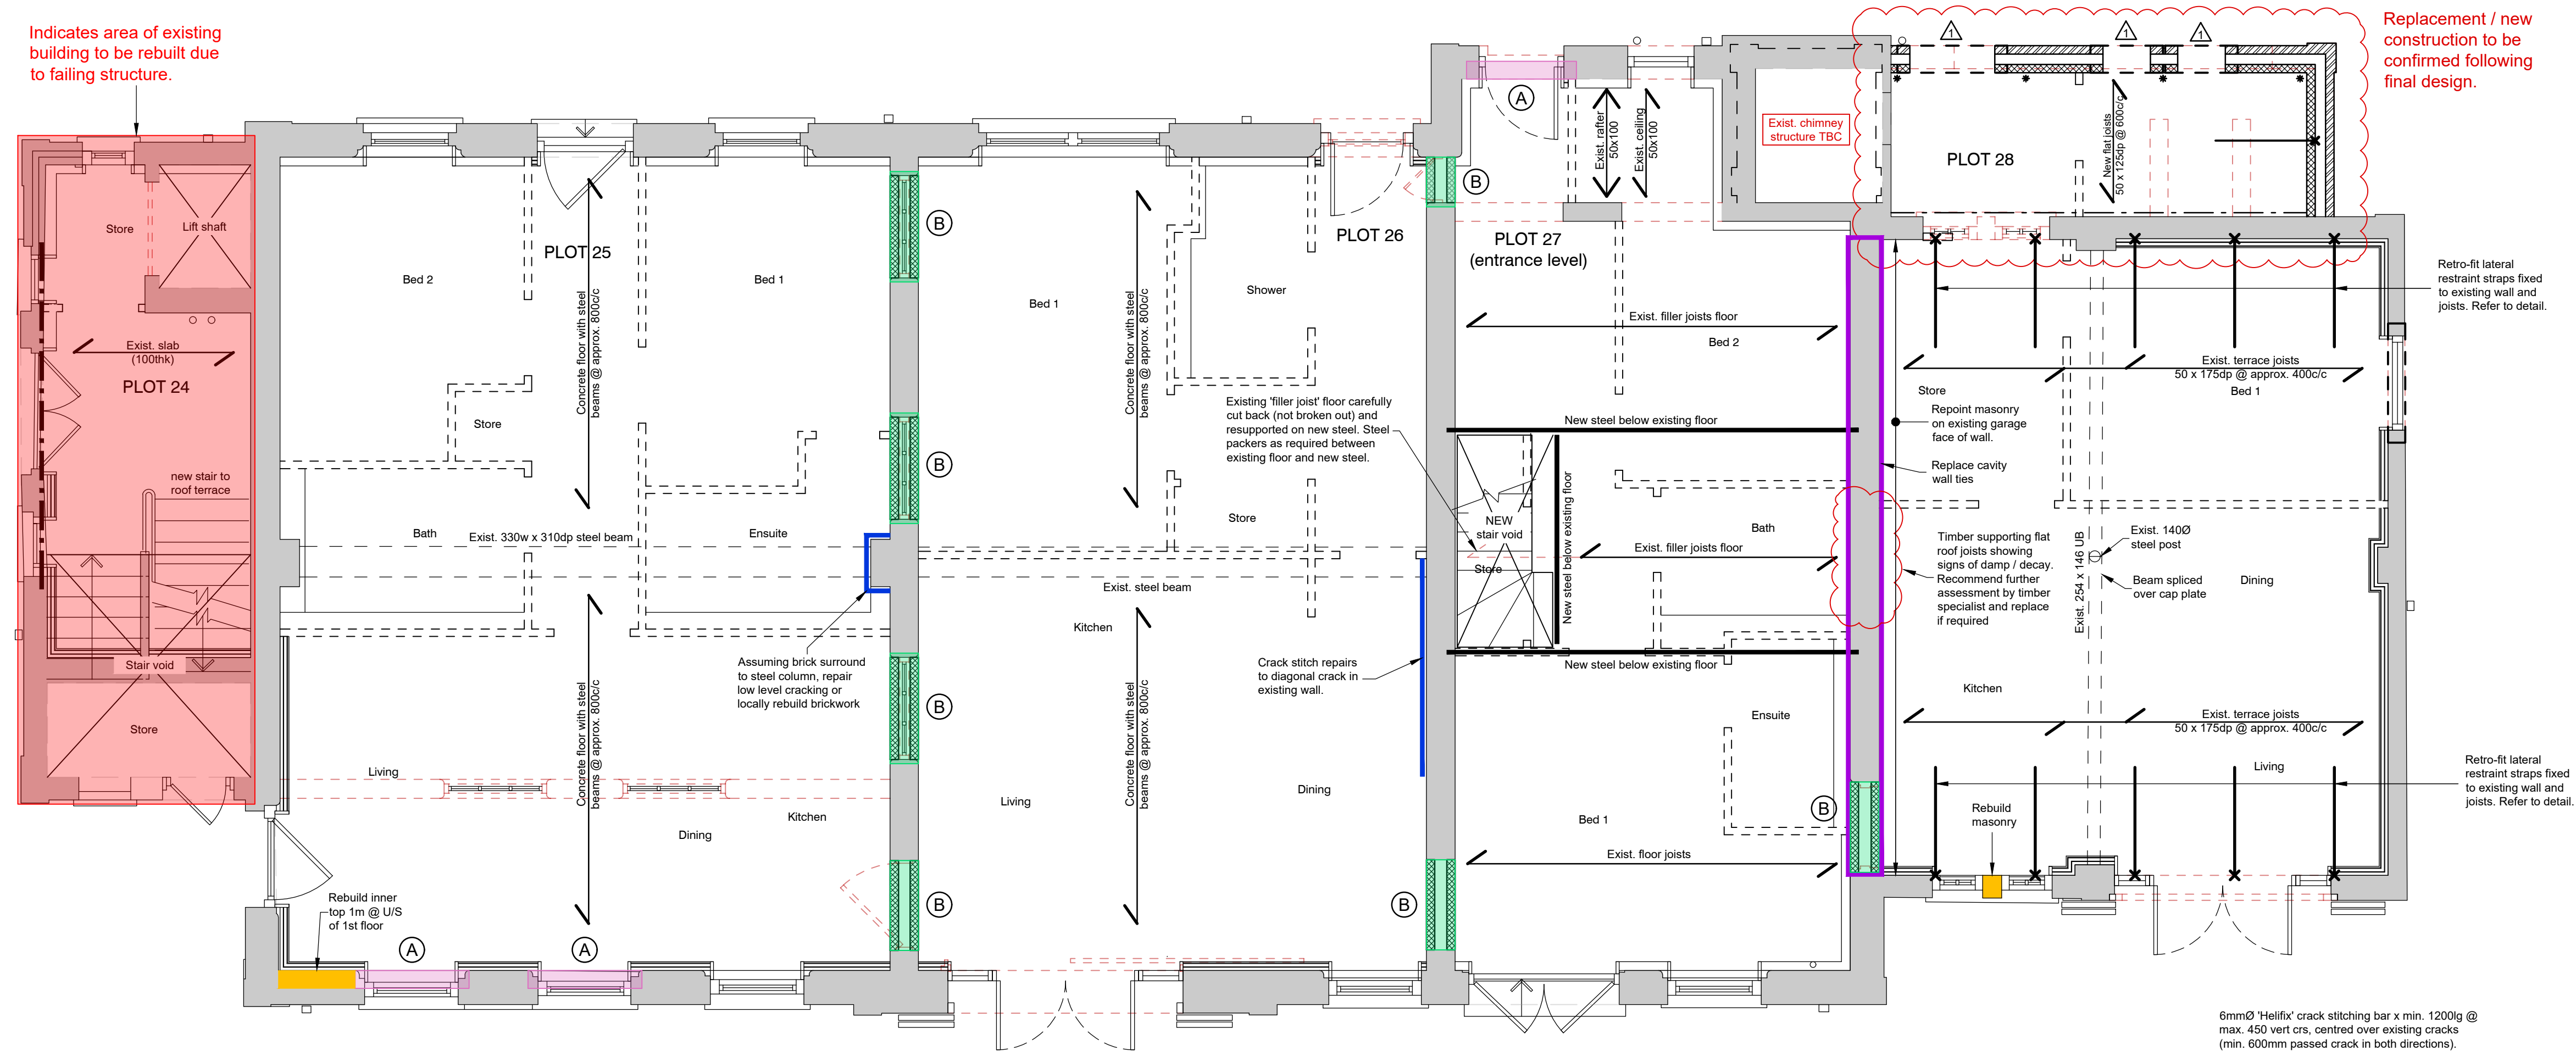
Indicates area of existing building to be rebuilt due to failing structure.

Replacement / new construction to be confirmed following final design.

Retro-fit lateral restraint straps fixed to existing wall and joists. Refer to detail.

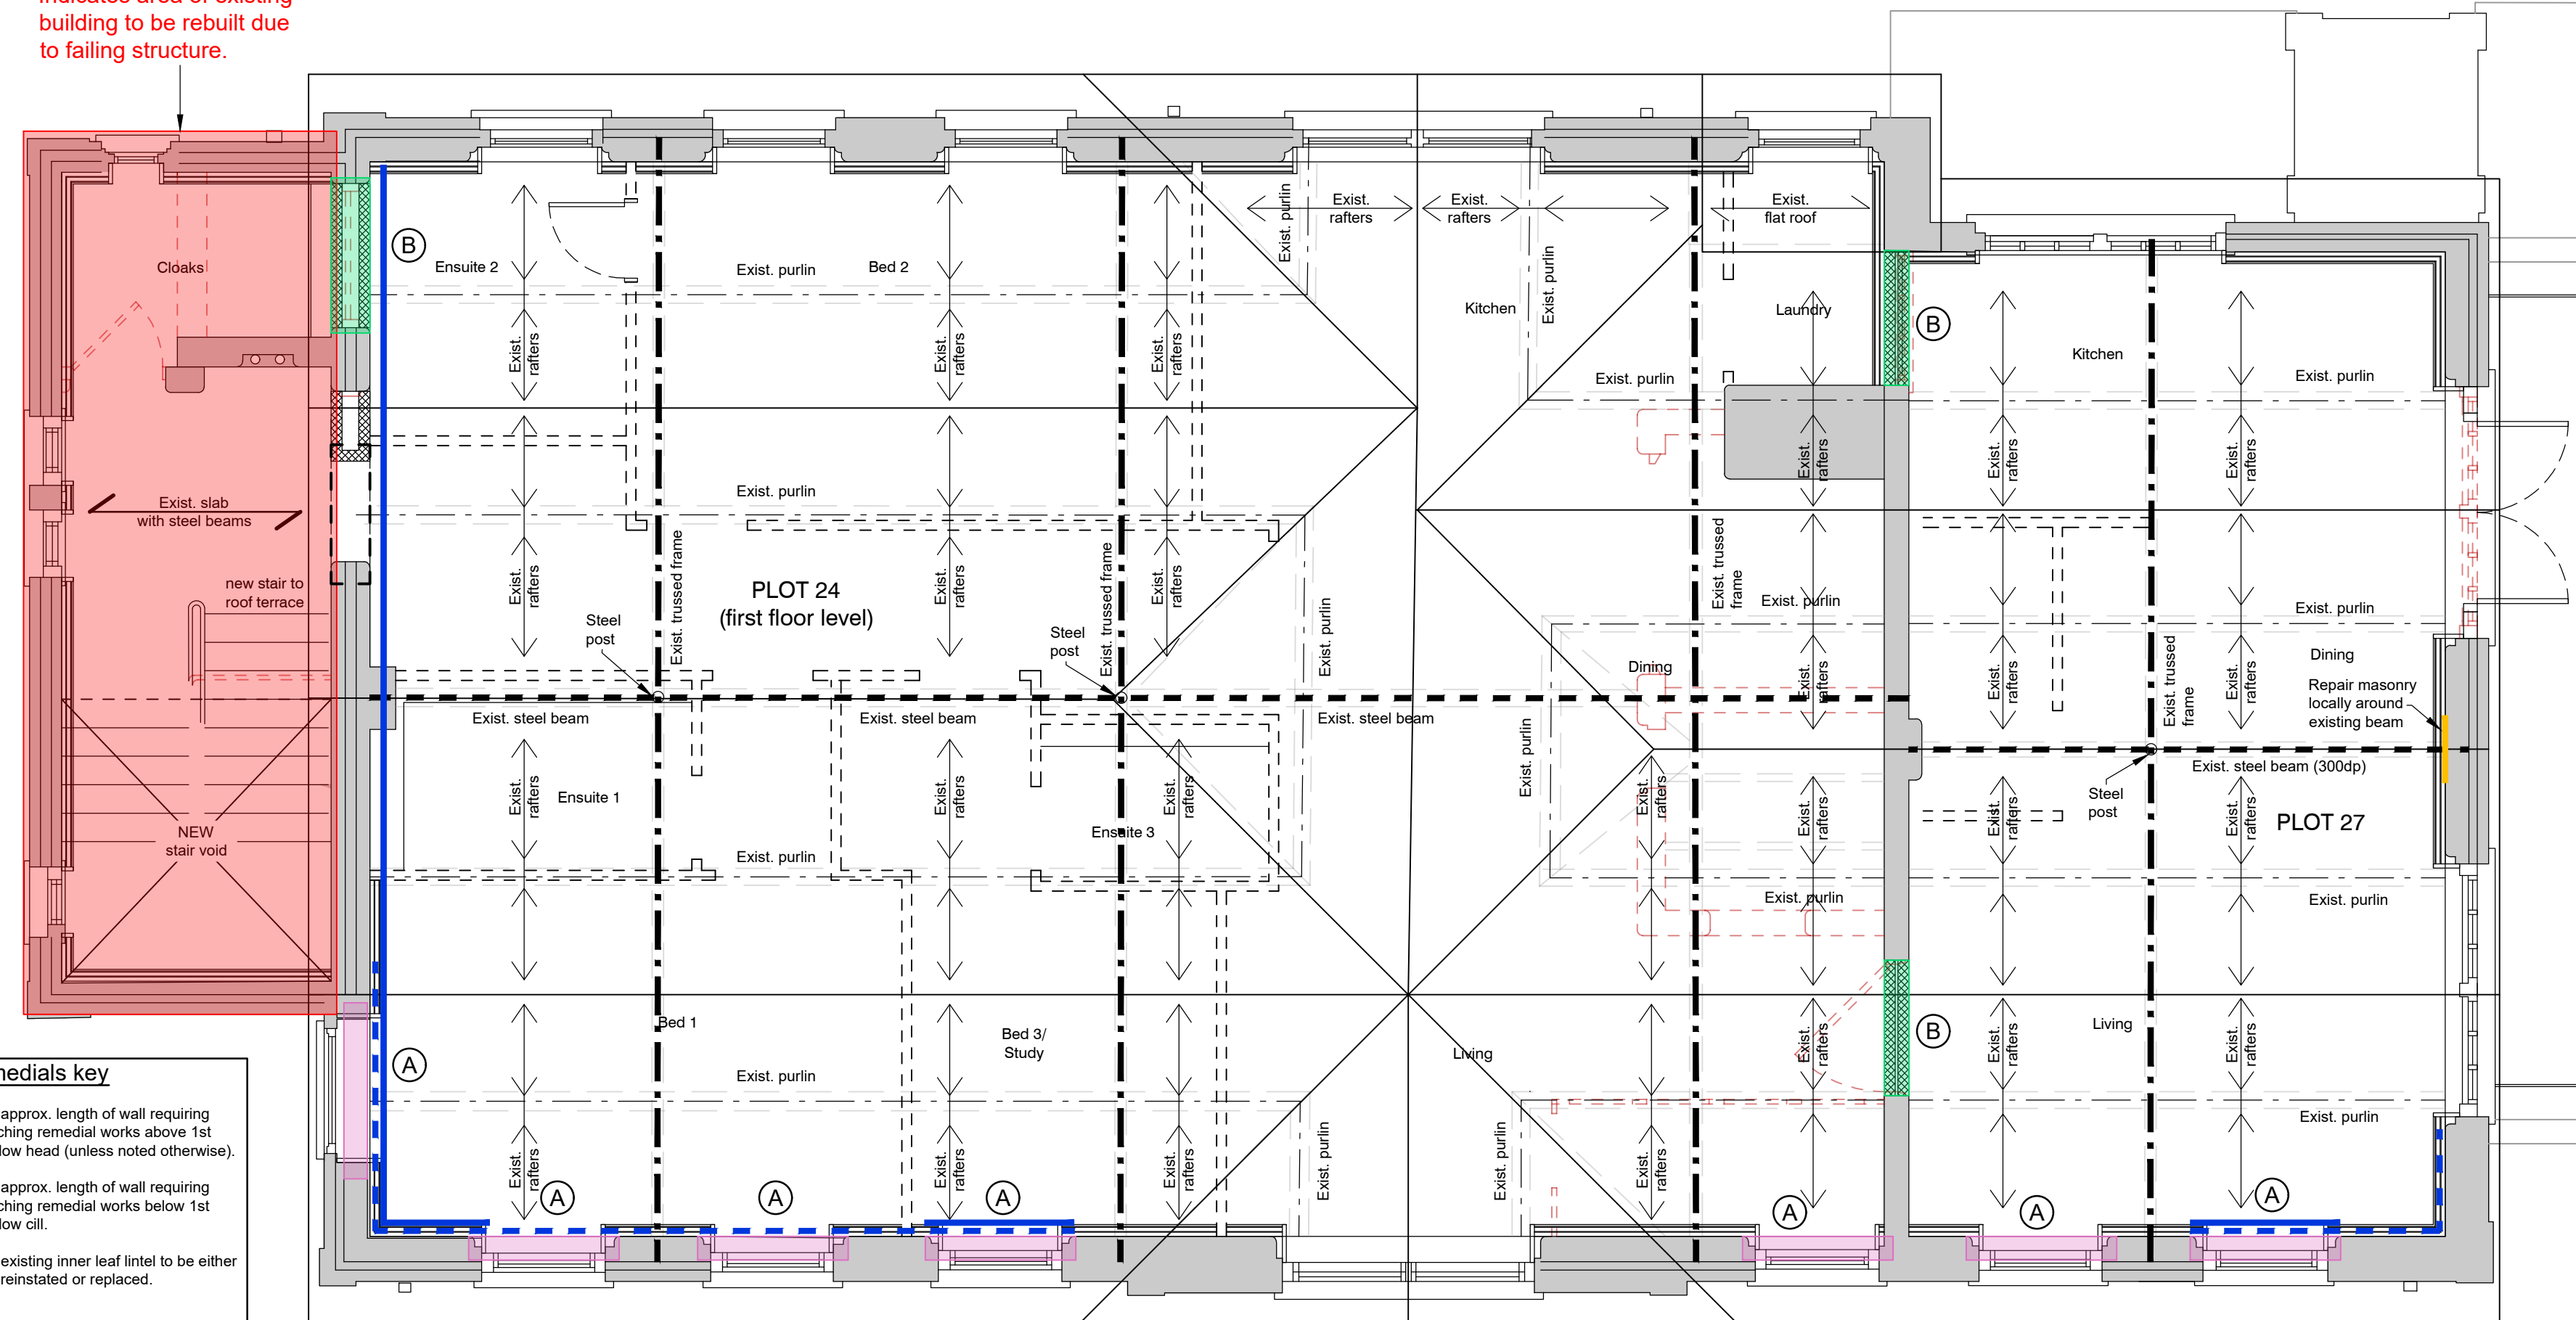
Indicates area of existing building to be rebuilt due to failing structure.

Retro-fit lateral restraint straps fixed to existing wall and joists. Refer to detail.
