## REMEDIATION VERIFICATION REPORT

**FORMER HARES DAIHATSU  
STATION ROAD, RUSTINGTON, BN16 3BH**

**REC REFERENCE: 1CO100632/P5/R1**

**APRIL 2019**

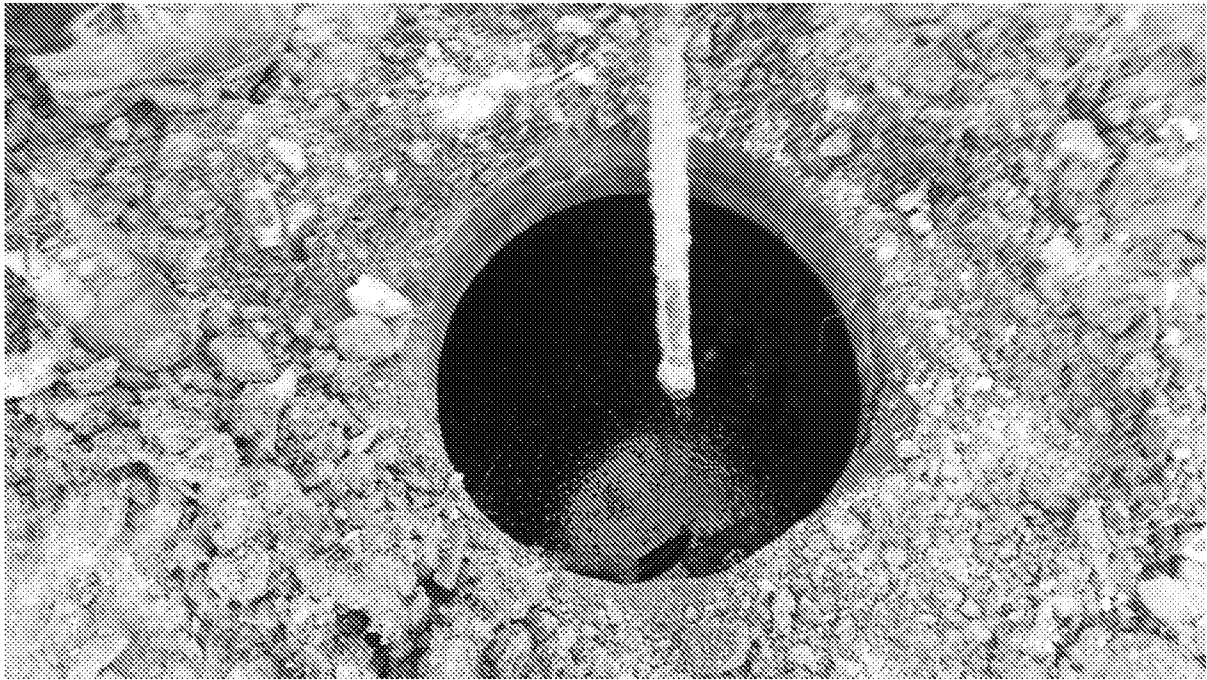
**Figure 4 - Former soakaway filled with impacted material (Southern Source)**

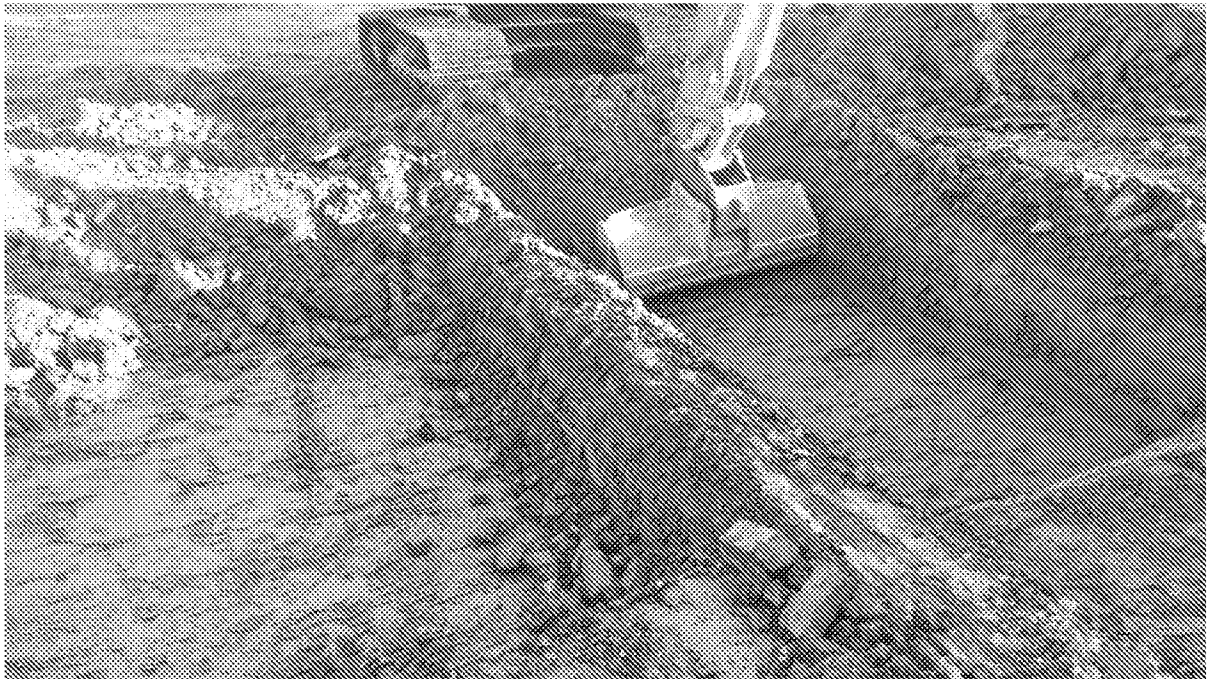
**Figure 5 - Excavation to determine extent of Southern Source, based on visual evidence and PID screening**

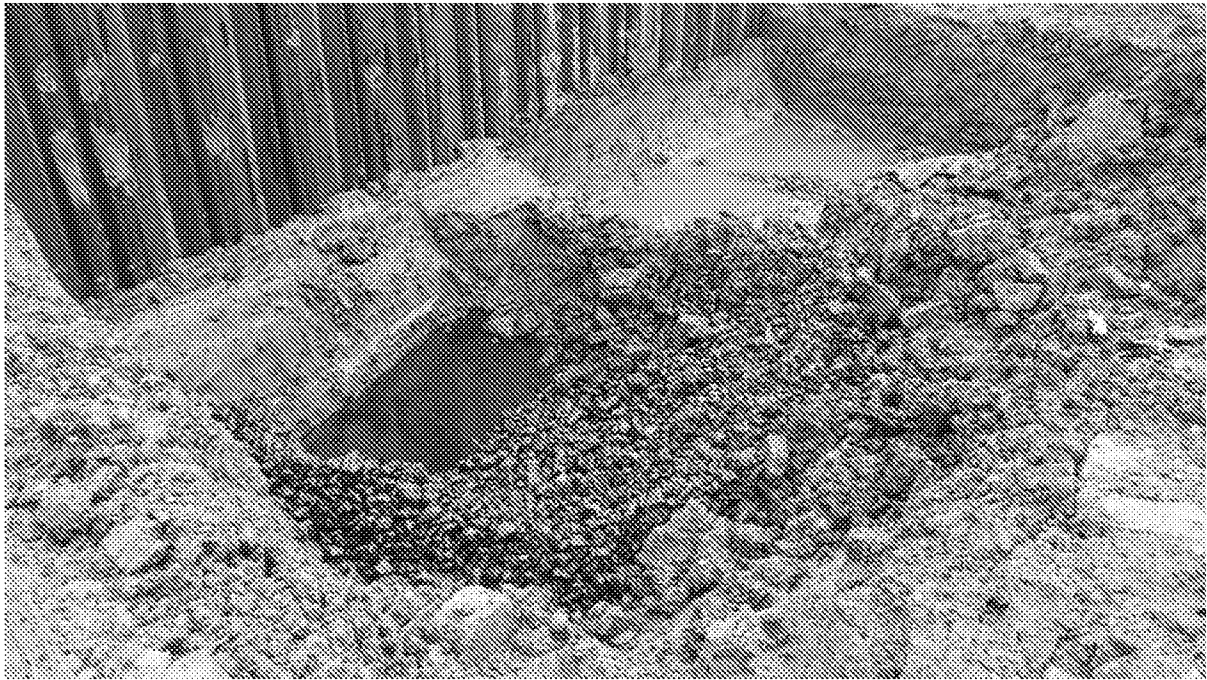
**Figure 6 - Impacted materials within excavation in Southern Source area, groundwater at circa 7.0 mbgl. This excavation was made and subsequently backfilled prior to commencement of in situ remediation.**

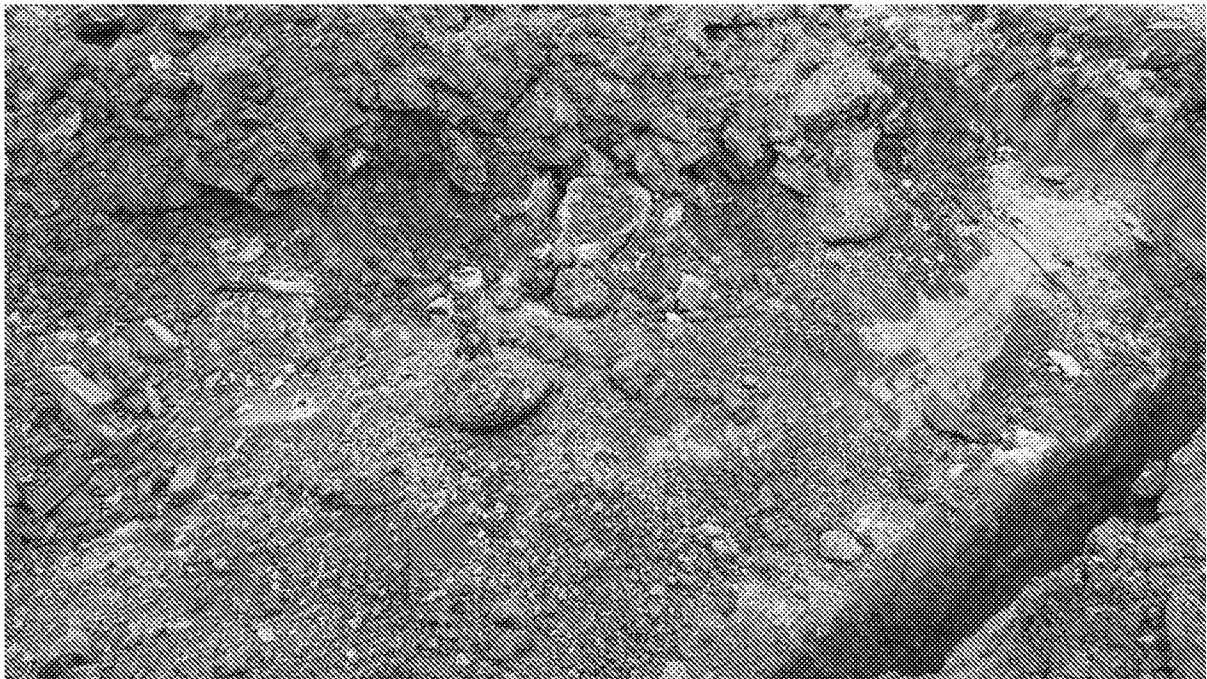
**Figure 7 - Large former fuel tank during excavation (part of Northern Source)**

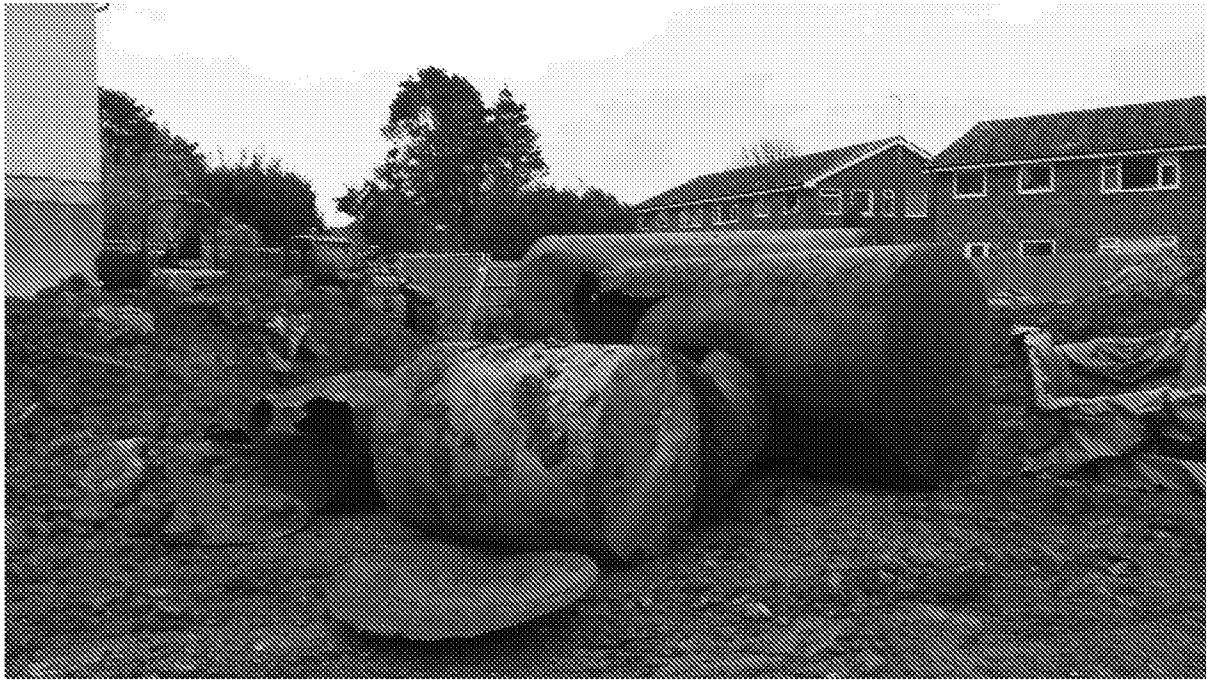
**Figure 8 - Former fuel tanks following gas free and removal from source location**

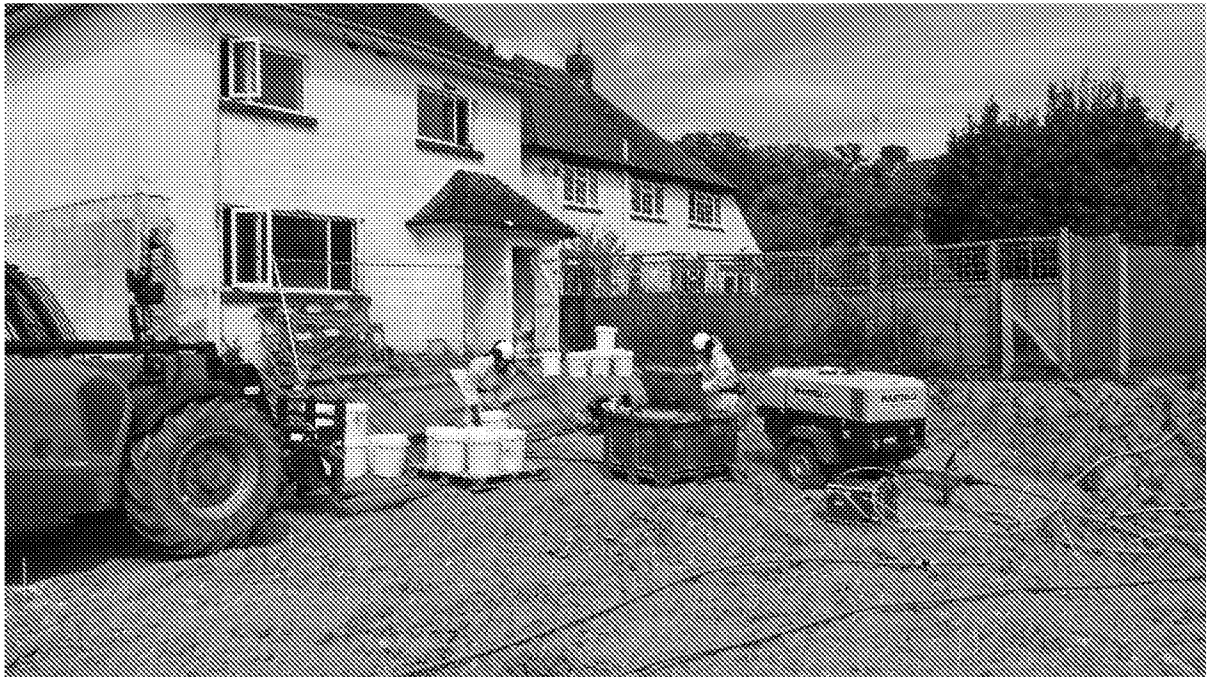
**Figure 9 - Preparation of oxygen biochem for injection works (Tor Drilling engineers, operating on behalf of McAuliffe / Geostream)**

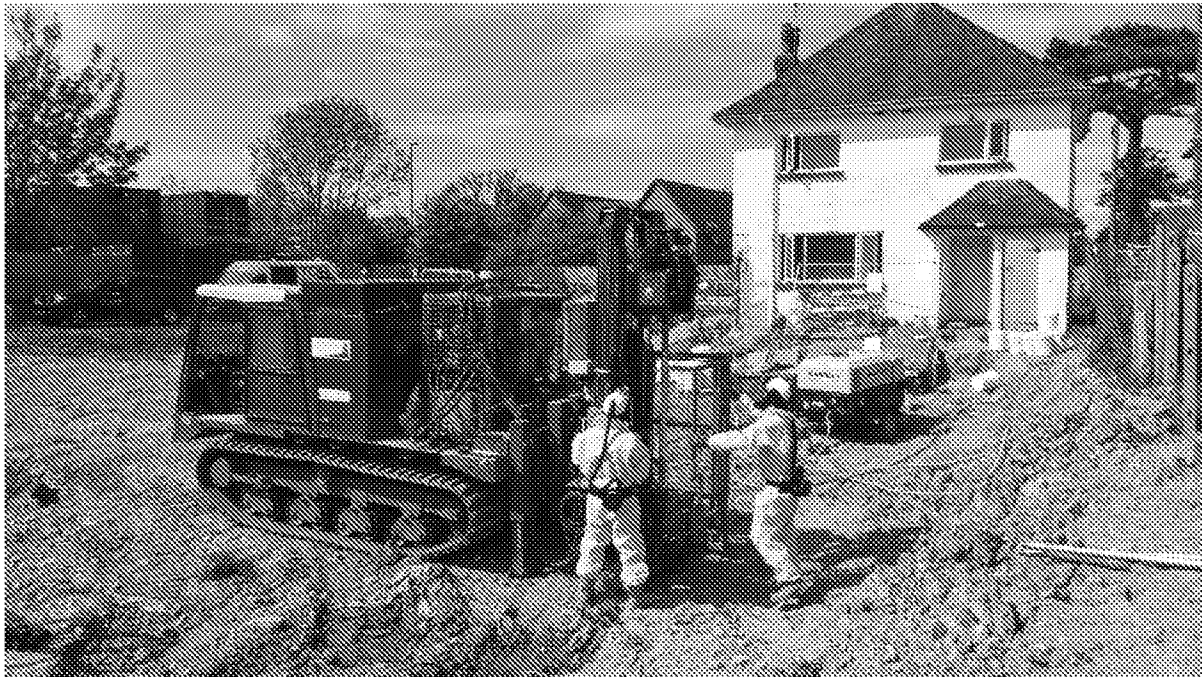
Figure 10 - During direct injection of oxidising agent into Southern Source area

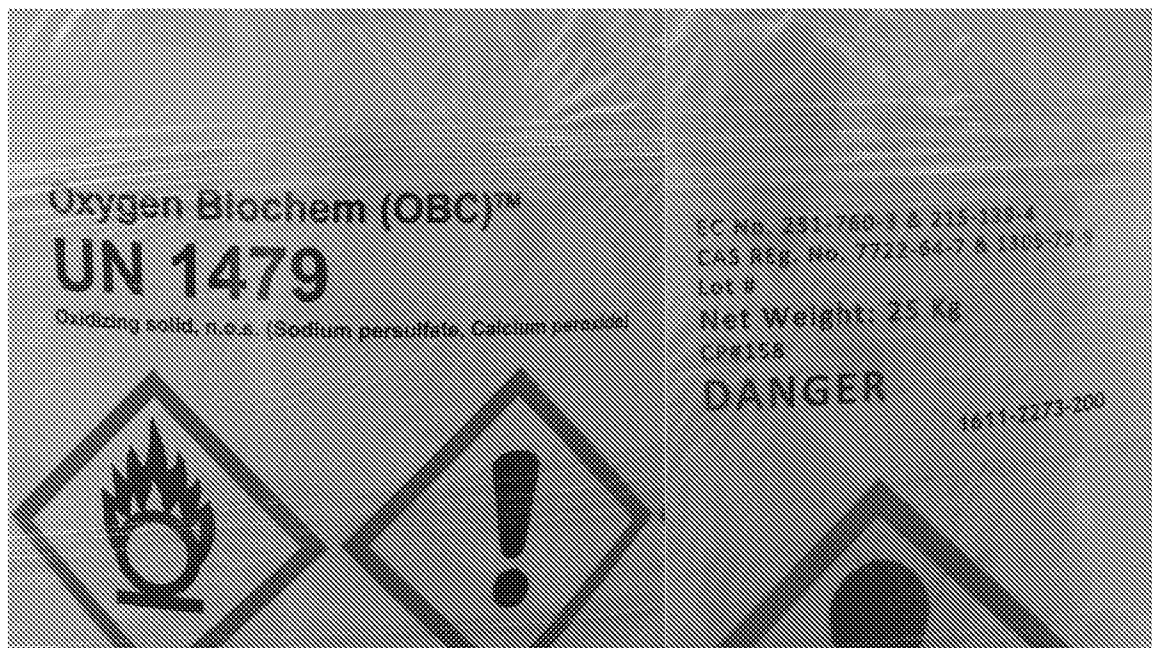
Figure 11 - Detail of oxidising agent specification as displayed on the packaging. OBC was stored in sealed 25kg tubs in a specially designated area of the site.

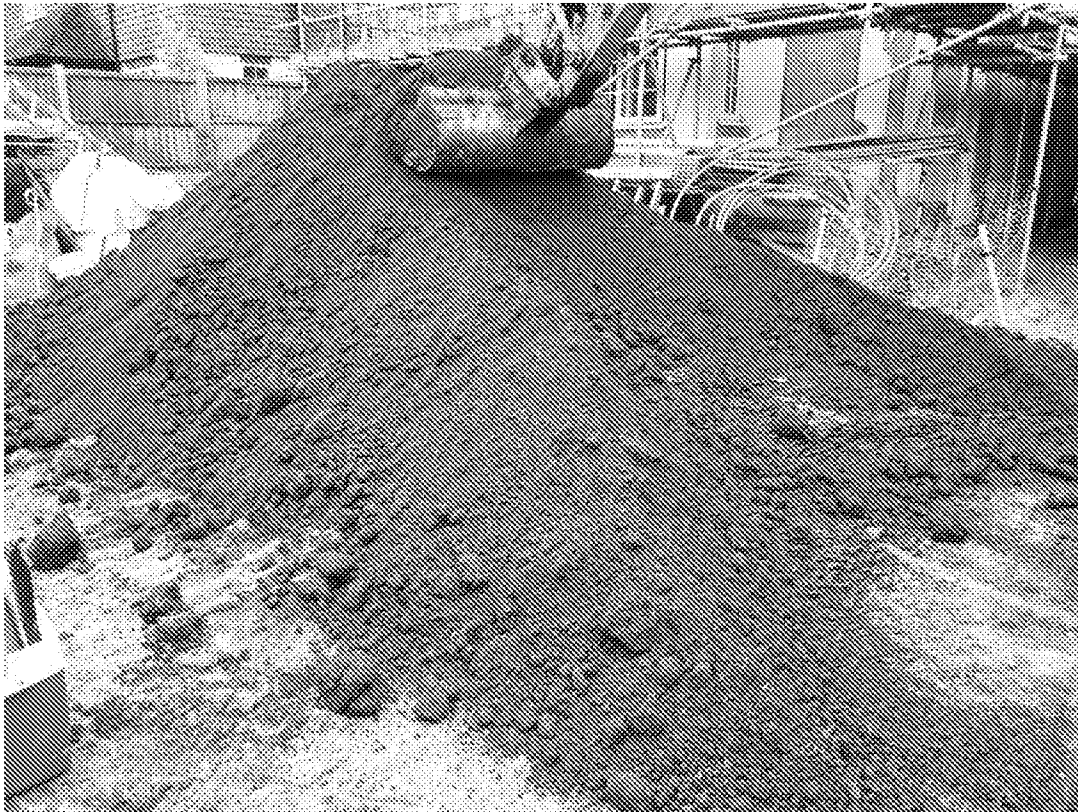
**Figure 12 – Imported topsoil stockpile 1, sampled by REC on 05/02/2019**

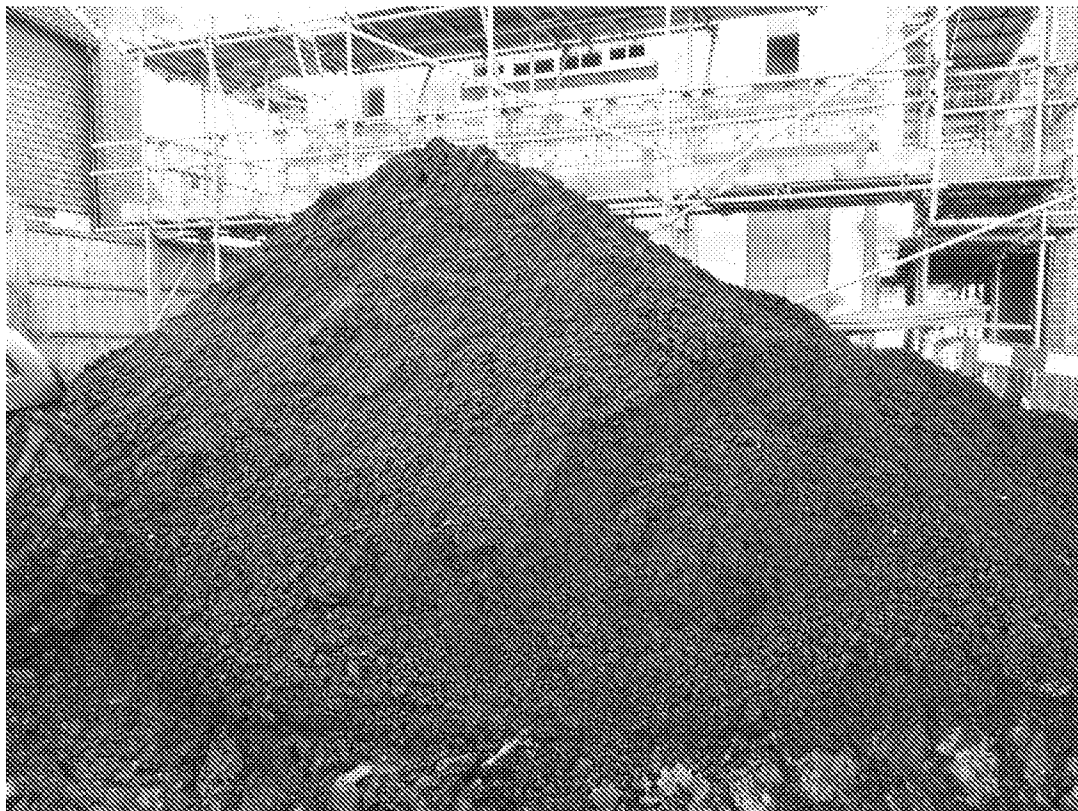
**Figure 13 – Imported topsoil stockpile 2, sampled by REC on 20/02/2019**

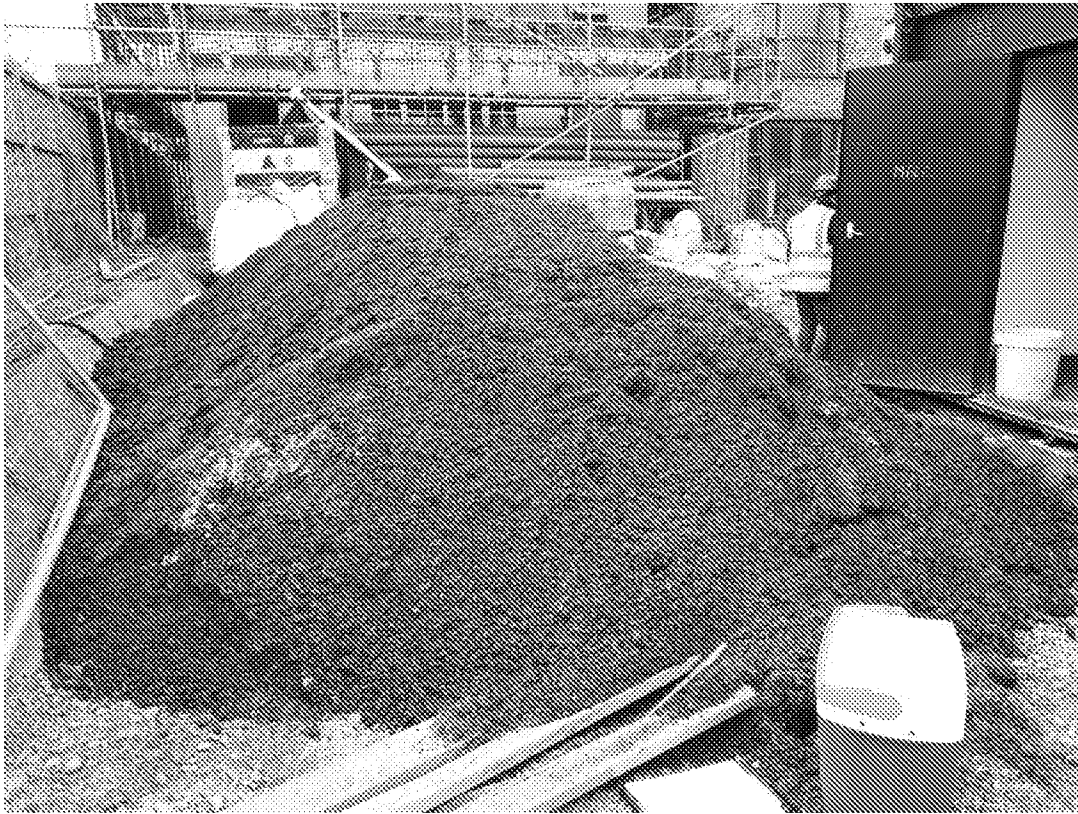
**Figure 14 – Imported topsoil stockpile 4, sampled by REC on 21/03/2019**

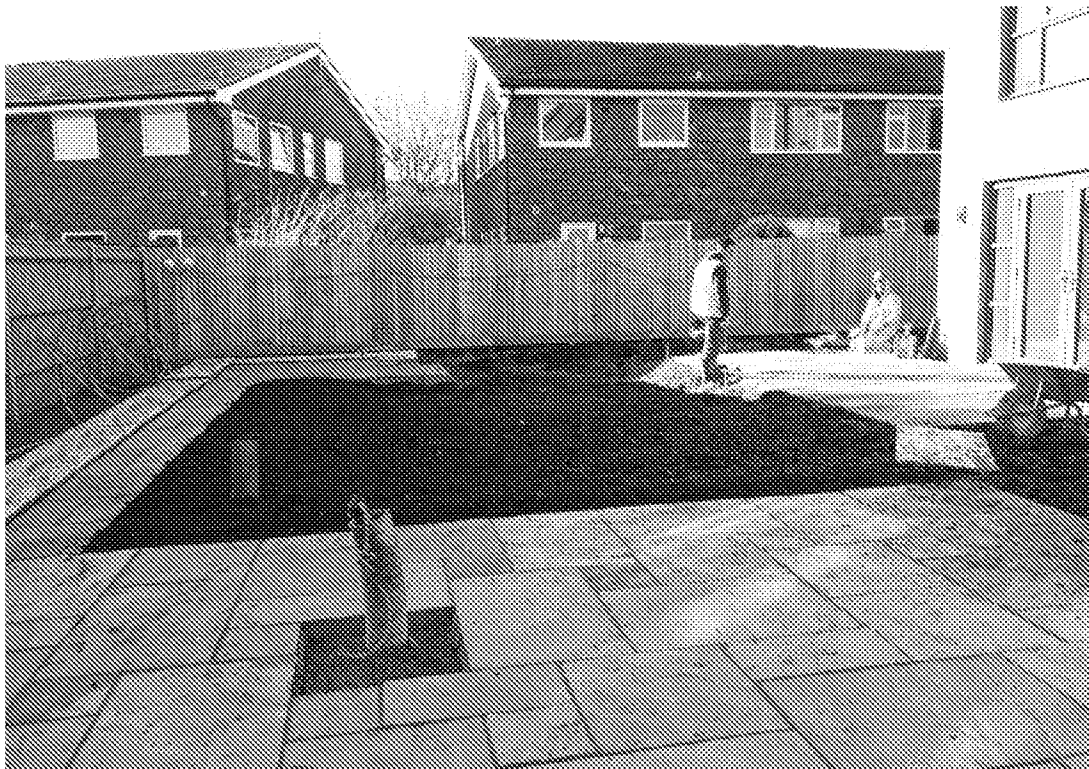
**Figure 15 – Imported soil placed in communal gardens in southeast corner of site. Groundwater monitoring wells remain exposed prior to setting beneath flush covers.**

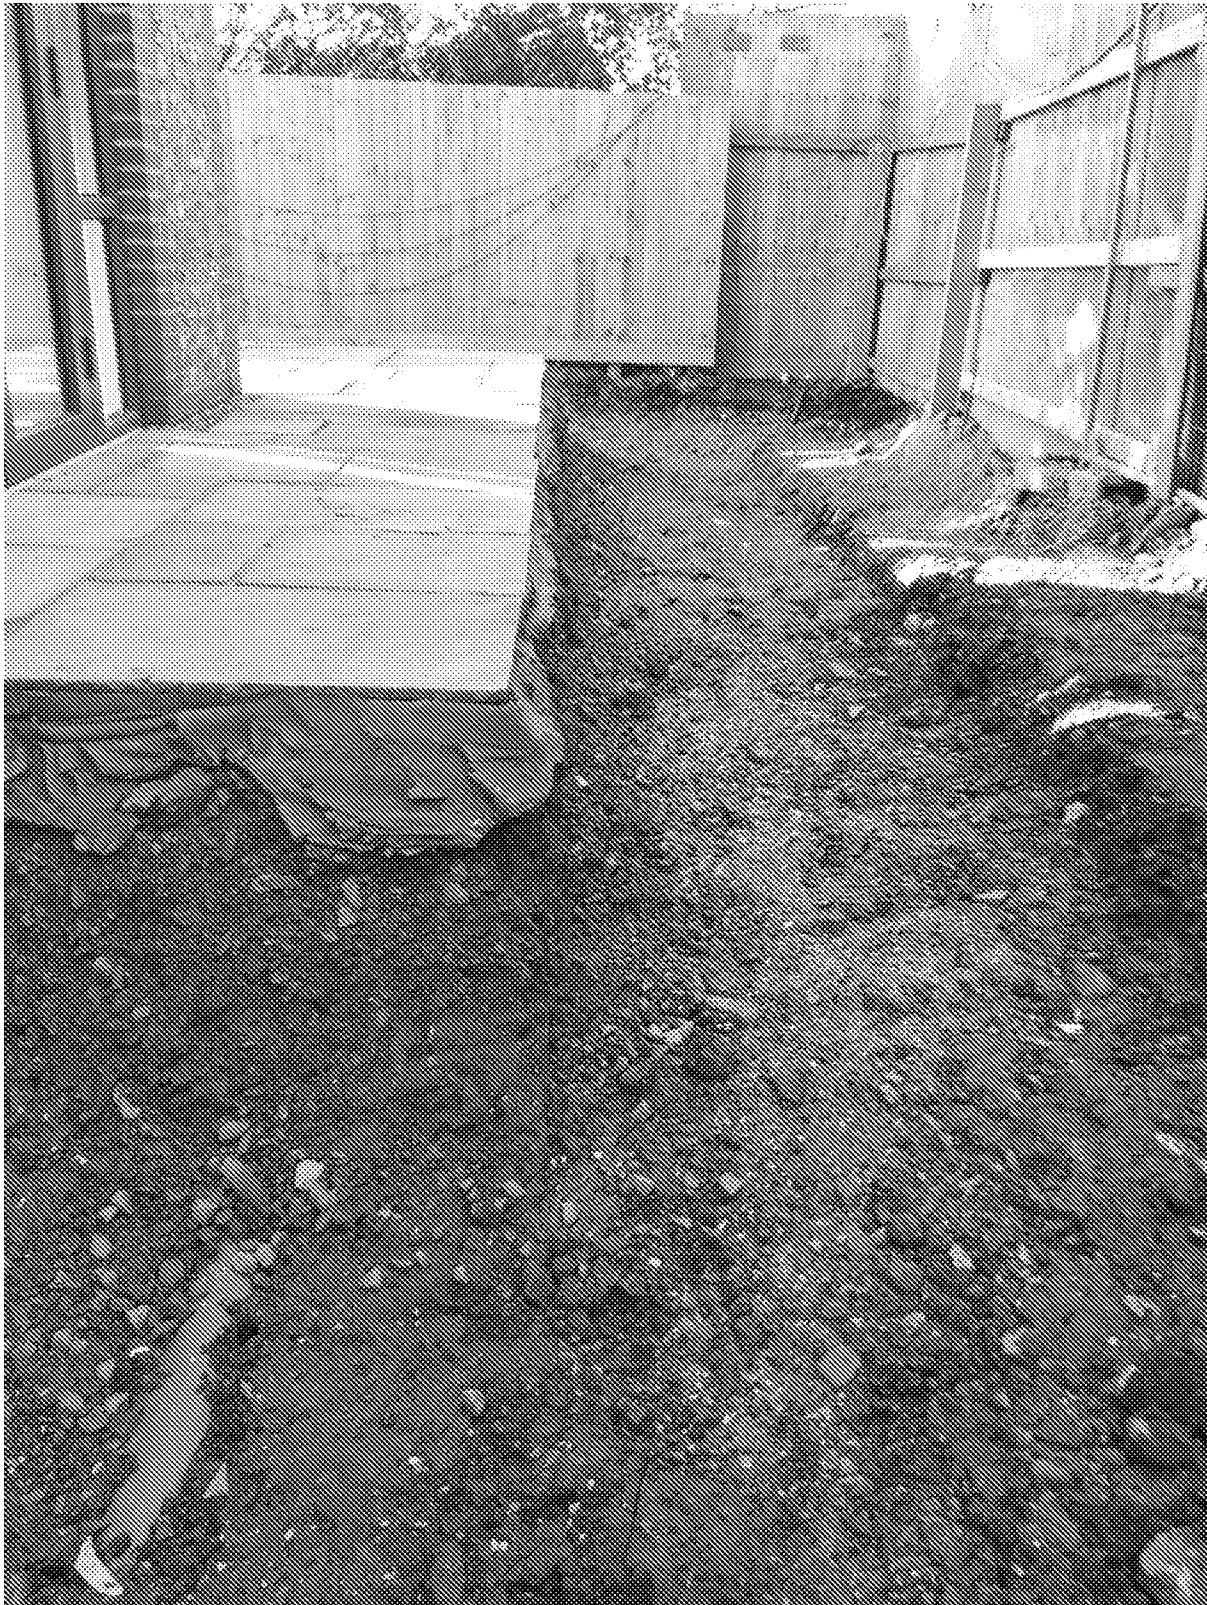
**Figure 16 – Area of impacted soils in west of site excavated to 600mm below finished levels prior to soil placement.**

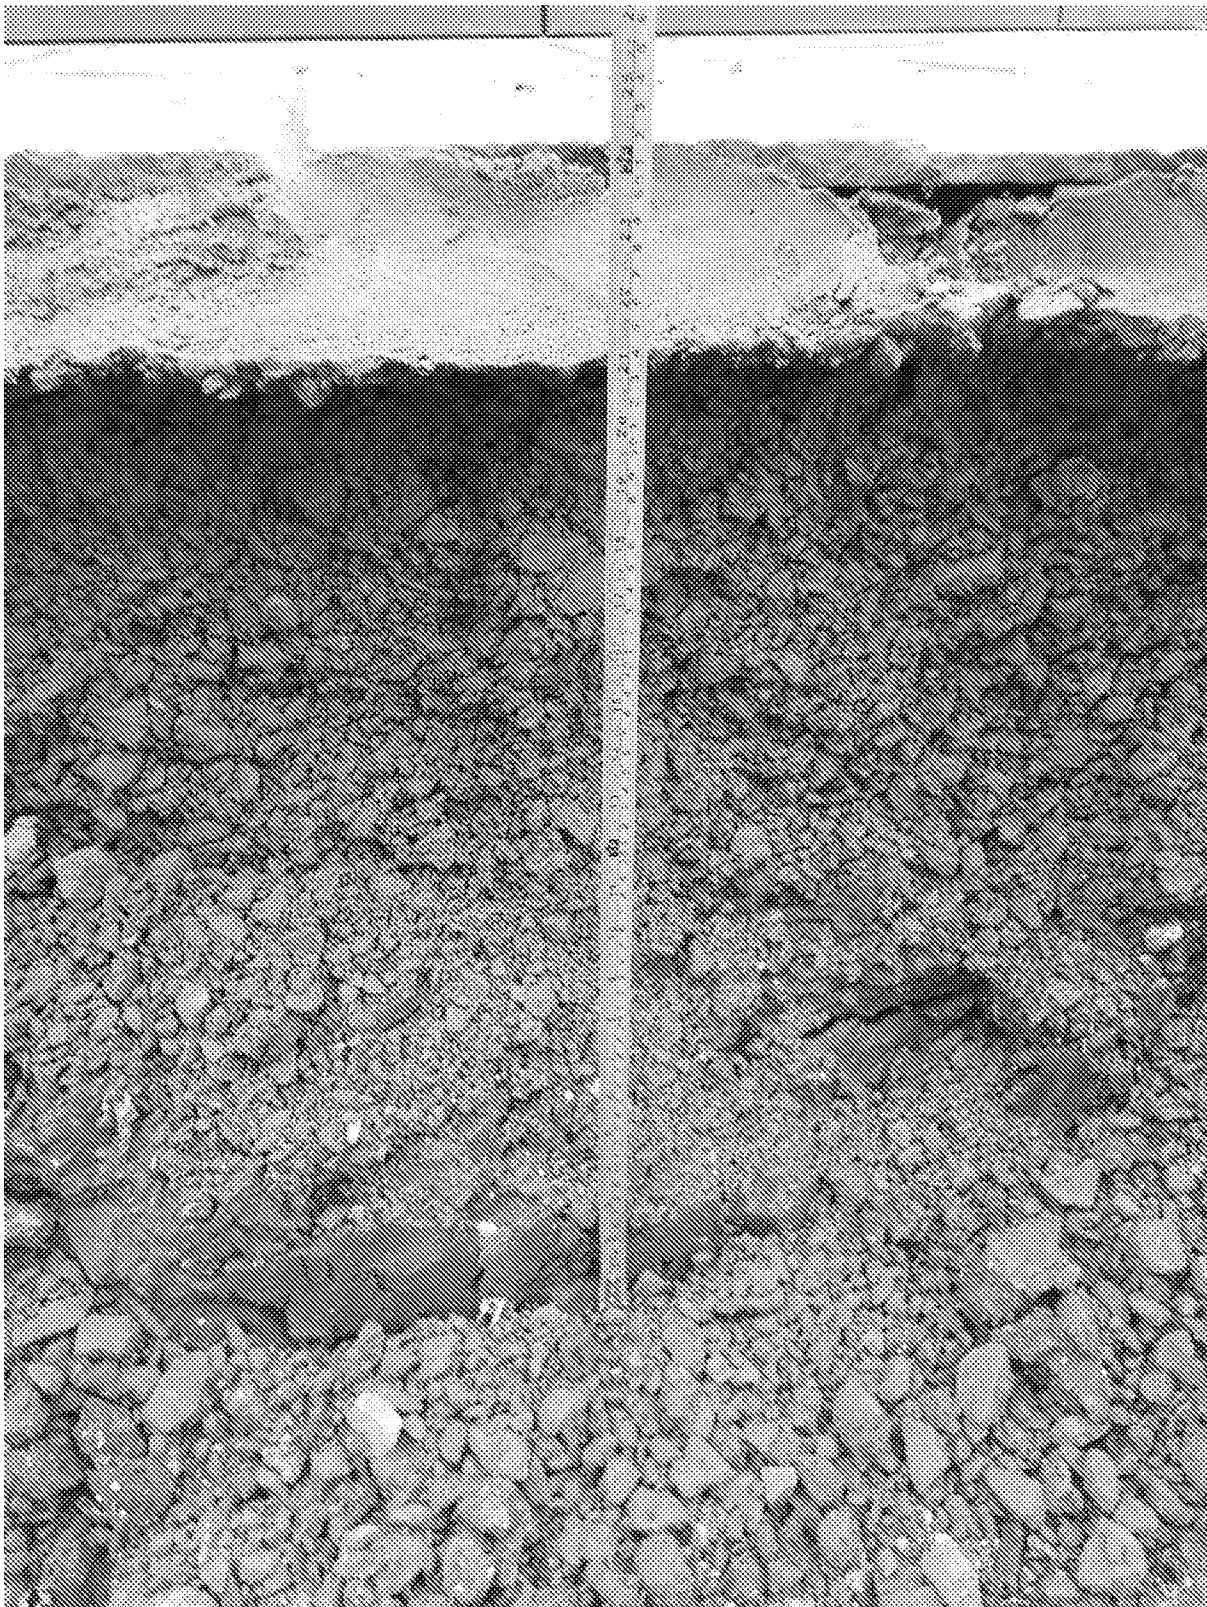
**Figure 17 – Confirmation that 600mm depth has been achieved in west of site.**

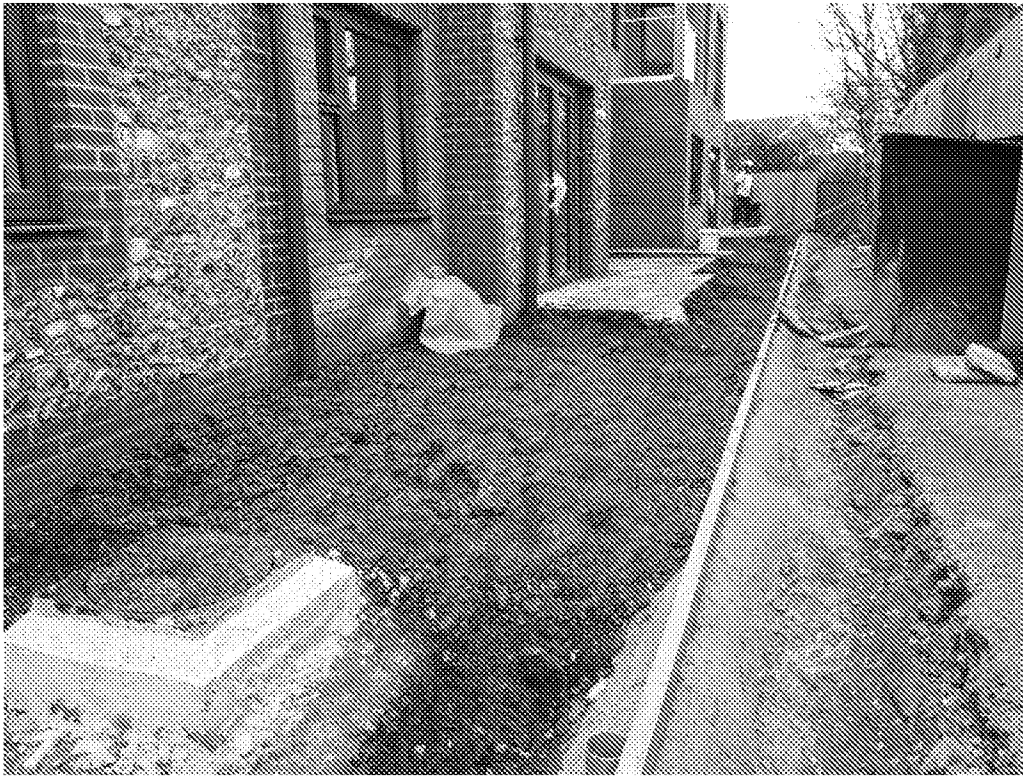
**Figure 18 – Imported topsoil being during placement within excavated area in west of site. Right of the image is an area which will form a public footpath outside the finished site boundary.**

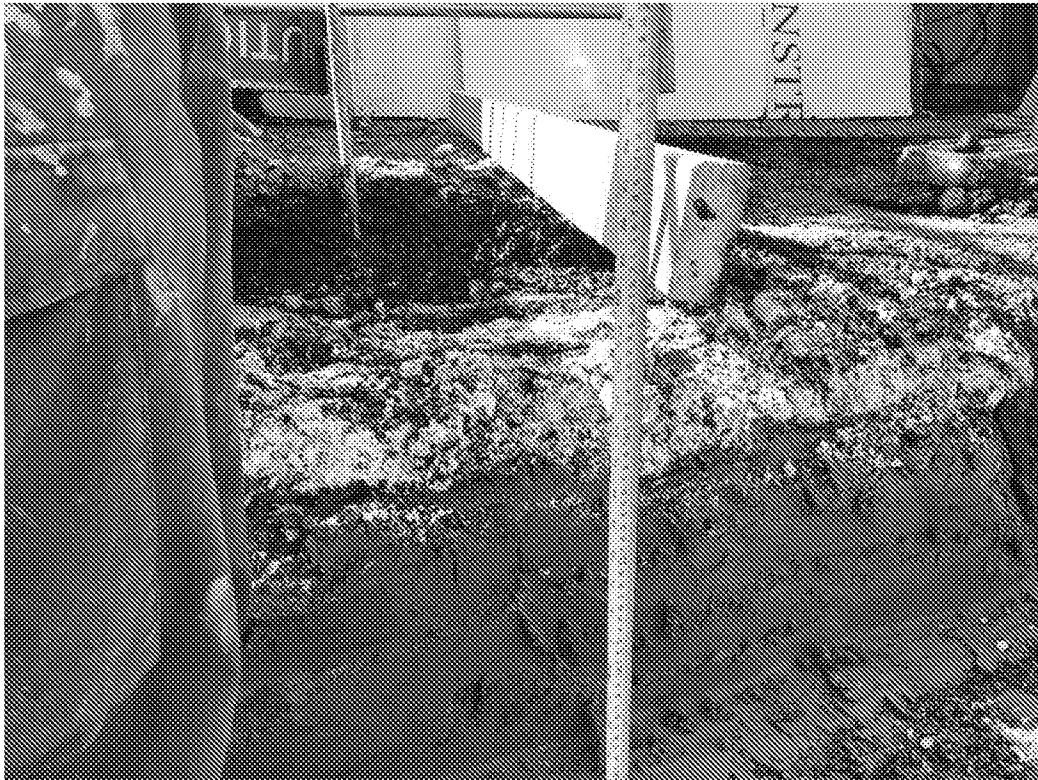
**Figure 19 – Confirmation that 600mm has been achieved in soft landscaping areas in the north of site (photograph supplied by Hackwood Homes Ltd on 03/04/2019).**
