# **PHOTOGRAPHIC SCHEDULE: EXISTING FARMHOUSE**

**REPLACEMENT FARMHOUSE, FARM OFFICE & EQUESTRIAN FACILITIES**

**GOOSE GREEN, HOE LANE, BINSTED, ARUNDEL, BN18 OLQ.**

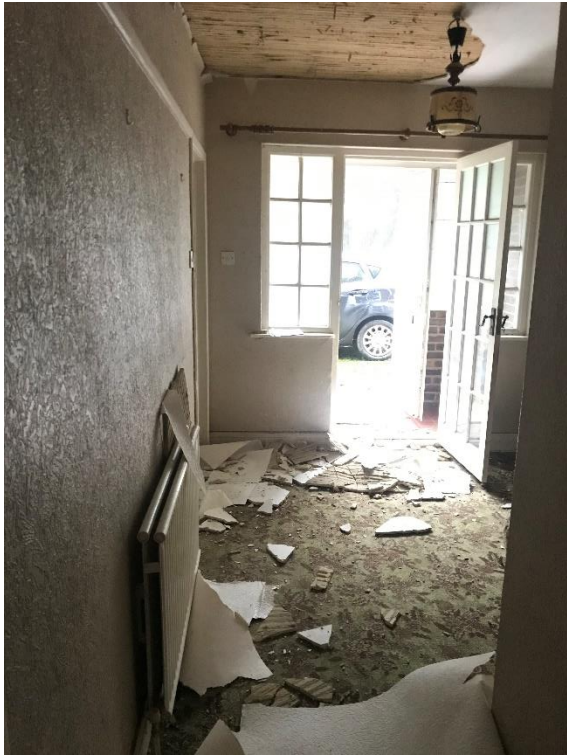
**Plate VI : Ground floor entrance hall – damaged ceiling**

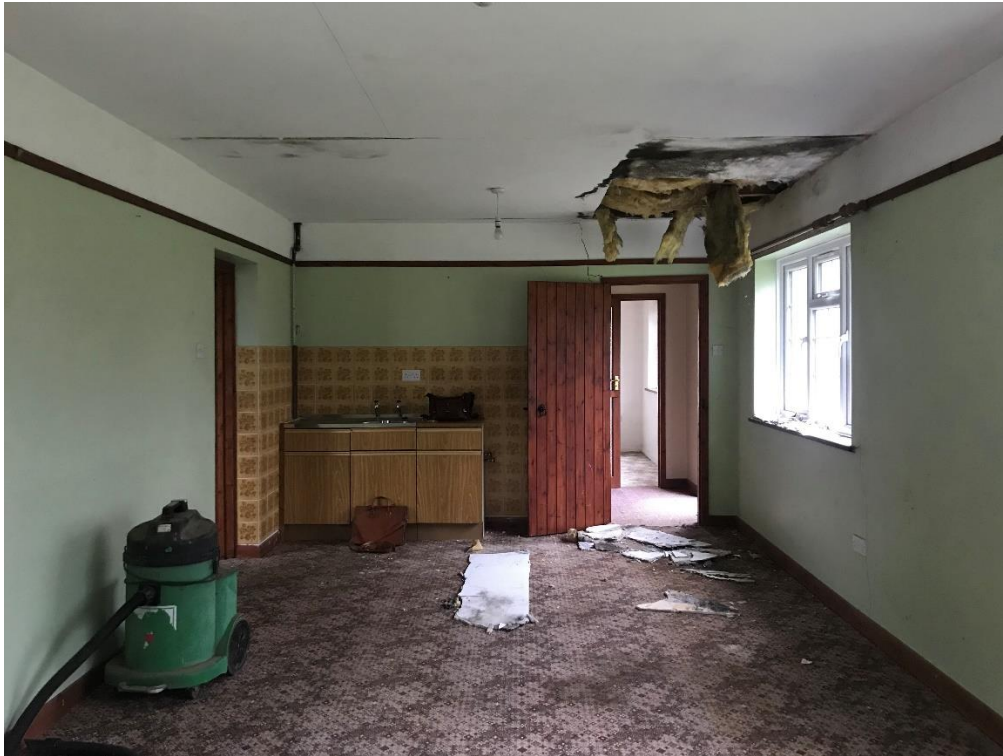
**Plate VIII : Ground floor dining room – damaged ceiling with water ingress to the failing roof covering**

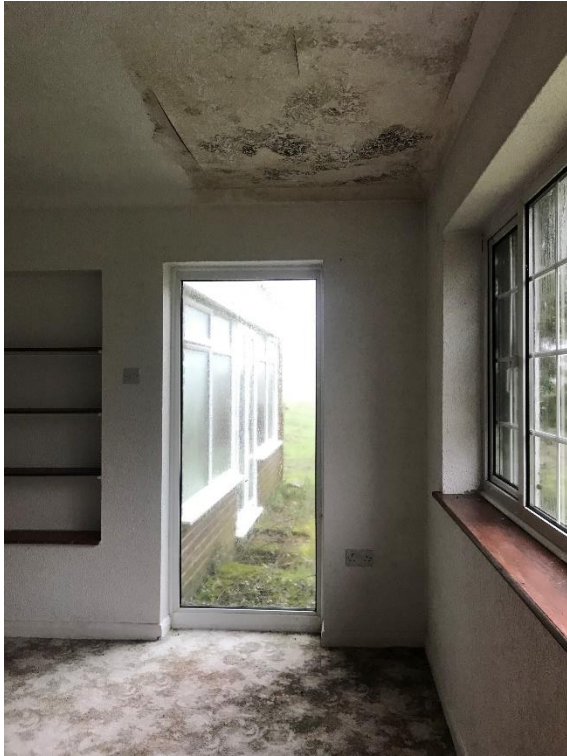
**Plate X : Ground floor rear reception room – Further water ingress damage to ceilings**

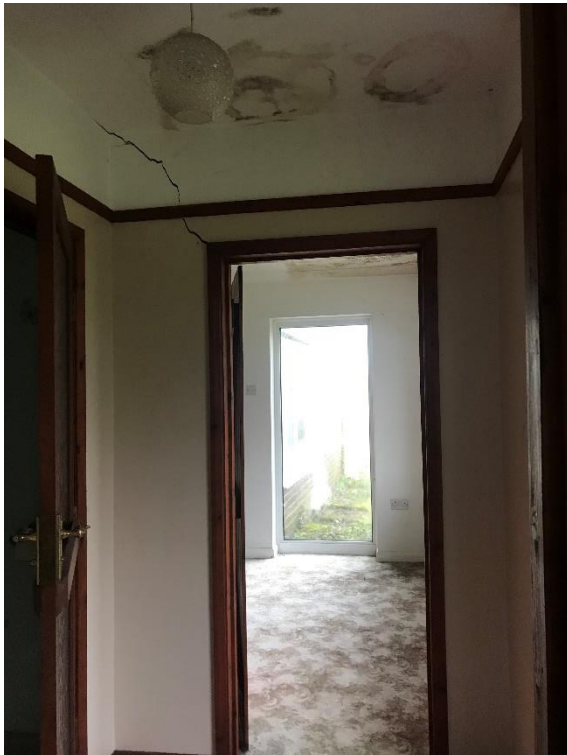
**Plate XI : Rear ground floor - Structural cracking and water damage**

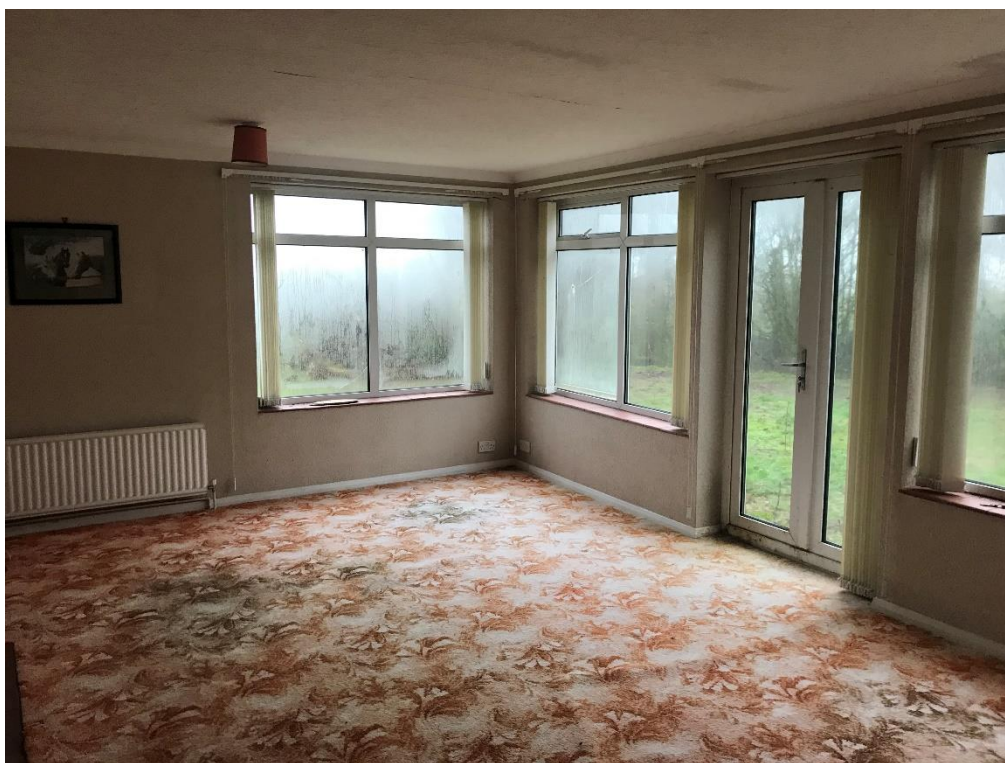
**Plate XII : Ground floor rear flat roofed area – Damp ingress to ceiling and failed glazing**

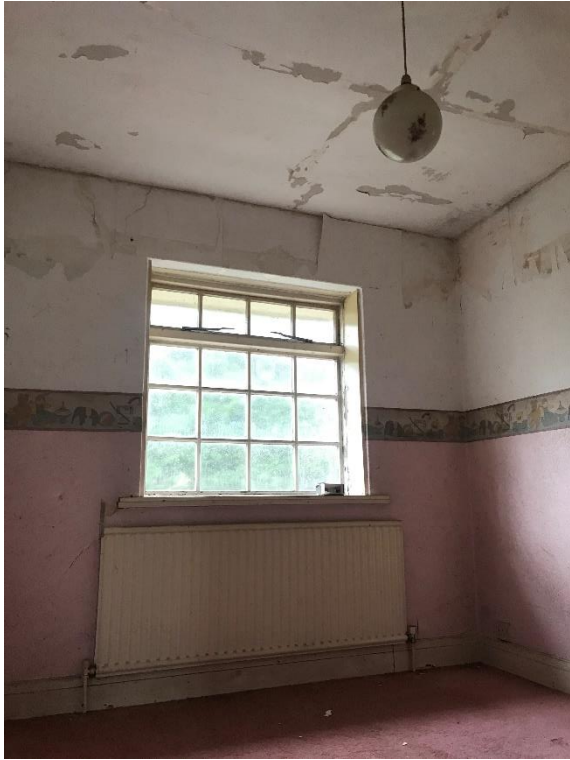
**Plate XIV : First floor – front bedroom with signs of rainwater ingress.**
