Project Name: Sussex Business Village

Project Description: CCTV Survey, Trace & Plot

Inspection Standard: MSCC5 Sewers & Drainage GB (SRM5 Scoring)

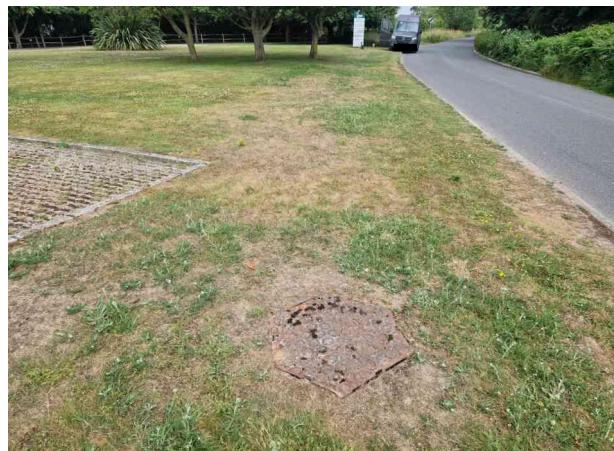
SW1 (Assumed to connect to HW2)

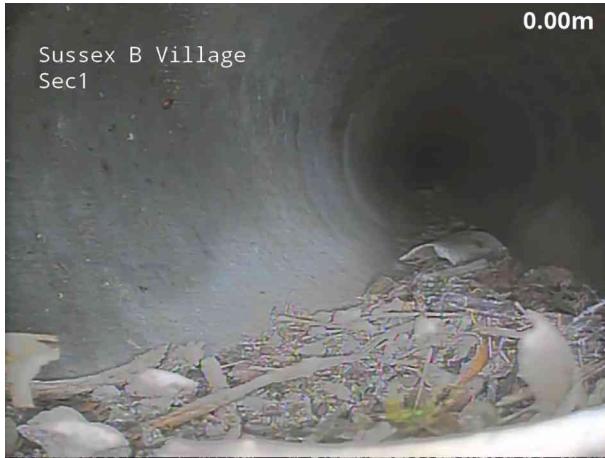
| No. | m+ | Code | Observation |
|---|---|---|--|
| 3 | 0.00 | DER | Settled deposits, coarse, 5% cross-sectional area loss, start |

1, 00:00:04, 0.00 m
Settled deposits, coarse, 5% cross-sectional area loss, start

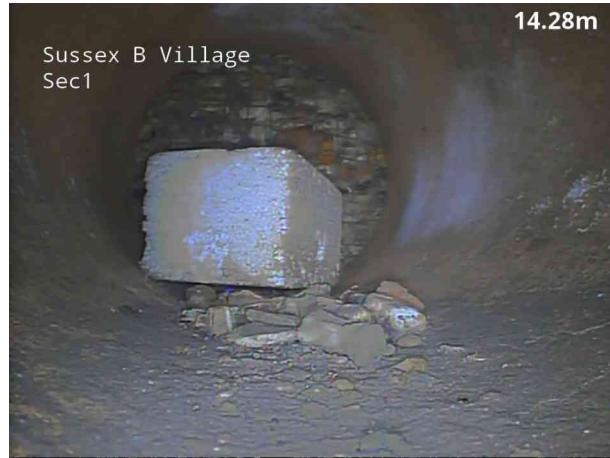
| No. | m+ | Code | Observation |
|---|---|---|--|
| 4 | 15.00 | DER | Settled deposits, coarse, 5% cross-sectional area loss, finish |

2, 00:01:33, 15.00 m
Settled deposits, coarse, 5% cross-sectional area loss, finish

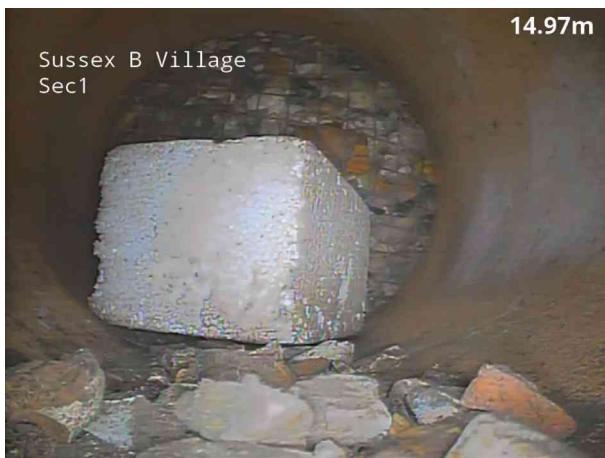
Grade 5: Best practice suggests that this pipe is at a high risk of backing up or causing flooding.

| Section | PLR | Grade | Description |
|---|---|---|---|
| 1 | HW2X | 5 | Other obstacles from 5 o'clock to 10 o'clock, 60% cross-sectional area loss |

| No. | m+ | Code | Observation |
|---|---|---|--|
| 5 | 15.00 | OBZ | Other obstacles from 5 o'clock to 10 o'clock, 60% cross-sectional area loss, Polystyrene block |

3, 00:01:45, 15.00 m
Other obstacles from 5 o'clock to 10 o'clock, 60%
cross-sectional area loss, Polystyrene block

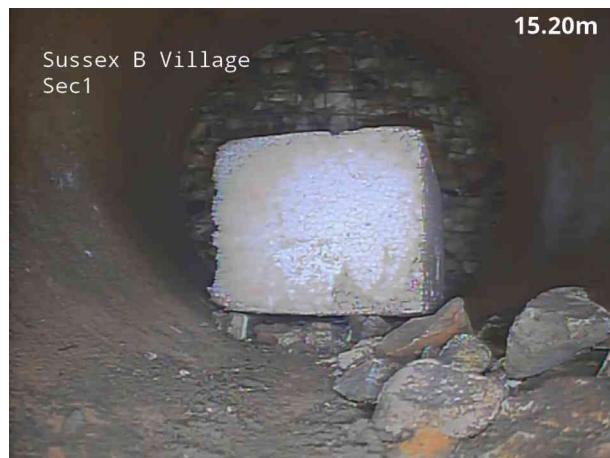
| No. | m+ | Code | Observation |
|---|---|---|--|
| 6 | 15.20 | OFF | Finish node, outfall, reference: HW2, Buried fine gauge grill retaining shingle. |

4, 00:01:55, 15.20 m
Finish node, outfall, reference: HW2, Buried fine gauge grill
retaining shingle.
