**Project Name:** Park Rd Culvert - Barnham

**Project Description:** Culvert Survey

**Inspection Standard:** MSCC5 Sewers & Drainage GB (SRM5 Scoring)

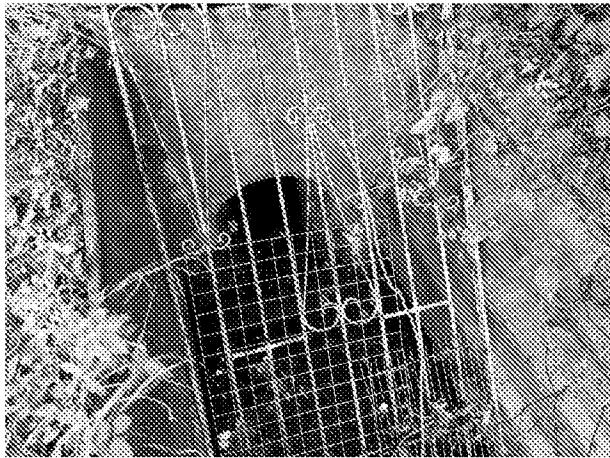
**1, 0.00 m**

Start node, outfall, reference: HW1, Located within private grounds

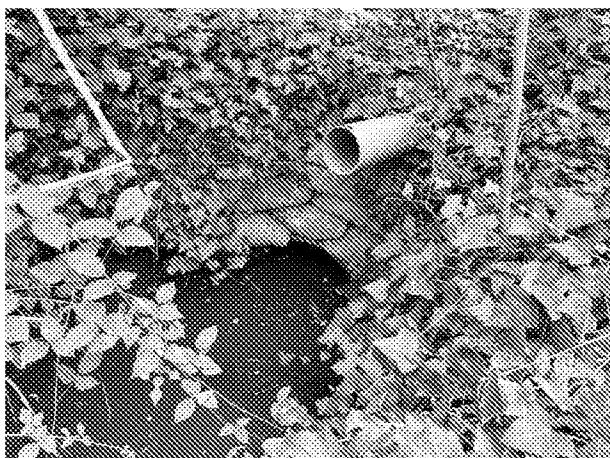
**3, 55.00 m**

Finish node, outfall, reference: HW2, Unable to carry out full CCTV survey due to permissions.

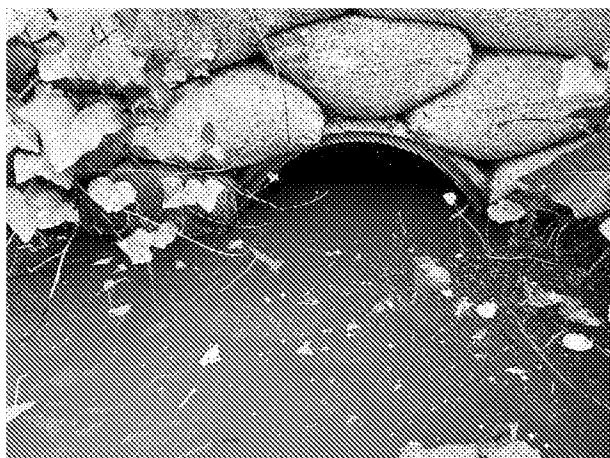
**4, 55.00 m**

Finish node, outfall, reference: HW2, Unable to carry out full CCTV survey due to permissions.
