**Report of Bat Survey  
(including Barn Owls)**

**conducted  
on stables and a barn  
at  
Wandleys Farm  
Walberton  
on  
16<sup>th</sup> January 2008**

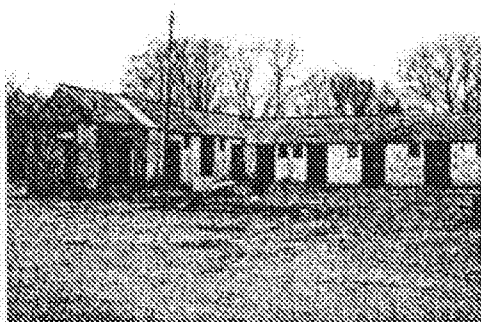
Southern end of large stable block

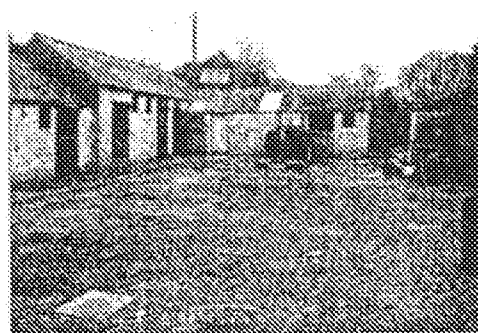
Northern end of large stable block

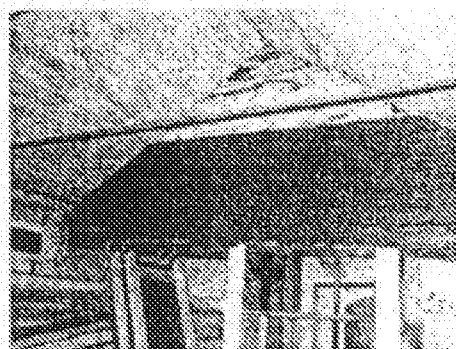
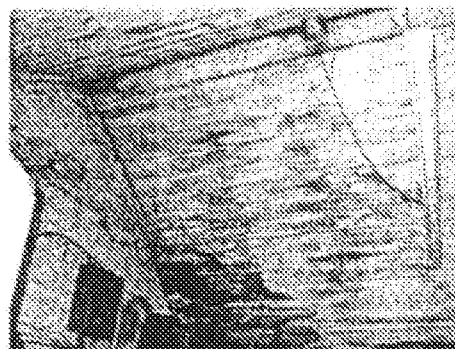
The small section of roof which had been lined over a tack room could be viewed well from the ground due to its low height. The slate tiles were tightly fitted and no evidence could be seen externally to suggest that bats were accessing this area in any numbers. There was a small space into the ridge but there was no evidence to suggest that this was accessed by numbers of bats. Internally the boarding was poorly fitted at the eastern end and was damaged. There were no bat droppings falling from these areas.

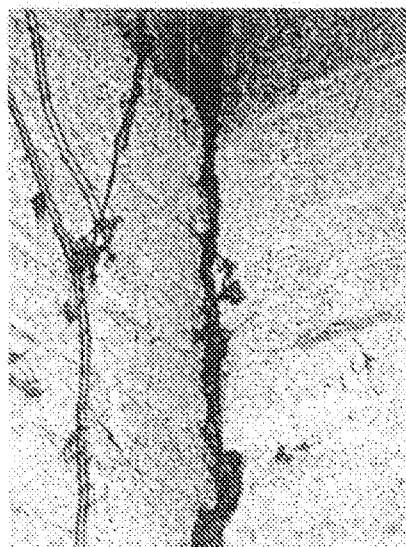
There were two large cracks in the corners of stables on the southern end large enough for bats to enter, one is shown below.

These were considered and no evidence was seen to suggest that bats had or were accessing these spaces which were very dusty, with cobwebs and debris within them

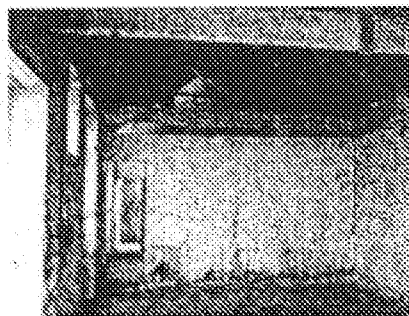
The stables were divided by wooden partition walls fitted to the eaves as shown below and brick walls between the main stable sections.

The partition walls appeared to be a wooden supporting structure with planking either side providing a wooden cavity. This cavity was accessible to animals where the partition wall butted up to the outer brick walls but the surveyor did not see any evidence to suggest that bats were accessing this space most of which appeared to be very dusty and well cobwebbed. Most of the partition wall was in good condition with planks fitting tightly.

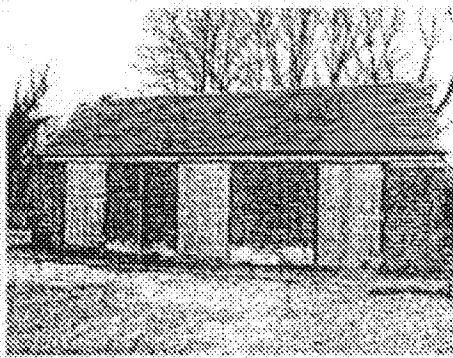
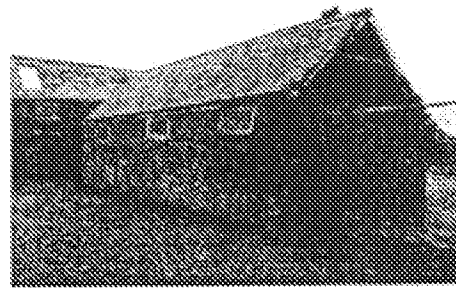
A small rectangular block of three stables lay along side the lane and to the south of the large stable block. The walls were brick and the gable ends to the north and south of the building were damaged and open from the eaves up to the ridge as shown in the photo on the right above.

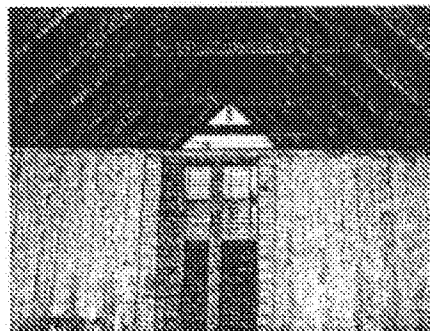
A damaged box which appeared to be an owl box was fitted into the southern end of the stables. This was completely open due to the loss of the end of the wall and there was no evidence seen to suggest that this was utilised by owls currently.

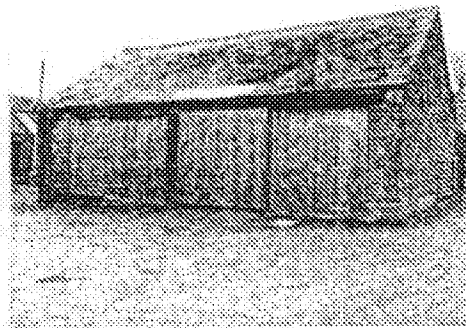
East facing side of barn with wooden doors

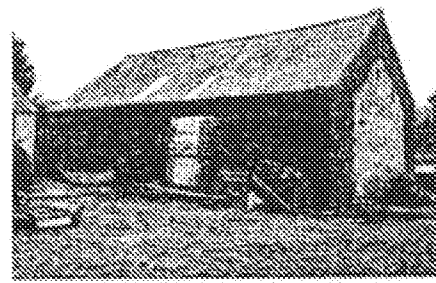
West facing elevation

There was some damage to the brickwork on the southern and northern ends of the west facing wall and to the southern wall where a building had previously been attached but there was no evidence seen to suggest that bats were utilising these areas.
