Green Lane Forestry LLP

## Application for tree works: work to tree(s) in a conservation area

**Location:** The Old Apple Store, The Street, Walberton, West Sussex, BN18 0PJ

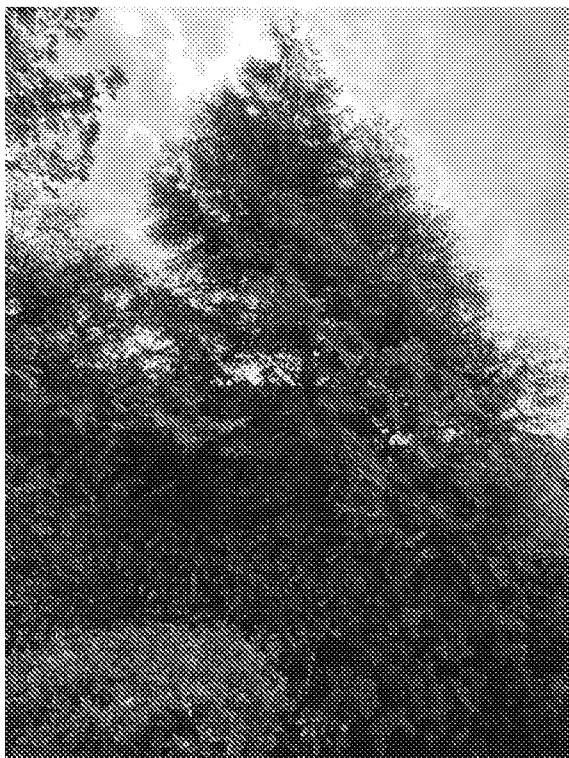
**4.2.1** Causing damage to wall; The roots of the tree are causing subsidence damage with the trunk pushing against the wall in the wind (*Figures. 1 & 11*).

*Figure. 1 Cypress (T3)*

**4.1** Removal of entire tree.

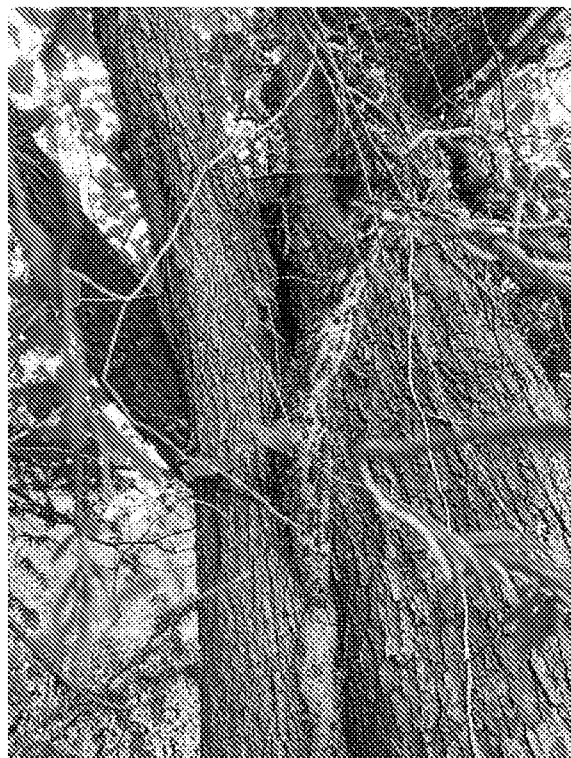
1.2.2 Damage to the stem; several small wounds on the trunk are allowing water ingress and rot.

*Figure. 2 Hawthorn trunk (T5)*

1.1 Removal of the entire tree.

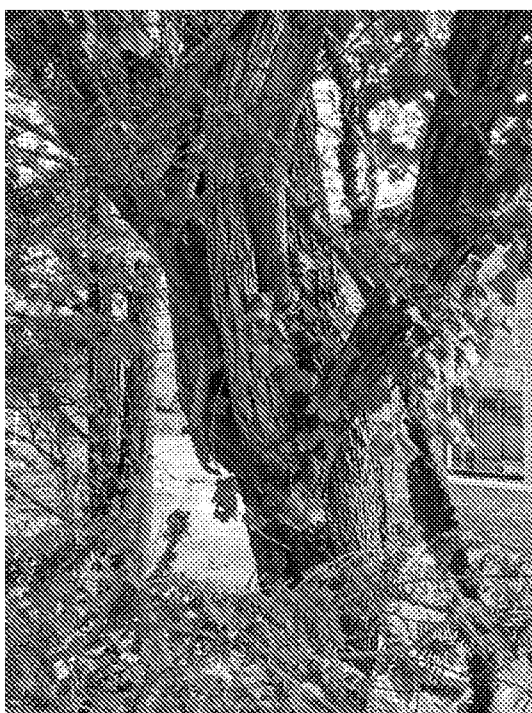
*Figure. 3 Hawthorn stem (T5)*

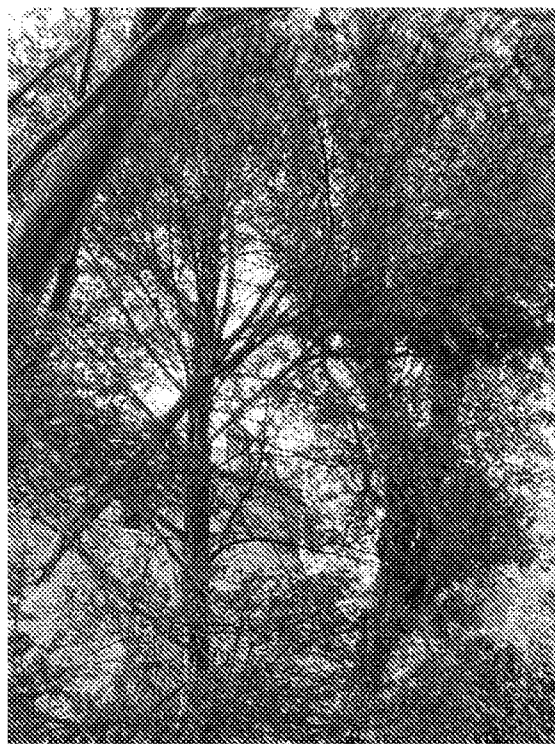
**3.2.1** Dead wood and dying off, this tree comprises of 70% dead or dying to 30% living wood. The tree regularly drops its dead limbs on to the driveway. If the tree is not removed it will eventually drop limbs on the buildings.

*Figure. 6 Dead branch from Maple (T1)*

**3.1** Removal of entire tree.

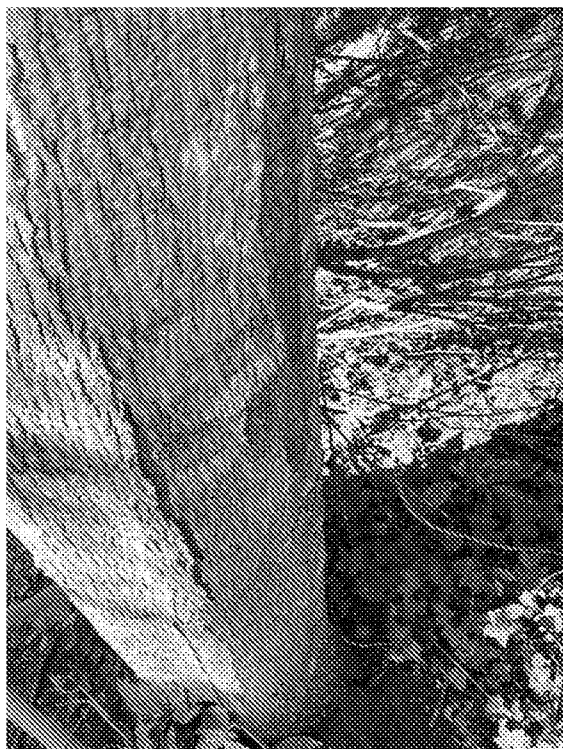
**3.2.2** Heavily leaning, this tree is heavily leaning and has cracks appearing on the stem, it will likely fall if left (*Figures. 7, 9, 10, 13*).

*Figure. 7 Maple stem (T1)*

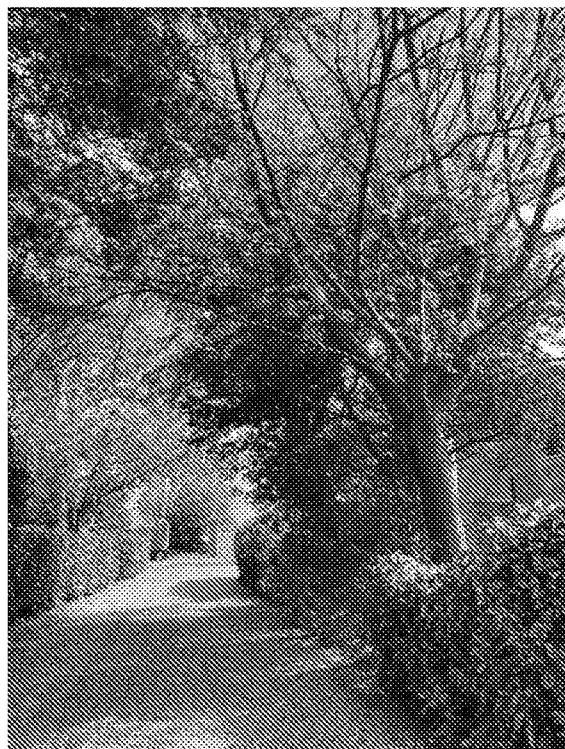
**2.2.2** Shadowing the ground; the shadow cast by this tree and others is preventing anything from growing under the canopy, ground-level plant growth would greatly benefit the area (*Figure. 8*).

*Figure. 8 Trees overhanging driveway*

**2.1** Removal of the entire tree.

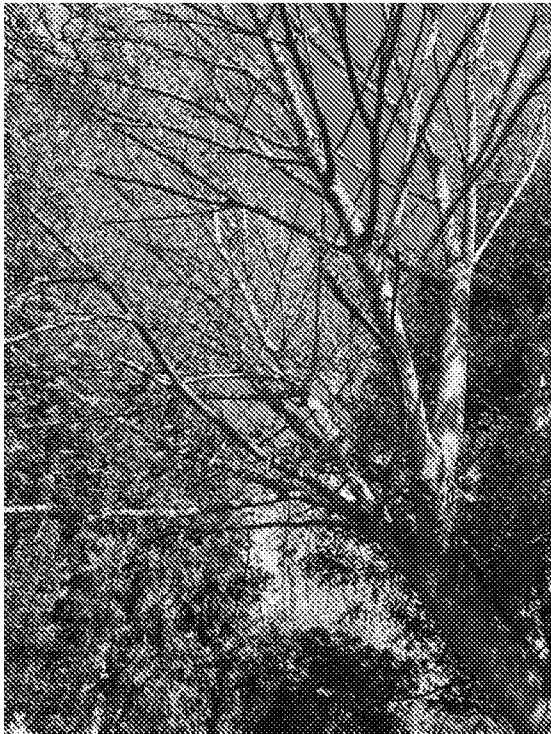
*Figure. 9 Maple (T1)*

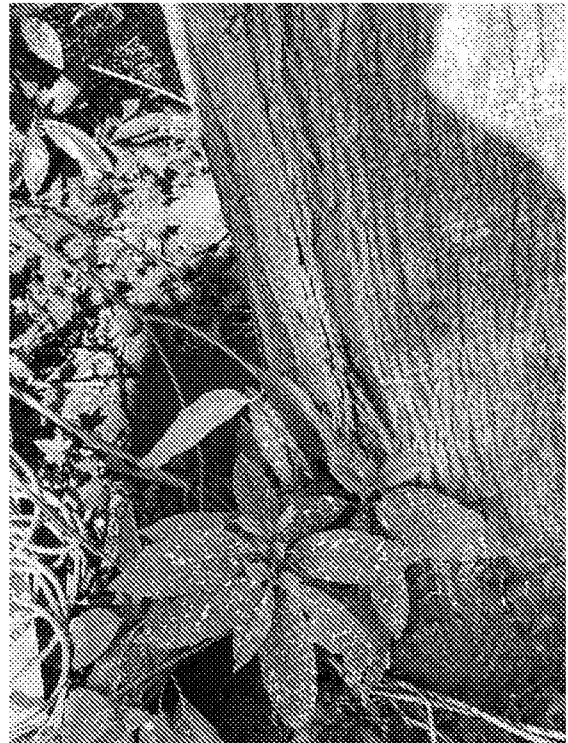
*Figure. 10 Maple stem damage (T1)*

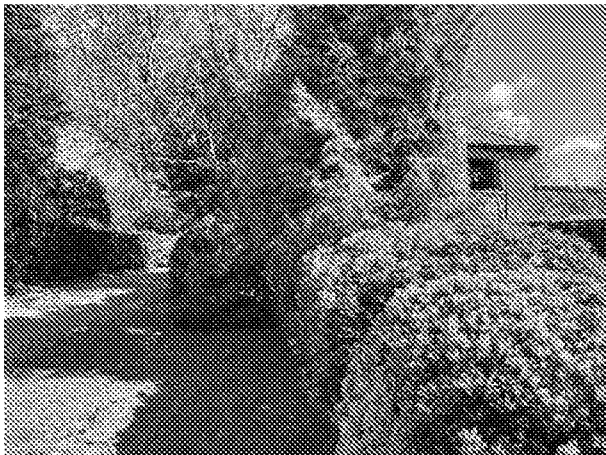
*Figure. 11 Cypress (T3)*

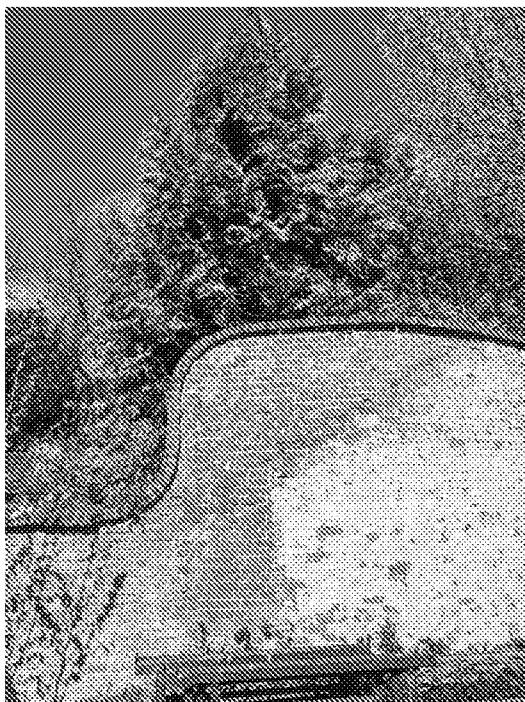
*Figure. 13 Cypress (T3)*

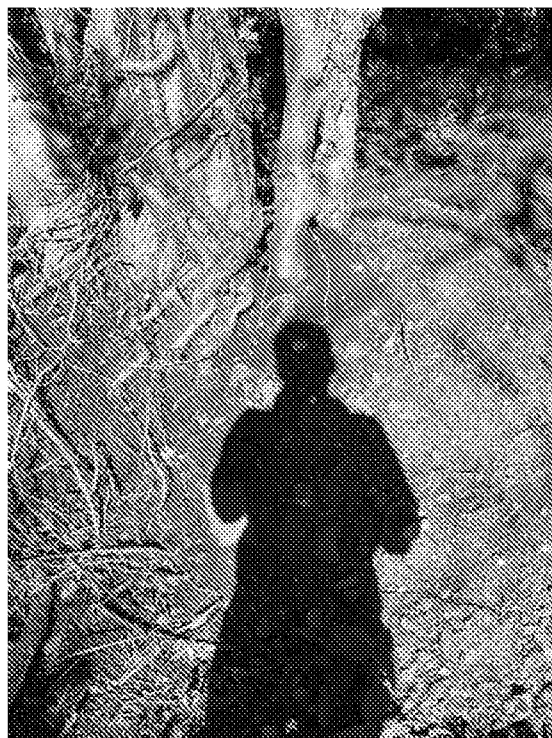
**5.2.1** Heavily leaning and uprooting; this very leggy multi-stemmed holly tree is situated underneath a large lime tree, this has led the tree to look for light elsewhere, causing it to be weighted heavily on one side. Roots are starting to lift (*Figure. 14*).

*Figure. 14 Holly Stem (T4)*

#### **5.1 Removal of entire tree.**

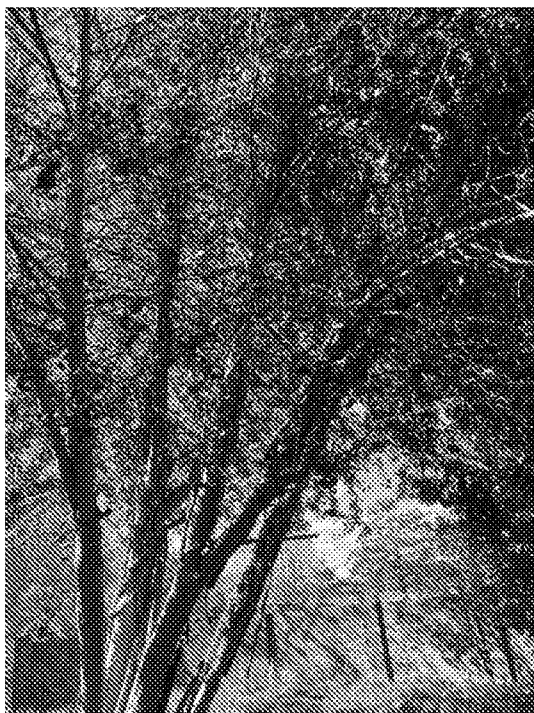
**5.2.2** Interfering with other trees, as the grows towards available light, it is growing into other, healthier trees (*Figure. 15*).

*Figure. 15 Holly (T4)*

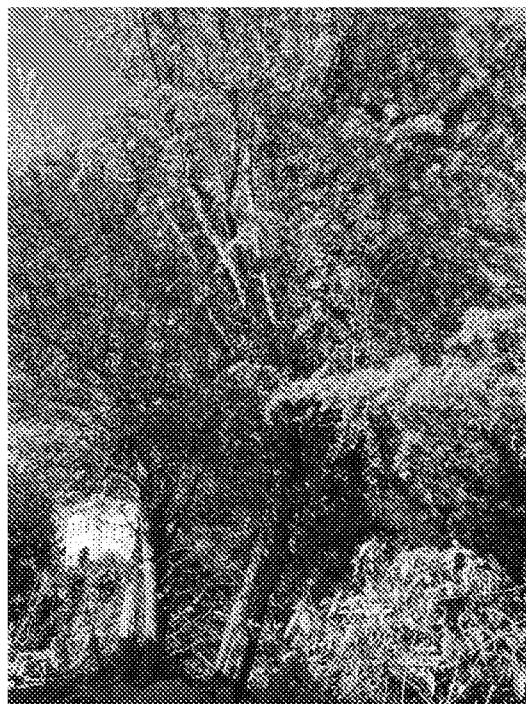
1.2.3 Competing with other trees (*Figure. 16*); this tree is positioned next to other equally unhealthy trees and in the shadow of other much larger trees situated to the east. This is causing the tree to recede, and slowly die off.

*Figure. 16 Hawthorn (T5)*
