## ALL HOURS PLUMBING

| Project Name:<br>Tye Lane | Contract Number: | Contact:<br>Aeropark | Date:<br>14/04/2026 |

Inspection Report

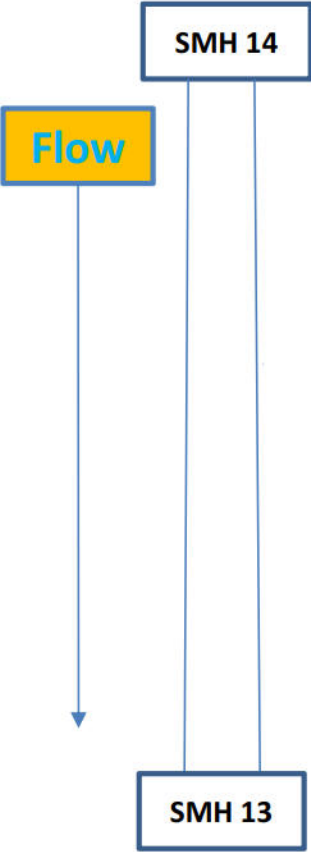
0.0M ST Start Of Survey  
0.0M WL Water Level 0 %

5.0M JN Line Drops In From The Left

6.1M JN Line Drops In From The Right

13.1M MH Camera Enters Manhole S 13

REM ; THERE ARE NO MAJOR DEFECTS WITH THIS SECTION OF PIPE

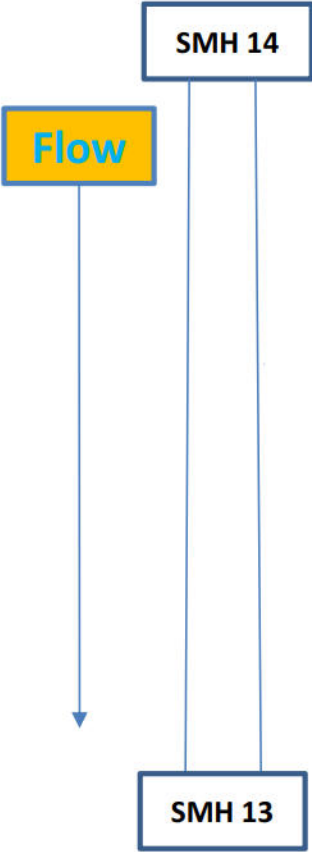
0.0M ST Start Of Survey  
0.0M WL Water Level 0 %

5.0M JN Line Drops In From The Left

6.1M JN Line Drops In From The Right

13.1M MH Camera Enters Manhole S 13

REM ; THERE ARE NO MAJOR DEFECTS WITH THIS SECTION OF PIPE

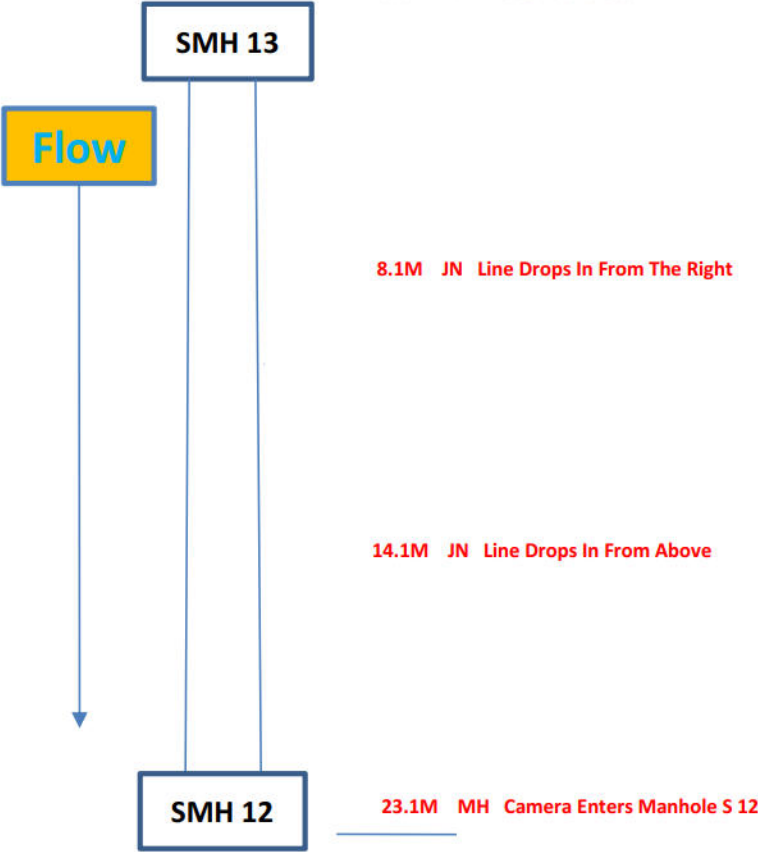
0.0M ST Start Of Survey  
0.0M WL Water Level 0 %

REM ; THERE ARE NO DEFECTS WITH THE PIPEWORK BUT THERE IS DEBRIS IN THE LINE, WE HAVE TRIED TO REMOVE AS MUCH AS WE CAN BY BACK JETTING THE LINE AS UNABLE TO GET LORRY NEAR TO MANHOLE S 12

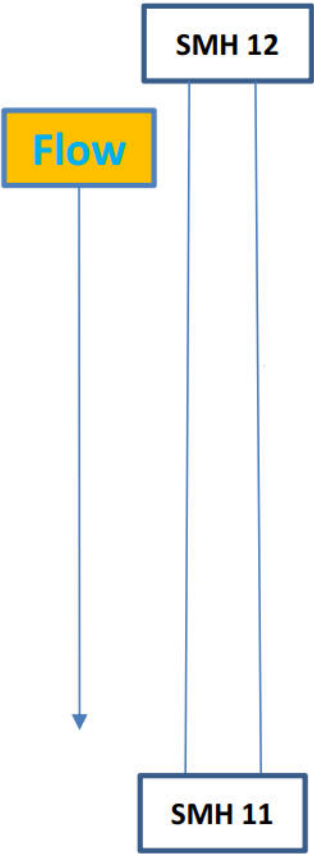
0.0M ST Start Of Survey  
0.0M WL Water Level 0 %  
1.9M JN Line Drops In From Above

REM ; THERE ARE NO MAJOR DEFECTS WITH THIS SECTION OF PIPE

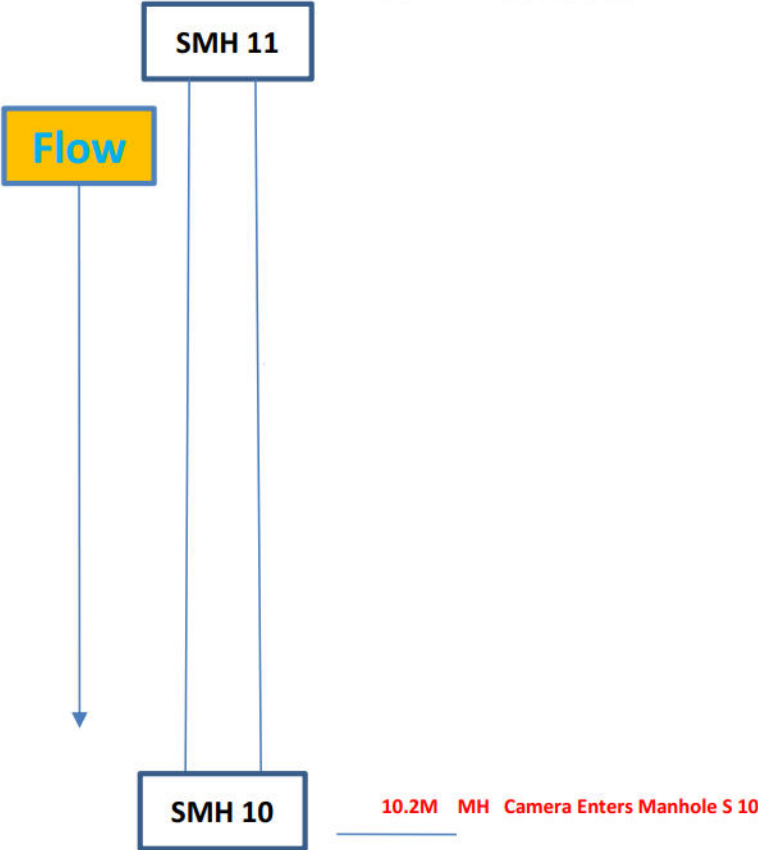
0.0M ST Start Of Survey  
0.0M WL Water Level 0 %

REM ; THERE ARE NO MAJOR DEFECTS WITH THIS SECTION OF PIPE

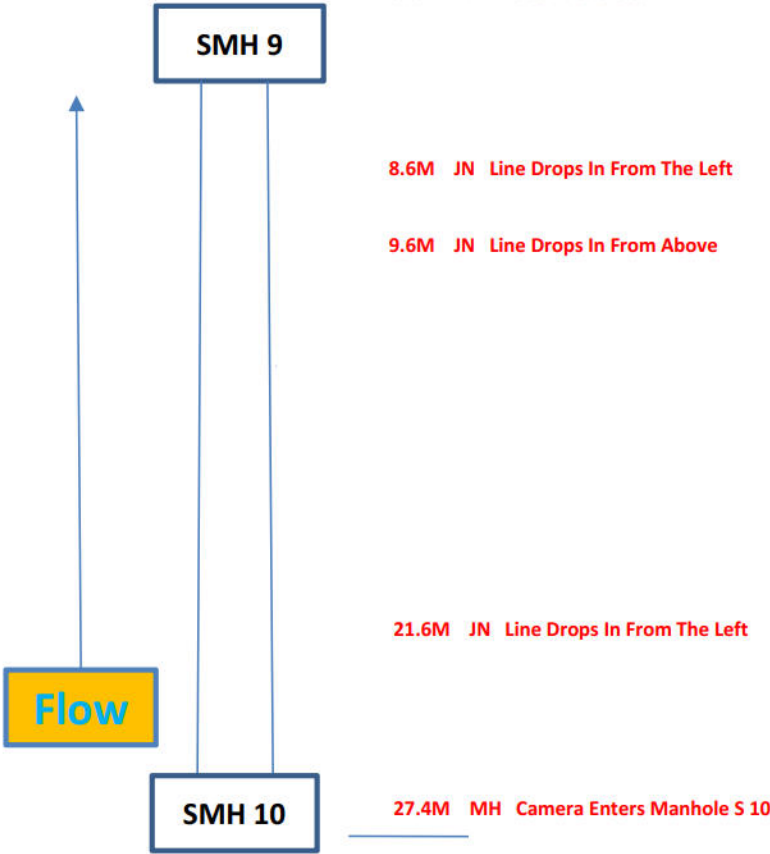
0.0M ST Start Of Survey  
0.0M WL Water Level 0 %

REM ; THERE ARE NO MAJOR DEFECTS WITH THIS SECTION OF PIPE

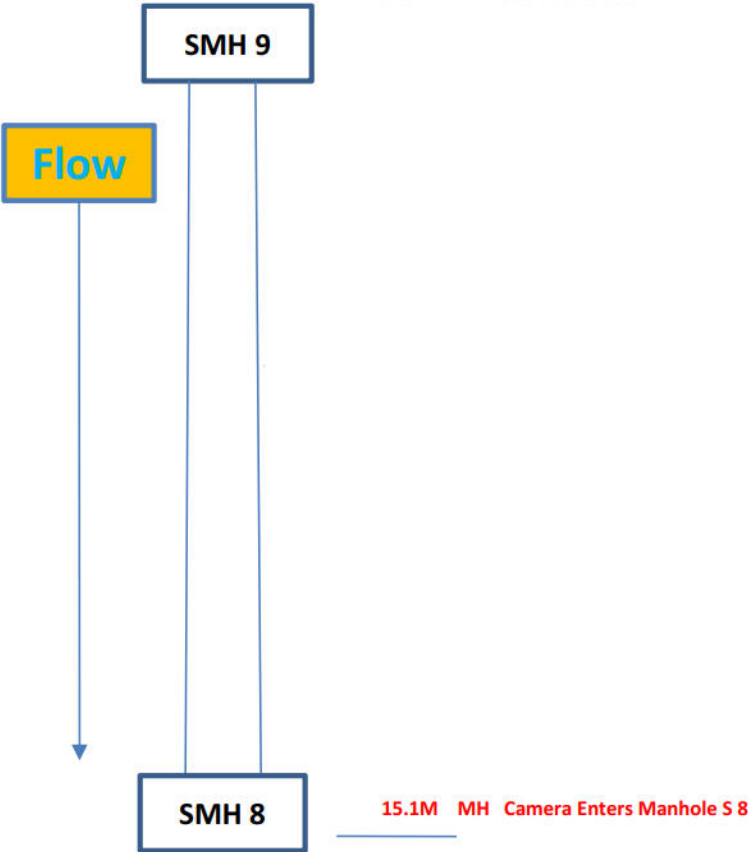
0.0M ST Start Of Survey  
0.0M WL Water Level 0 %

REM ; THERE ARE NO MAJOR DEFECTS WITH THIS SECTION OF PIPE
