## ALL HOURS PLUMBING

### Project-Information

| Project Name:<br><b>Tye Lane</b> | Contract Number: | Contact:<br><b>Aeropark</b> | Date:<br><b>18/05/2026</b> |

Inspection Report

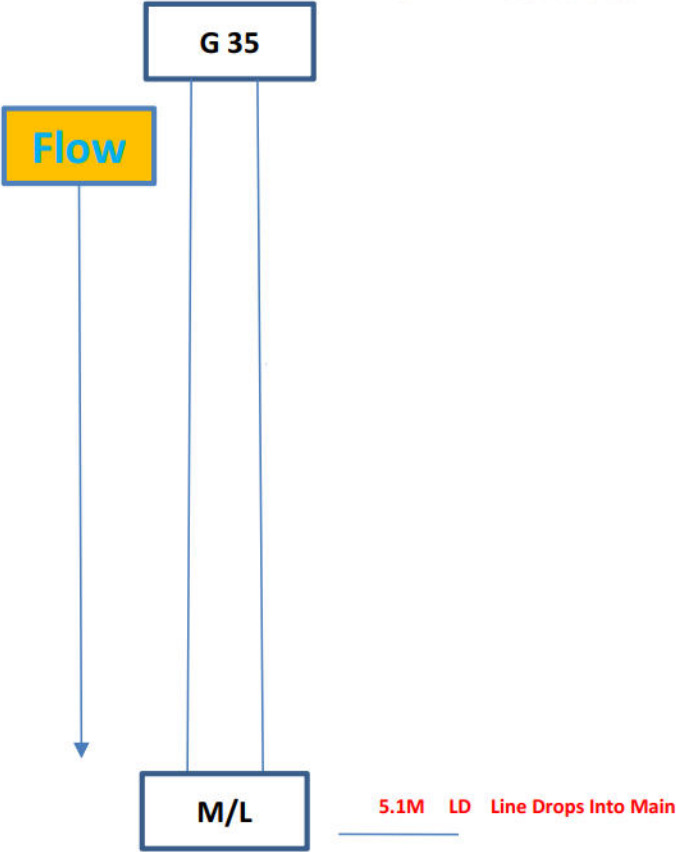
0.0M ST Start Of Survey  
0.0M WL Water Level 0 %

REM ; THERE ARE NO MAJOR DEFECTS IN THIS SECTION OF PIPE THE CONCRETE HAS BEEN REMOVED

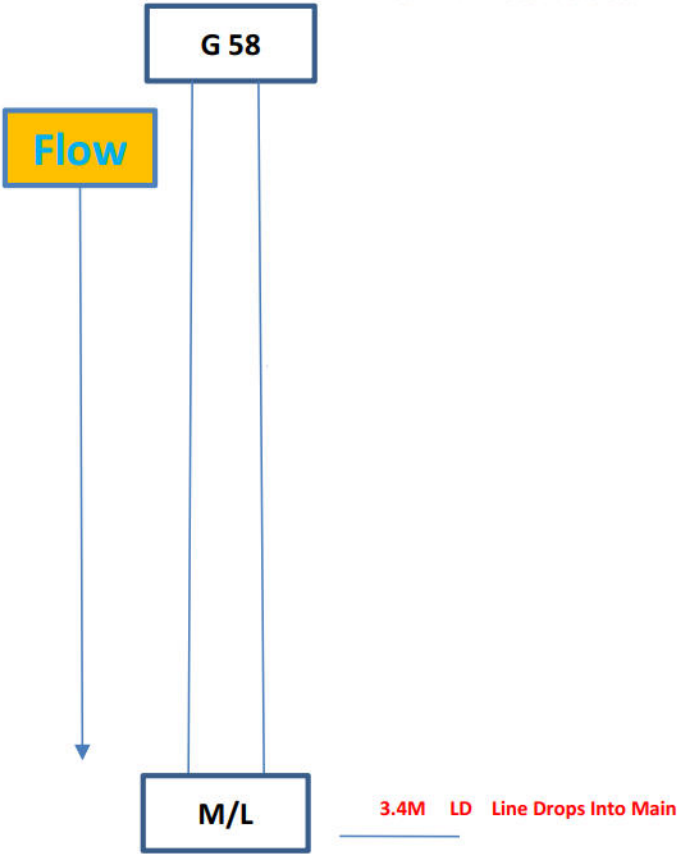
0.0M ST Start Of Survey  
0.0M WL Water Level 0 %

REM ; THERE ARE NO MAJOR DEFECTS IN THIS SECTION OF PIPE THE CONCRETE HAS BEEN REMOVED

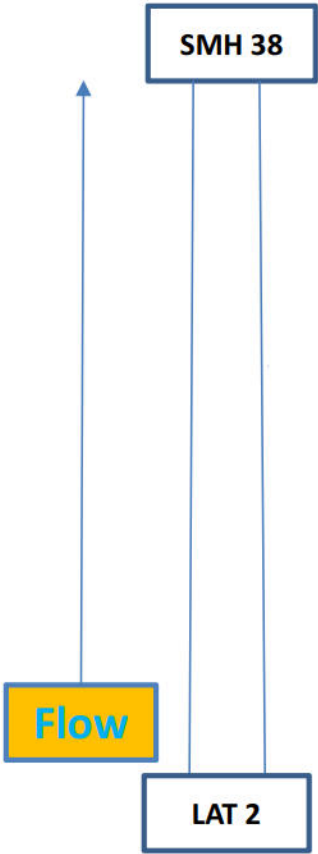
4.6M ST Start Of Patch Liner  
5.2M ED End Of Patch Liner

10.1M PR Pipe Reduces To 100MM

REM ; THERE ARE NO MAJOR DEFECTS IN THIS SECTION OF PIPE THE LINE HAS BEEN PATCH REPAIRED

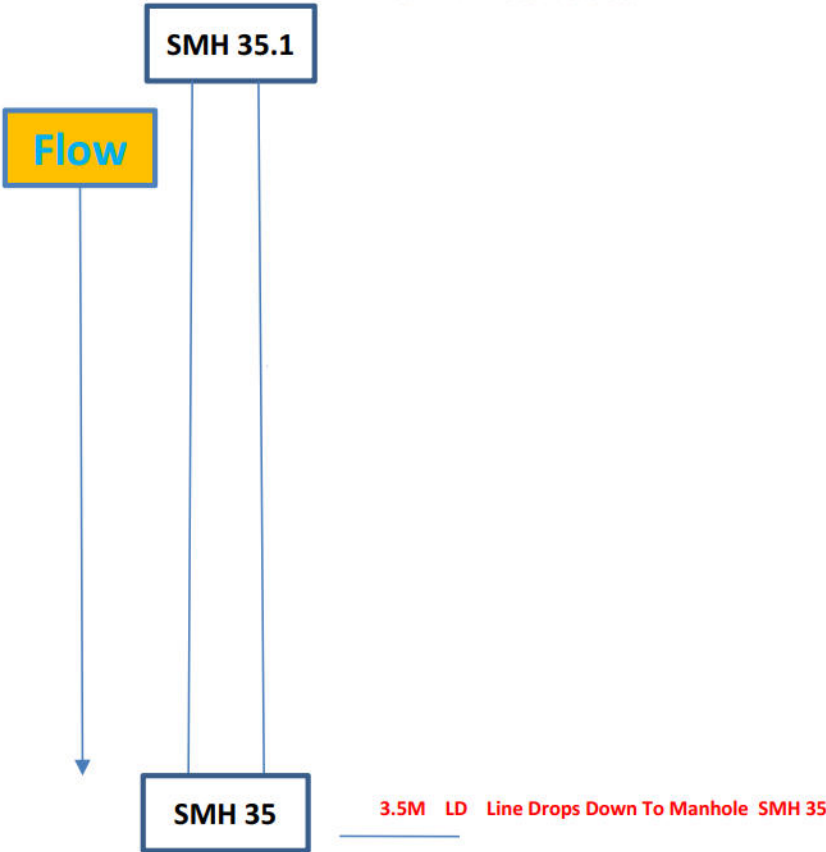
REM ; THERE ARE NO MAJOR DEFECTS IN THIS SECTION OF PIPE

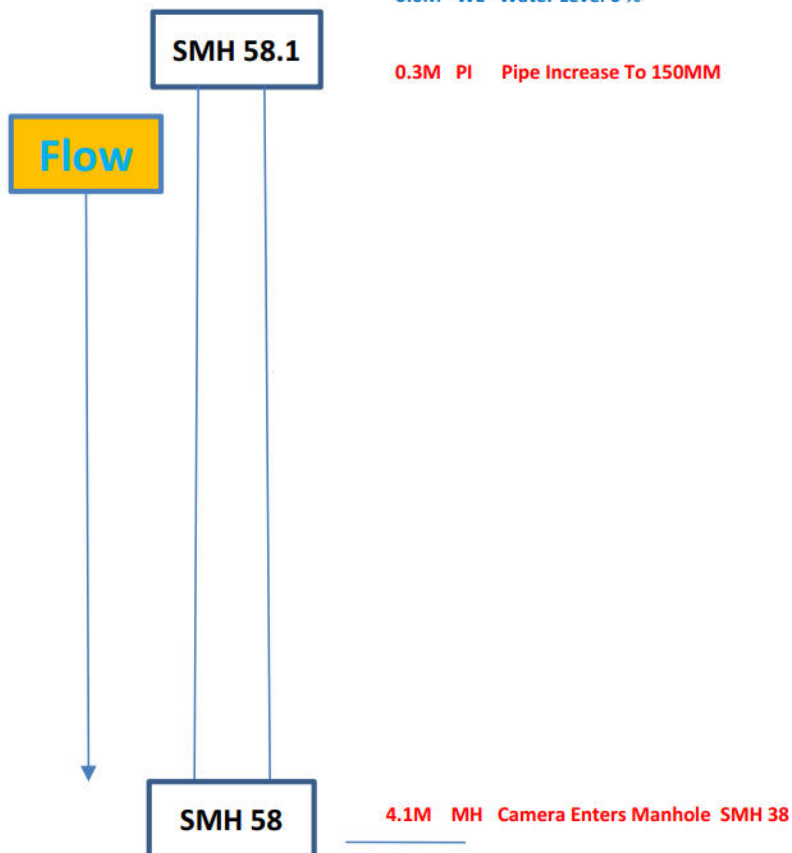
0.3M PI Pipe Increase To 150MM

REM ; THERE ARE NO MAJOR DEFECTS IN THIS SECTION OF PIPE

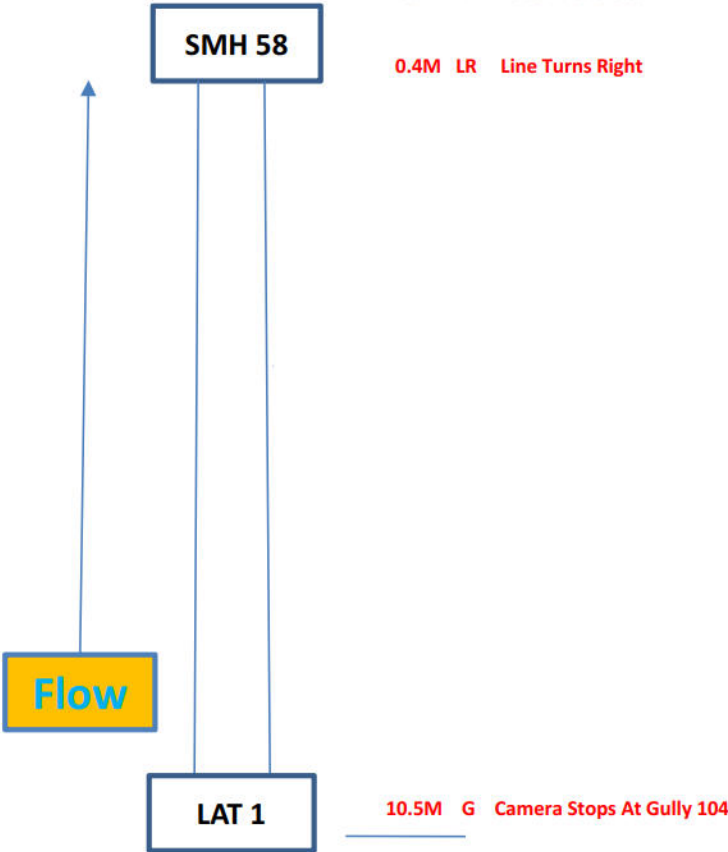
0.4M LR Line Turns Right

REM ; THERE ARE NO MAJOR DEFECTS IN THIS SECTION OF PIPE

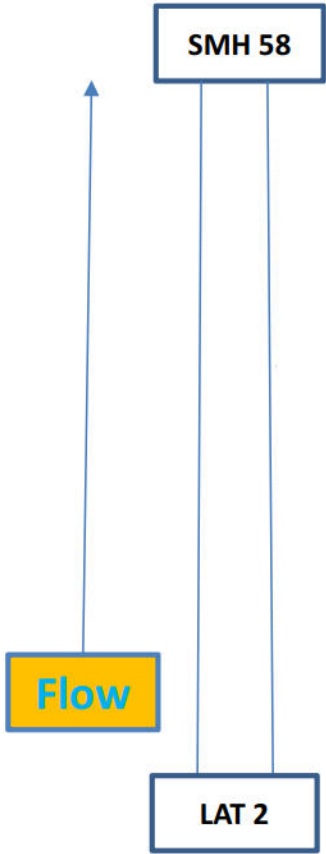
6.4M PD Deformity In Bottom Of Pipe

9.7M PD Deformity In Bottom Of Pipe

REM ; THERE ARE A COUPLE OF DEFORMITIES IN THIS SECTION OF PIPE, THIS COULD HAVE BEEN IN MANUFACTOR OF PIPE

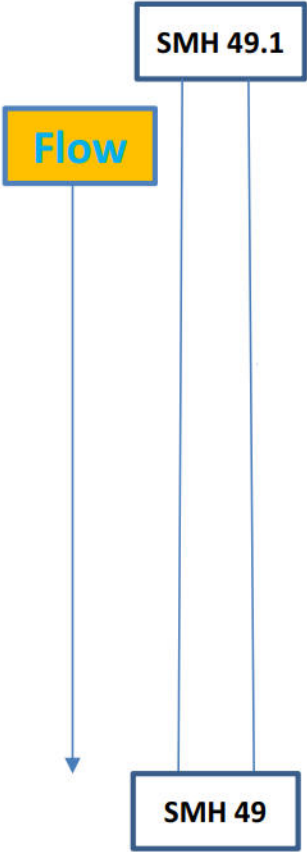
0.9M PI Pipe Increases To 150mm

REM ; THERE ARE NO MAJOR DEFECTS IN THIS SECTION OF PIPE

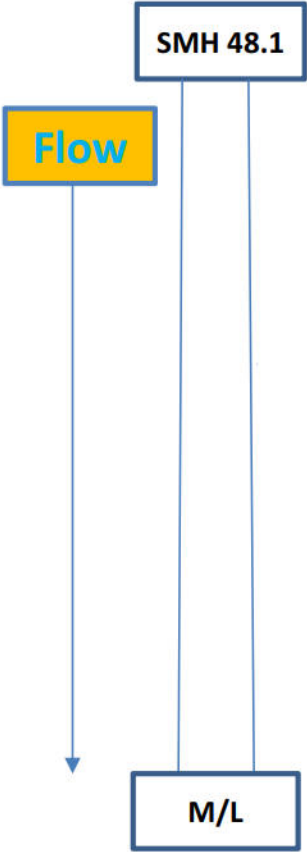
0.9M PI Pipe Increases To 150mm

REM ; THERE ARE NO MAJOR DEFECTS IN THIS SECTION OF PIPE

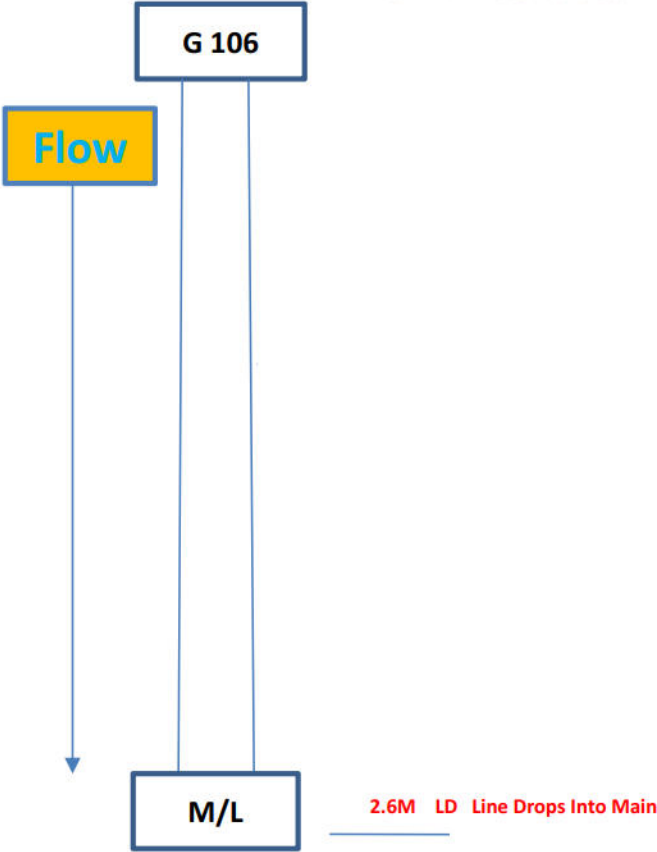
REM ; THERE ARE NO MAJOR DEFECTS IN THIS SECTION OF PIPE

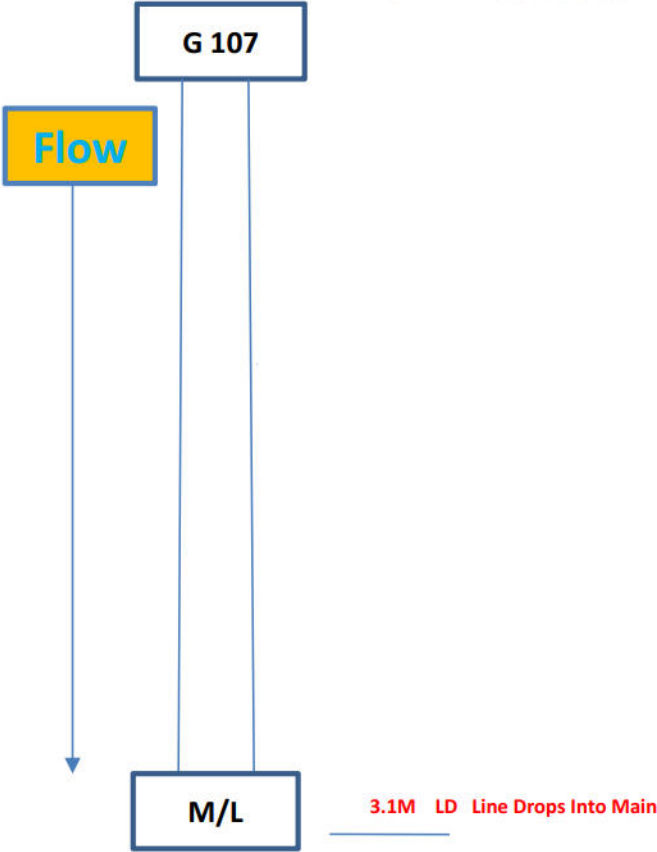
REM ; THERE ARE NO MAJOR DEFECTS IN THIS SECTION OF PIPE

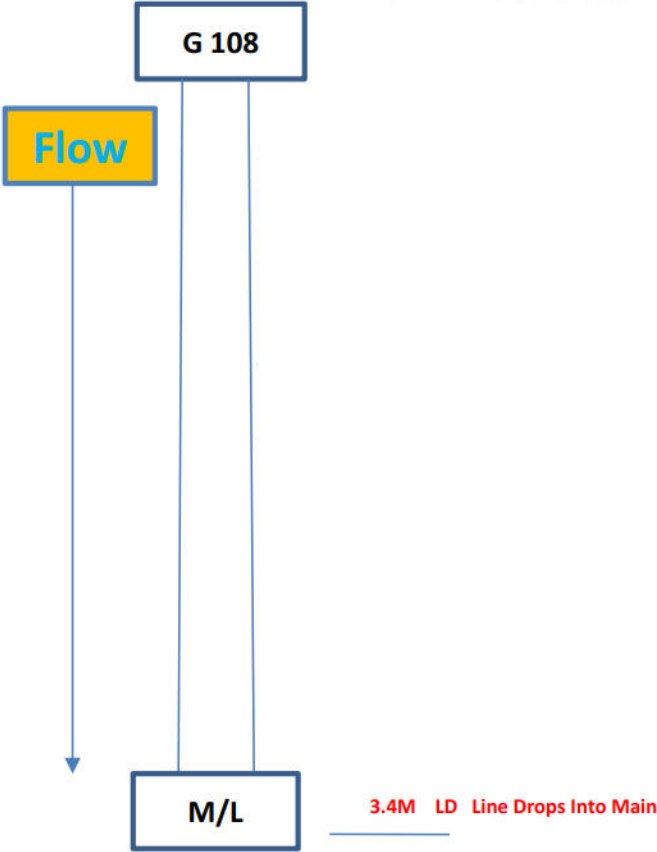
REM ; THERE ARE NO MAJOR DEFECTS IN THIS SECTION OF PIPE

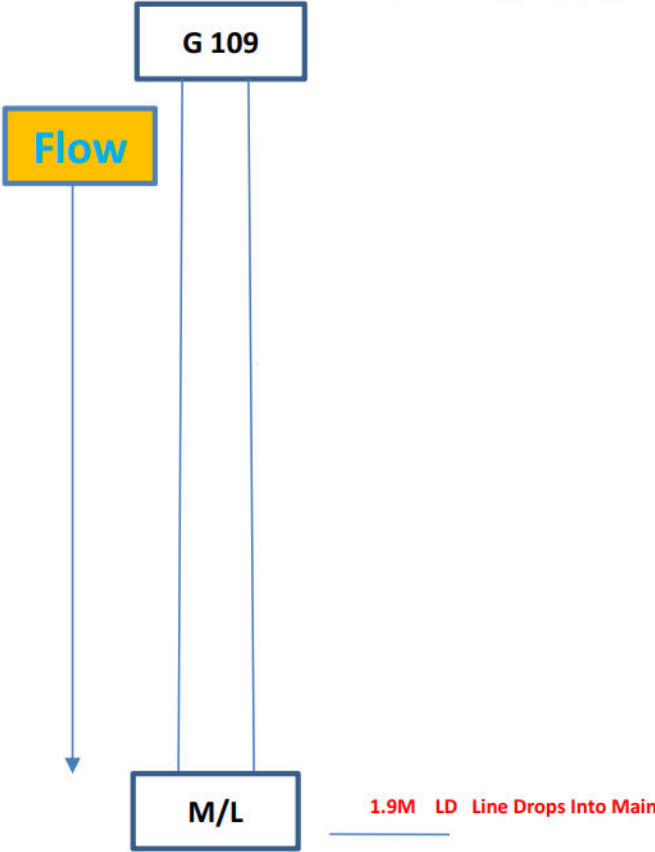
REM ; THERE ARE NO MAJOR DEFECTS IN THIS SECTION OF PIPE

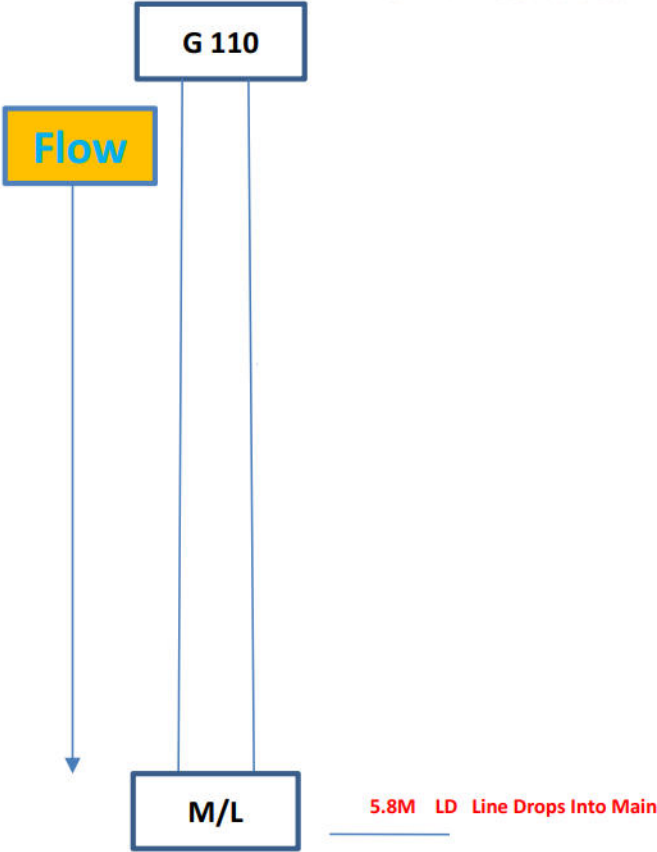
REM ; THERE ARE NO MAJOR DEFECTS IN THIS SECTION OF PIPE

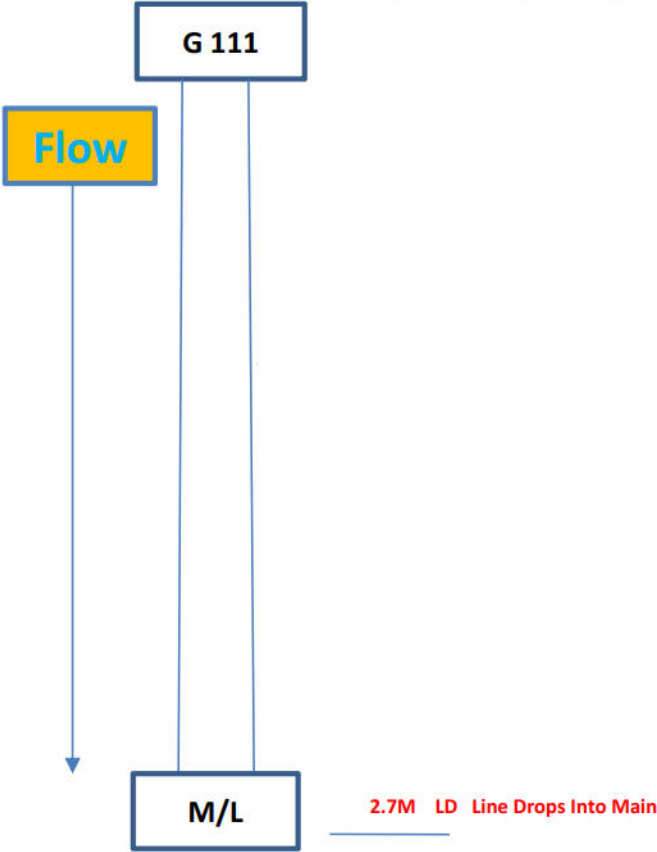
REM ; THERE ARE NO MAJOR DEFECTS IN THIS SECTION OF PIPE

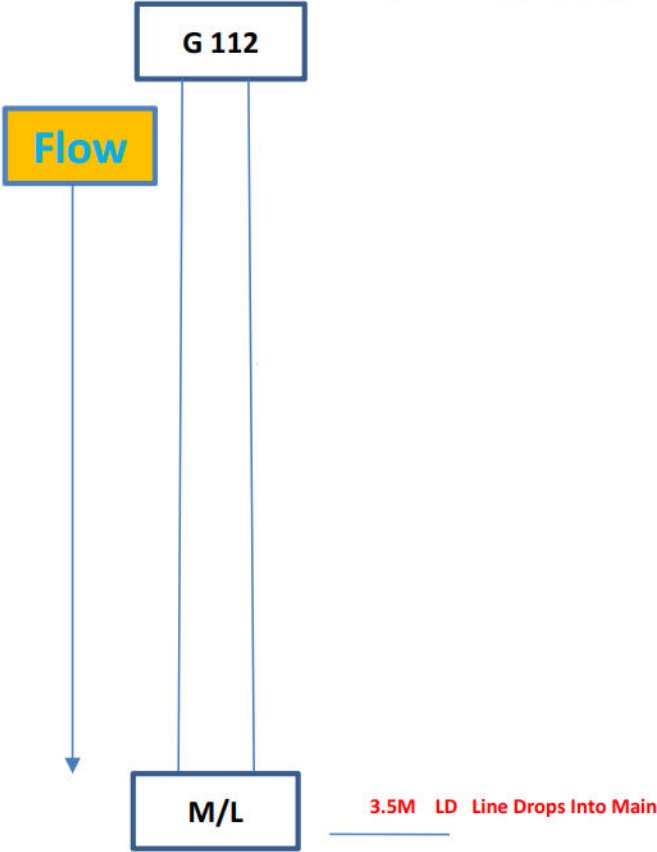
REM ; THERE ARE NO MAJOR DEFECTS IN THIS SECTION OF PIPE

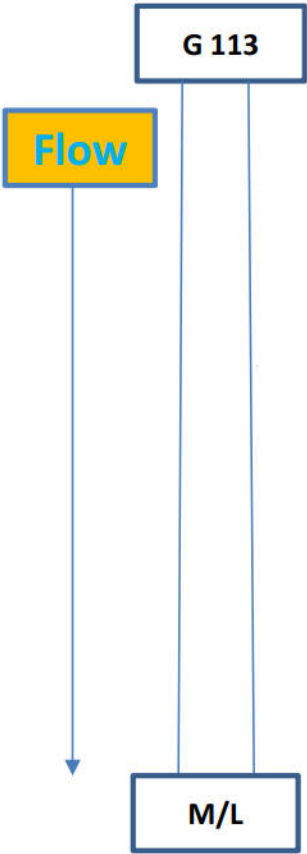
1.0M JN Line Drops In From The Right From G 114

2.7M LD Line Drops Into Main

REM ; THERE ARE NO MAJOR DEFECTS IN THIS SECTION OF PIPE

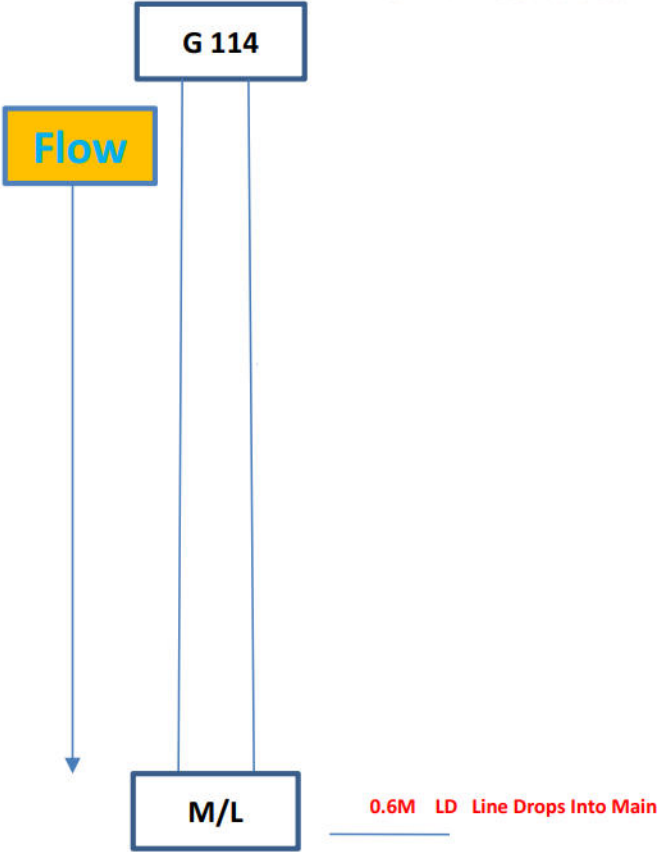
REM ; THERE ARE NO MAJOR DEFECTS IN THIS SECTION OF PIPE

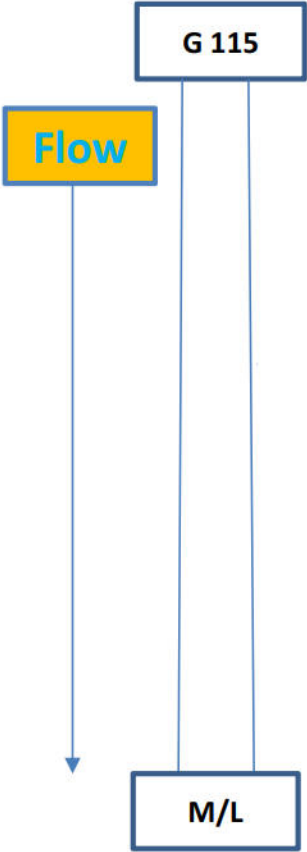
0.0M ST Start Of Survey  
0.0M WL Water Level 0 %  
0.1M JN Line Drops In From The Right From G 116

4.2M LD Line Drops Into Main

REM ; THERE ARE NO MAJOR DEFECTS IN THIS SECTION OF PIPE

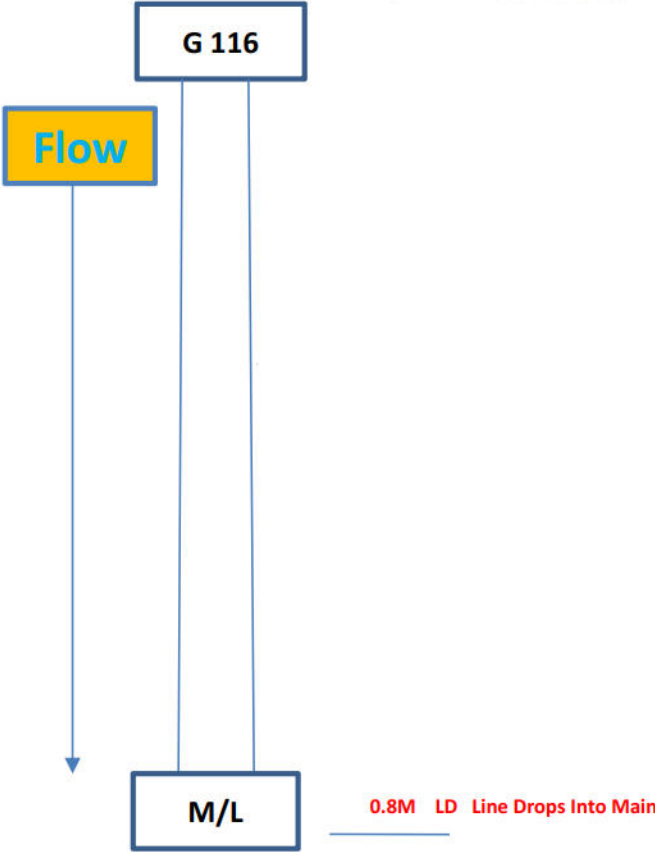
REM ; THERE ARE NO MAJOR DEFECTS IN THIS SECTION OF PIPE

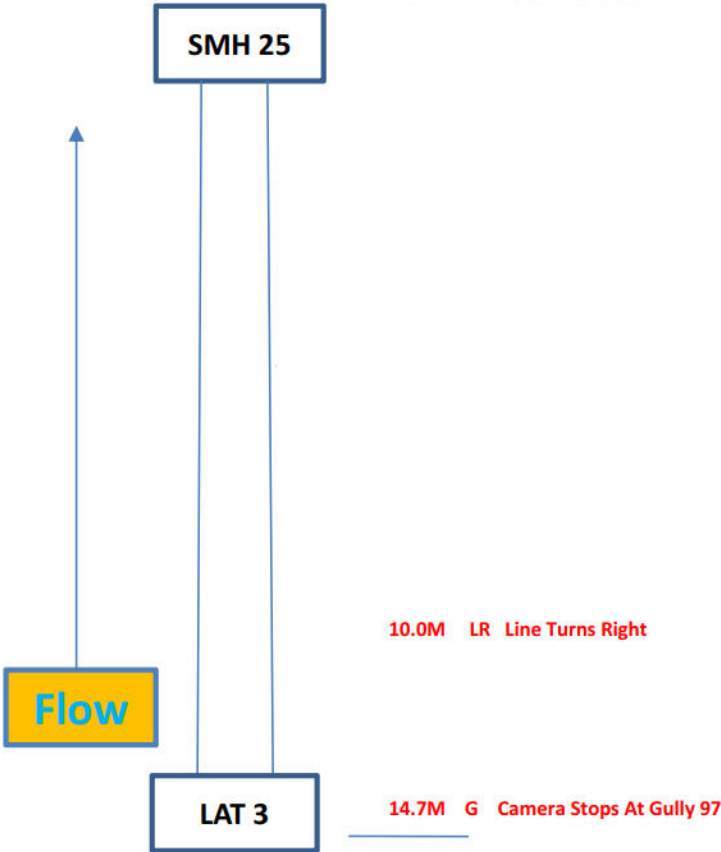
REM ; THERE ARE NO MAJOR DEFECTS IN THIS SECTION OF PIPE, THE PUG HAS BEEN REMOVED

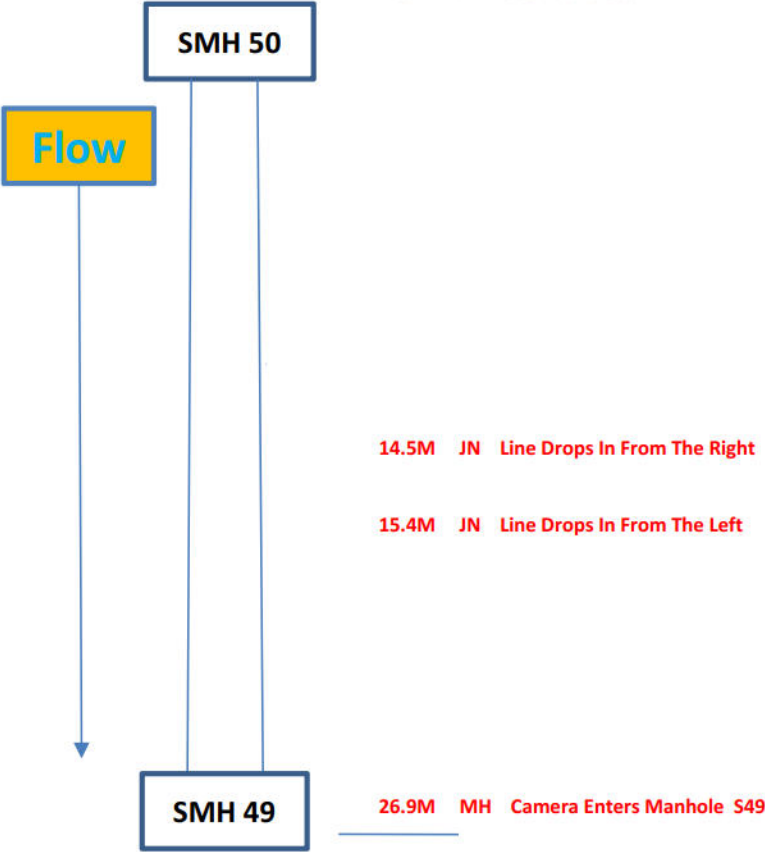
REM ; THERE ARE NO MAJOR DEFECTS IN THIS SECTION OF PIPE

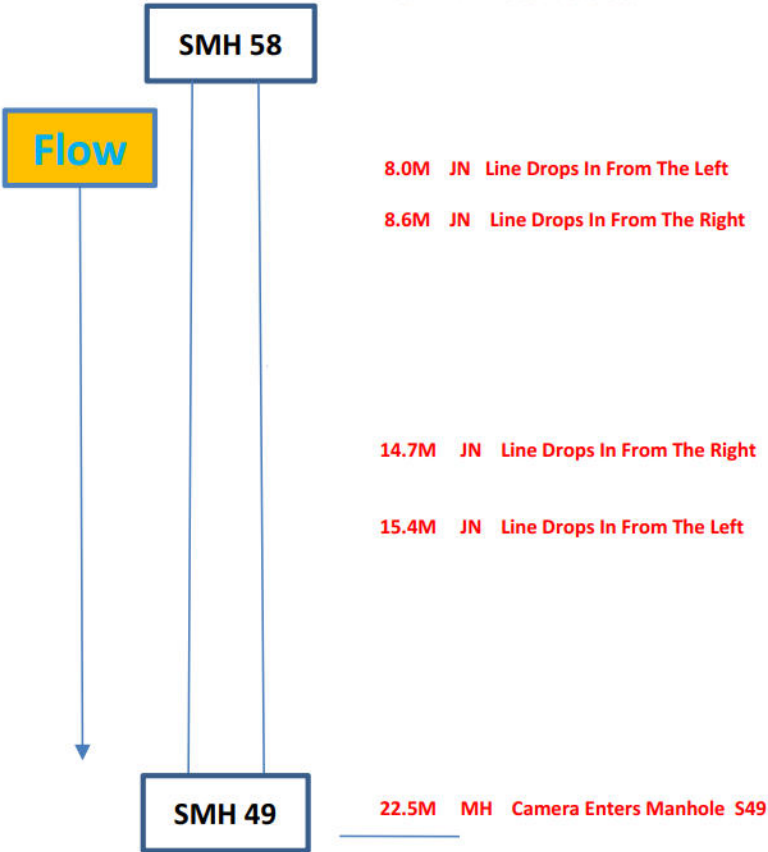
REM ; THERE ARE NO MAJOR DEFECTS IN THIS SECTION OF PIPE

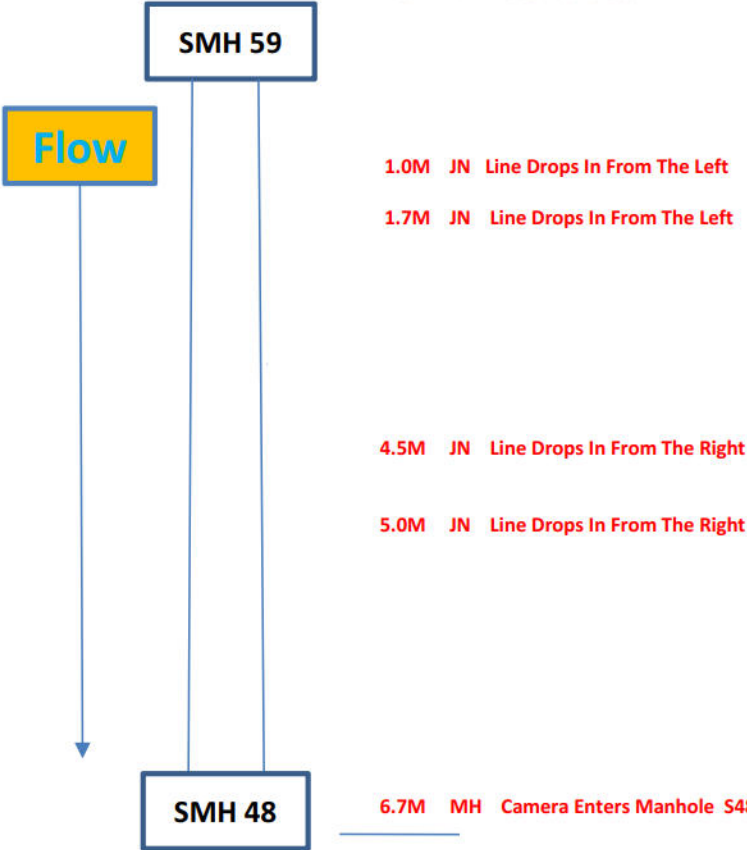
REM ; THERE ARE NO MAJOR DEFECTS IN THIS SECTION OF PIPE

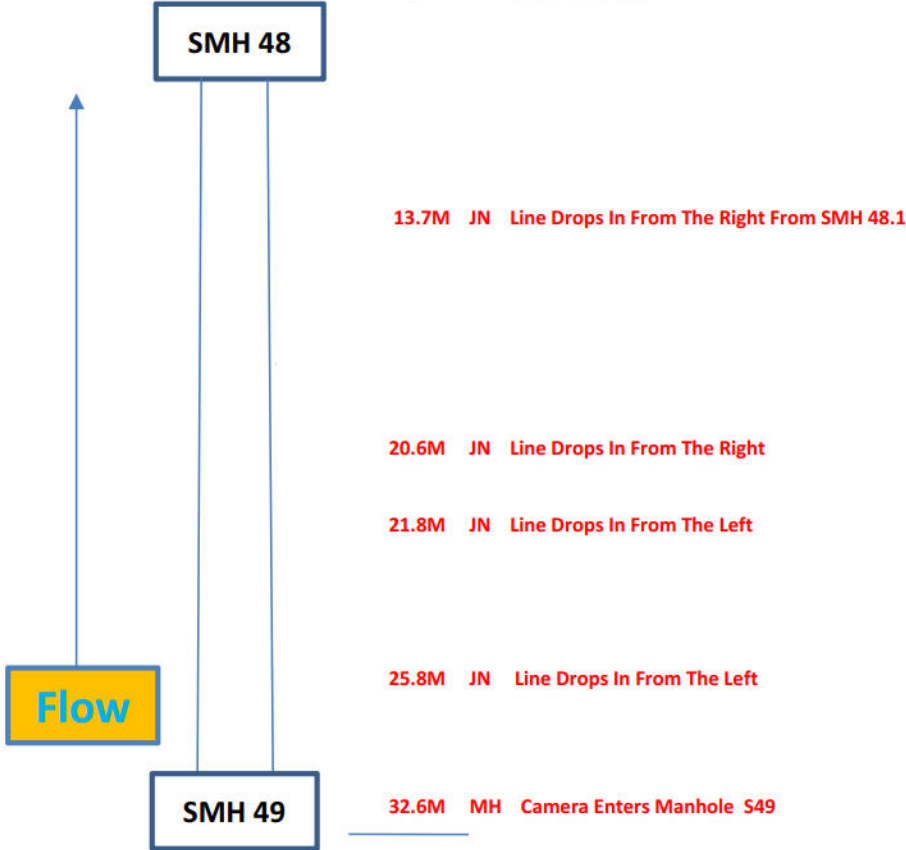
REM ; THERE ARE NO MAJOR DEFECTS IN THIS SECTION OF PIPE

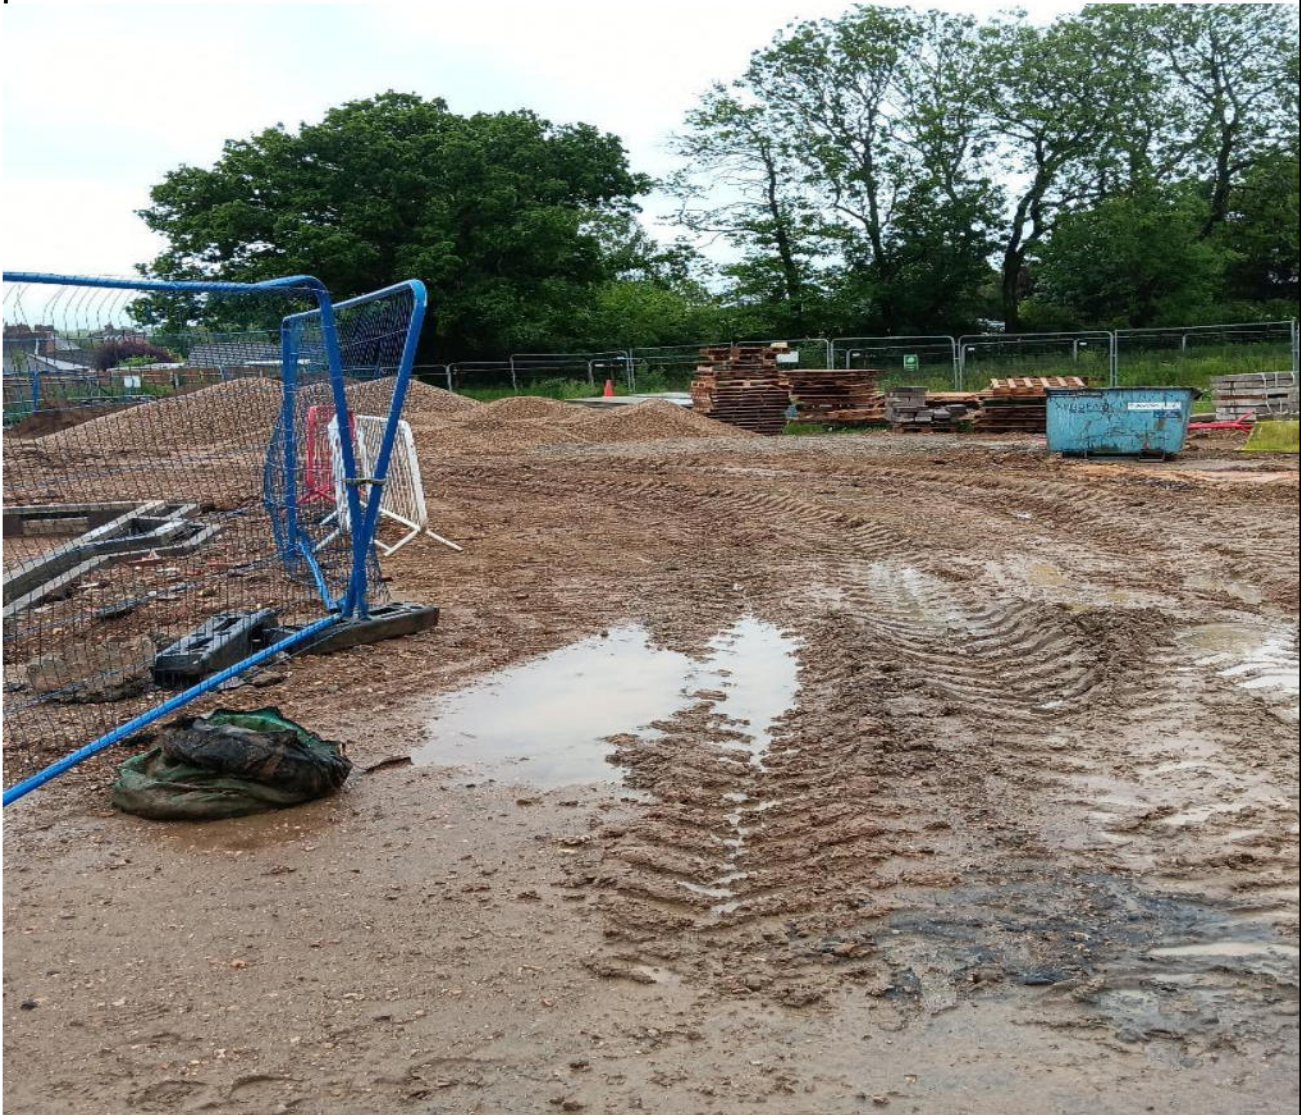
| Place<br>Tye Lane | Road: | Date:<br>19/05/26 | Section Number<br>27 | PLR: |

**UNABLE TO GET LORRY NEAR MANHOLE SMH 46  
WHICH IS UNDER THE RED CONE TO JET BACK TO  
MANHOLE SMH 48**

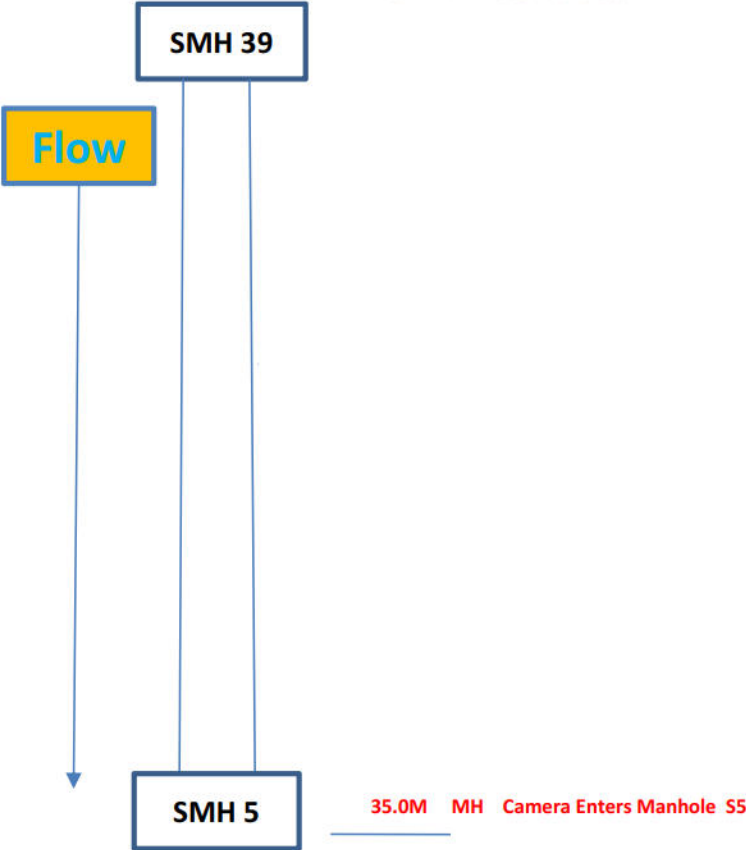
REM ; THERE ARE NO MAJOR DEFECTS IN THIS SECTION OF PIPE. THERE IS SOME SILT IN THE BOTTOM END OF THE RUN BUT WE ARE UNABLE TO GET THE LORRY NEAR SMH 5 TO JET THE LINE BUT THE SMALL LAYER OF SILT WILL NOT CAUSE ANY PROBLEMS WITH THE DRAIN FLOWING
