## ALL HOURS PLUMBING

| Project Name:<br><b>Tye Lane</b> | Contract Number: | Contact:<br><b>Aeropark</b> | Date:<br><b>18/05/2026</b> |

Inspection Report

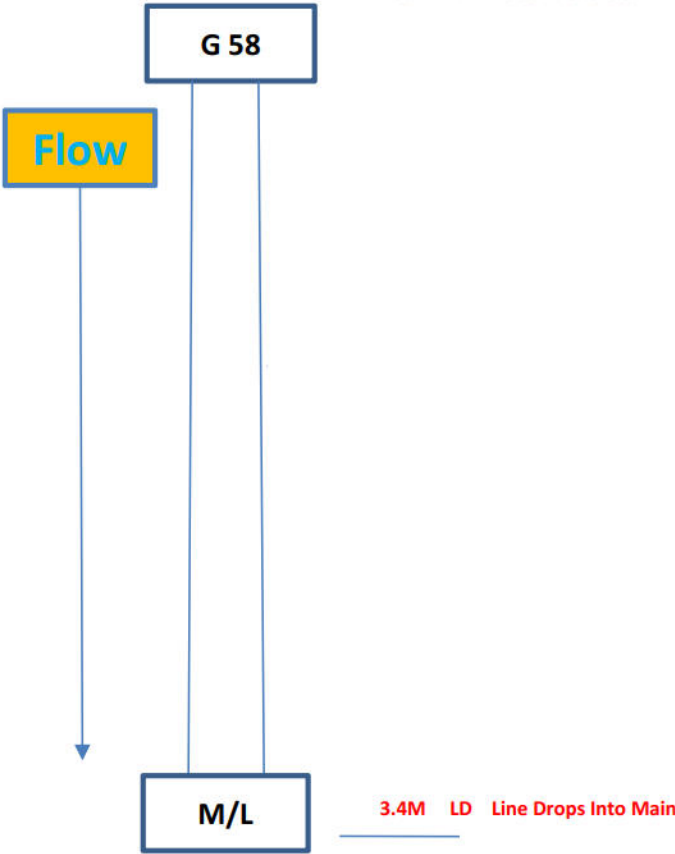
REM ; THERE ARE NO MAJOR DEFECTS IN THIS SECTION OF PIPE THE CONCRETE HAS BEEN REMOVED

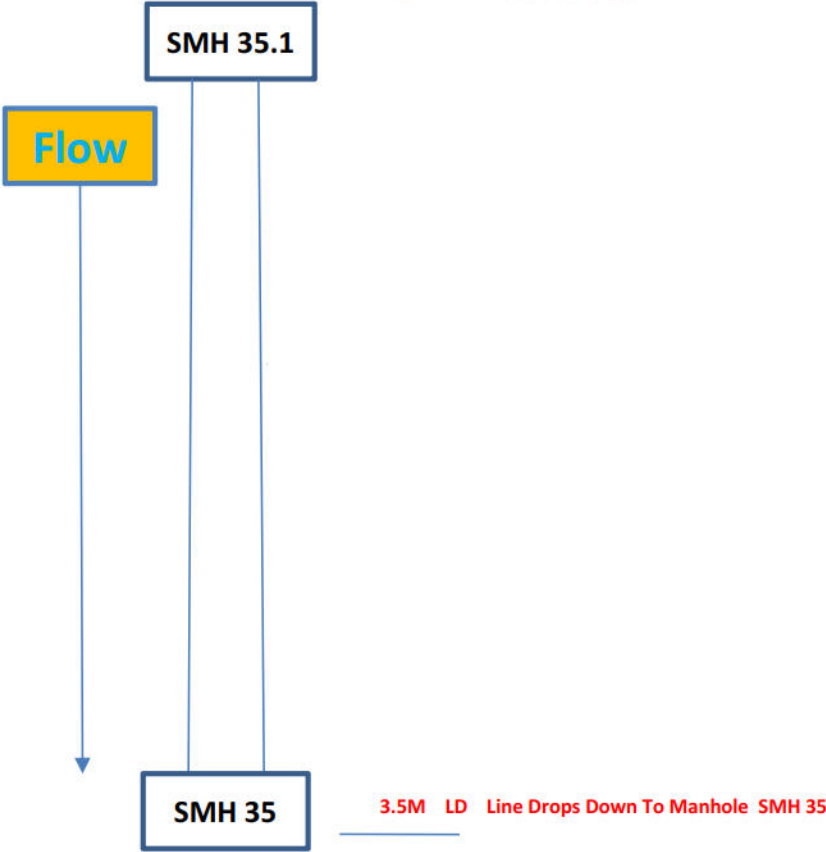
REM ; THERE ARE NO MAJOR DEFECTS IN THIS SECTION OF PIPE

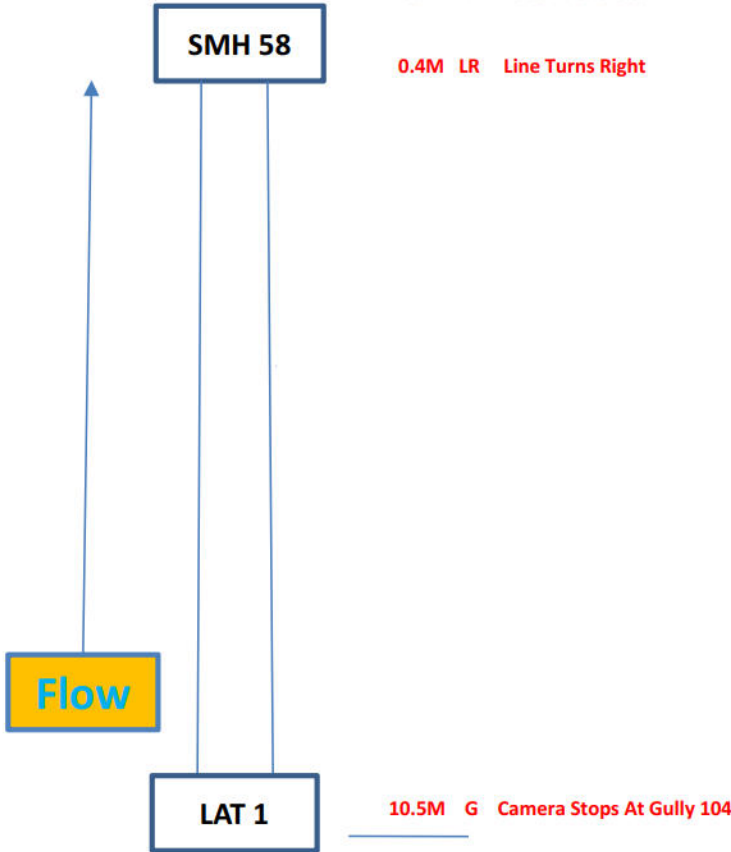
0.4M LR Line Turns Right

REM ; THERE ARE NO MAJOR DEFECTS IN THIS SECTION OF PIPE

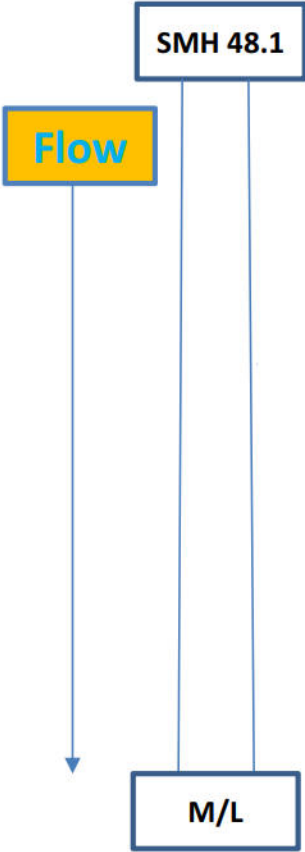
0.9M PI Pipe Increases To 150mm

REM ; THERE ARE NO MAJOR DEFECTS IN THIS SECTION OF PIPE

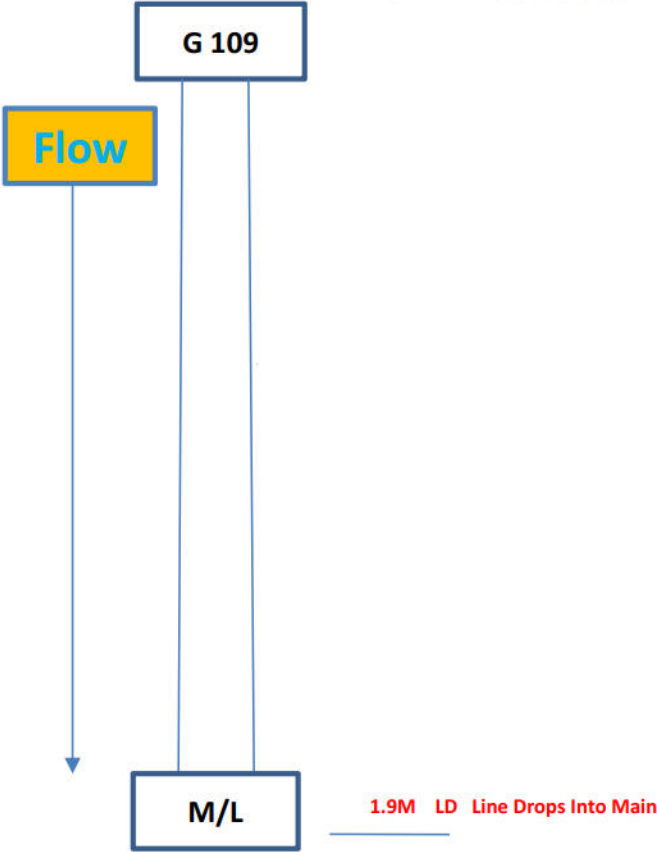
REM ; THERE ARE NO MAJOR DEFECTS IN THIS SECTION OF PIPE

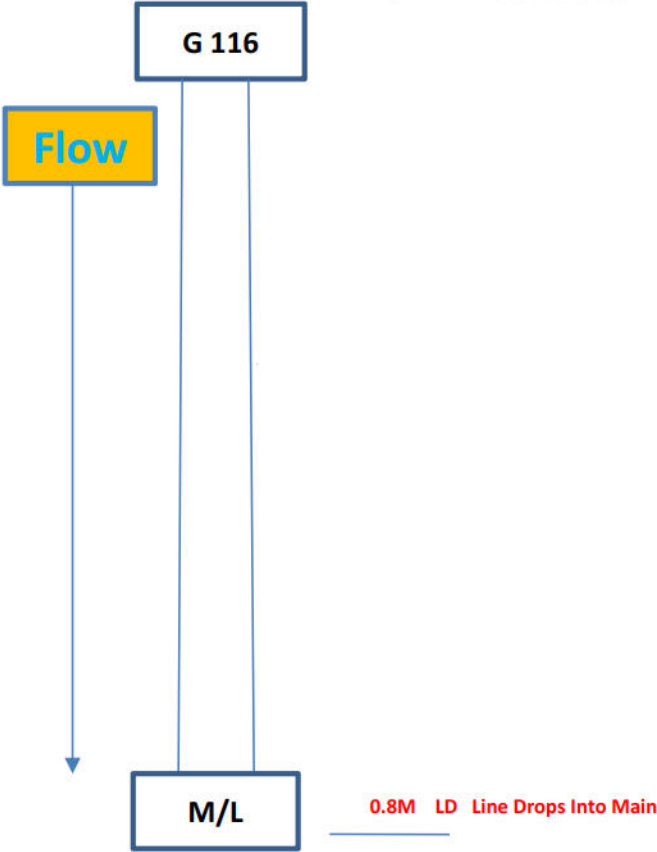
REM ; THERE ARE NO MAJOR DEFECTS IN THIS SECTION OF PIPE

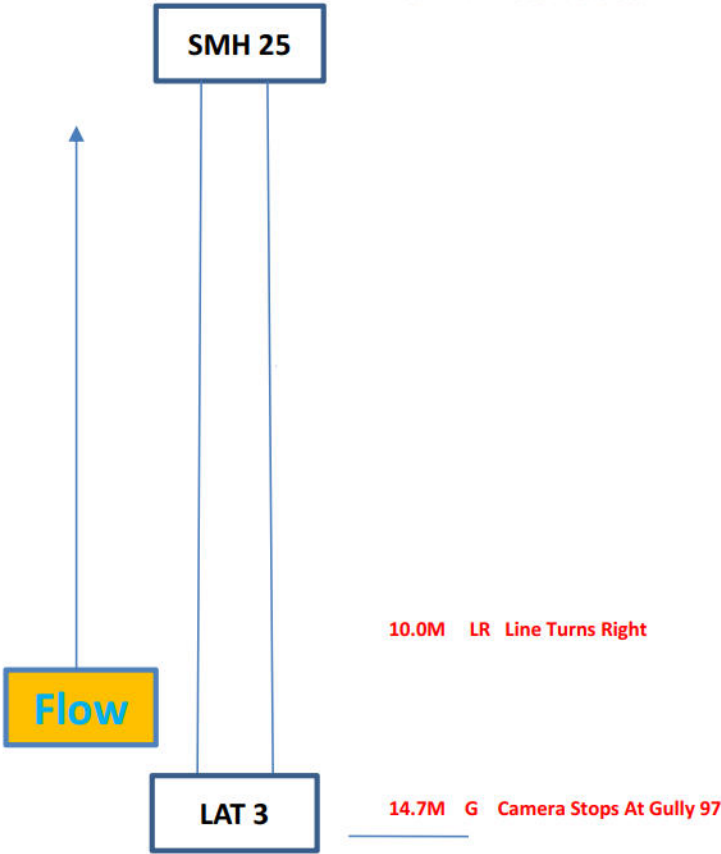
REM ; THERE ARE NO MAJOR DEFECTS IN THIS SECTION OF PIPE, THE PUG HAS BEEN REMOVED

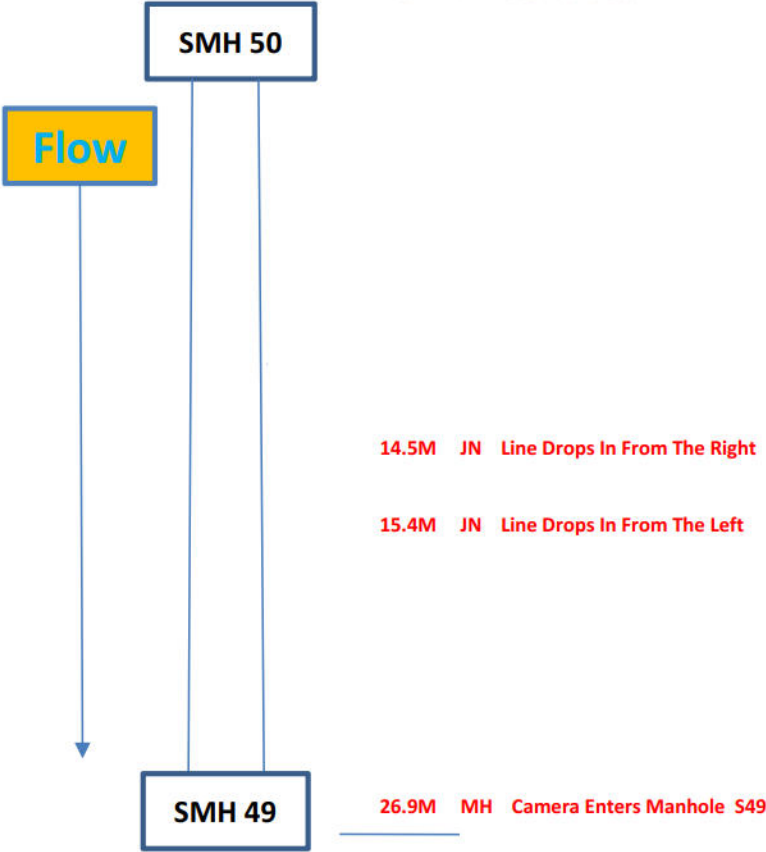
REM ; THERE ARE NO MAJOR DEFECTS IN THIS SECTION OF PIPE

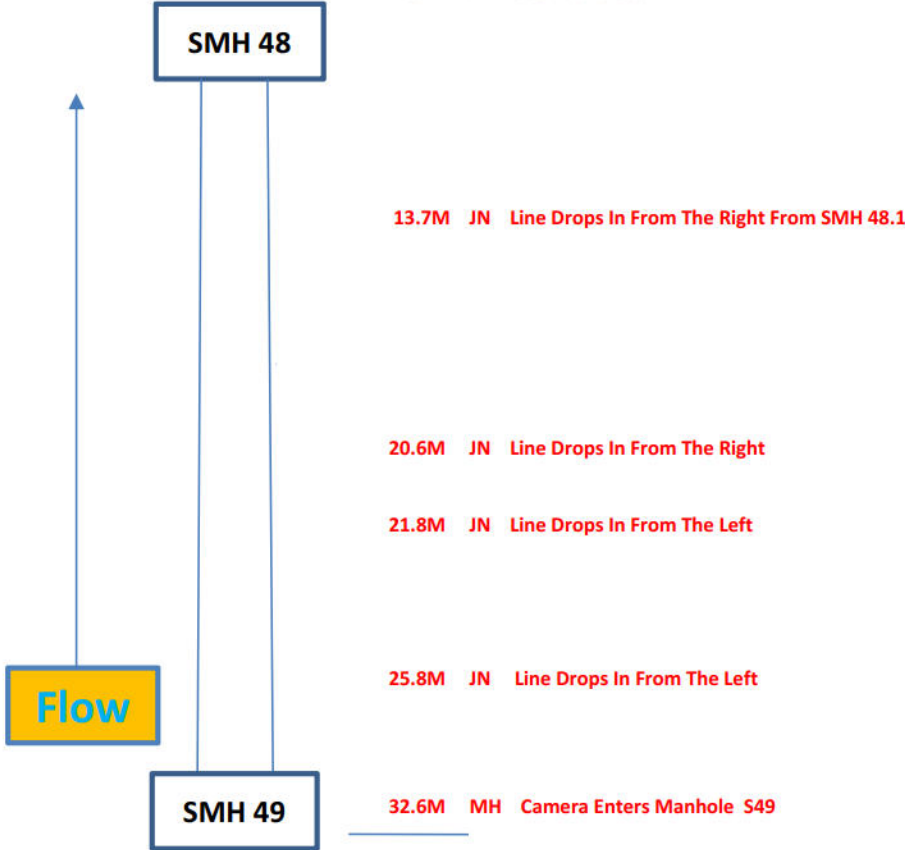
REM ; THERE ARE NO MAJOR DEFECTS IN THIS SECTION OF PIPE

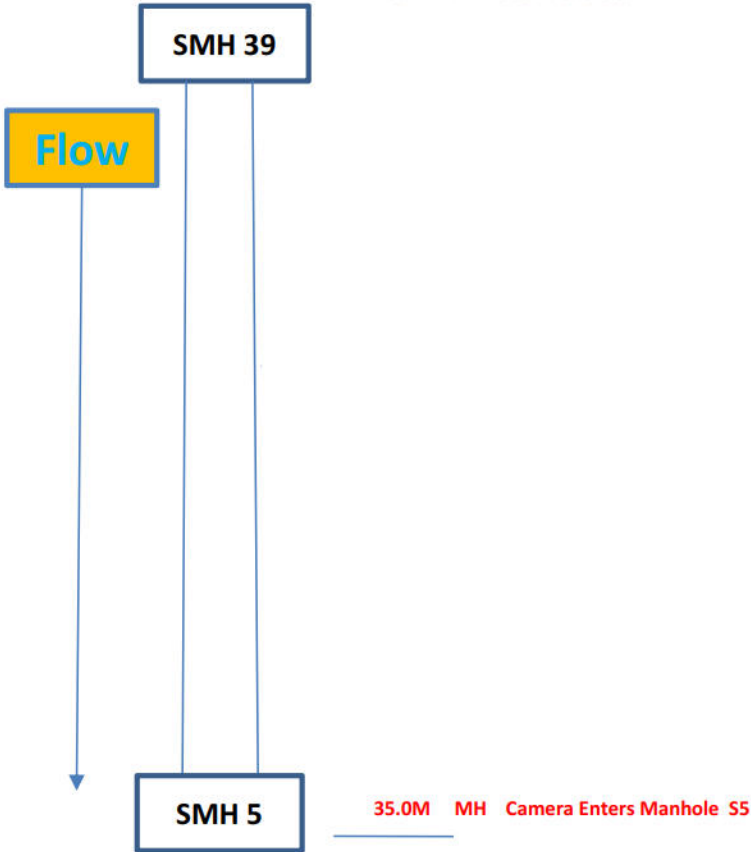
REM ; THERE ARE NO MAJOR DEFECTS IN THIS SECTION OF PIPE. THERE IS SOME SILT IN THE BOTTOM END OF THE RUN BUT WE ARE UNABLE TO GET THE LORRY NEAR SMH 5 TO JET THE LINE BUT THE SMALL LAYER OF SILT WILL NOT CAUSE ANY PROBLEMS WITH THE DRAIN FLOWING
