## ALL HOURS PLUMBING

| Project Name:<br>Tye Lane | Contract Number: | Contact:<br>Aeropark | Date:<br>14/04/2026 |

Inspection Report

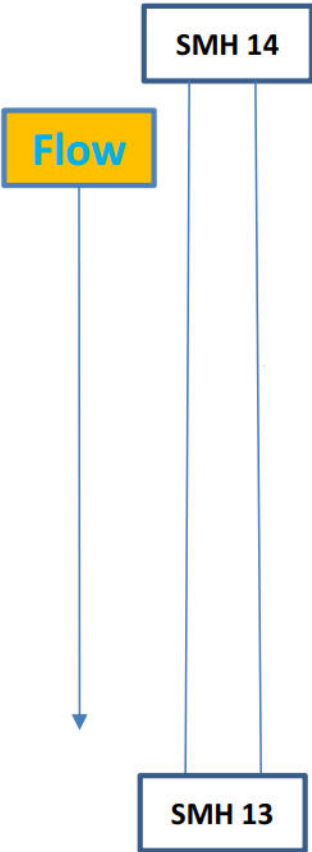
0.0M ST Start Of Survey  
0.0M WL Water Level 0 %

5.0M JN Line Drops In From The Left

6.1M JN Line Drops In From The Right

13.1M MH Camera Enters Manhole S 13

REM ; THERE ARE NO MAJOR DEFECTS WITH THIS SECTION OF PIPE

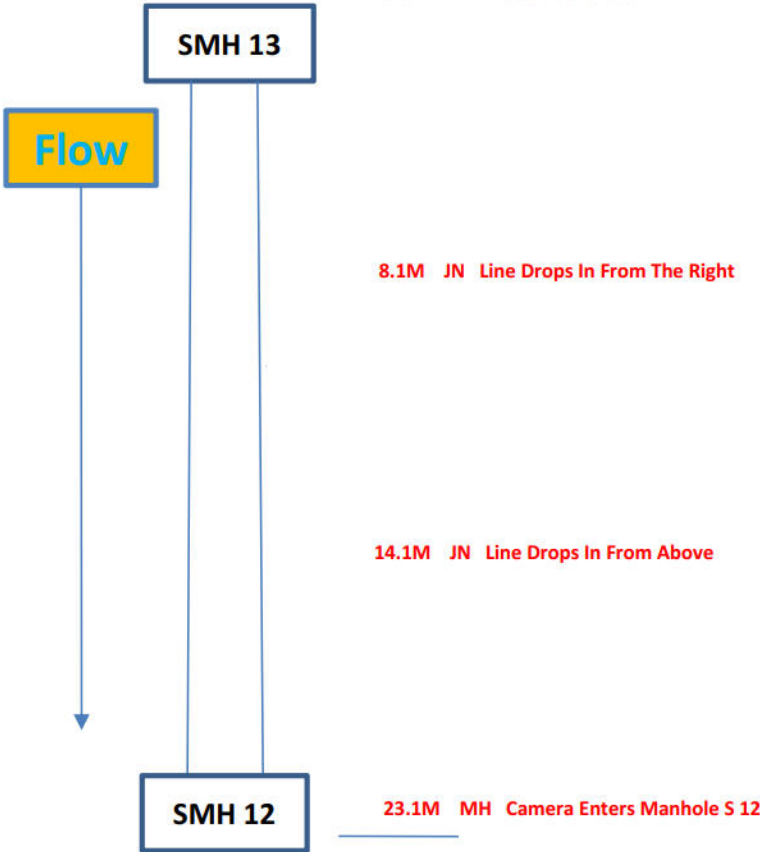
0.0M ST Start Of Survey  
0.0M WL Water Level 0 %

REM ; THERE ARE NO DEFECTS WITH THE PIPEWORK BUT THERE IS DEBRIS IN THE LINE, WE HAVE TRIED TO REMOVE AS MUCH AS WE CAN BY BACK JETTING THE LINE AS UNABLE TO GET LORRY NEAR TO MANHOLE S 12

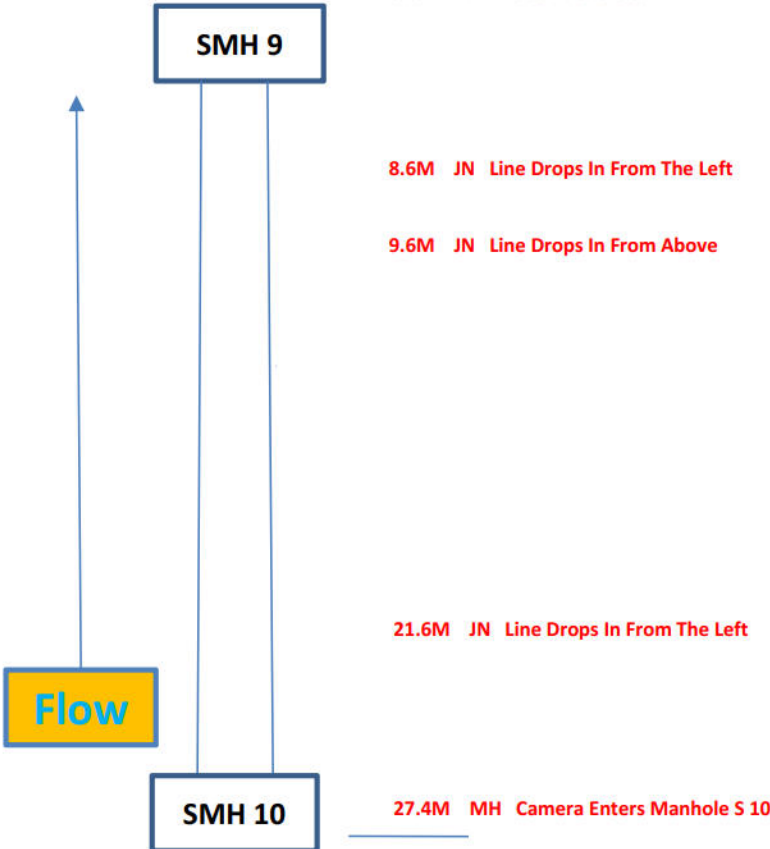
0.0M ST Start Of Survey  
0.0M WL Water Level 0 %

REM ; THERE ARE NO MAJOR DEFECTS WITH THIS SECTION OF PIPE
