# Drainage Verification Report

Barnfield House, Arundel Road, Fontwell BN18 0SD

Planning Ref: WA/80/22/PL

Ref: **C2911**

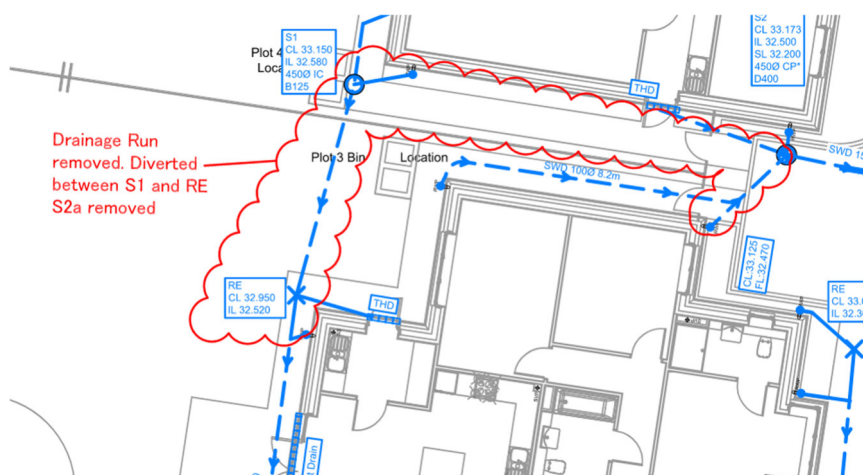
- S1 - S2a:

- 3.1.1 An initial drainage CCTV survey was undertaken in June 2025 of the 'as built' surface water drainage system. The CCTV survey confirmed that the majority of the system was generally in good working order however the survey did note some issues within the network.
- 3.1.2 The CCTV Drainage survey picked up on faults within the system, such as debris within the system and indicates some structural damage within the pipework. Remedial works were subsequently undertaken and a secondary CCTV drainage survey was conducted in September 2025 which confirms that all remedial works were undertaken and the system is clear of debris and structurally sound. A copy of this report can be found in **Appendix A**.
- 3.1.3 The CCTV Drainage survey also notes that the following chambers have not been installed, and the drainage runs deviate from the approved drainage layout:

- 3.1.4 These changes have been highlighted by the survey company and a copy of the revised plans can be found within **Appendix B**

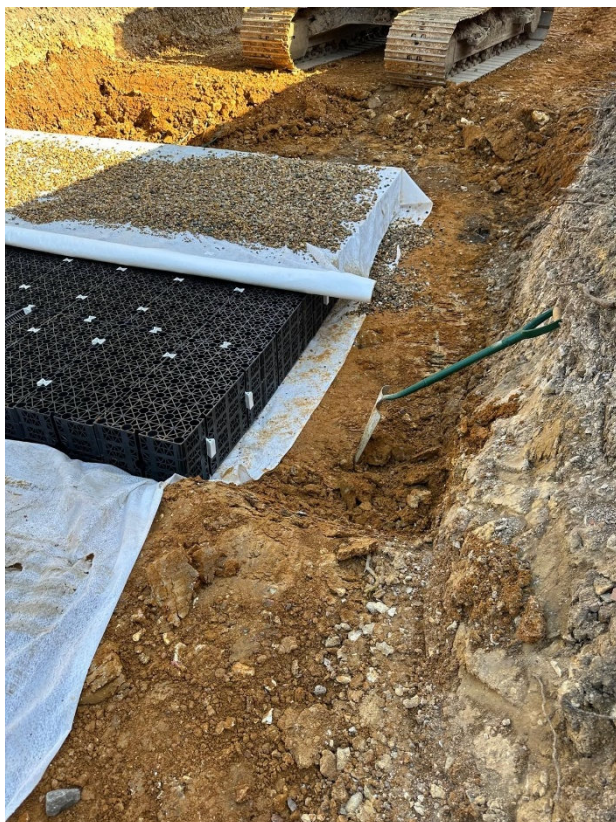
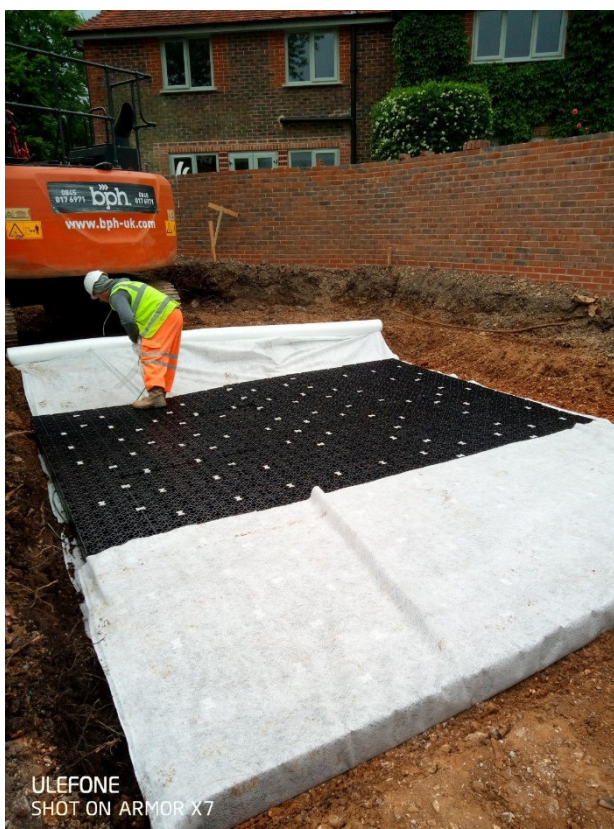
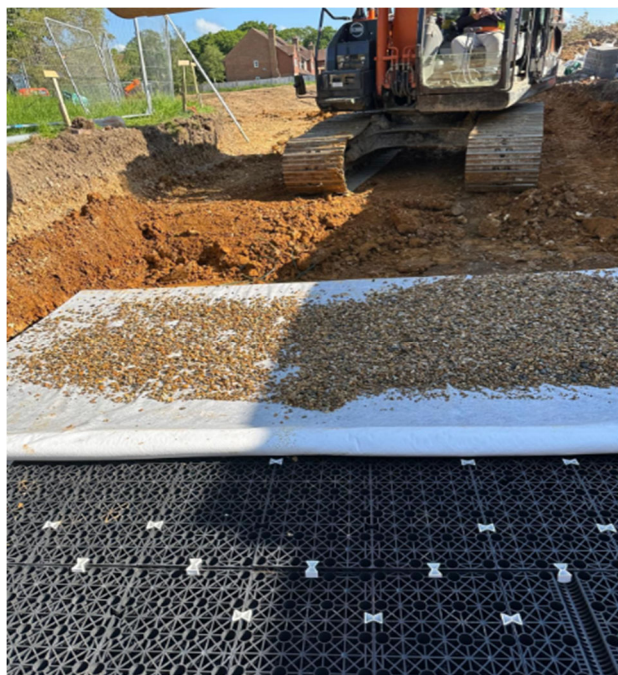
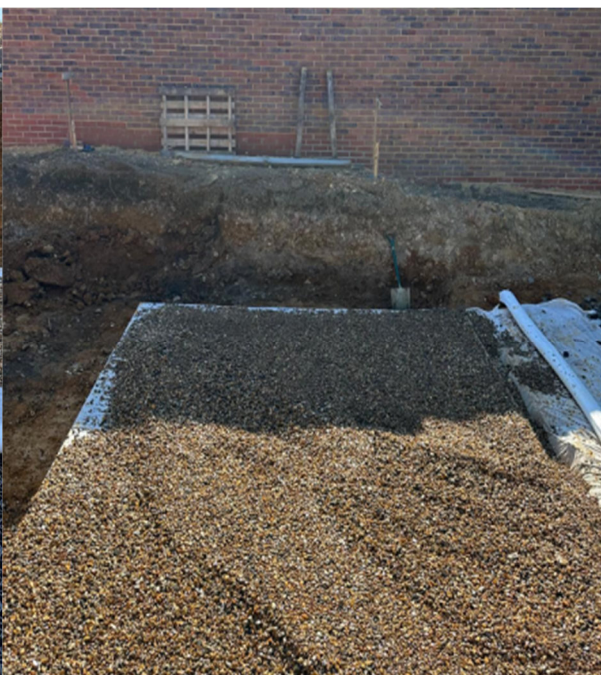
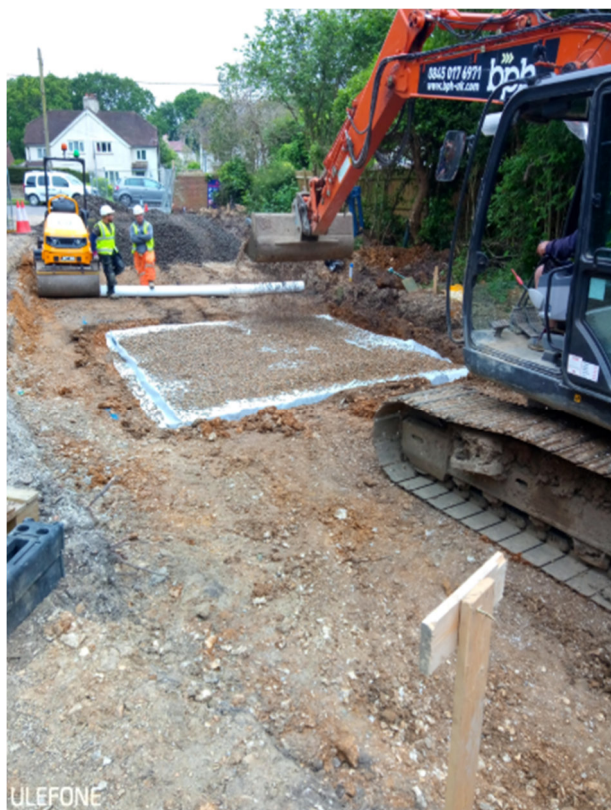
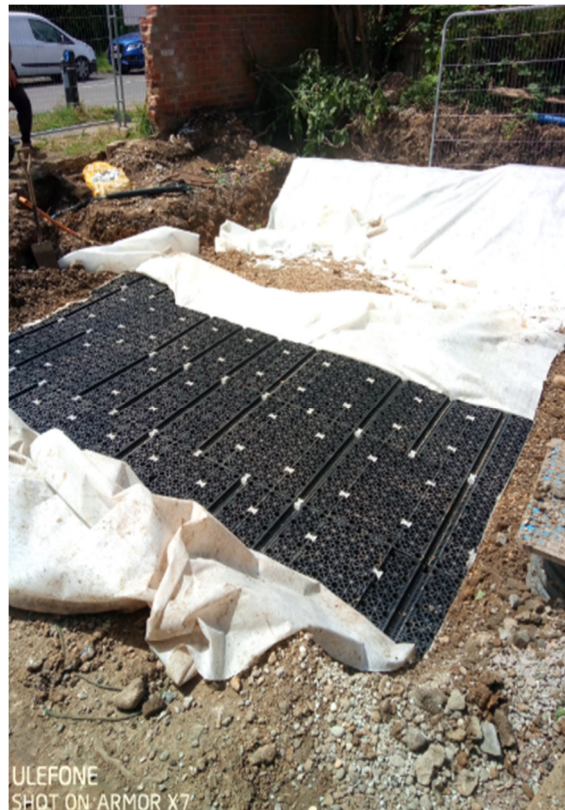
4.2 The proposed drainage network utilises Permavoid crates to provide additional storage. A review of the installation photographs confirms that the Permavoid system has been installed correctly using the clips and it is wrapped in a permeable geotextile allowing infiltration into ground as designed.

**Fig 2. Installation of permavoids**

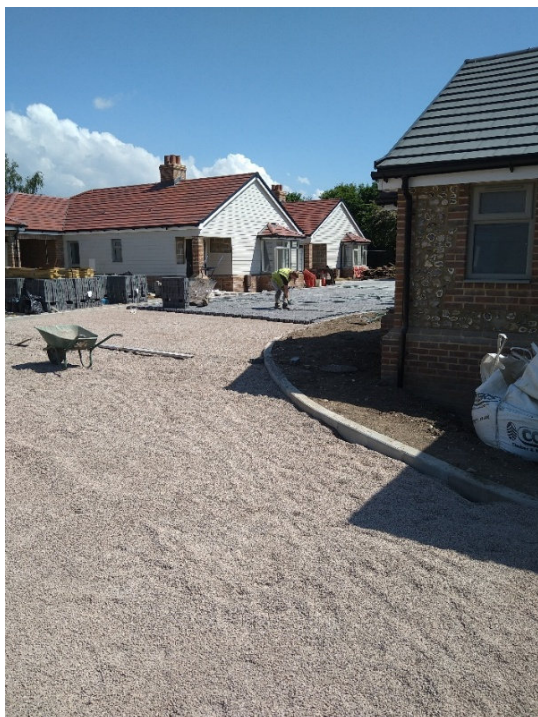
**No. 7 (Drainage Plan Sheet 1)**

- 4.3 The main SuDS feature on this site is the permeable paved area; the site photographs of the installation of the permeable paved areas confirm the correct installation of a permeable sub-base using the specified aggregate and grading alongside the installation of the correct non-woven geotextile. It is clear that the base course has also been core drilled as per the proposed construction details.

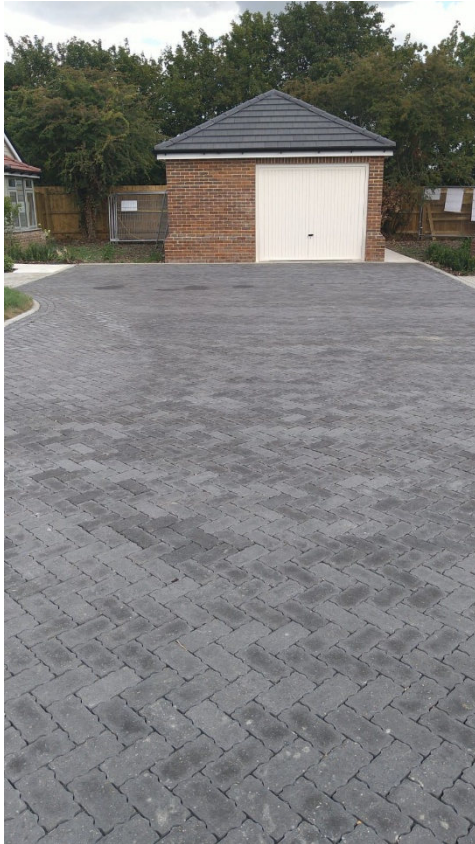
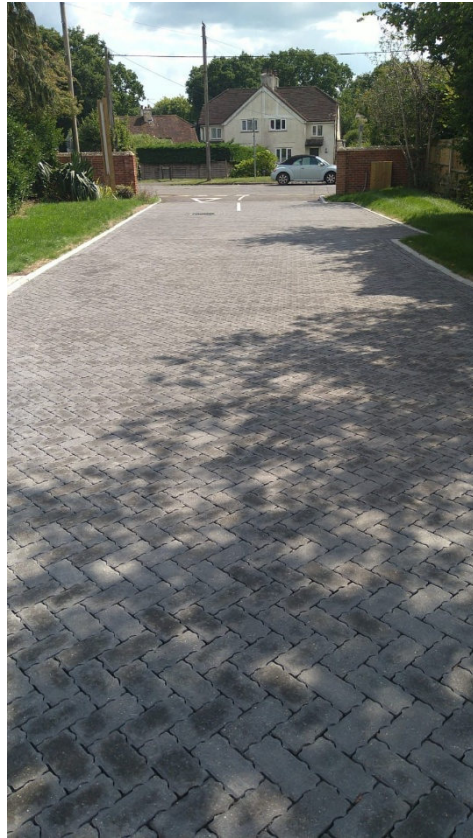
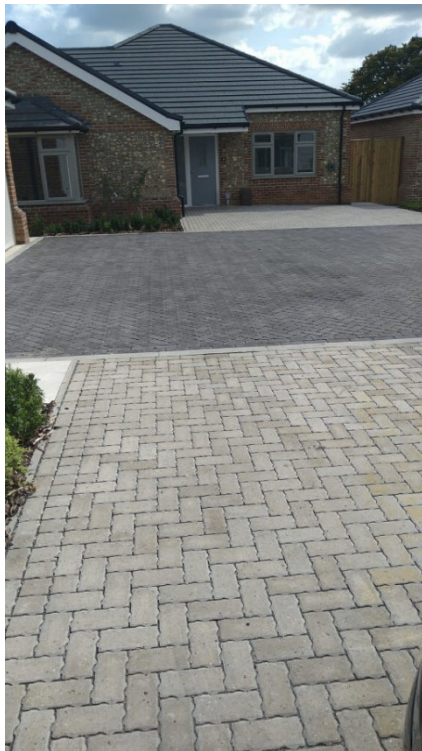
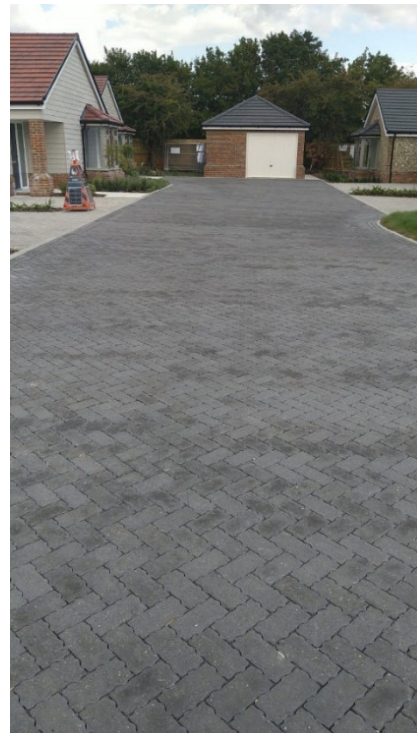
**Fig 4. Permeable Parking Areas Cont.**

4.4 The following photographs are of the as constructed permeable parking areas the day following heavy downpour:

- 6.4 The SuDS features appear to be in good working order, with the permeable areas being dry following a heavy downpour the night prior. The drainage runs were noted to be clear with no standing water or debris confirming that the network is working as intended.

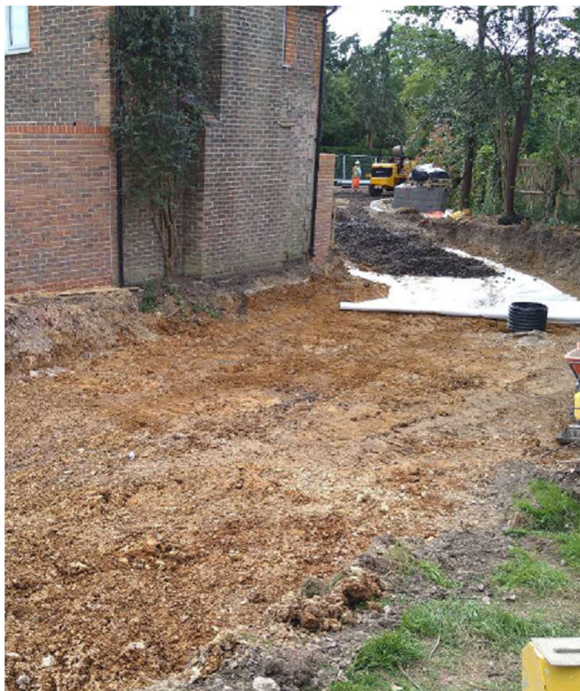
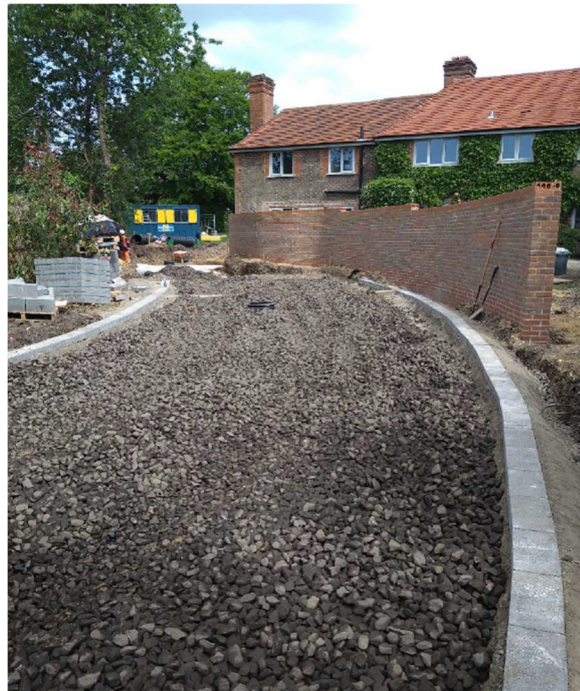
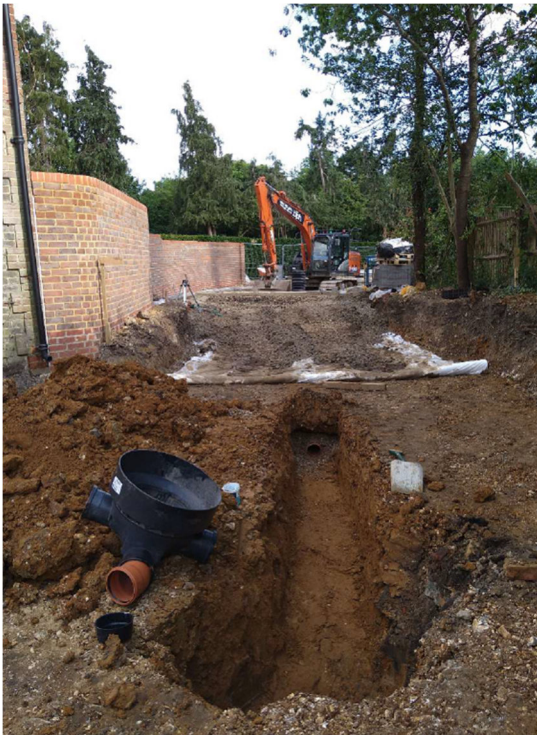
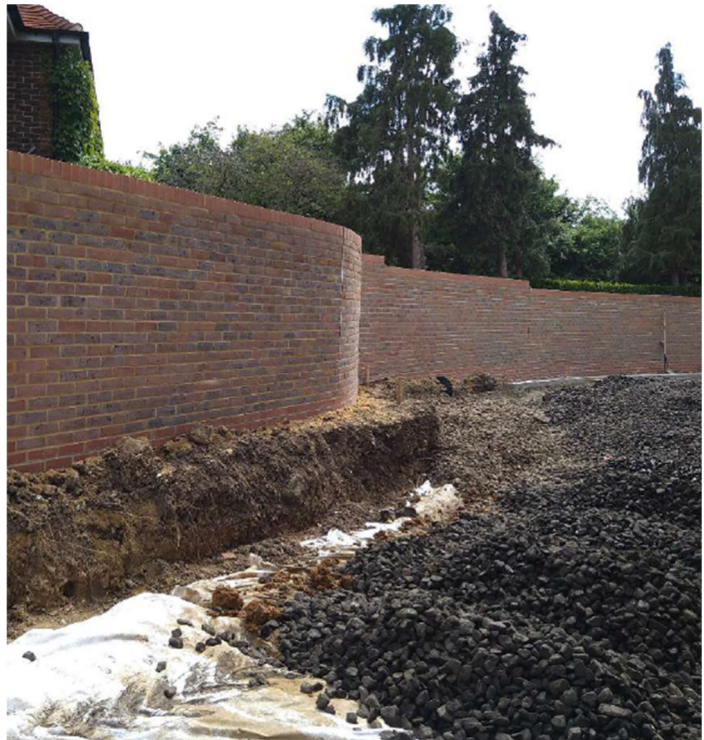
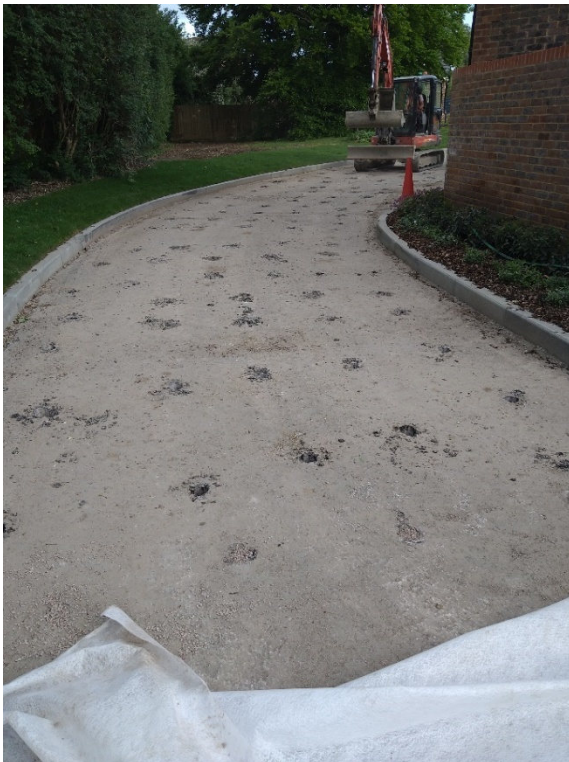
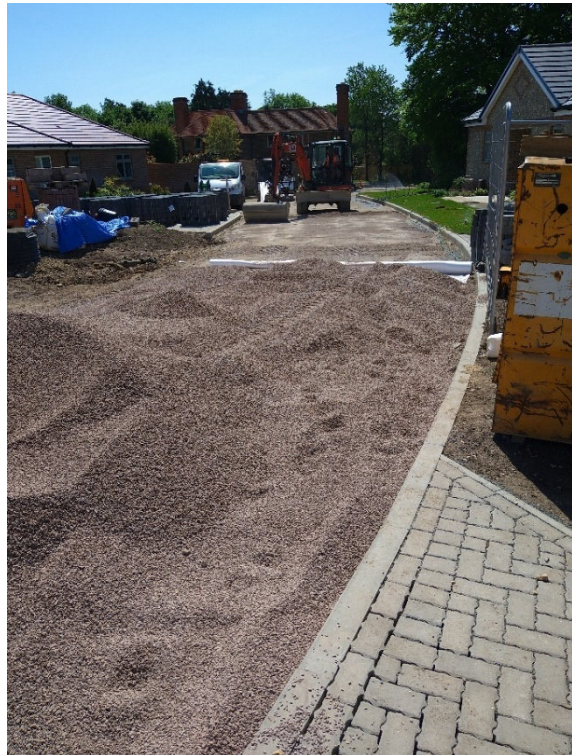
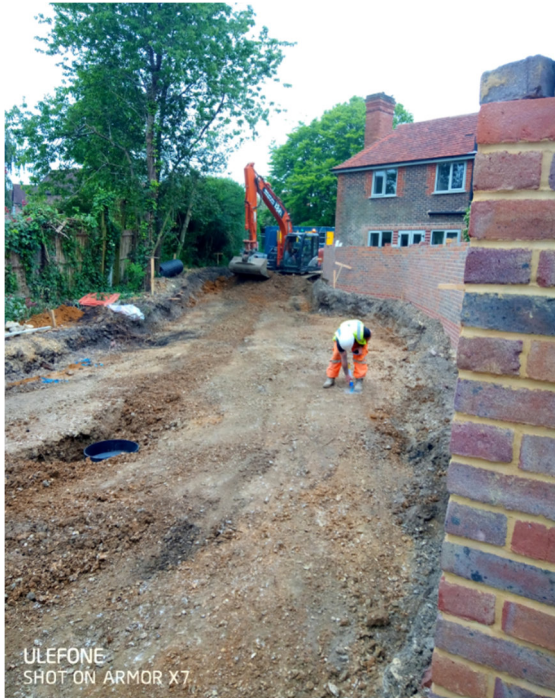
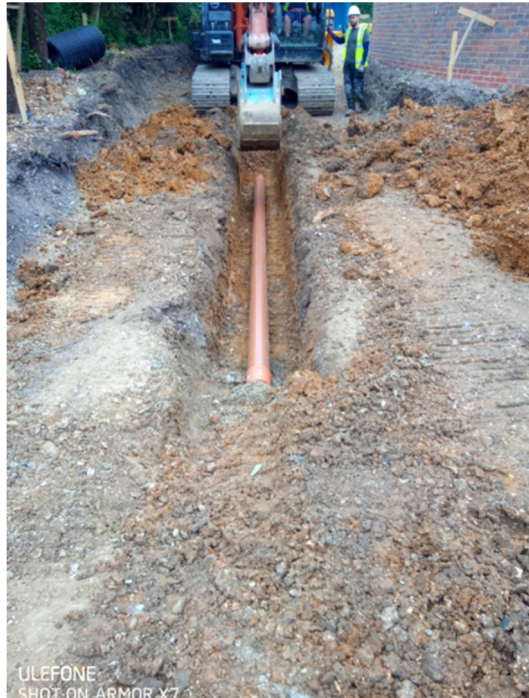
**Fig 5. Road Formation.**

All roads have been constructed in accordance with the Proposed Permeable Access Road and Permavoid subbase detail shown below and installed as shown in the photographs provided:

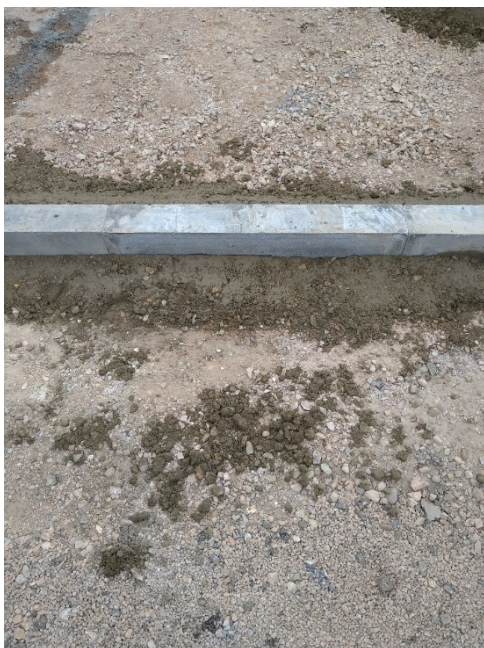
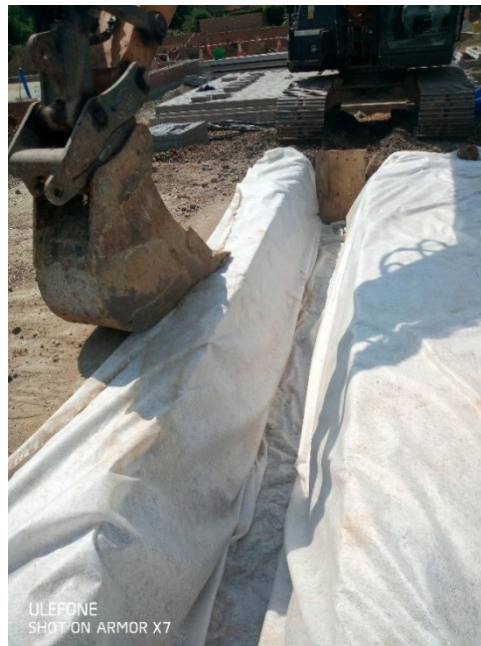
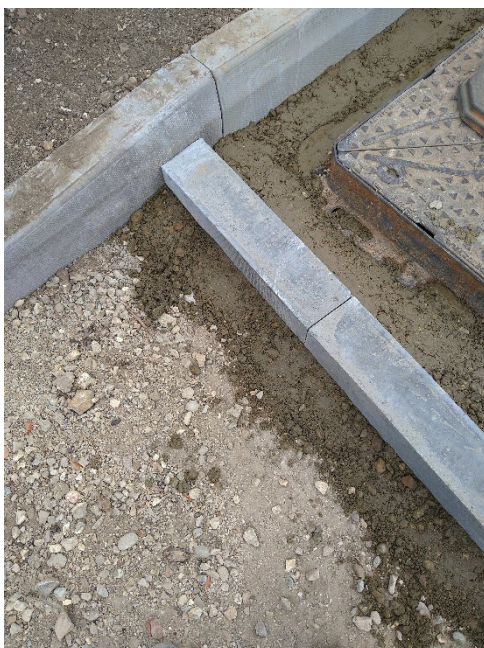
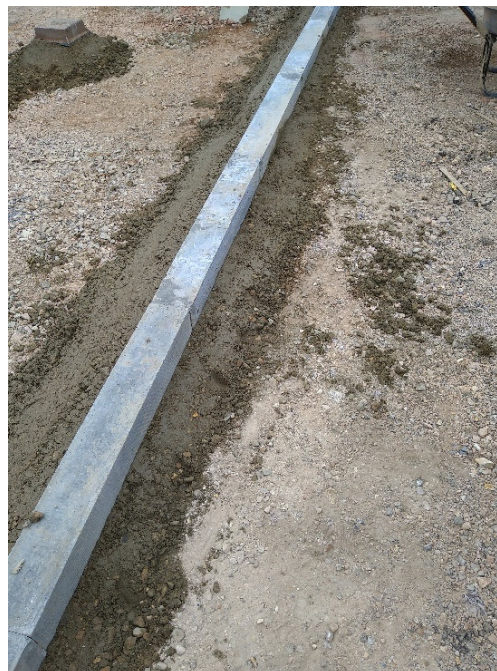
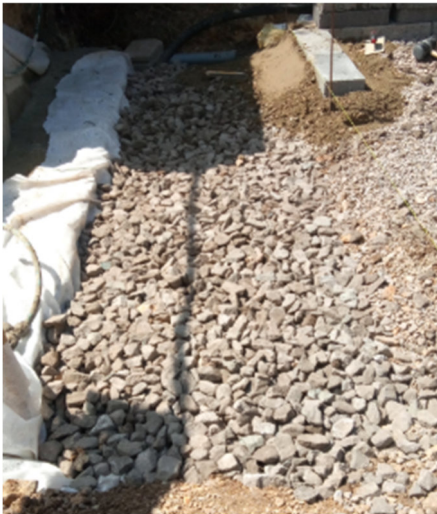
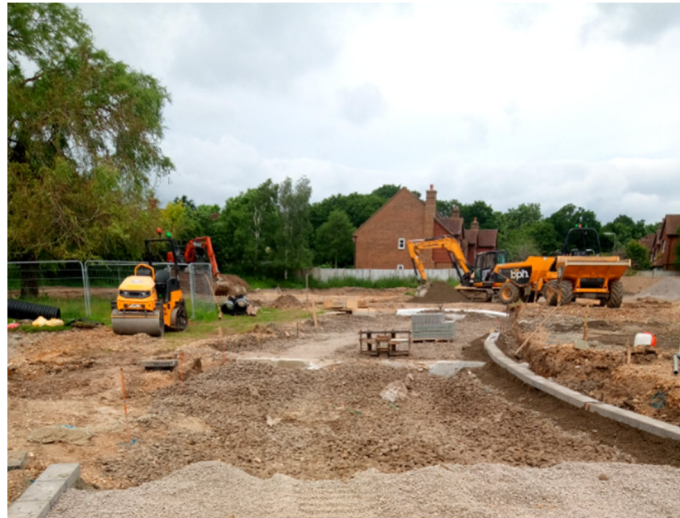
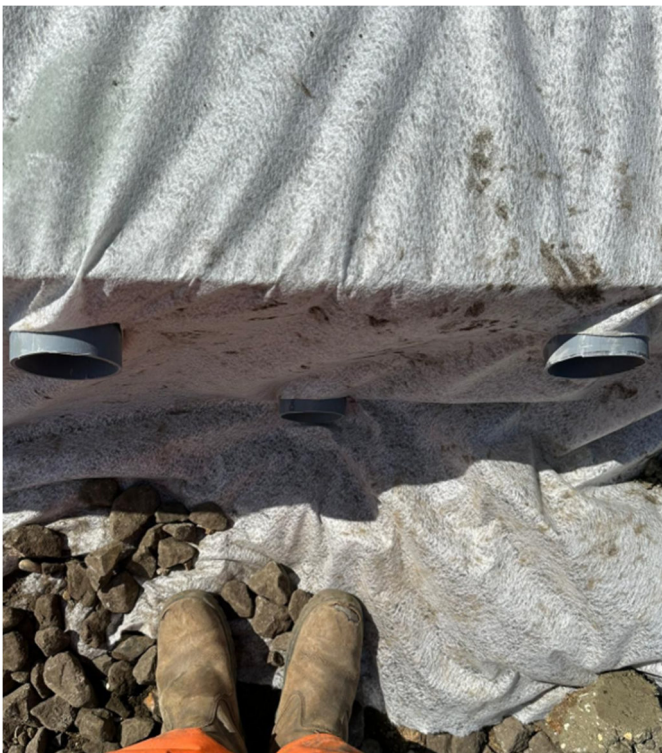
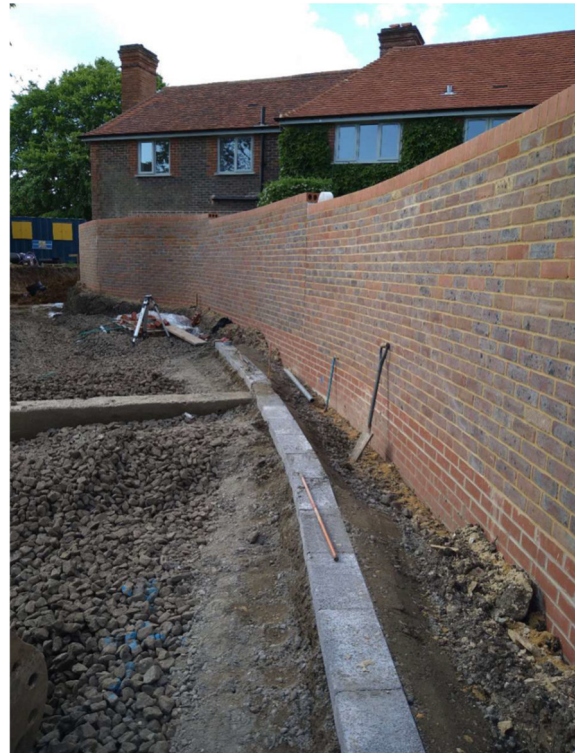
**Fig 6. Concrete Dam**

- 4.5 It was proposed that concrete dams were installed within the access road of the site to allow as much storage as possible with the sub-base of the paving. The photographs indicate that this was installed within the access road as per the design.

All concrete dams have been installed in accordance with the approved designs and as shown in the following photographs.

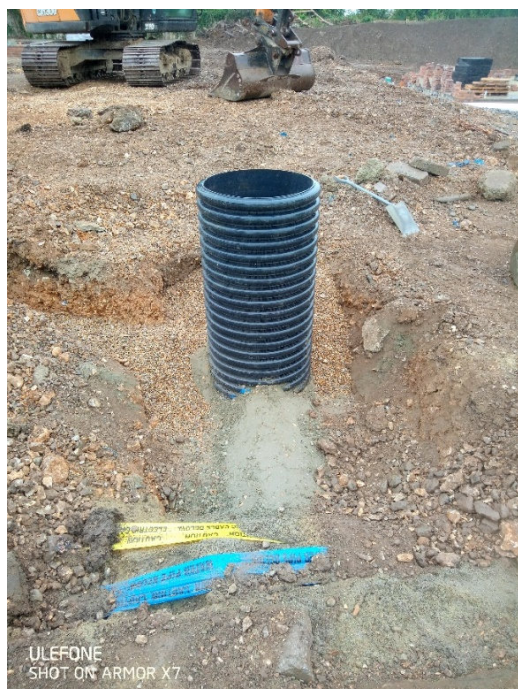
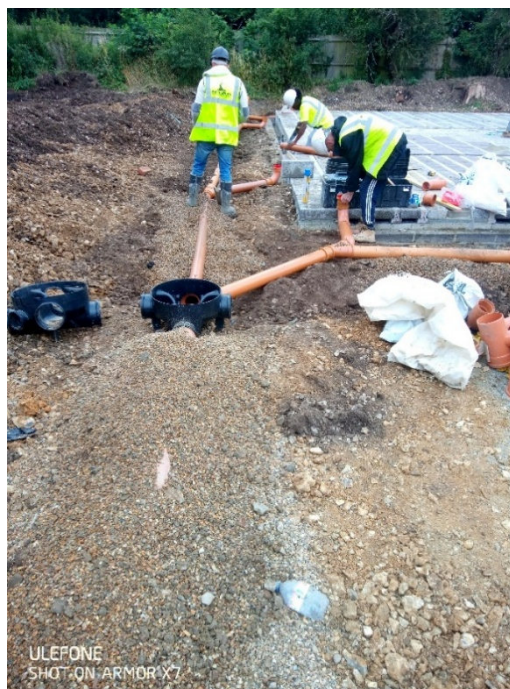
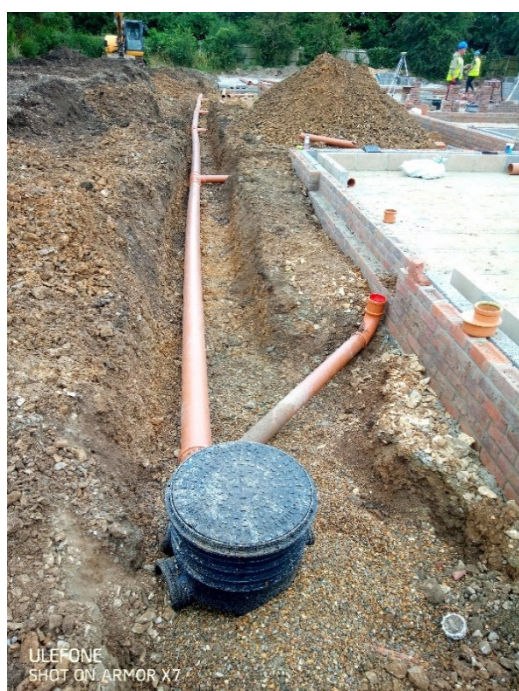
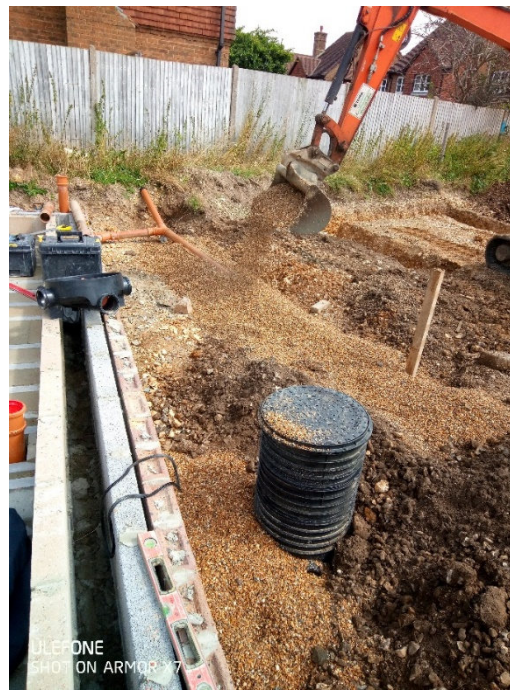
**Fig 7. Surface water inspection chambers**

- 4.6 This section will look at the installed chambers on site, in particular, the orifice flow control chambers that are proposed at the gravel trenches. The chambers looked to be installed correctly, and the drainage runs incoming align with what was on the proposed drainage layout.

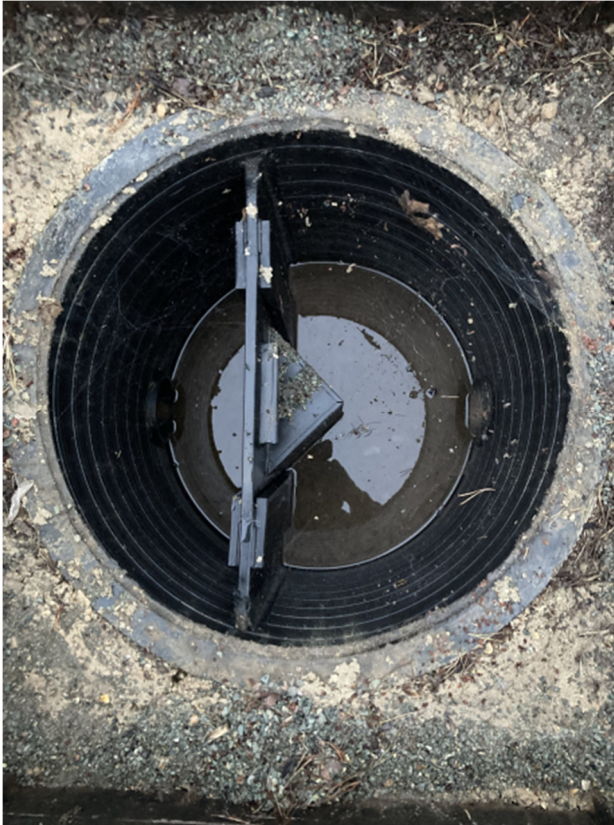
**No.30 (Drainage Plan Sheet 2)**

An orifice drain has been installed as shown below and marked as located on Drainage Plan Sheet 2.

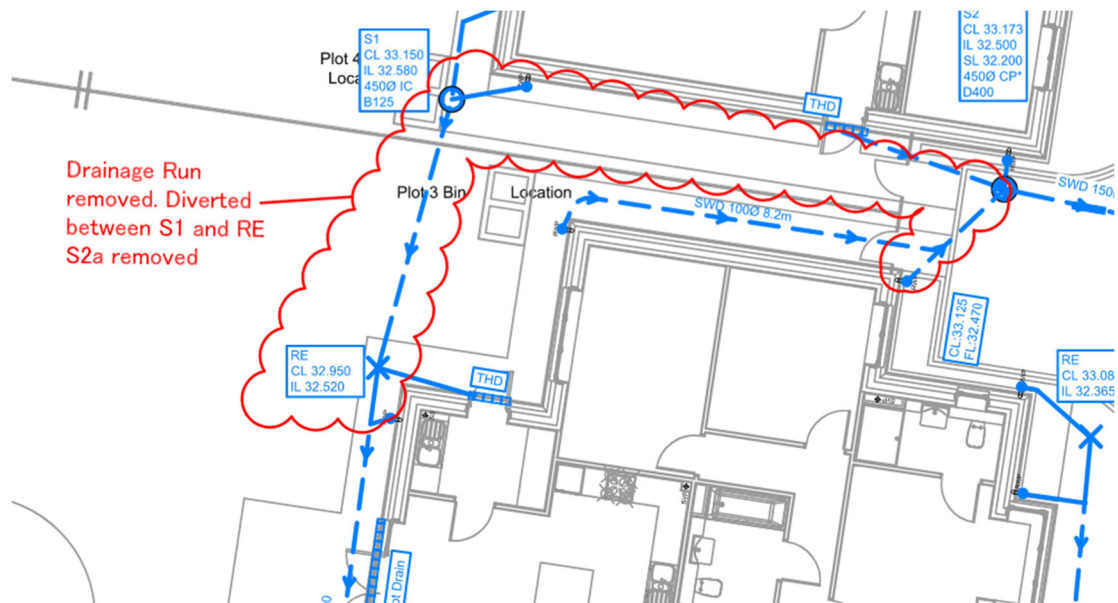
- 5.1 There are a few discrepancies between the approved drainage design and the drainage network that was installed on site. A copy of the marked up plan from the CCTV Surveyors will be supplied within **Appendix B**.
1. Chambers S1, S2a and S9 have not been installed on site with the associated drainage making the same connection downstream apart from S1 which has been diverted into the rodding eye which then discharges into S12. It should be noted that this has no impact on the effectiveness of the drainage network as the changes are minor.
