Inspection Report

| Site; Tye Lane<br>Place: Warblington | | Division:<br>District: S.W<br>Tape No: 1 | | Start MH: F31.1A<br>End MH: LAT 1<br>Total Length: | |
| Purpose:<br>Use:<br>Catchment: | Structural Defects<br>FOUL<br>P1 Schedule | Size/Shape: Circular dia 100mm<br>Material: PLASTIC<br>Lining:<br>Category: | | | |

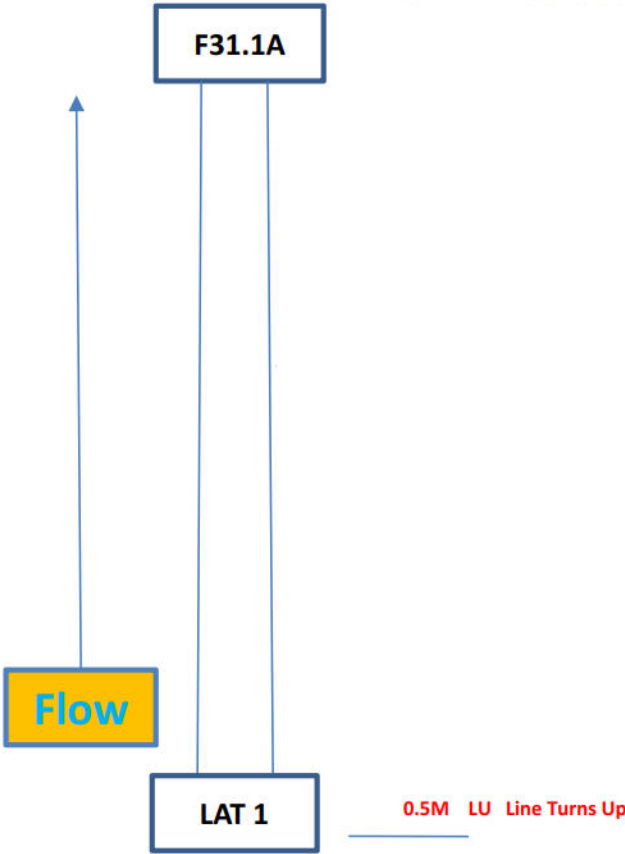
0.0M ST Start Of Survey  
0.0M WL Water Level 0%

REM ; THERE ARE NO DEFECTS WITH THIS SECTION OF PIPE
