Inspection Report

| Site; Tye Lane<br>Place: Warblington | | Division:<br>District: S.W<br>Tape No: 1 | | Start MH: F31.1A<br>End MH: LAT 2<br>Total Length: | |
| Purpose:<br>Use:<br>Catchment: | Structural Defects<br>FOUL<br>P1 Schedule | Size/Shape: Circular dia 100mm<br>Material: PLASTIC<br>Lining:<br>Category: | | | |

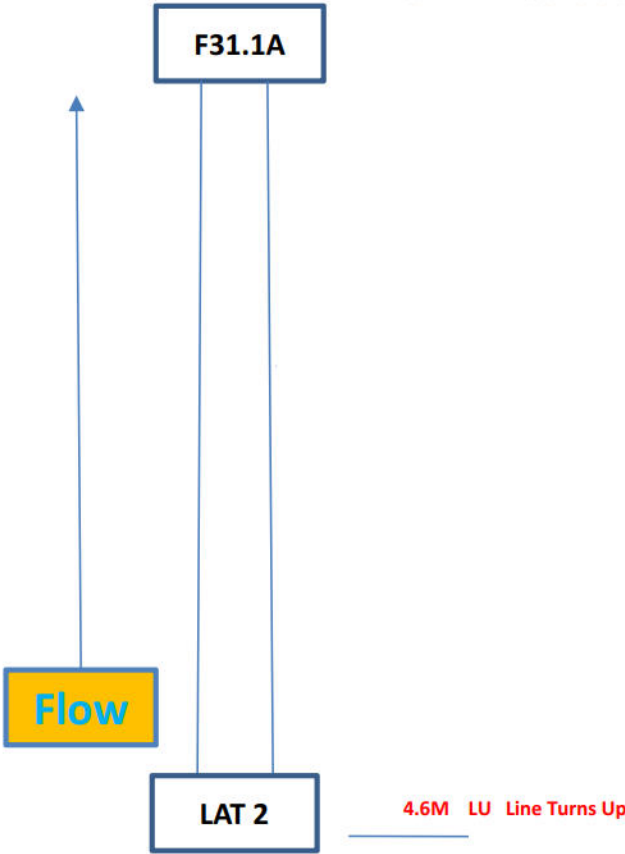
0.0M ST Start Of Survey  
0.0M WL Water Level 0%

REM ; THERE ARE NO DEFECTS WITH THIS SECTION OF PIPE
