Inspection Report

| Site; Tye Lane<br>Place: Warblington | | Division:<br>District: S.W<br>Tape No: 1 | | Start MH: F31.1A<br>End MH: F31.1B<br>Total Length: | |
| Purpose:<br>Use:<br>Catchment: | Structural Defects<br>FOUL<br>P1 Schedule | Size/Shape: Circular dia 100mm<br>Material: PLASTIC<br>Lining:<br>Category: | | | |

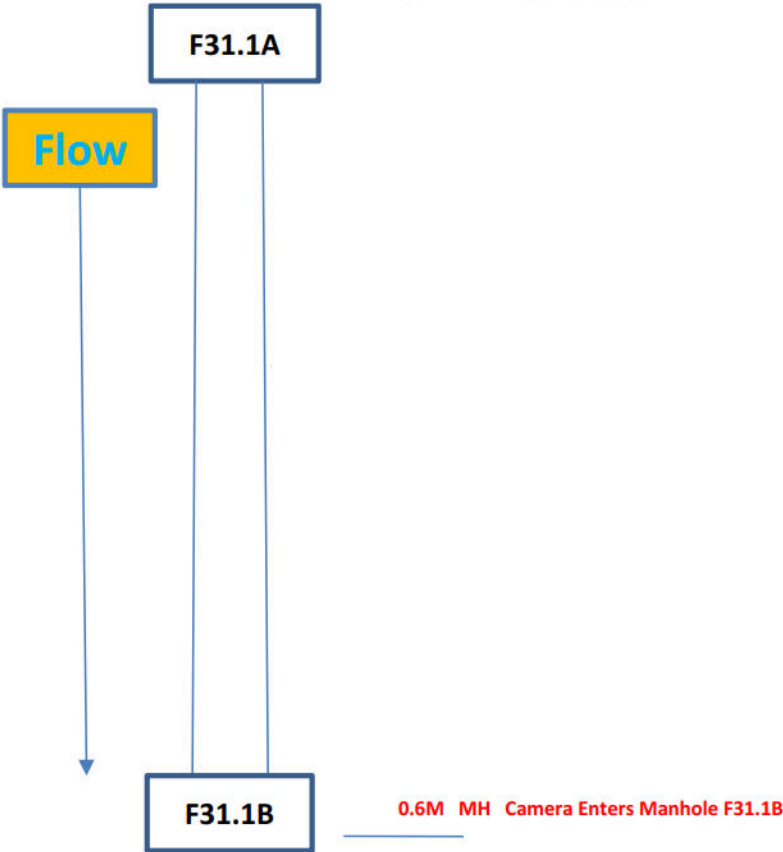
0.0M ST Start Of Survey  
0.0M WL Water Level 0%

REM ; THERE ARE NO DEFECTS WITH THIS SECTION OF PIPE
