Inspection Report

| Site; Tye Lane<br>Place: Warblington | | Division:<br>District: S.W<br>Tape No: 1 | | Start MH: F31.1B<br>End MH: LAT 1<br>Total Length: | |
| Purpose:<br>Use:<br>Catchment: | Structural Defects<br>FOUL<br>P1 Schedule | Size/Shape: Circular dia 100mm<br>Material: PLASTIC<br>Lining:<br>Category: | | | |

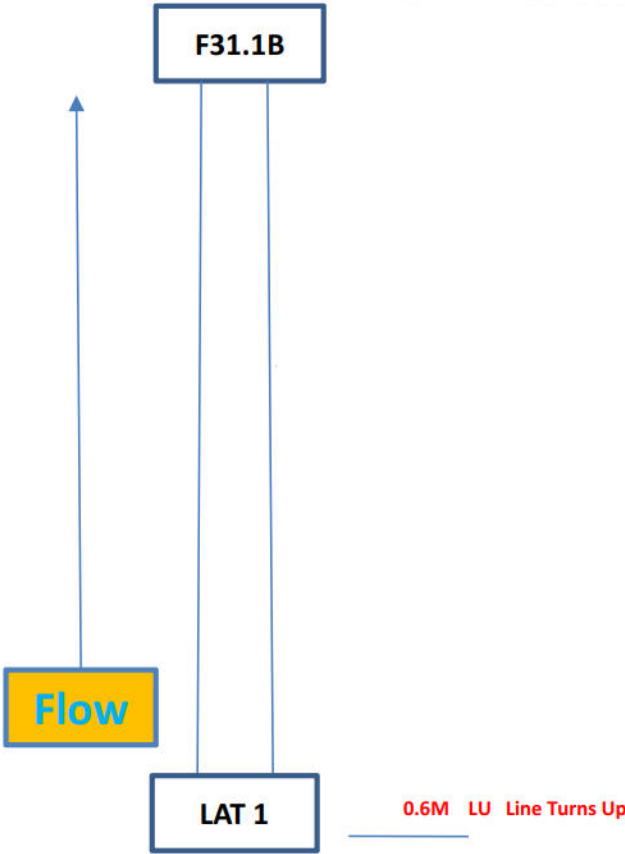
0.0M ST Start Of Survey  
0.0M WL Water Level 0%

REM ; THERE ARE NO DEFECTS WITH THIS SECTION OF PIPE
