Inspection Report

| Site; Tye Lane<br>Place: Warblington | | Division:<br>District: S.W<br>Tape No: 1 | | Start MH: F31.1B<br>End MH: LAT 2<br>Total Length: | |
| Purpose:<br>Use:<br>Catchment: | Structural Defects<br>FOUL<br>P1 Schedule | Size/Shape: Circular dia 100mm<br>Material: PLASTIC<br>Lining:<br>Category: | | | |

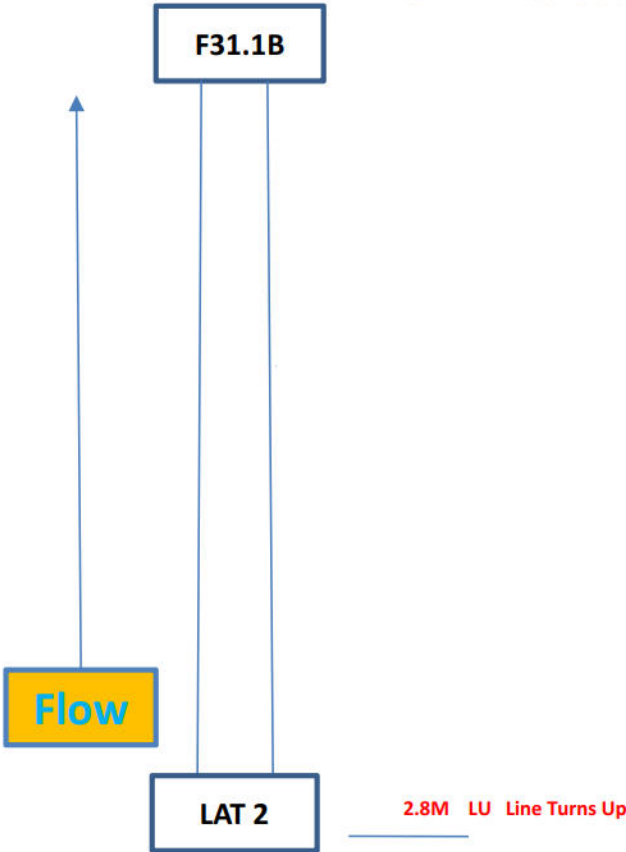
0.0M ST Start Of Survey  
0.0M WL Water Level 0%

REM ; THERE ARE NO DEFECTS WITH THIS SECTION OF PIPE
