Inspection Report

| Site; Tye Lane<br>Place: Warblington | | Division:<br>District: S.W<br>Tape No: 1 | | Start MH: F31.1B<br>End MH: F31.1<br>Total Length: | |

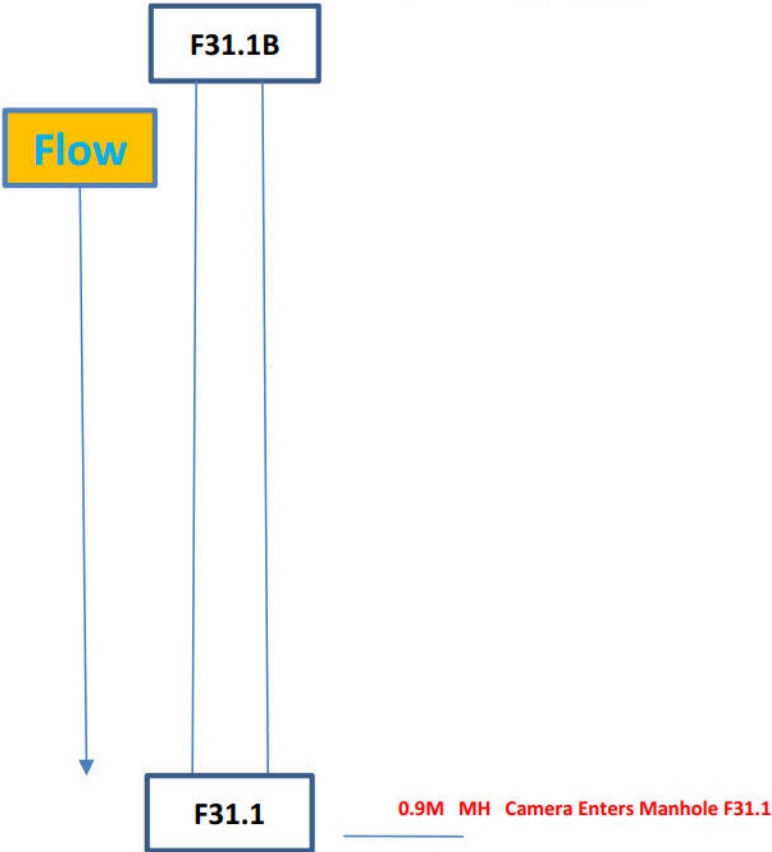
0.0M ST Start Of Survey  
0.0M WL Water Level 0%

REM ; THERE ARE NO DEFECTS WITH THIS SECTION OF PIPE
